PAPER 79-31

**ENGINEERING GEOLOGY AND GEOTECHNICAL
STUDY OF DRYNOCH LANDSLIDE, BRITISH COLUMBIA**

D.F. VANDINE

1980

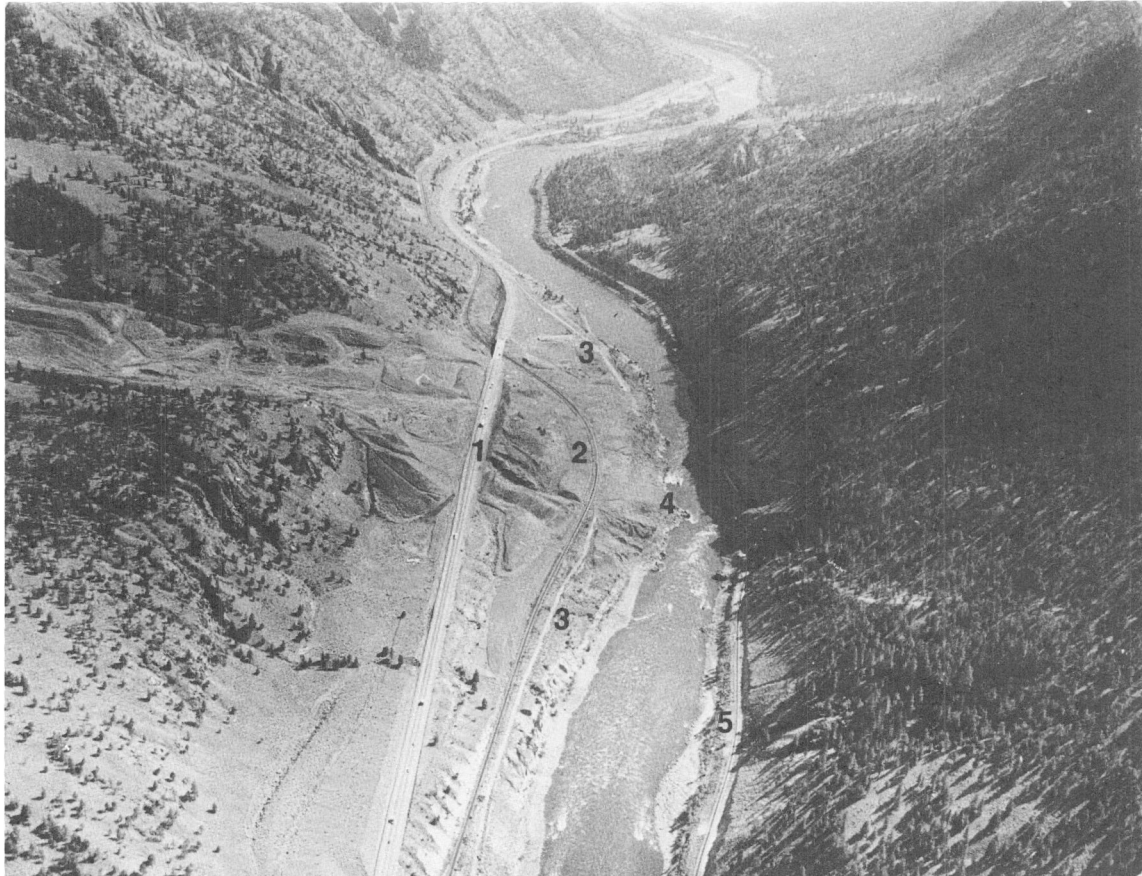
Figure 1. Oblique aerial photograph looking southward down lower Thompson Valley and across the toe of Drynoch landslide (to left). Transportation routes from left to right are:

- 1 - New Trans-Canada Highway;
- 2 - Canada Pacific railway;
- 3 - Old Trans-Canada Highway (note how the central portion has been disrupted);

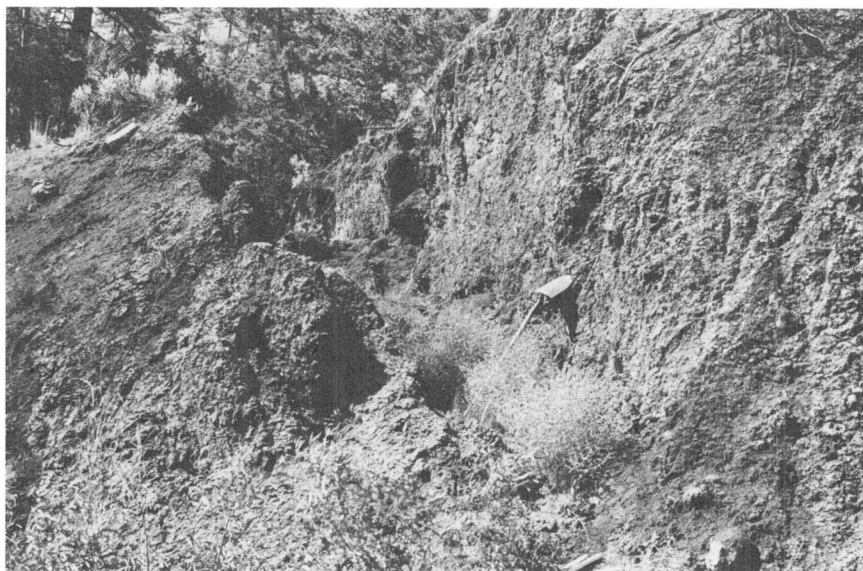
During site investigations, many small surface expressions of movement were noted. At the break in slope of the slide surface (Fig. 5A), about 900 m from Thompson River, large transverse tensions cracks up to 2 m wide have developed (Fig. 6) as well as smaller ones near the toe (Fig. 8) where material is constantly being eroded by the river. Longitudinal shear cracks have developed where the more rapidly moving central portion of the slide adjoins the slower moving areas or relatively stable sides (Fig. 7). Vegetated portions of Drynoch landslide, especially those areas at higher elevations, indicate movement by a bent configuration of trees. In two areas within the slide, one approximately

Figure 6. Large tension crack at break in slope of Drynoch landslide; the crack is 1.8 m wide and more than 3 m deep. (GSC 175637)

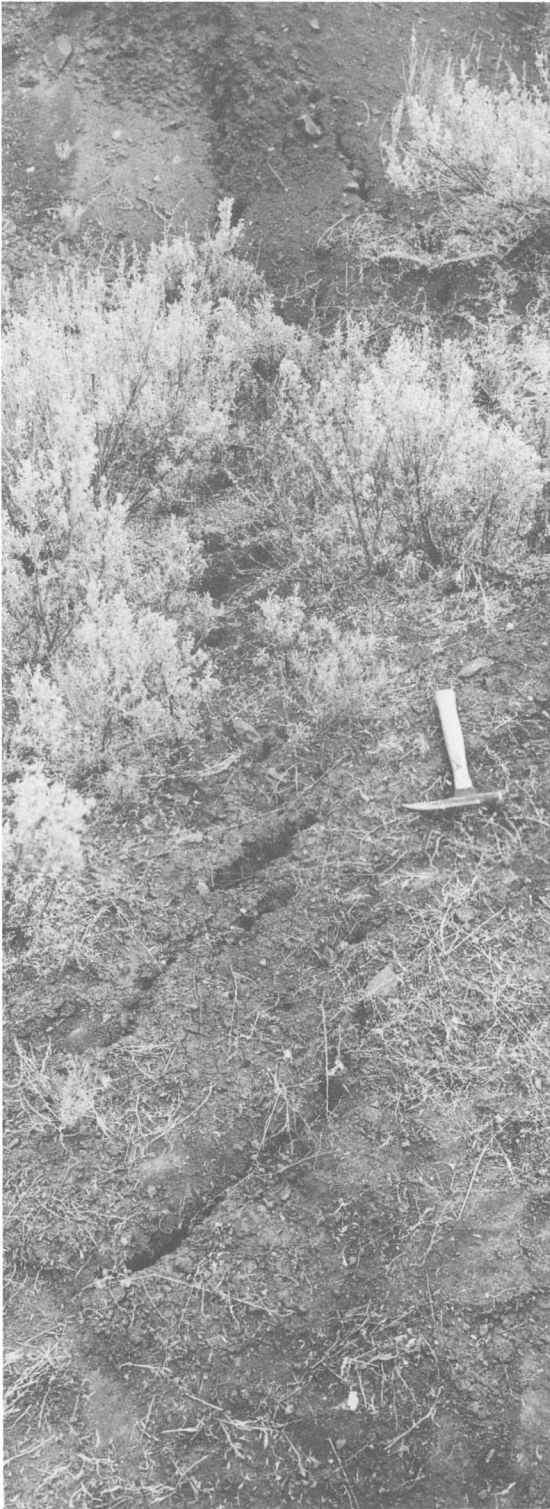
Figure 7. Shear cracks developed within Drynoch landslide. Direction of movement is indicated by the head end of the hammer. (GSC 175690-1)

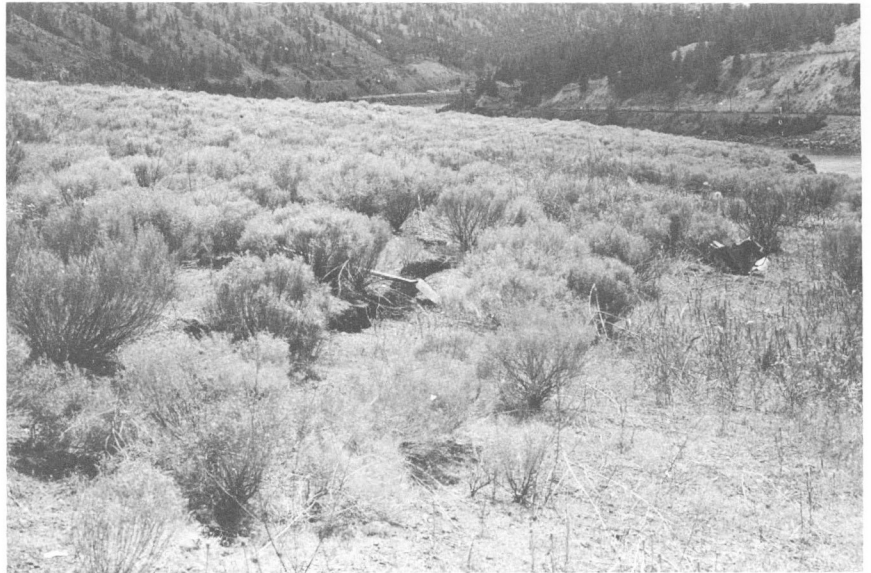
Figure 8. View looking south across the toe of Drynoch landslide showing tension crack of incipient toe failure. Shovel is 1.3 m long. Sage is typical of vegetation on lower portion of landslide. (GSC 175625)

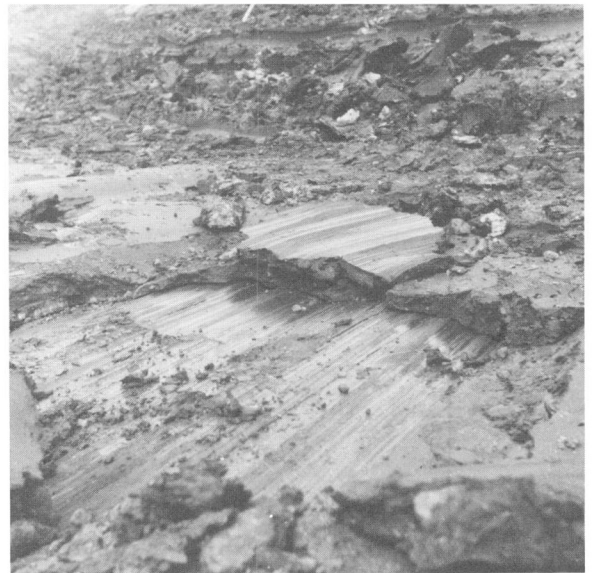
1.2 km east of Thompson River and the other in the gravel pit exposure, slickensides have been noted (Fig. 9) by various observers.

Figure 9. Large slickensides and fluting found on failure plane of Drynoch landslide. Failure plane was exposed in 1961 during construction activity. Photo by British Columbia Department of Highways.

During highway construction in 1961, roots were uncovered along a failure plane of the slide and were dated at 3175 ± 150 years (I-462, Armstrong and Fulton, 1965, p. 103). Charcoal from an Indian fire pit (found by the writer) in the upper portion of the slide has been dated at 900 ± 50 years (GSC-2056). These dates provide little information on the historical movement of the slide except that it was probably moving about 3000 years ago and that the upper portion was relatively stable about 1000 years ago. No precise date for beginning of movement has been found, but it is evident that the slide debris overrode the exposed Mazama ash after 6600 years ago.

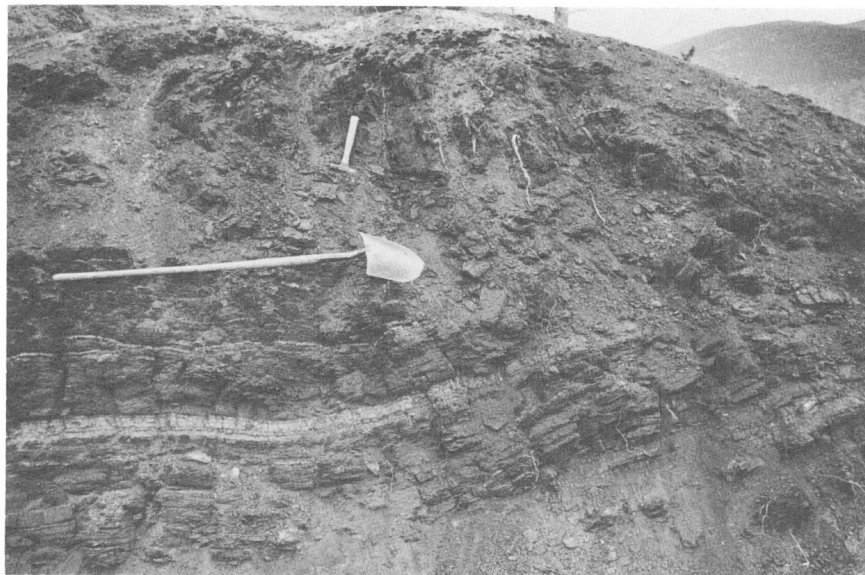
Figure 13. Outcrop of folded Tertiary sedimentary beds north of Drynoch landslide. Dark bands are mudstone and shale; light bands are sandstone beds. (GSC 175668)

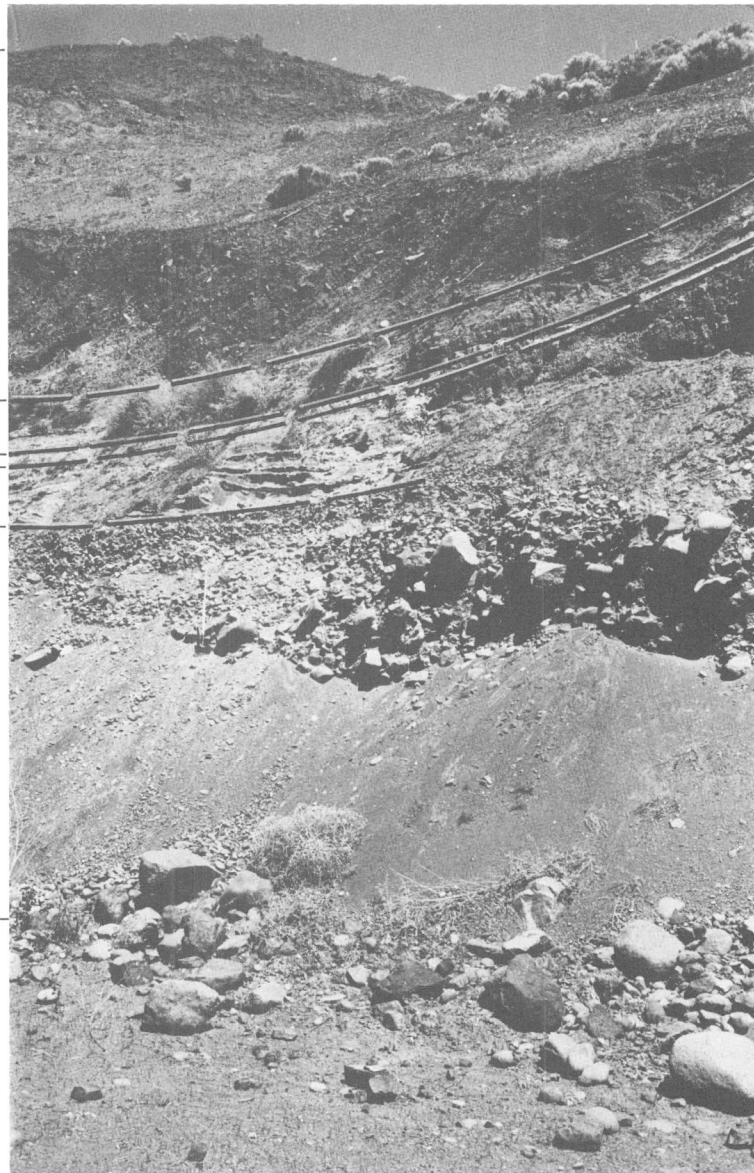
Figure 15

An exposure of unconsolidated material found in a gravel pit near the toe of Drynoch landslide. Shovel is approximately 1.3 m long. (GSC 175588)

The Quaternary history of the immediate Drynoch landslide locality has been interpreted by R.J. Fulton (pers. comm., 1968) from an exposure in a gravel pit near the toe of the landslide (Fig. 15). The lower 6 m of the exposure consists of the upper fluvial sand and gravel terrace mentioned previously. Up to 0.6 m of eolian sand lies in a depression on top of the river terrace. Charcoal and cultural material found in the sand have been dated at 7530 years (GSC-530, Lowden et al., 1969, p. 31), indicating that Thompson River had receded and the shore could support human activity by that time. Less than 3.7 m of poorly sorted and washed gravel in a sandy matrix overlies the sand; the deposit dips to the west and probably originated from an alluvial fan on Squianny Creek. Alluvial fans are characteristic at the mouths of most major creeks in the area. A volcanic ash lens up to 5 cm thick is found within the fan

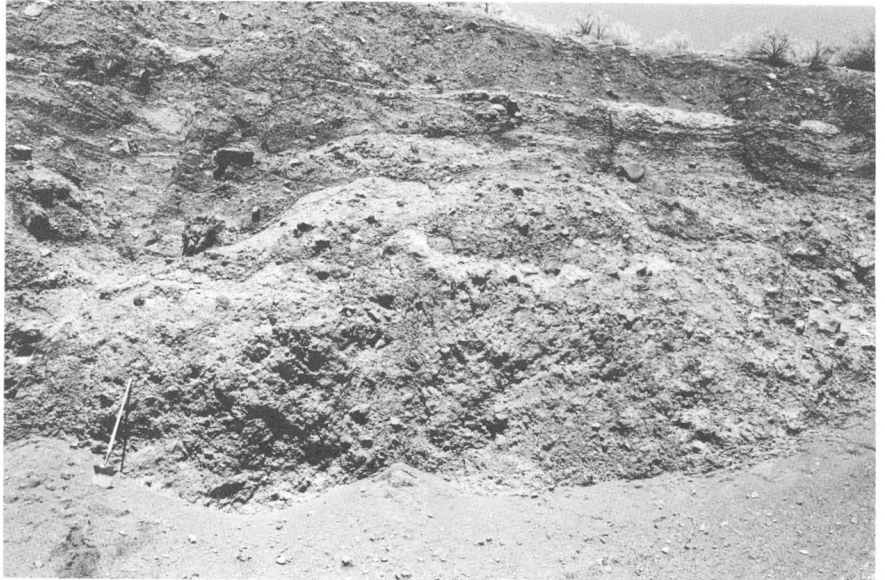
Figure 16

Slide debris exposed on the north side of Drynoch landslide. Note the variety of grain size of granular material and the flow patterns within the exposure. Shovel is approximately 1.3 m long. (GSC 175589)

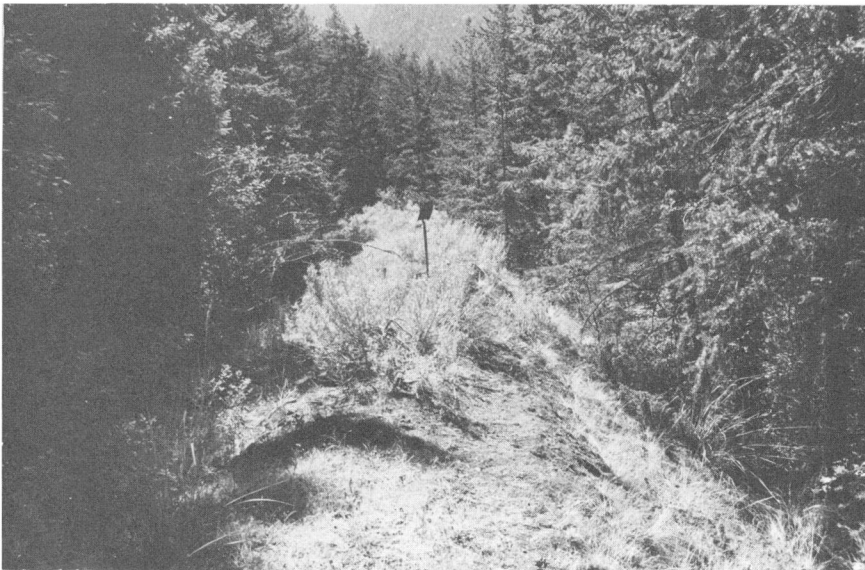
Figure 17

A ridge, resembling a lateral moraine, on south side of Drynoch landslide. The slide is to the right of the photograph. Shovel is approximately 1.3 m long. (GSC 175646)

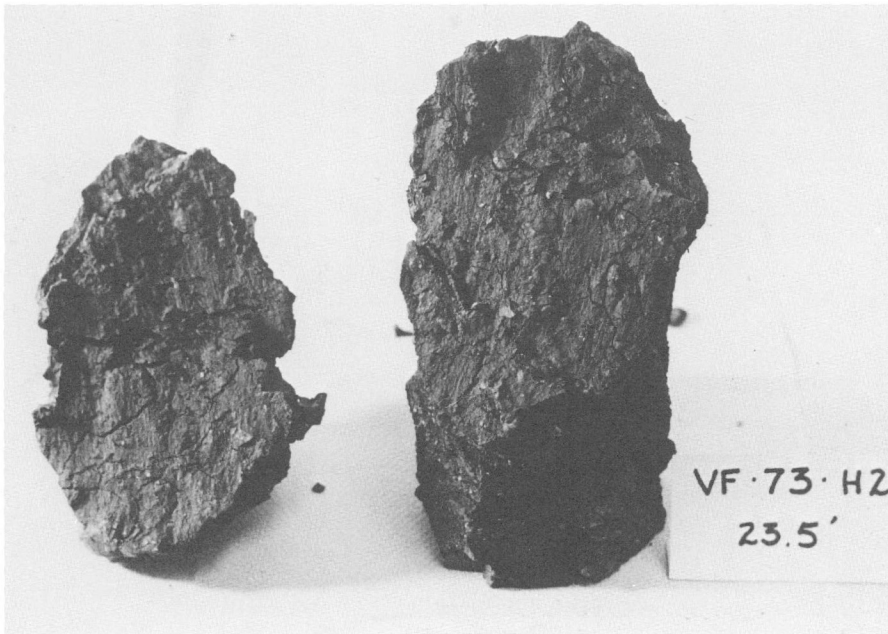
Figure 24 shows slickenside features developed on the failure plane of a sample from 23.5 feet depth in testhole 2. Slickensides generally indicate alignment of clay particles and subsequent residual shear strength characteristics. Even though the strain controlled tests were taken to an axial strain of 10.8%, no significant strain softening occurred (Fig. 25).

Photograph showing slickensides formed during a laboratory triaxial shear test on a 8.56 cm diameter sample from debris of Drynoch landslide. Photo by Queen's University.
