NOEICK VALLEY AND ADJACENT GLACIERS:
INVENTORY OF
JÖKULHLAUP-INDUCED GEOMORPHIC CHANGES
AND
INDUSTRIAL-COMMERCIAL DAMAGE

MAP 2

Geology, hydrology and glaciology observations and data compiled by K. Ricker, Consultant.
Forestry losses compiled by R. Lenzi, Crown Forest Industries Ltd., Hagensborg, B.C.

Feb. 20, 1985

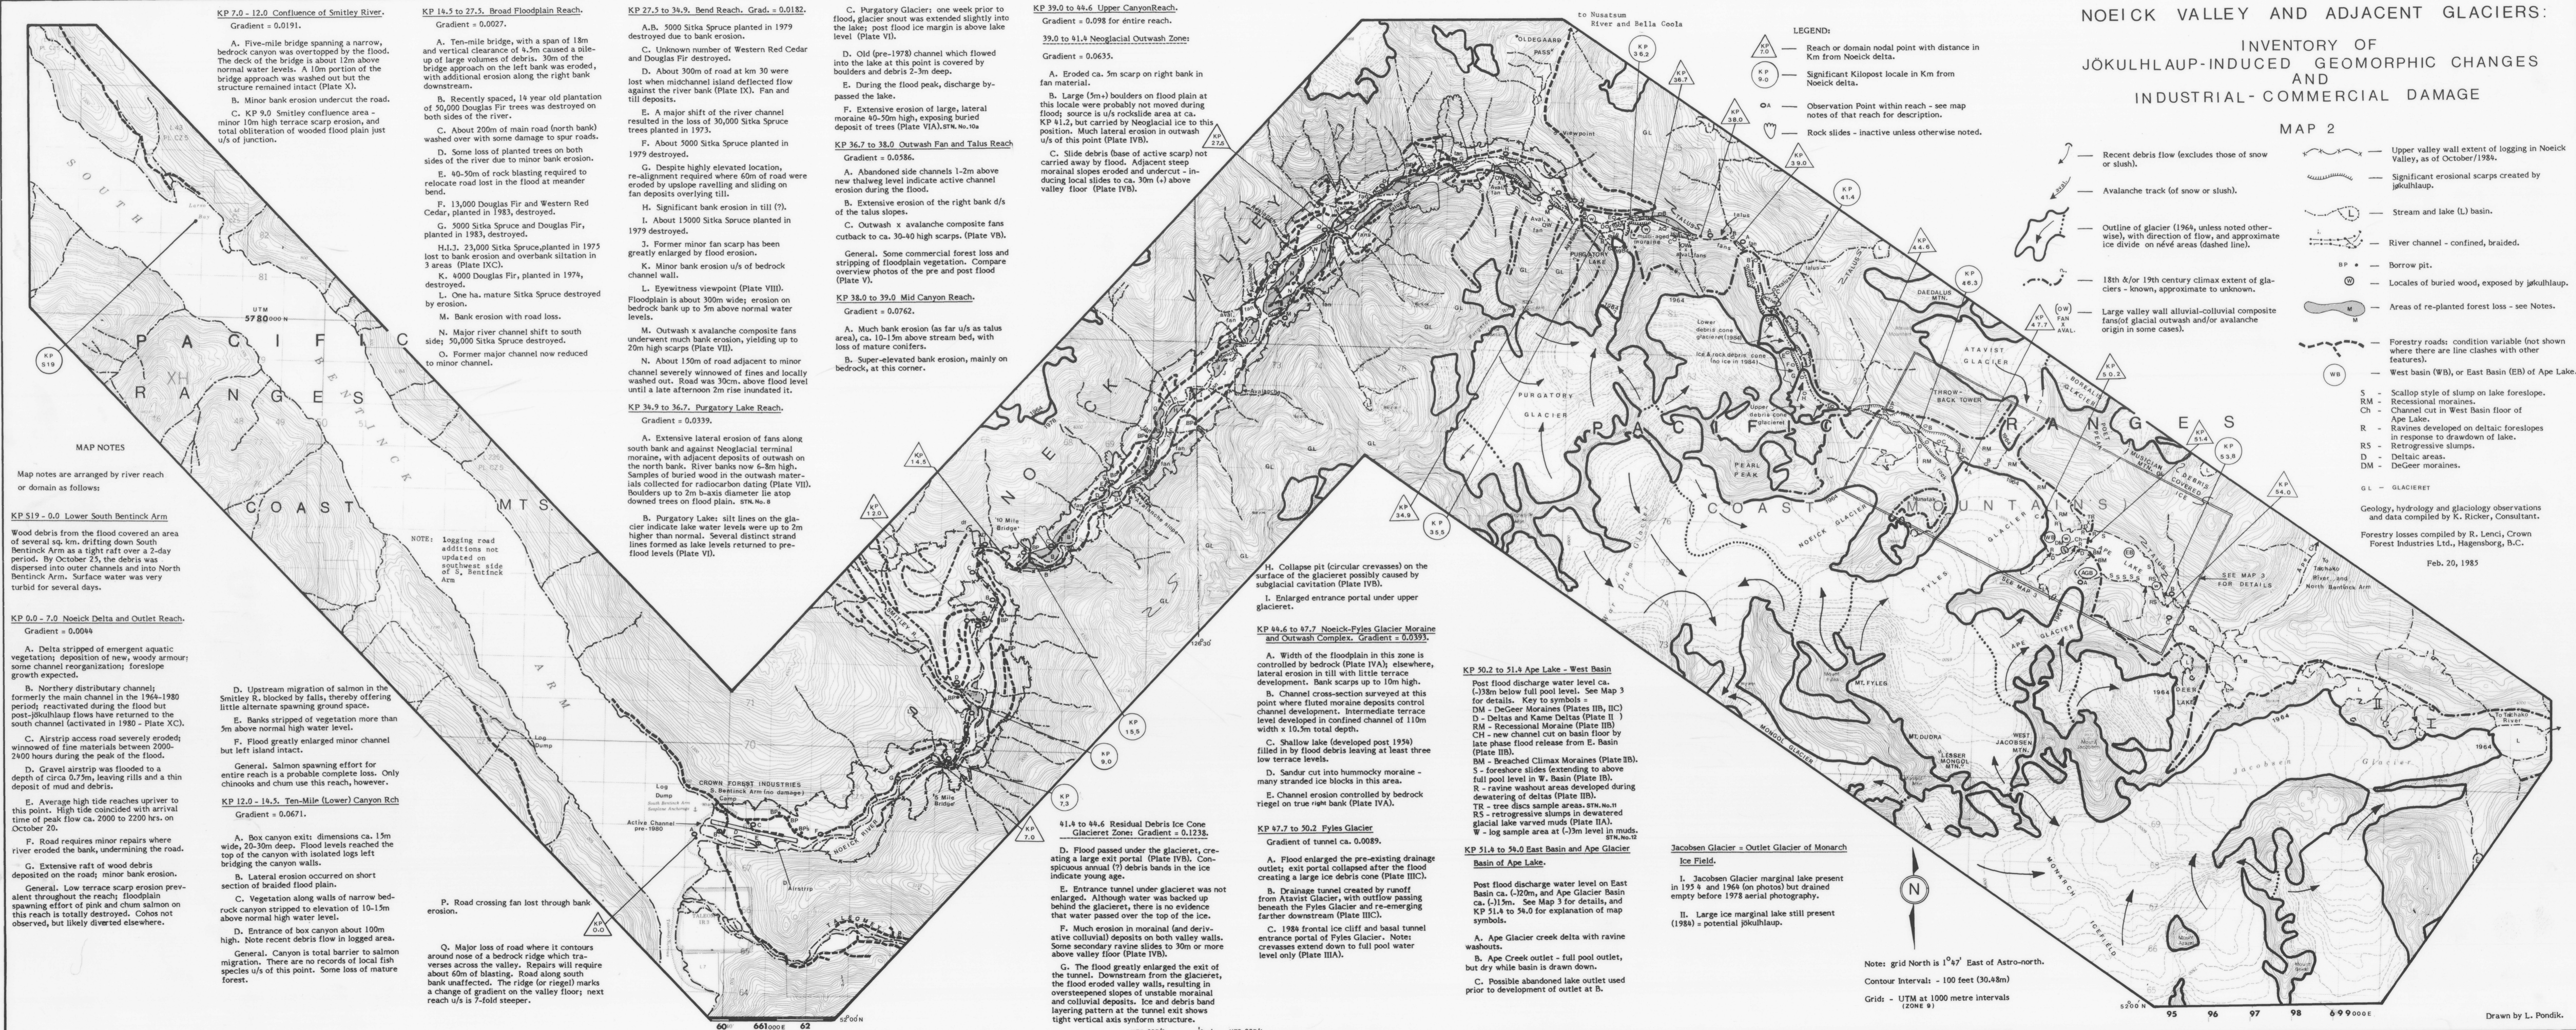
A. Five-mile bridge spanning a narrow, bedrock canyon was overtopped by the flood. The deck of the bridge is about 12m above normal water levels. A 10m portion of the bridge approach was washed out but the structure remained intact (Plate X).

C. KP 9.0 Smitley confluence area - minor 10m high terrace scarp erosion, and total obliteration of wooded flood plain just u/s of junction.

A. Ten-mile bridge, with a span of 18m and vertical clearance of 4.5m caused a pile-up of large volumes of debris. 30m of the bridge approach on the left bank was eroded, with additional erosion along the right bank downstream.

C. About 200m of main road (north bank) washed over with some damage to spur roads.

E. 40-50m of rock blasting required to relocate road lost in the flood at meander bend.

H.I. 23,000 Sitka Spruce, planted in 1975 lost to bank erosion and overbank siltation in 3 areas (Plate IXC).

N. Major river channel shift to south side; 50,000 Sitka Spruce destroyed.

D. About 300m of road at km 30 were lost when midchannel island deflected flow against the river bank (Plate IX). Fan and till deposits.

G. Despite highly elevated location, re-alignment required where 60m of road were eroded by upslope raveling and sliding on fan deposits overlying till.

N. About 150m of road adjacent to minor channel severely winnowed of fines and locally washed out. Road was 30cm. above flood level until a late afternoon 2m rise inundated it.

A. Extensive lateral erosion of fins along south bank and against Neoglacial terminal moraine, with adjacent deposits of outwash on the north bank. River banks now 6-8m high. Samples of buried wood in the outwash materials collected for radiocarbon dating (Plate VII). Boulders up to 2m b-axis diameter lie atop downed trees on flood plain. STK No. 8

D. Flood passed under the glacieret, creating a large exit portal (Plate IVB). Conspicuous annual (?) debris bands in the ice indicate young age.

G. The flood greatly enlarged the exit of the tunnel. Downstream from the glacieret, the flood eroded valley walls, resulting in oversteepened slopes of unstable morainal and colluvial deposits. Ice and debris band layering pattern at the tunnel exit shows tight vertical axis symform structure.

A. Flood enlarged the pre-existing drainage outlet; exit portal collapsed after the flood creating a large ice debris cone (Plate IIIIC).

C. Airstrip access road severely eroded; winnowed of fine materials between 2000-2400 hours during the peak of the flood.

D. Gravel airstrip was flooded to a depth of circa 0.75m, leaving rills and a thin deposit of mud and debris.

Q. Major loss of road where it contours around nose of a bedrock ridge which traverses across the valley. Repairs will require about 60m of blasting. Road along south bank unaffected. The ridge (or riegel) marks a change of gradient on the valley floor; next reach u/s is 7-fold steeper.
