**GEOLOGICAL SURVEY OF CANADA
OPEN FILE 1999**

**THE 1988 SAGUENAY EARTHQUAKE –
A SITE VISIT REPORT**

Denis Mitchell¹, René Tinawi² and Tim Law³

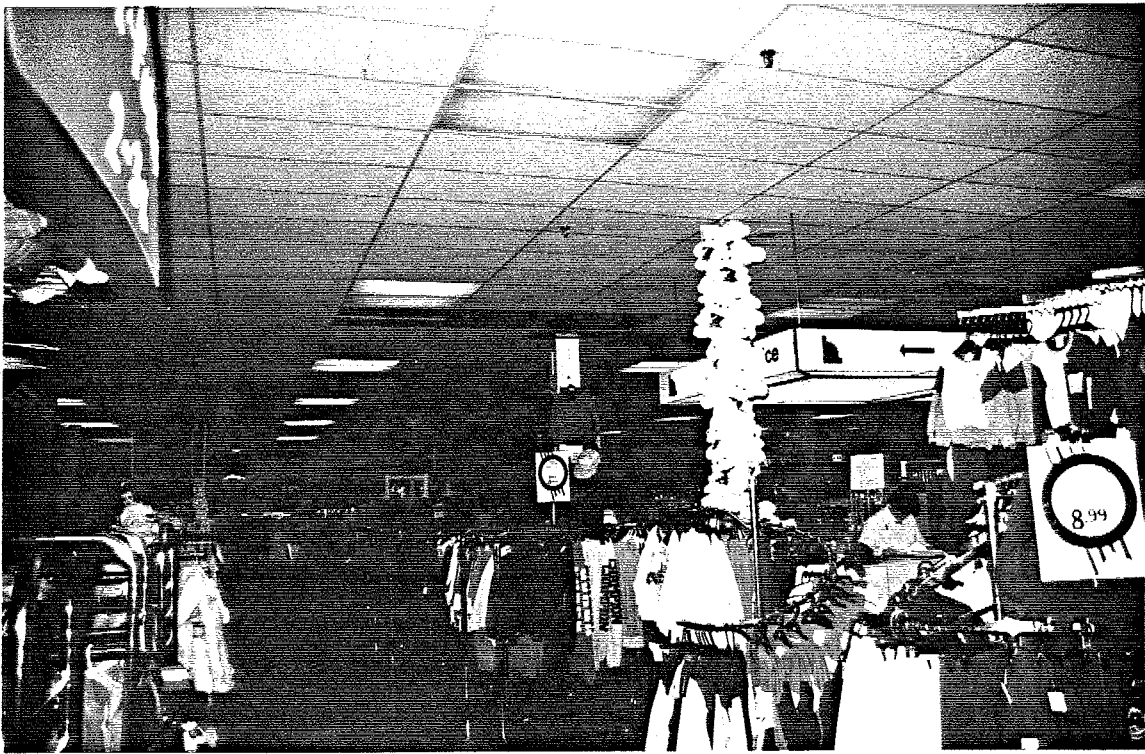
Place du Royaume is an indoor shopping plaza located on Boulevard Talbot. This one-storey structure has a structural system of light structural steel framing with infilled unreinforced masonry consisting of hollow concrete blocks. Figures 2.3 and 2.4 illustrates minor architectural damage in the Bay store, due to fallen ceiling tiles. As can be seen from Fig. 2.4 the ceiling tiles rested on standard inverted-tee supports which in turn were hung from the open-web steel joists of the roof framing by vertical hangers only. It is believed that the relatively long spans together with the lack of inclined hangers for the tee-bar supports resulted in differential movements of the very flexible tee-bars.

Figure 2.3 Damage to ceiling tiles in The Bay Store at Place du Royaume Shopping Plaza.

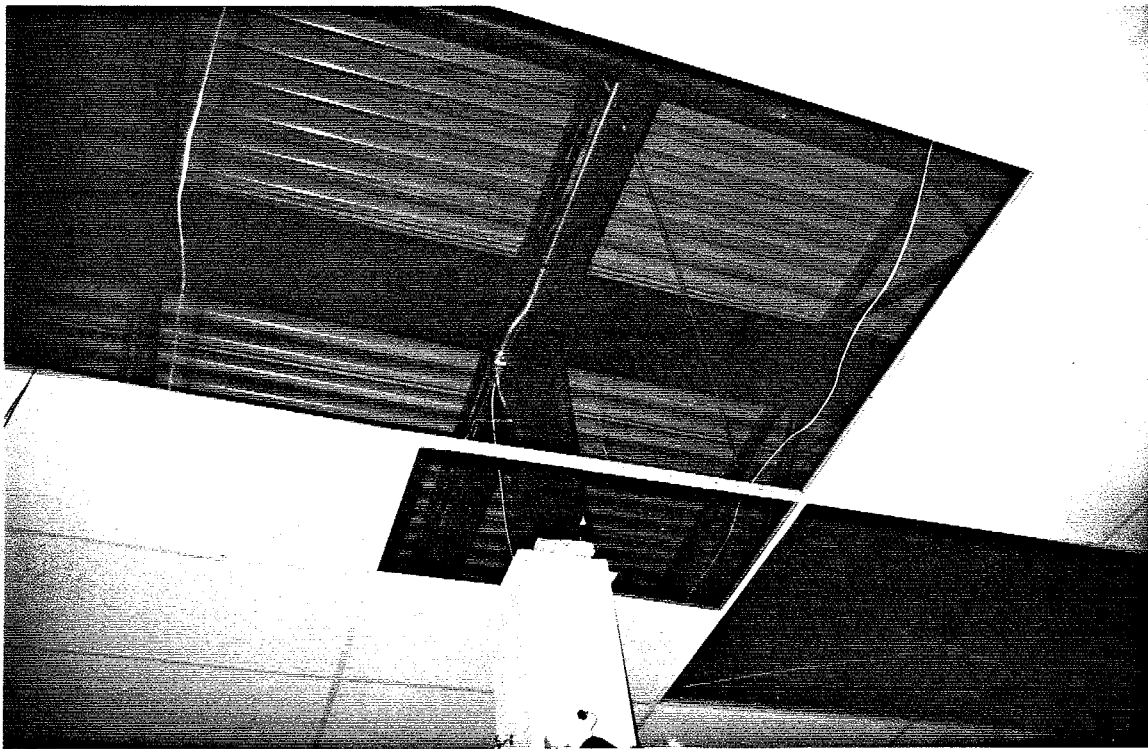
Figure 2.4 Close-up of supports for ceiling tiles.

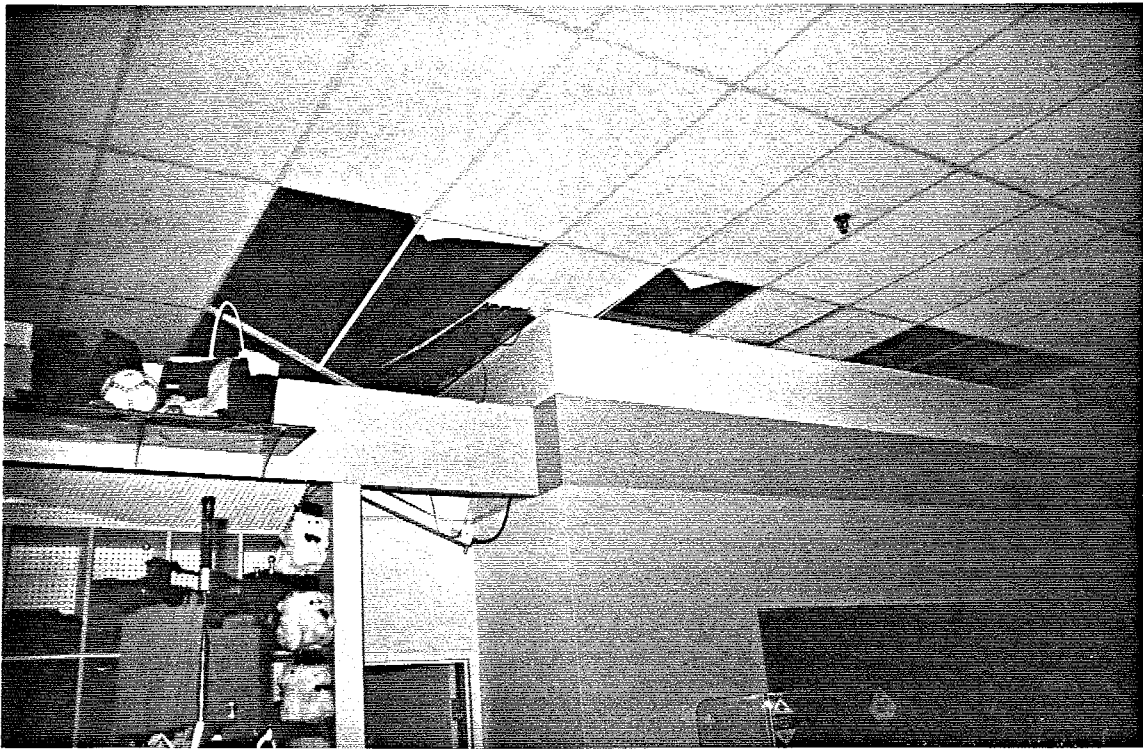
Figure 2.5 illustrates damage to the ceiling tile due to fallen masonry blocks from the topmost layer of the walls. Figure 2.6 shows an unreinforced masonry wall in which some of the remaining blocks of the top layer have been removed after the earthquake.

Figure 2.5 Damaged ceiling tiles due to fallen masonry blocks in The Bay store.

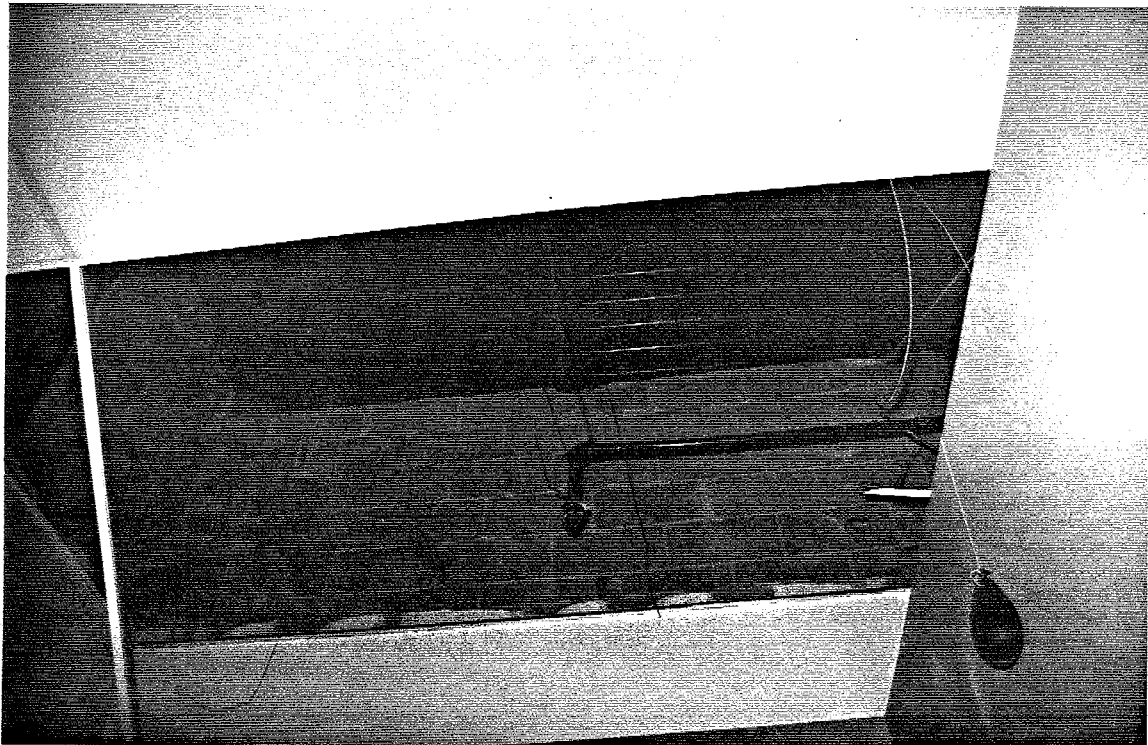
Figure 2.6 Masonry blocks with the top layer removed after the earthquake.

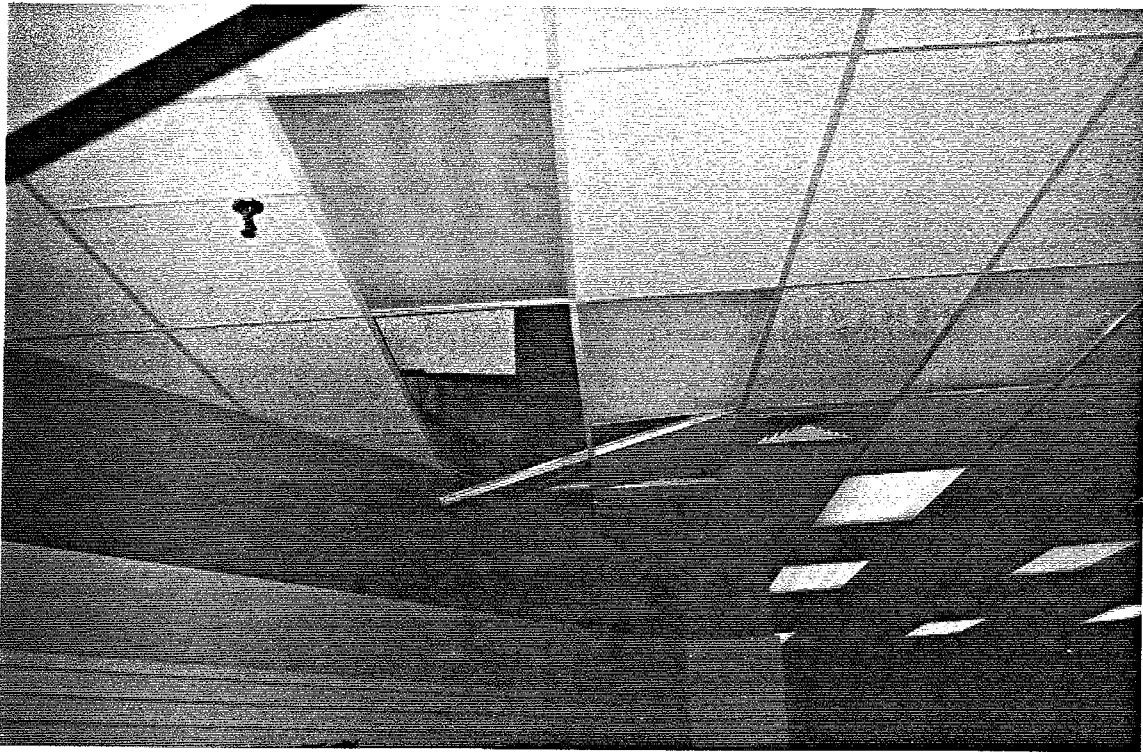
Similar problems were encountered in the Kébec Disque store of the same shopping plaza. Figure 2.7 shows damage to the ceiling tile due to fallen masonry blocks and Fig. 2.8 shows a lighting fixture that had fallen in the storage room due to inadequate support.

Figure 2.7 Damaged ceiling tiles due to fallen masonry blocks at Kébec Disque store in Place du Royaume Shopping Plaza.

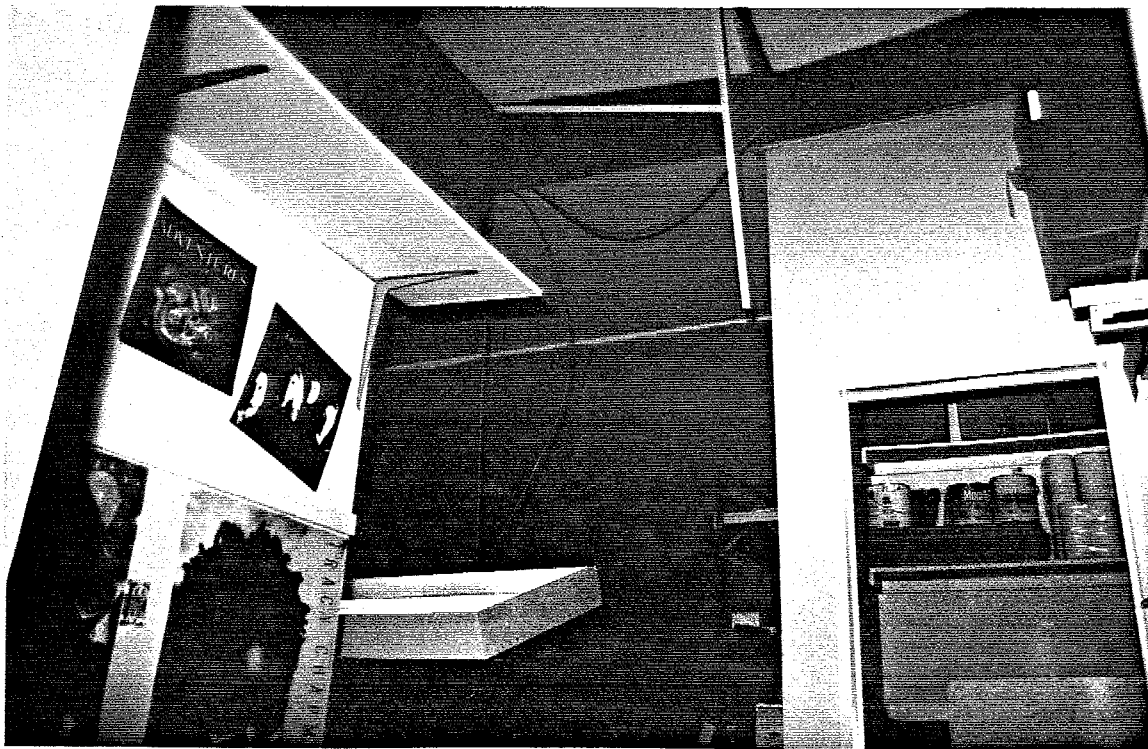
Figure 2.8 Damage to light fixture in Kébec Disque store due to loss of support.

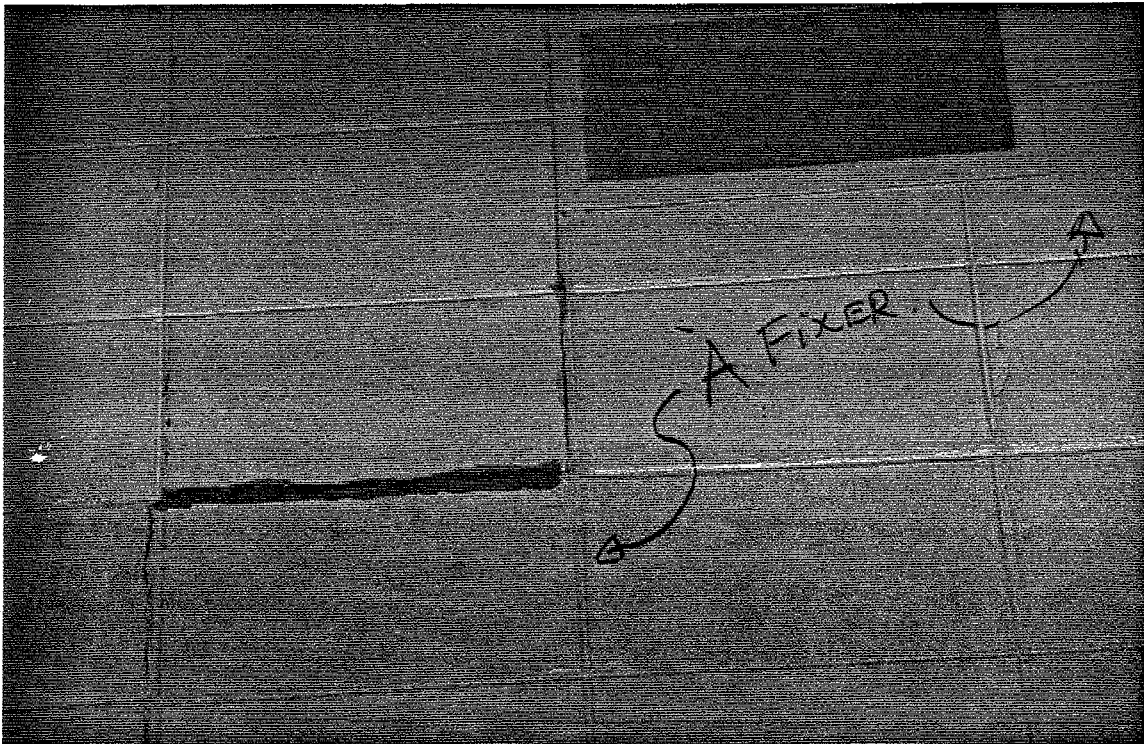
Figure 2.10 Cracking of joints in masonry blocks in Dominique Racine school.

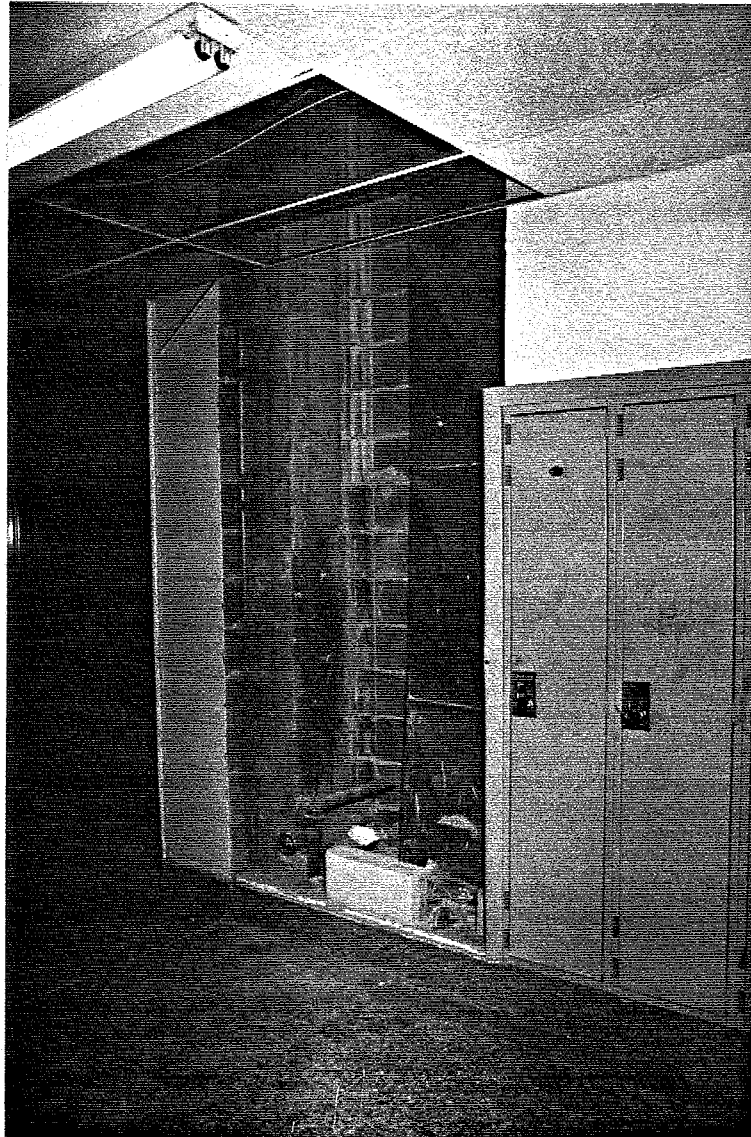
Figure 2.11 Collapse of masonry blocks in corridor of Dominique Racine school.

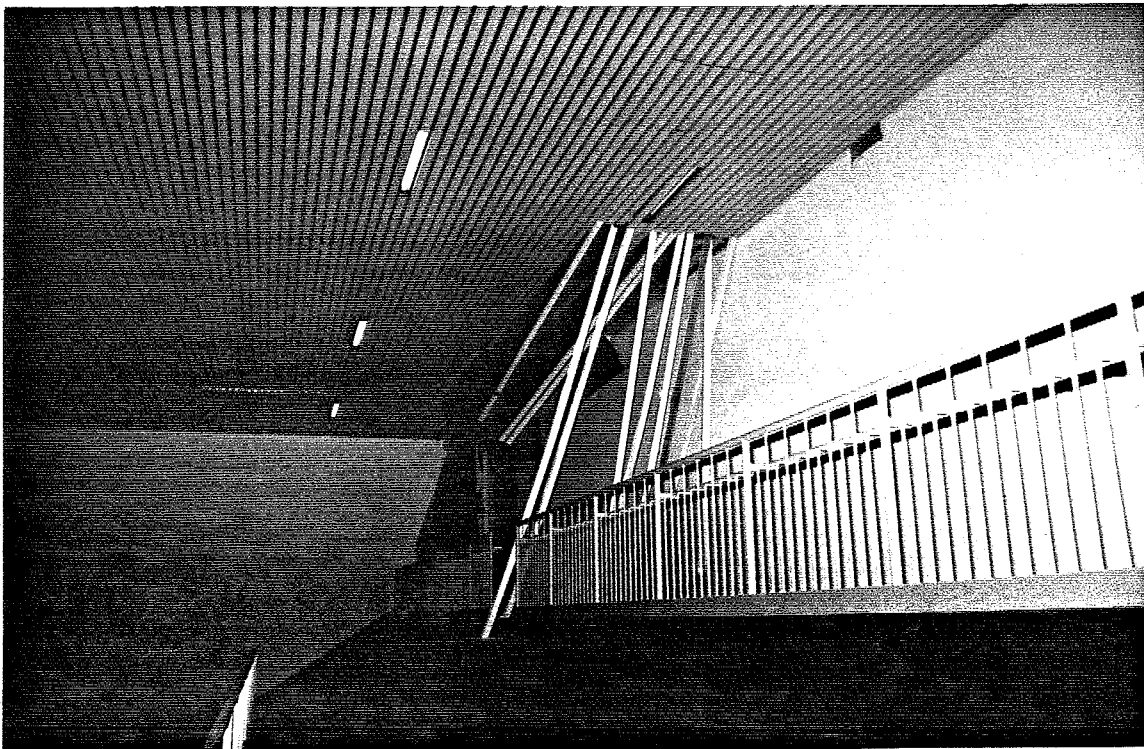
Figure 2.17 shows severe damage to the ceiling above the corridor and the seating area of the swimming pool located in the new wing. It is apparent from Fig. 2.18 that the damage to the ceiling was caused by falling masonry blocks which occurred over a length of 16 feet. Figures 2.19 and 2.20 show that the five top rows of 4 in. x 4 in. x 16 in. long hollow blocks had fallen. The unreinforced masonry was of "stack- block" construction and had no visible connection to the structural framing.

Figure 2.17 Damage to ceiling Dominique Racine school.

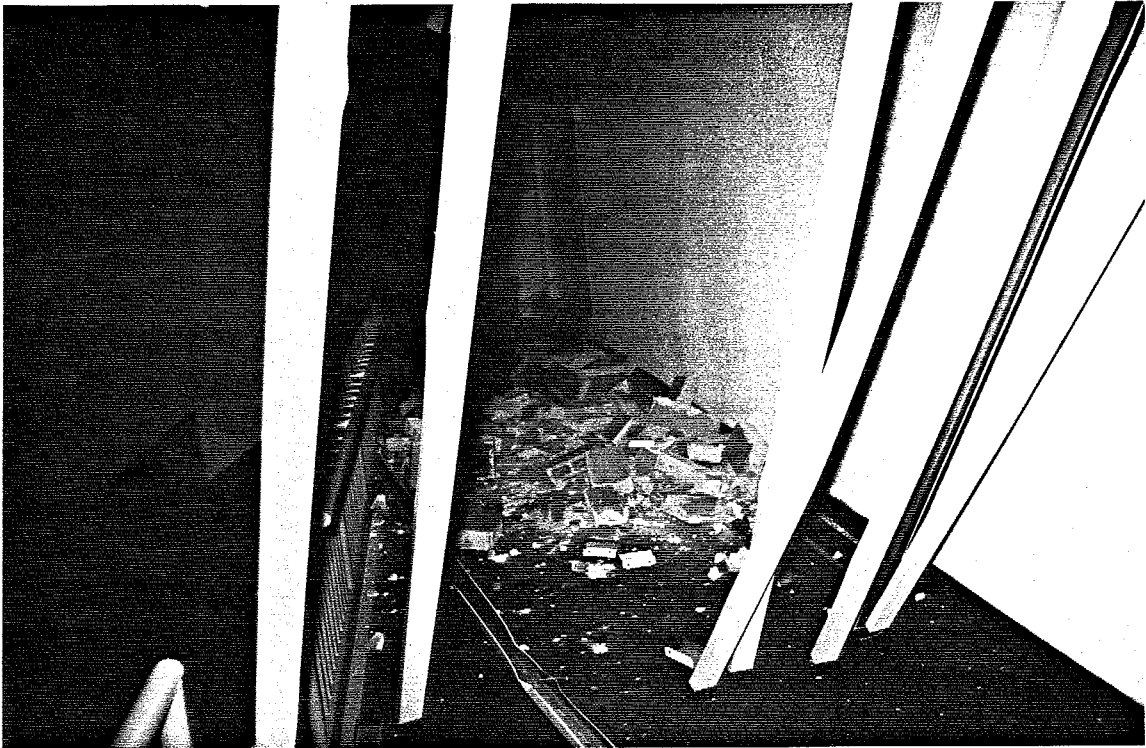
Figure 2.18 Debris from fallen masonry blocks in Dominique Racine school.

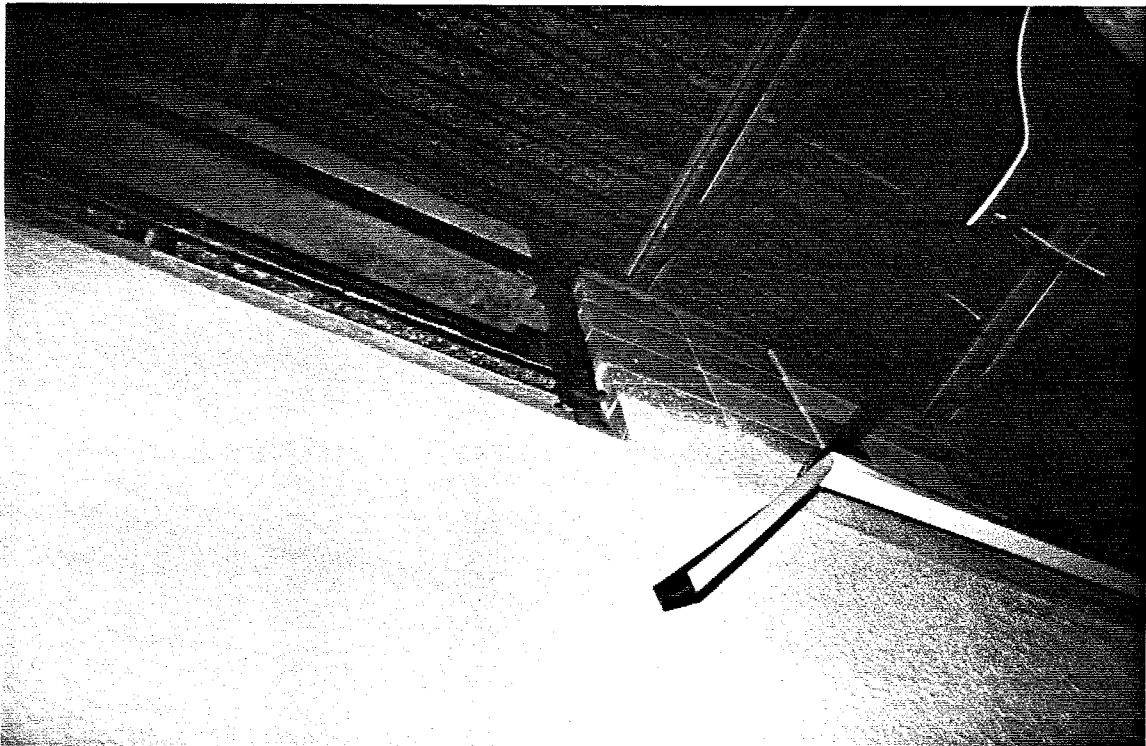
Figure 2.19 Missing masonry blocks at top of wall.

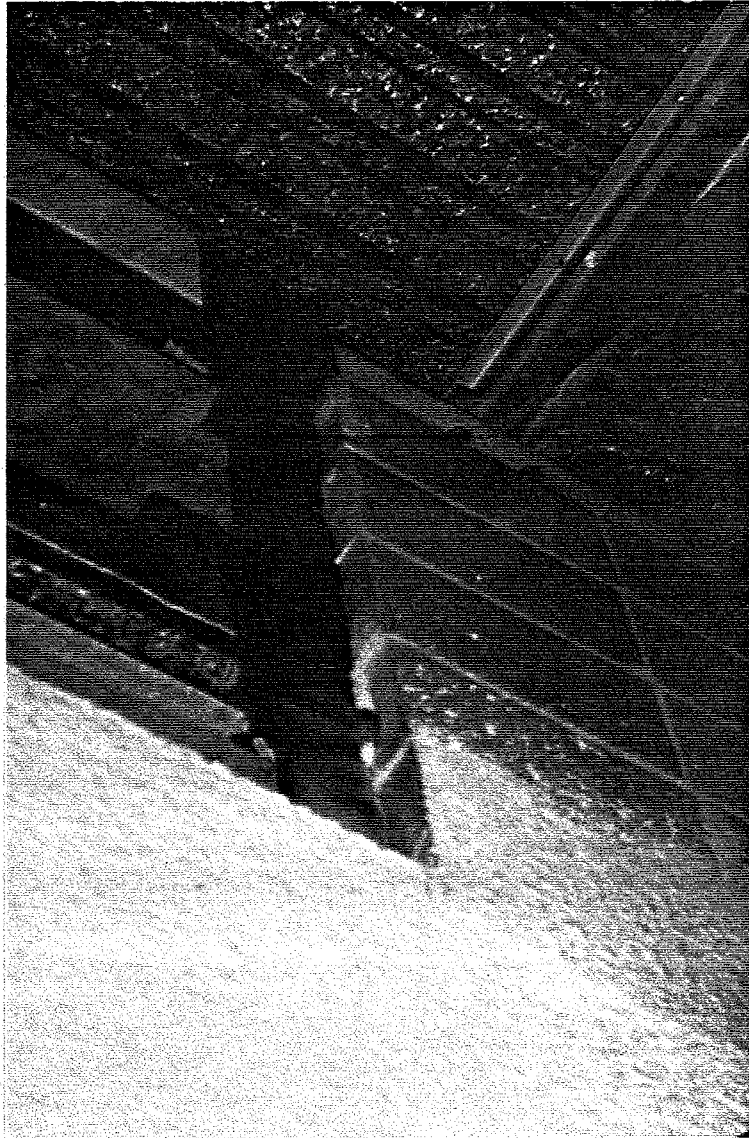
Figure 2.20 Detail of masonry blocks with no apparent connection to the steel frame.

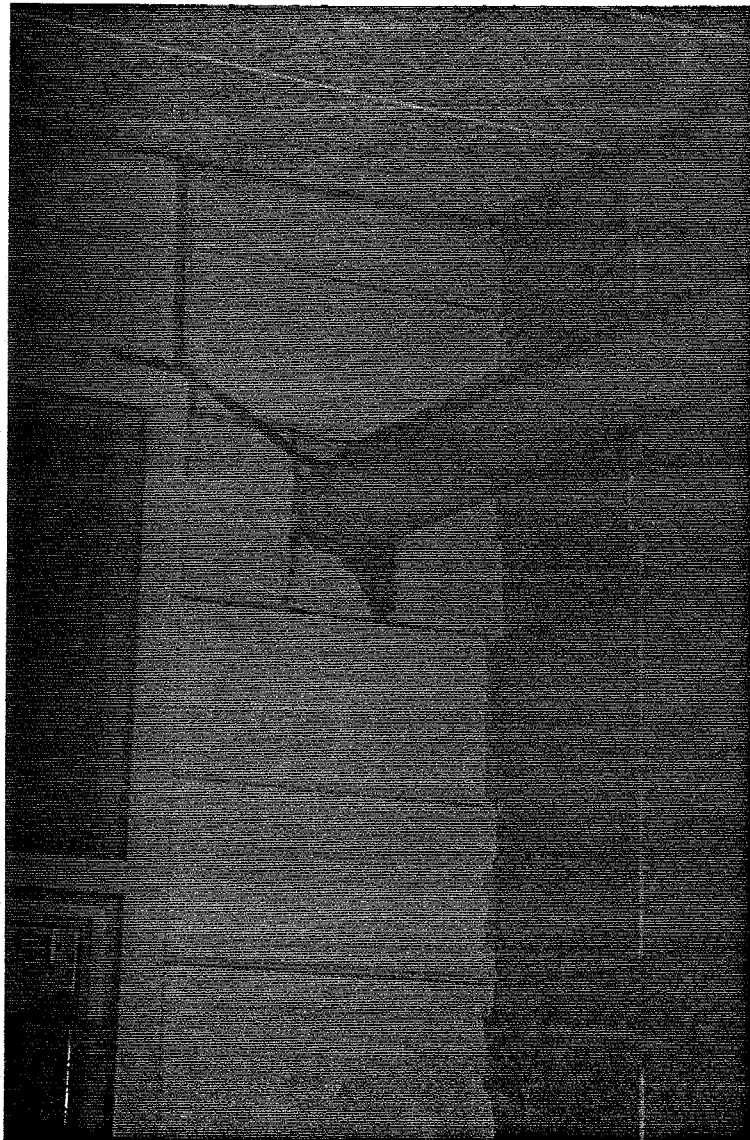
Figure 2.24 Cracking of interior masonry walls at joint between interconnecting corridor and older wing.

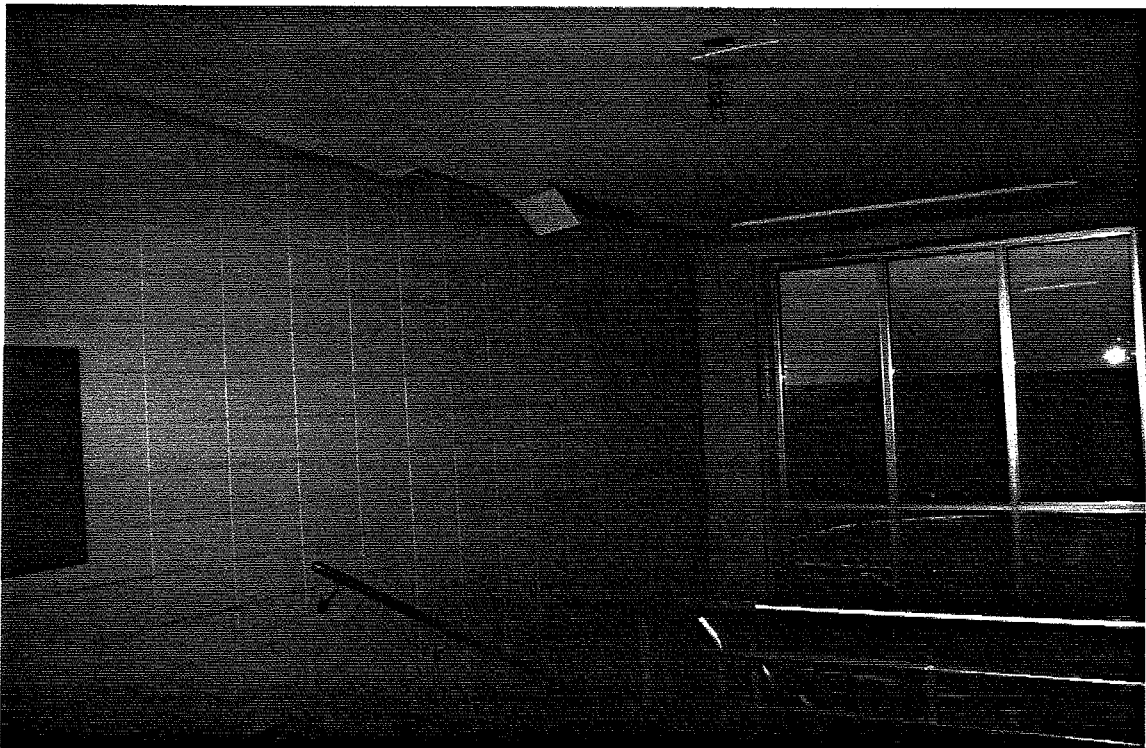
The south end of the newer wing had a staircase with a glass curtain wall as can be seen on the left side of Fig. 2.22. As can be seen from Fig. 2.25 and 2.26 there was considerable damage to the masonry wall perpendicular to the glass curtain wall resulting in a 4 in. separation and loss of ceiling tiles. This wall failed in flexure about its weak axis as the plane of the wall was perpendicular to the earthquake direction. Due to lack of connection between the walls, as shown in Fig. 2.26, there was no lateral support for that wall. Figure 2.27 shows the flexural failure crack with a major crack extending from the ceiling through the blocks and through the opening in the wall created by the electrical box.

Figure 2.25 Failure of masonry wall in stairwell of Pavillon Sagamie .

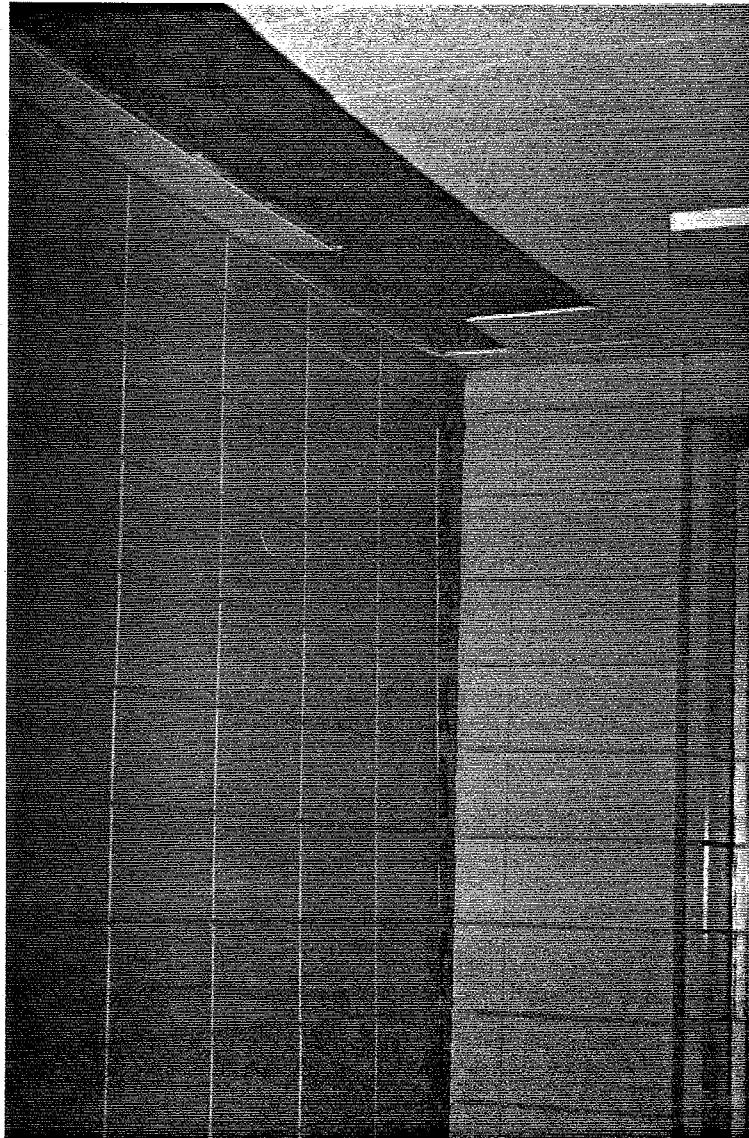
Figure 2.26 Four inch separation of walls and damage to ceiling tiles.

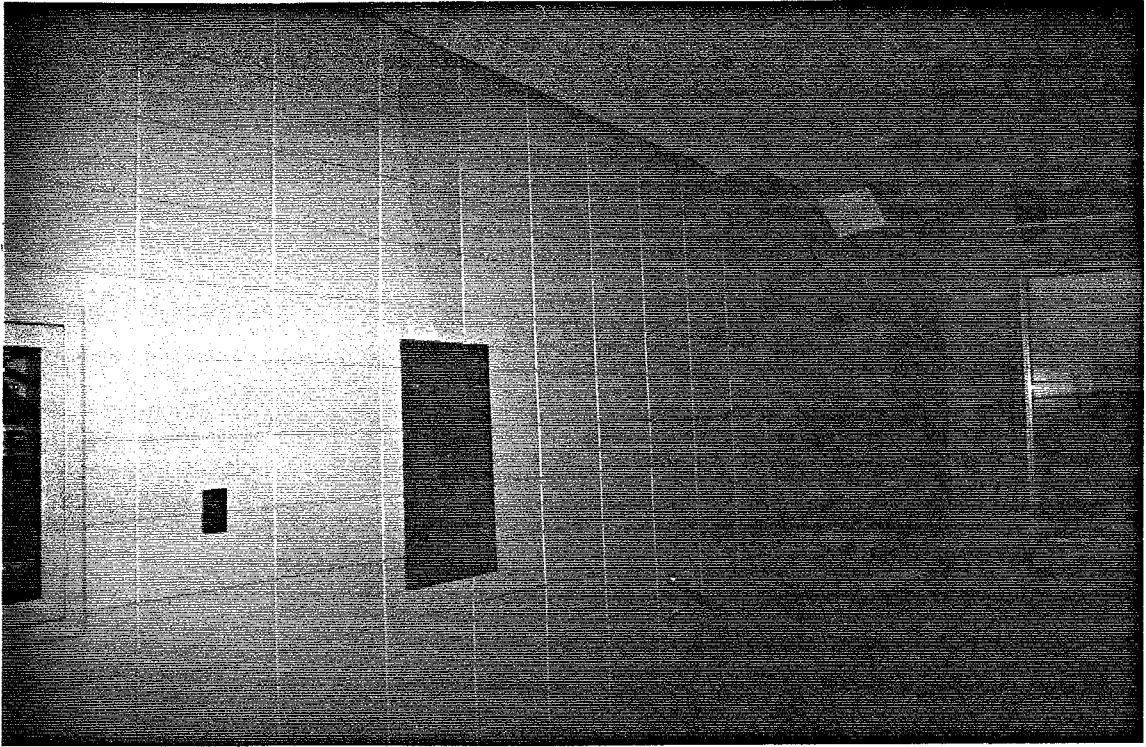
Figure 2.27 Flexural failure crack in masonry wall inside stairwell of Pavillon Sagamie.

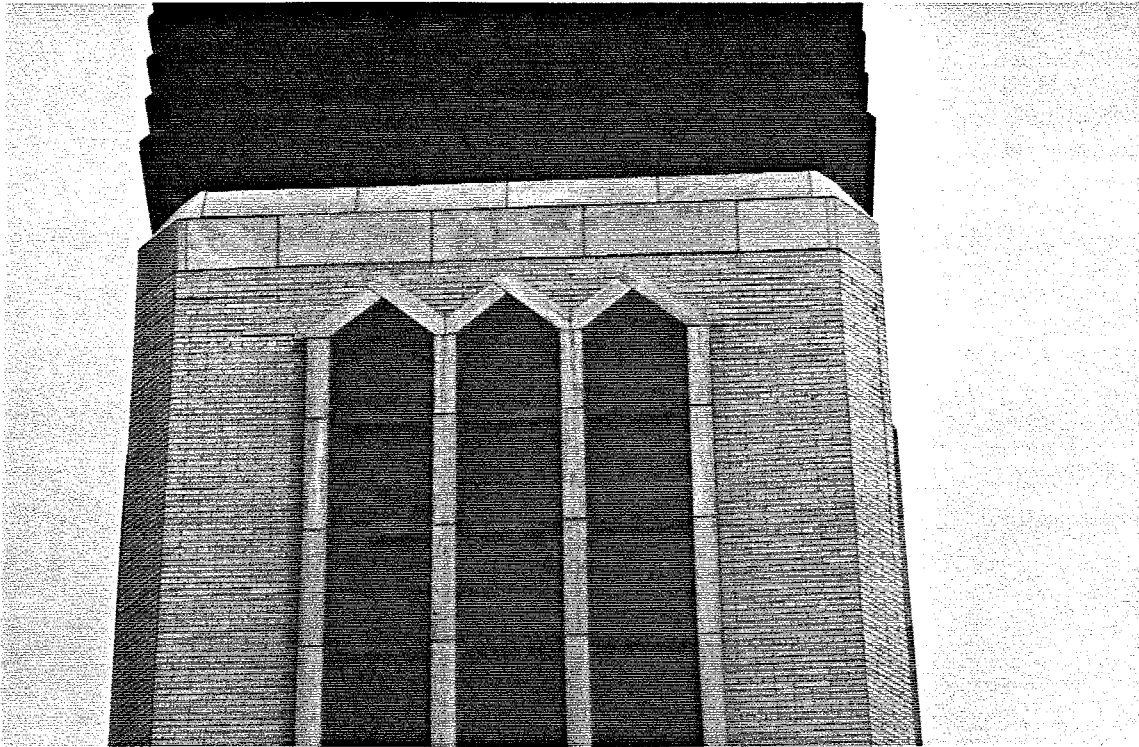
the chandeliers (see Fig. 2.29) together with the falling of decorative marble panels inside the nave of the church (see Fig. 2.30) contributed to the general panic of the congregation. Figure 2.31 shows the bell tower which experienced cracking in the masonry at the top of the windows (see Fig. 2.32).

Figure 2.32 Cracking of masonry walls of bell tower.

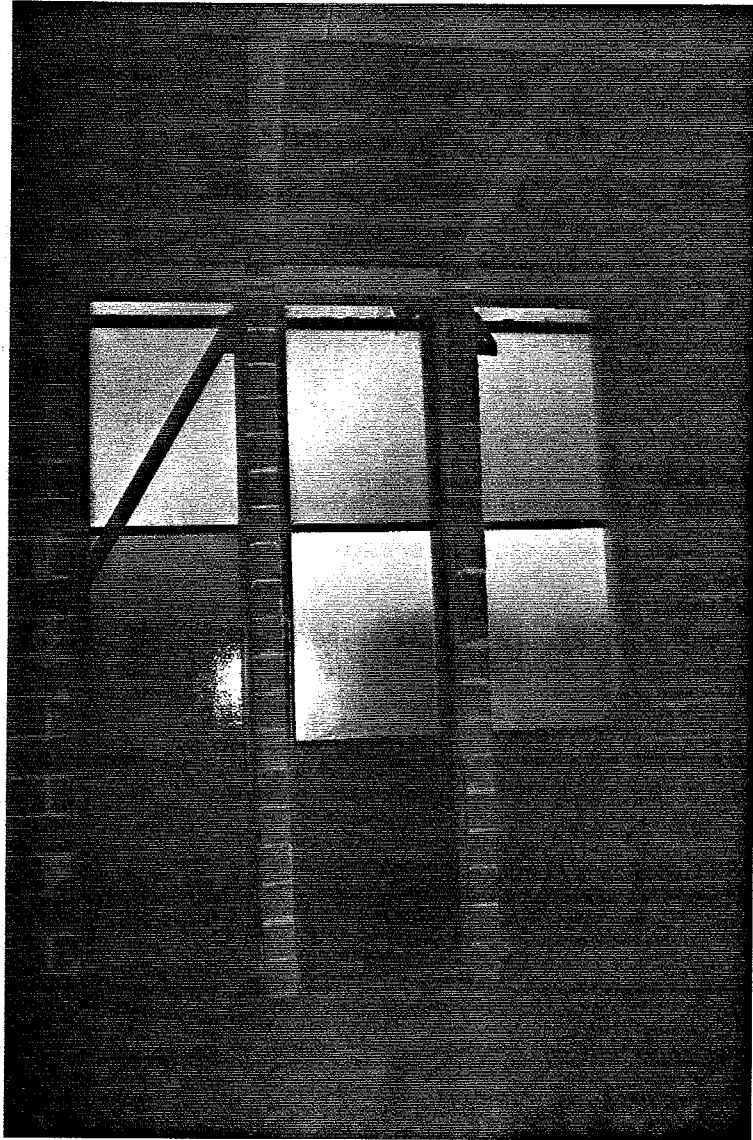
It was interesting to note that on the 6th floor a cross brace member was omitted during construction as shown in Fig. 2.35. This missing brace probably contributed to the damage.

Figure 2.35 Missing cross-brace in the sixth storey of bell tower.

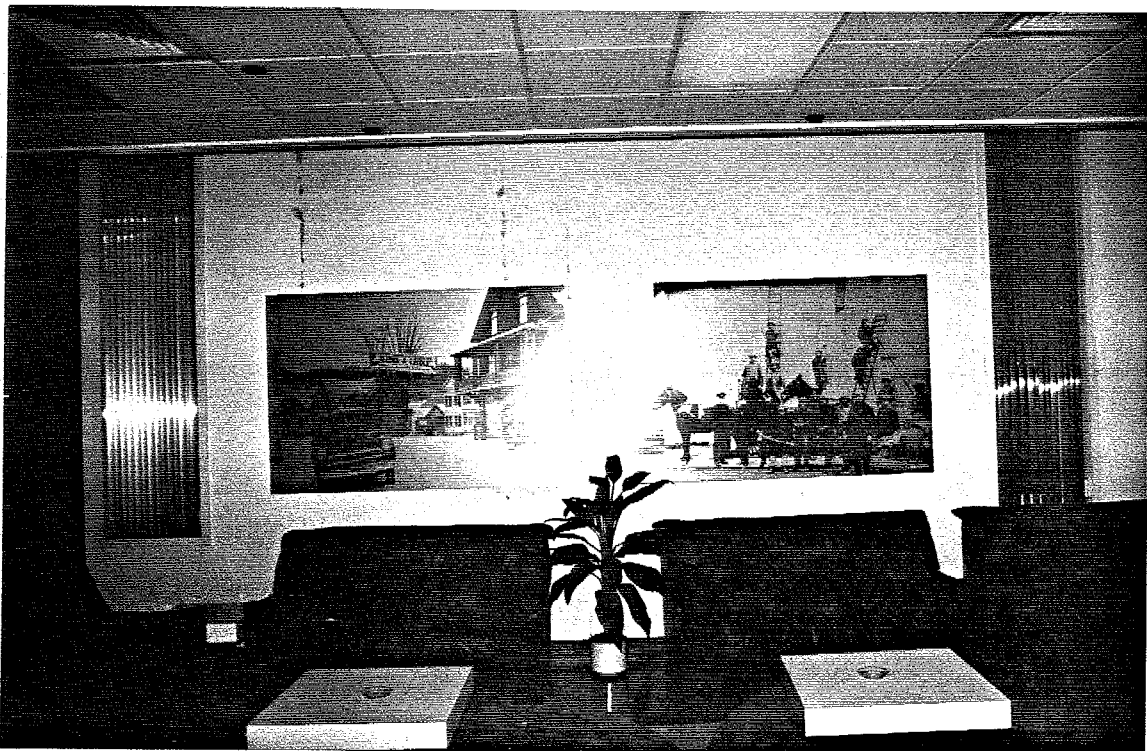
Figure 3.4 Cracks in second floor masonry walls of Edifice Municipale.

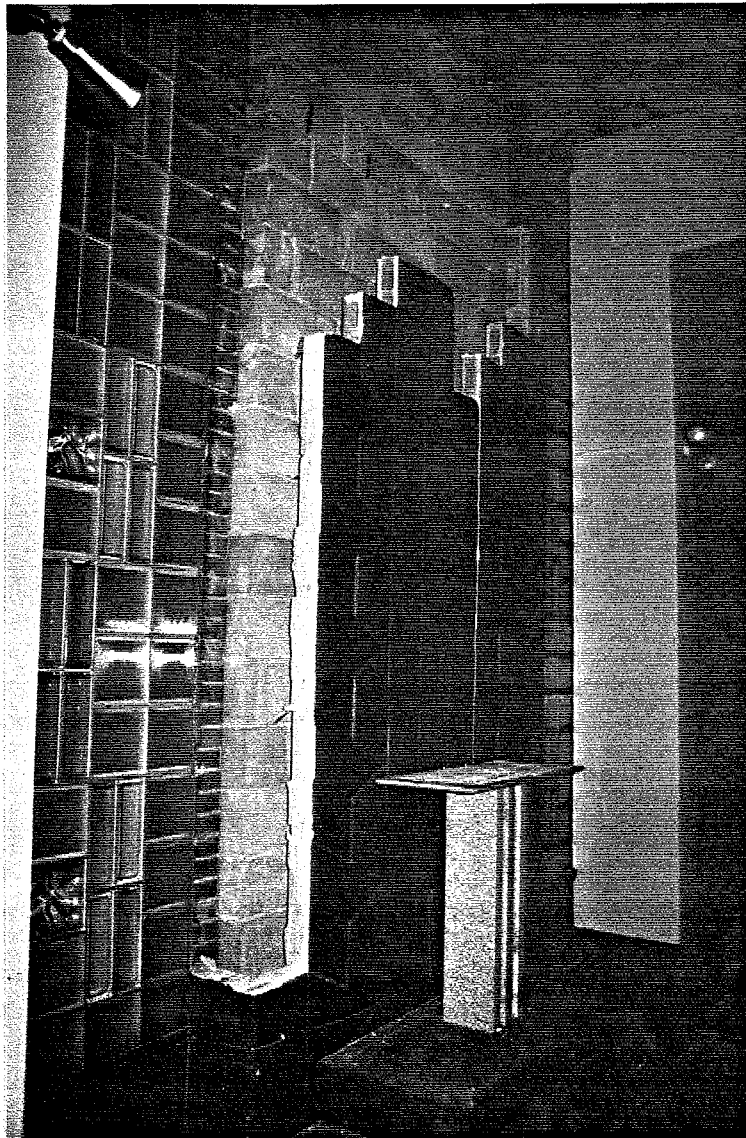
Extensive architectural damage was observed inside the chapel behind the altar. Figure 3.7 shows a decorative unreinforced masonry wall that collapsed. The reasons for the severe damage of this wall include the following:

Figure 3.7 Damage to decorative wall in Chapel.

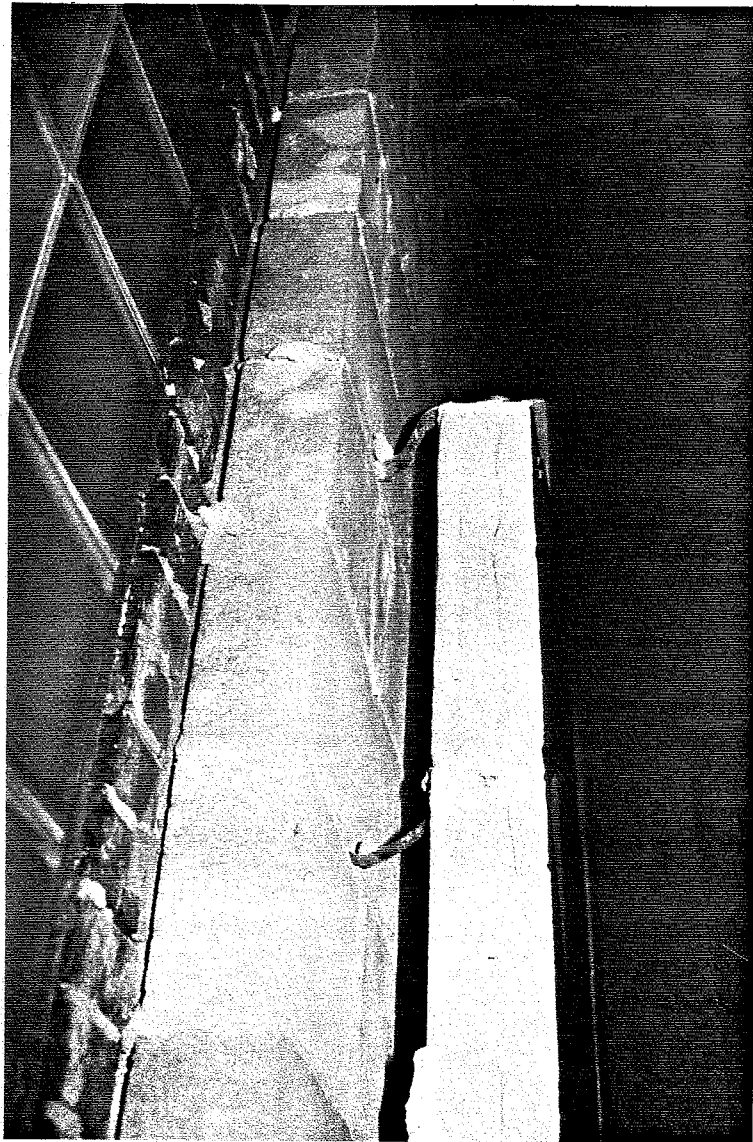
Figure 3.8 Ineffective tension ties between decorative wall and back-up wall.

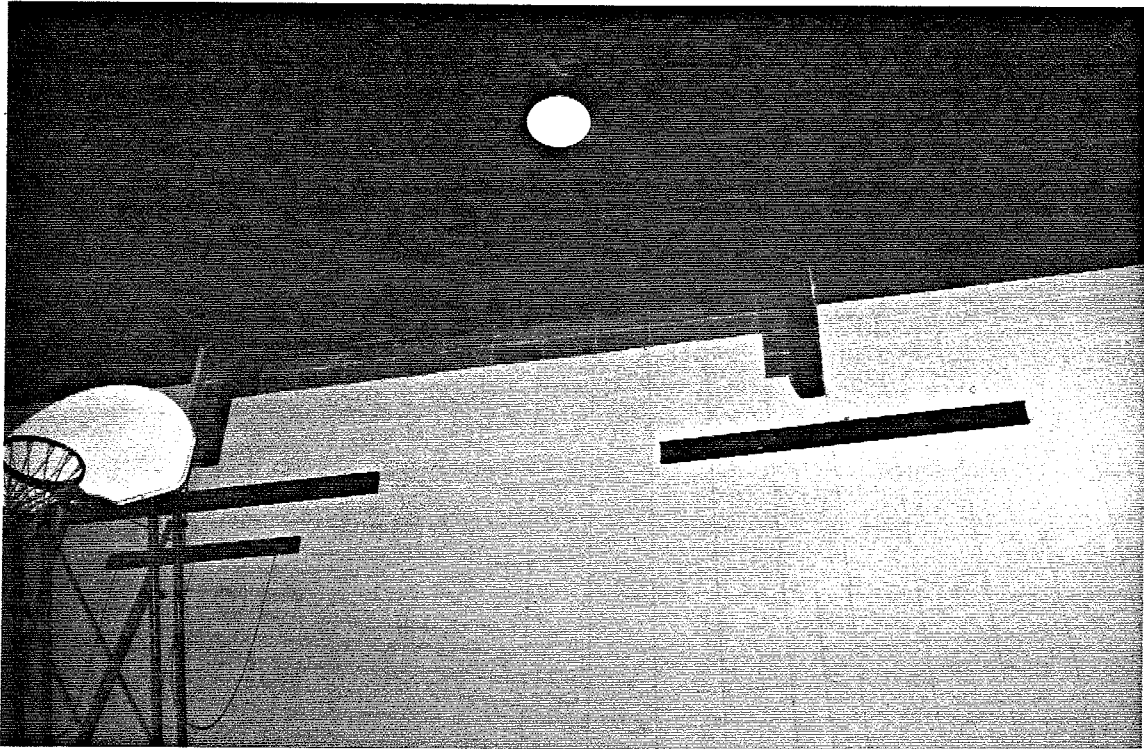
Figure 3.11 shows one of the gymnasium walls that suffered damage. One of these walls, which was approximately 33 ft. high, lost the top three layers of masonry blocks. All the walls were unreinforced masonry. Temporary repair measures, which were already taking place, included bolting 8 ft. long channel sections to both sides of the interior masonry walls centred on the steel column locations (see Fig. 3.11). In addition, a steel angle was added in order to hold the top layer of blocks in place. This angle, which runs parallel to the face of the exterior wall, was attached to the bottom of the roof joists by welding as shown in Fig. 3.12.

Figure 3.11 Damage to unreinforced masonry wall in gymnasium.

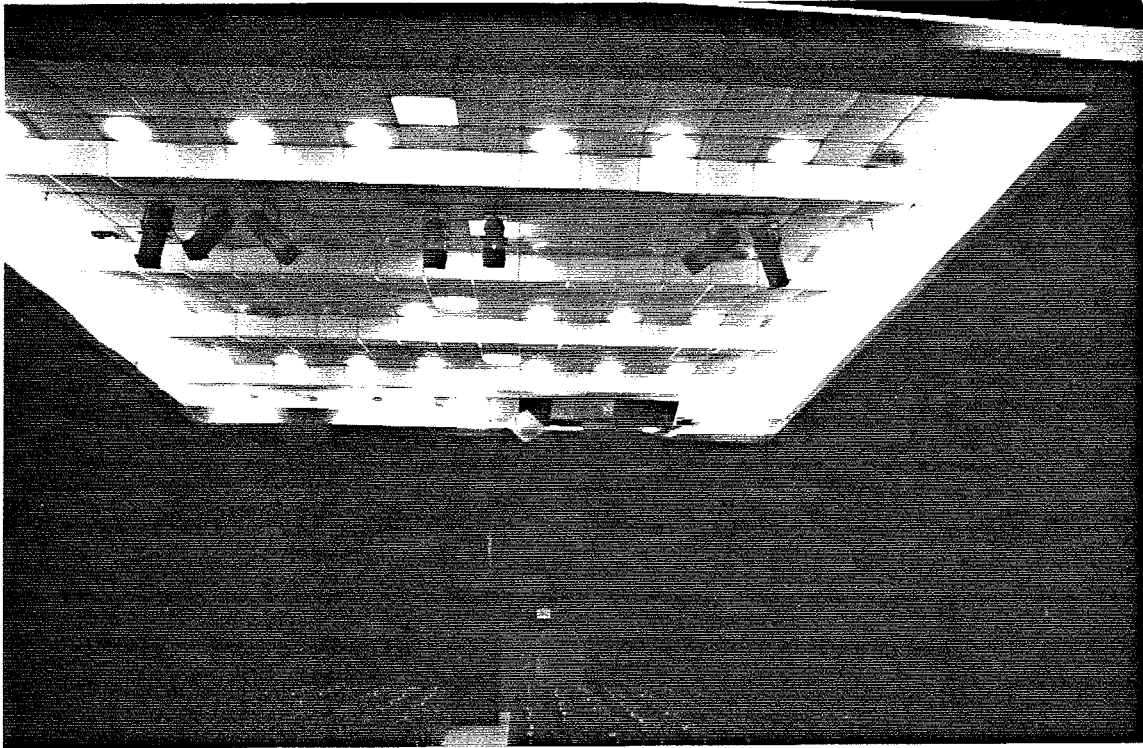
Figure 3.13 shows architectural damage to the ceiling tiles and to the lighting fixtures (see Fig. 3.14) of the auditorium located on the second floor. The ceiling was supported by inverted tee sections supported by vertical hangers. Also, the two top-most layers of concrete blocks fell from the back wall of the stage of the auditorium.

Figure 3.13 Damage to ceiling tiles and light fixtures of auditorium.

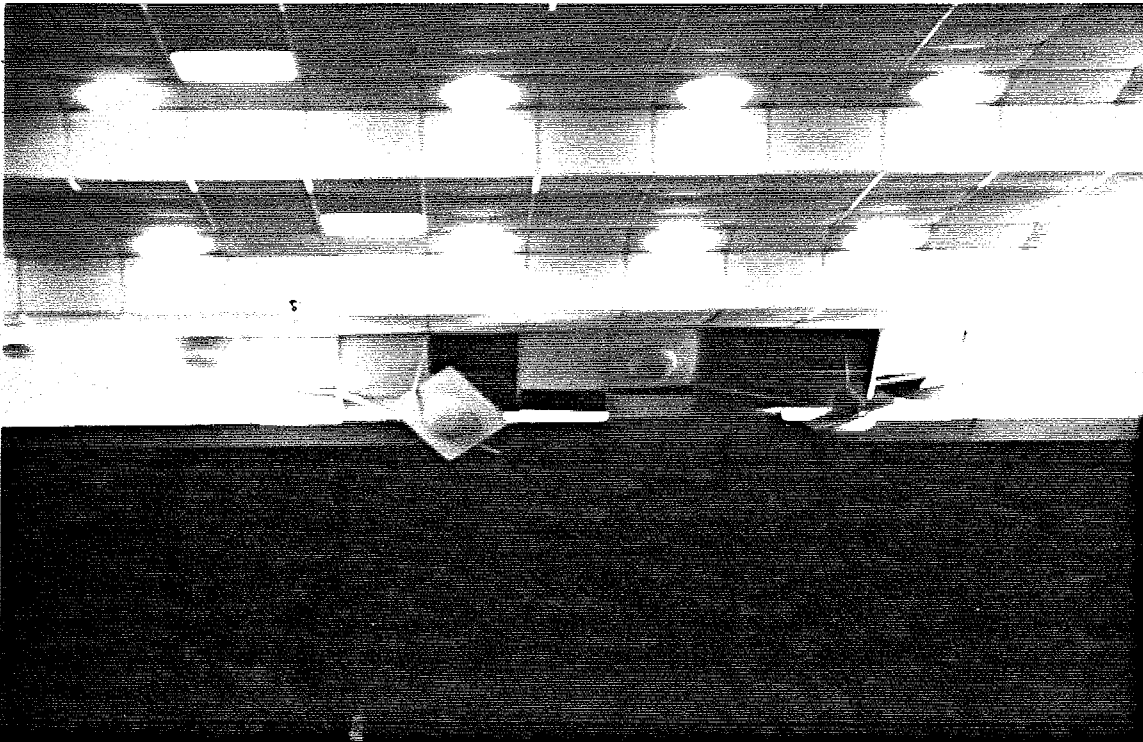
Figure 3.14 Close-up of damage to ceiling tiles and light fixtures.

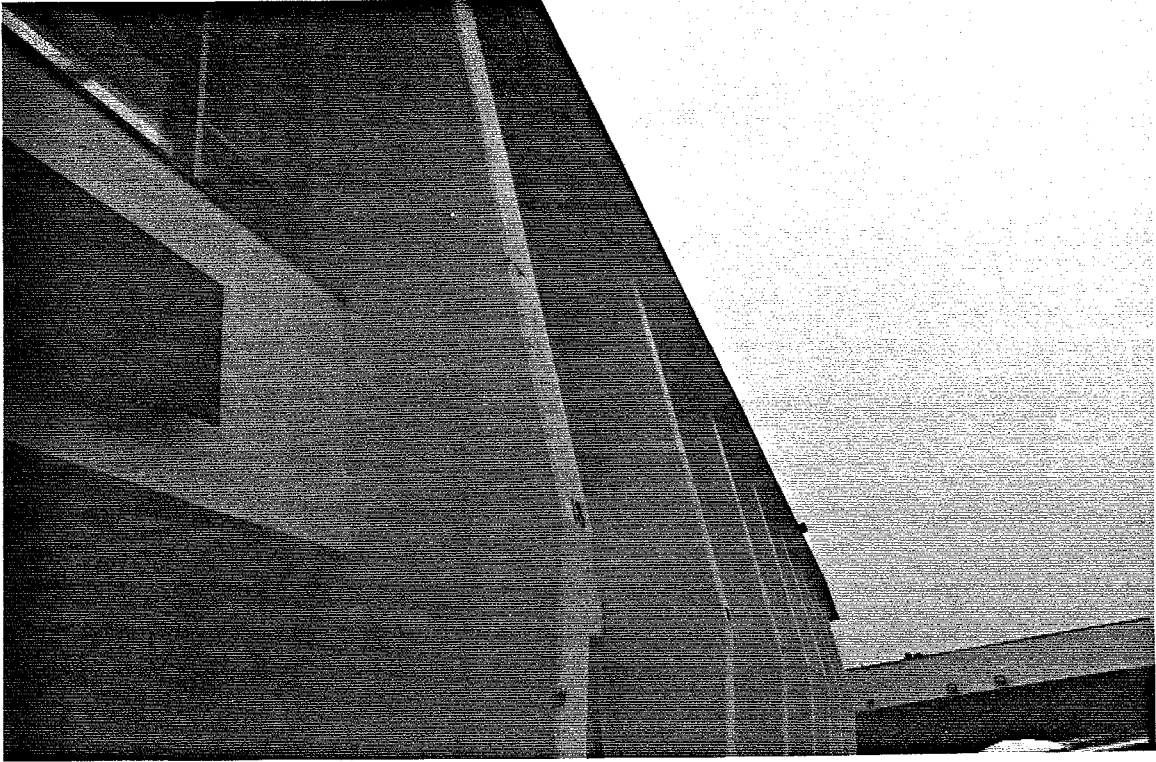
In the older wings, cracking was observed in all of the exterior concrete columns at the second floor level as shown in Fig. 3.15. This cracking occurred in a horizontal plane at the top of the deep spandrel beam. It is believed that this crack has taken place at the location of construction joints in the column (see Fig. 3.16).

Figure 3.15 Horizontal cracking in exterior columns of older wing.
