**GEOLOGICAL SURVEY OF CANADA
OPEN FILE 1999**

**THE 1988 SAGUENAY EARTHQUAKE –
A SITE VISIT REPORT**

Denis Mitchell¹, René Tinawi² and Tim Law³

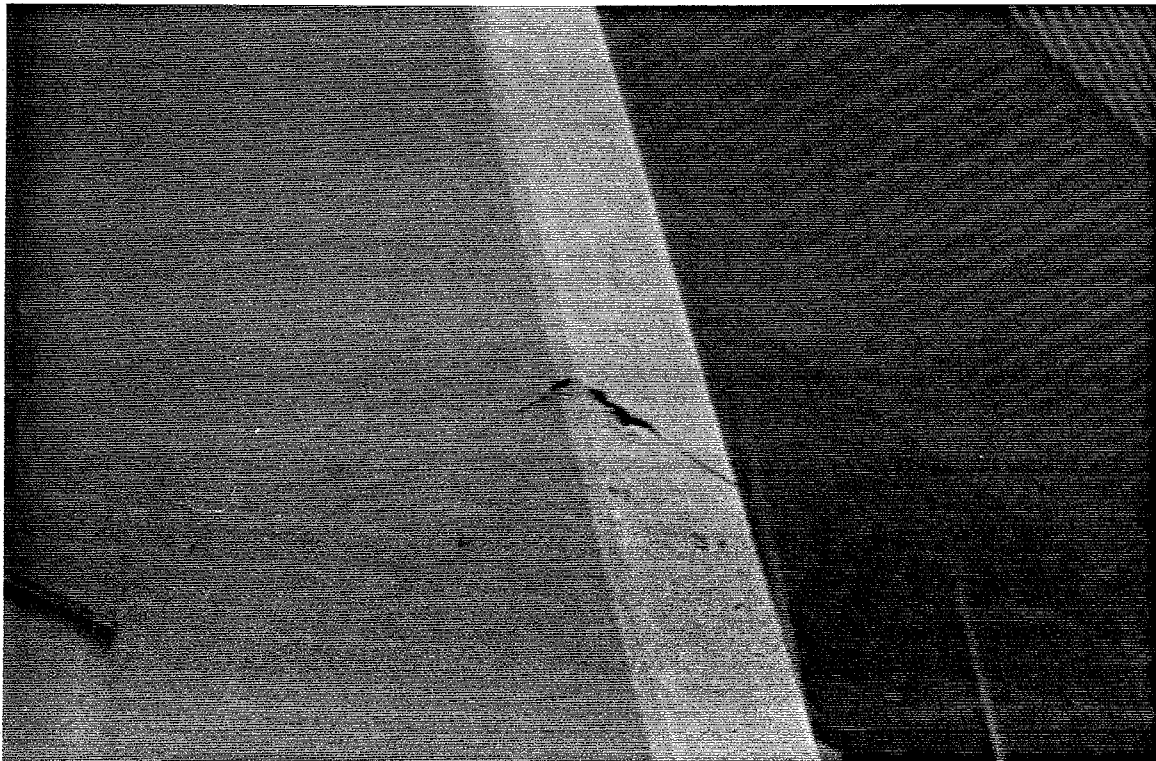
In the older wings, cracking was observed in all of the exterior concrete columns at the second floor level as shown in Fig. 3.15. This cracking occurred in a horizontal plane at the top of the deep spandrel beam. It is believed that this crack has taken place at the location of construction joints in the column (see Fig. 3.16).

Figure 3.16 Close-up of horizontal cracking in column.

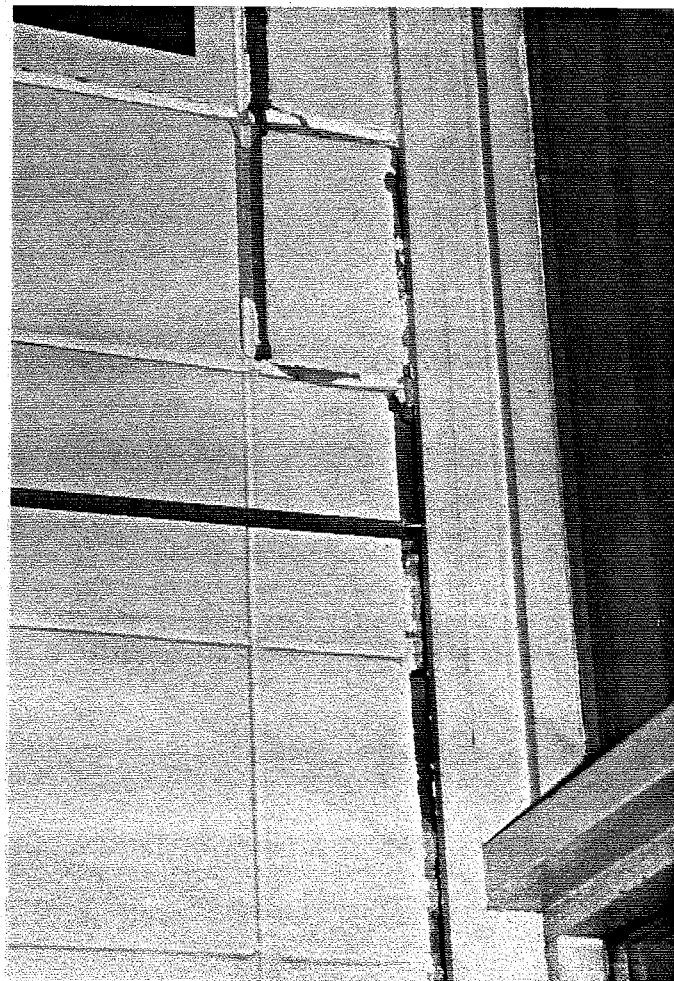
columns. Due to the ground motion, there was considerable differential movement between the roof and the floor slab causing extremely severe damage to the masonry partition walls between the slab and the roof (see Fig. 3.18 and 3.19).

Figure 3.19 Close-up of cracking in masonry partition wall.

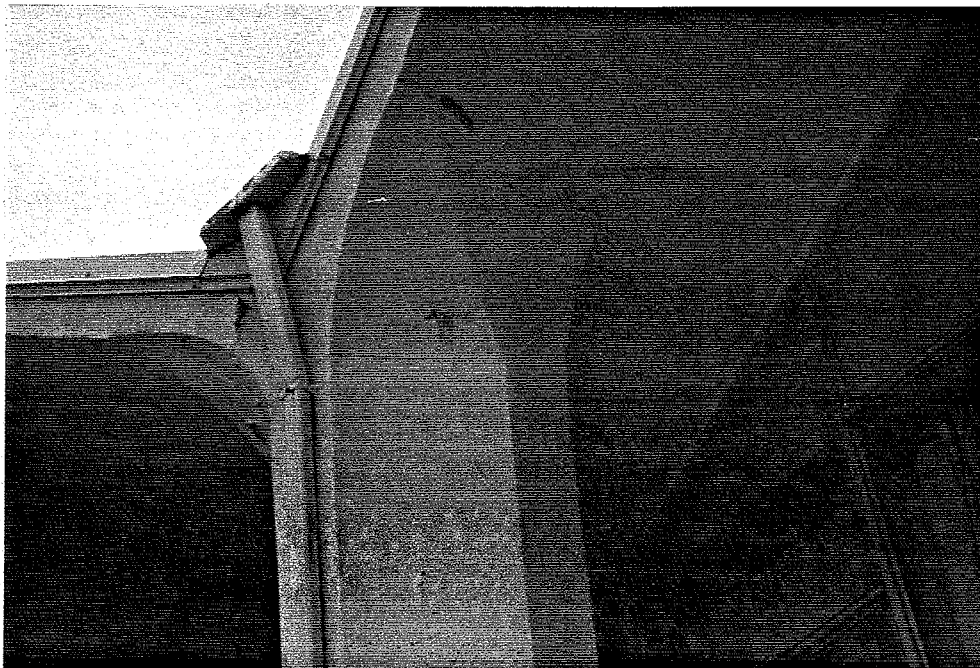
As can be seen from Figures 3.21 and 3.22 considerable cracking occurred in the roof around the perimeter of the column supporting it. Just below the roof level cracking was also observed in the column.

Figure 3.21 Cracking of column and roof slab.

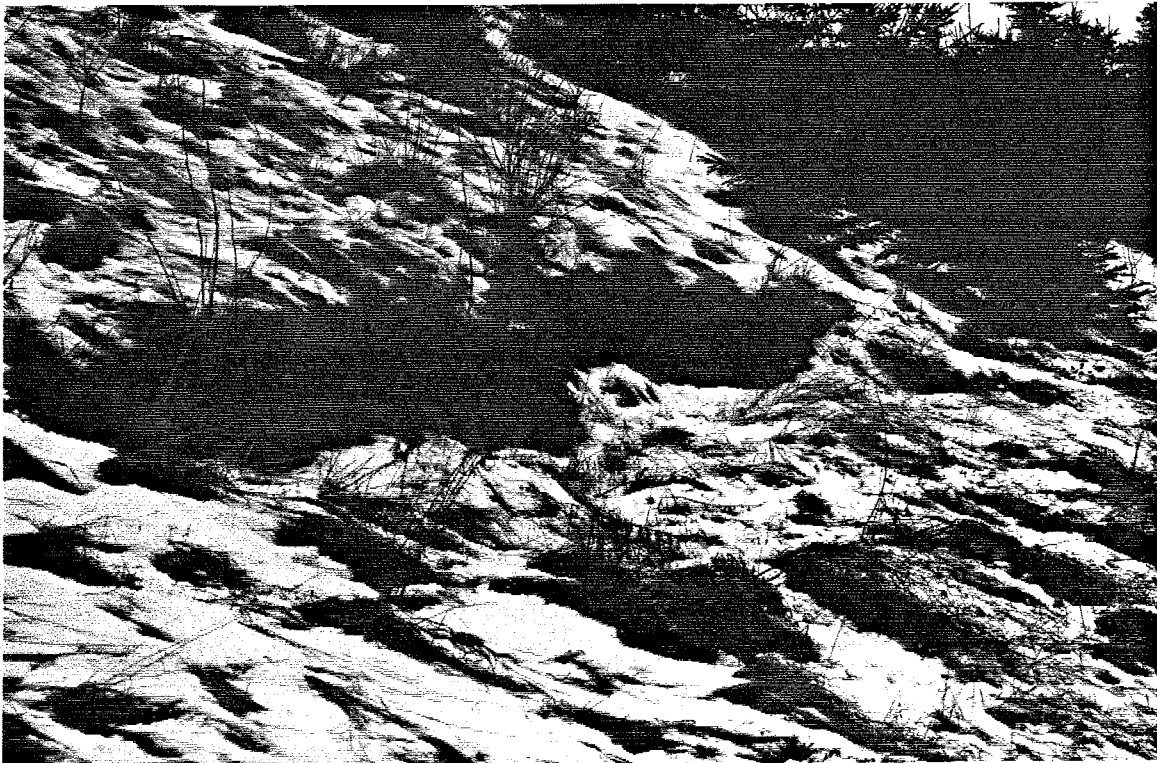
Soil settlement resulting in a small surface slump was observed on Route 170 between Chicoutimi and Ville de la Baie as shown in Fig. 3.25. A small surface slump was observed just outside Ville de la Baie as shown in Fig. 3.26. A more obvious, but small slope failure (see Fig. 3.27) was observed on Route 381 between Ville de la Baie and the villages of Ferland and Boileau.

Figure 3.25 Small surface slump on Route 170.

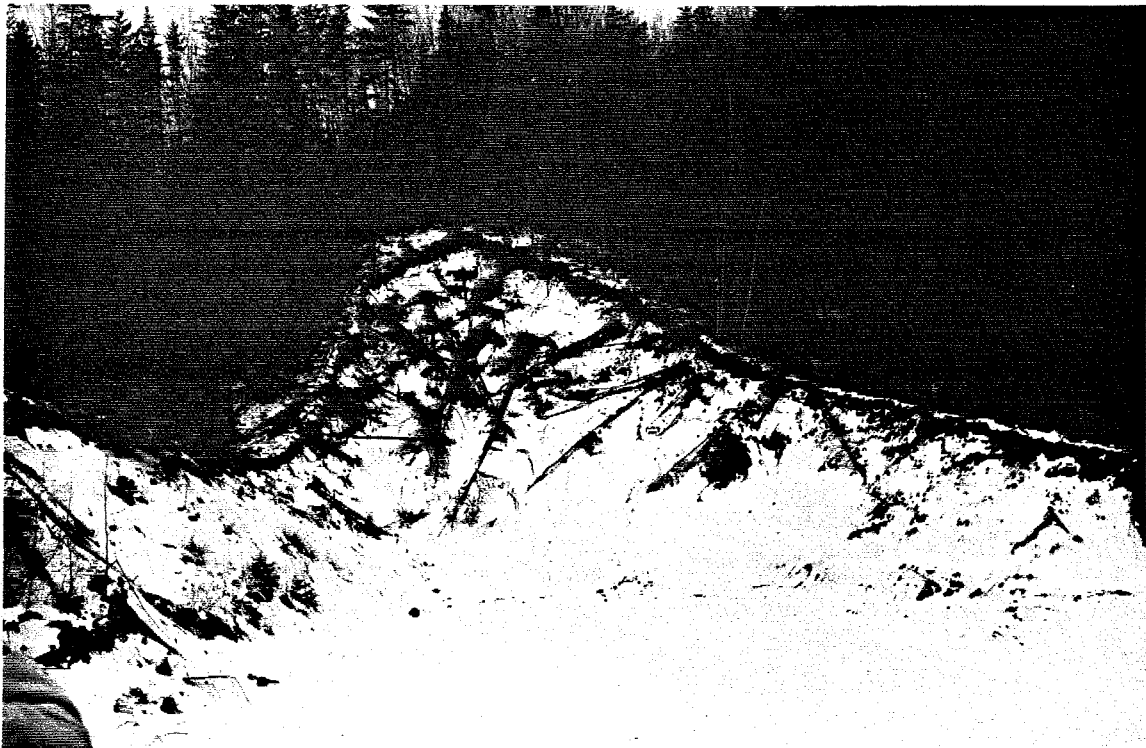
Figure 3.27 Small slope failure on Route 381.

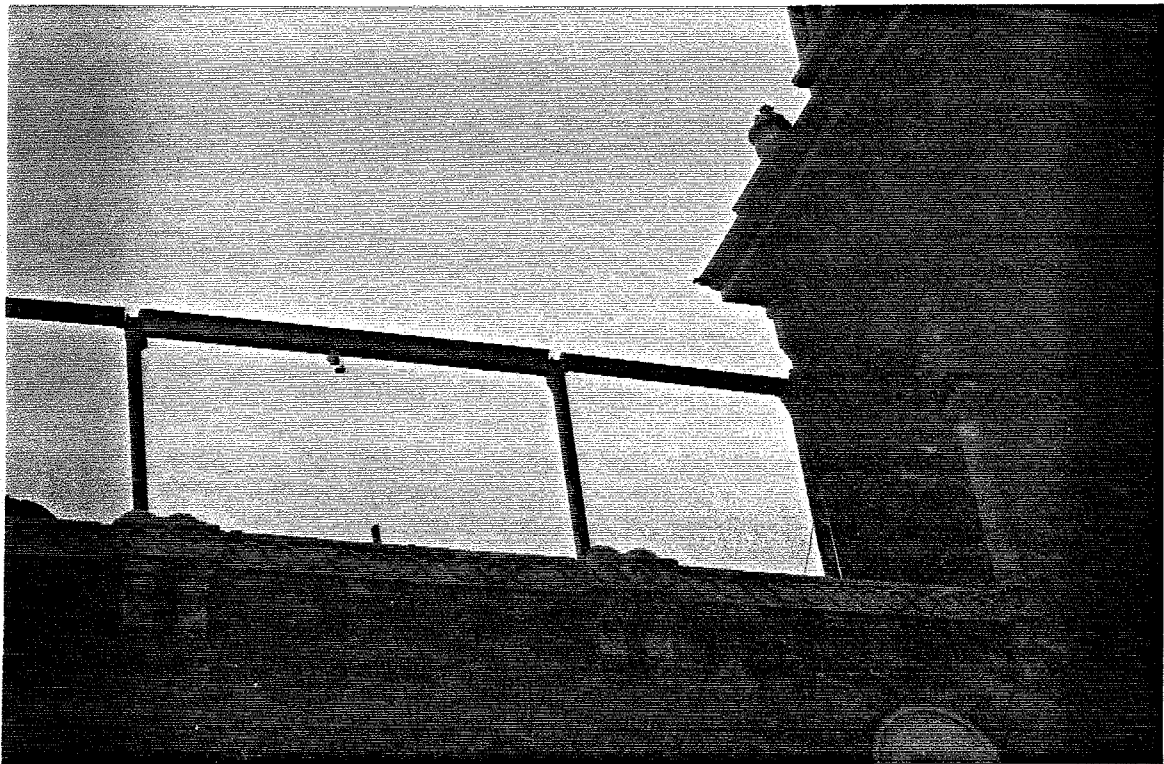
Figure 4.4 Close-up view of steel frame that supported masonry wall.

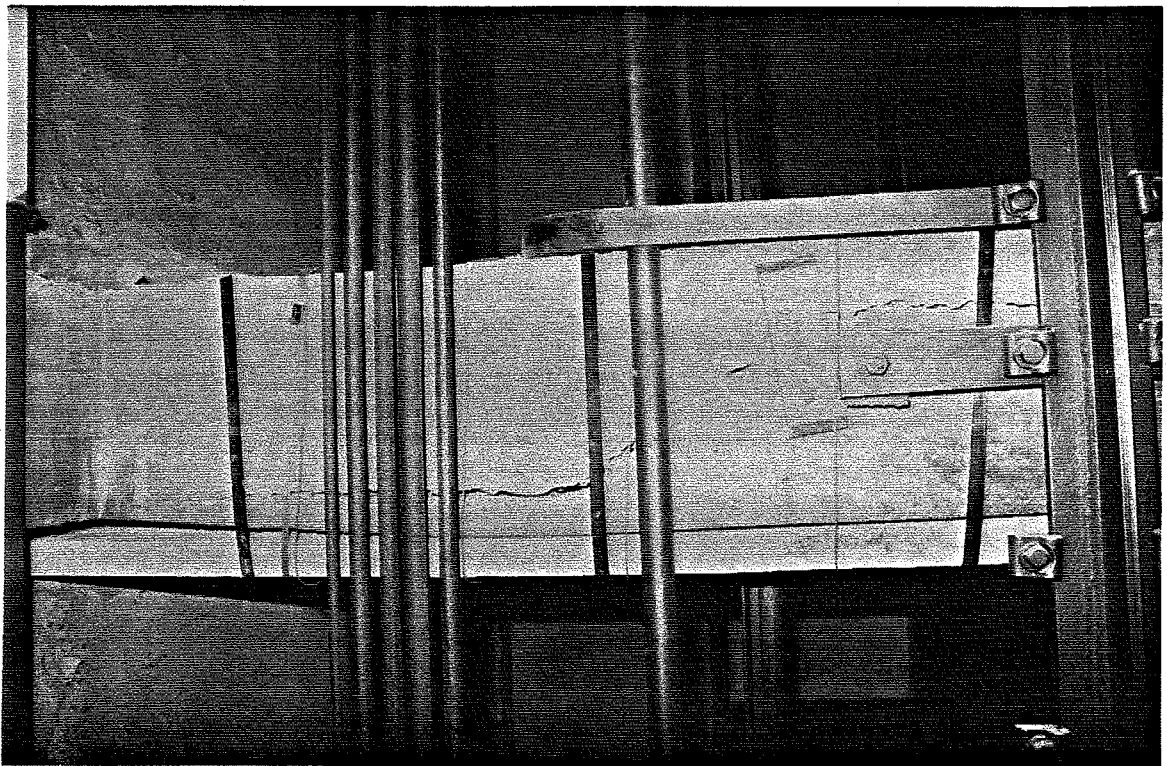
Figure 4.9 Photograph showing shear failure of reinforced concrete beam, counterweight guide support bracket and temporary repairs to beam.

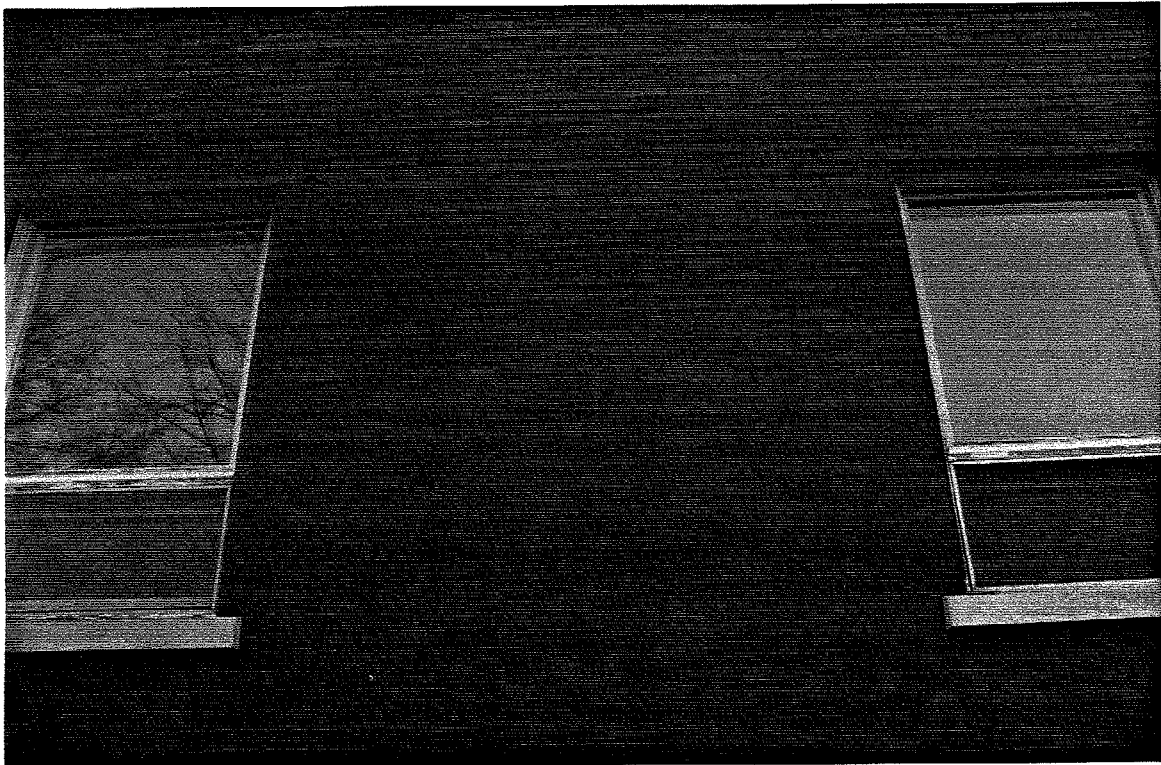
Figure 4.11 Diagonal cracks in masonry wall of Pavillon Notre Dame.

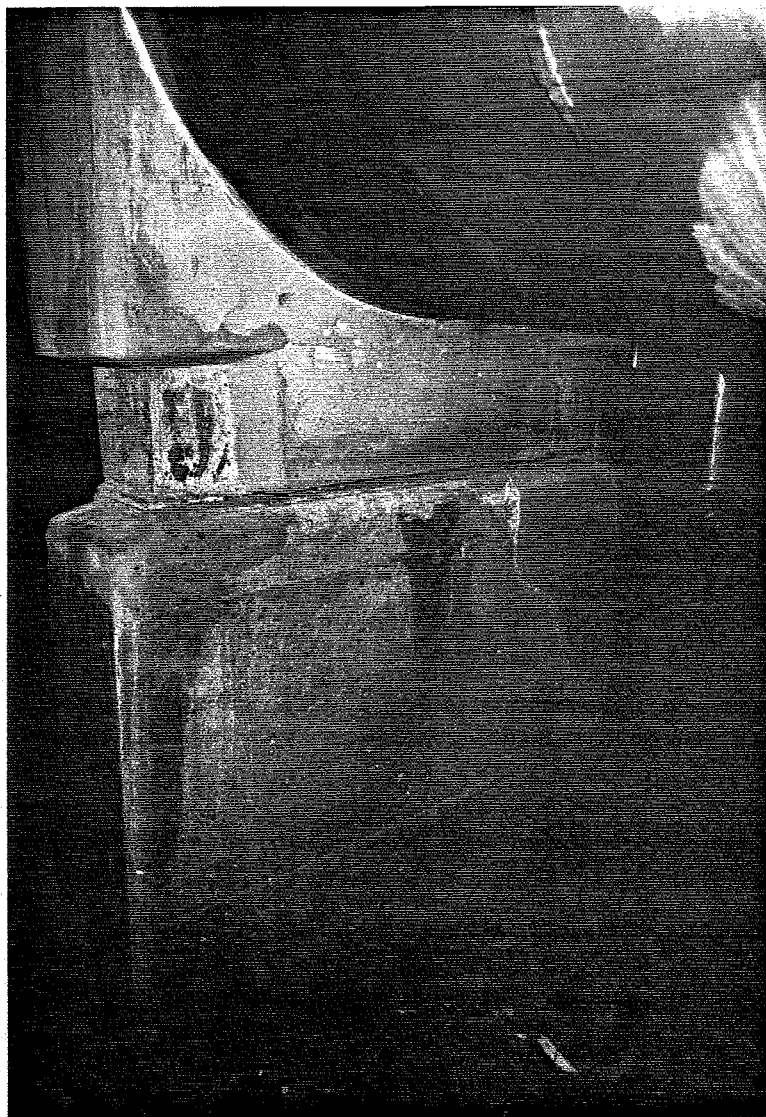
Figure 5.1 Spalling of cover of reinforced concrete support for heat exchanger.

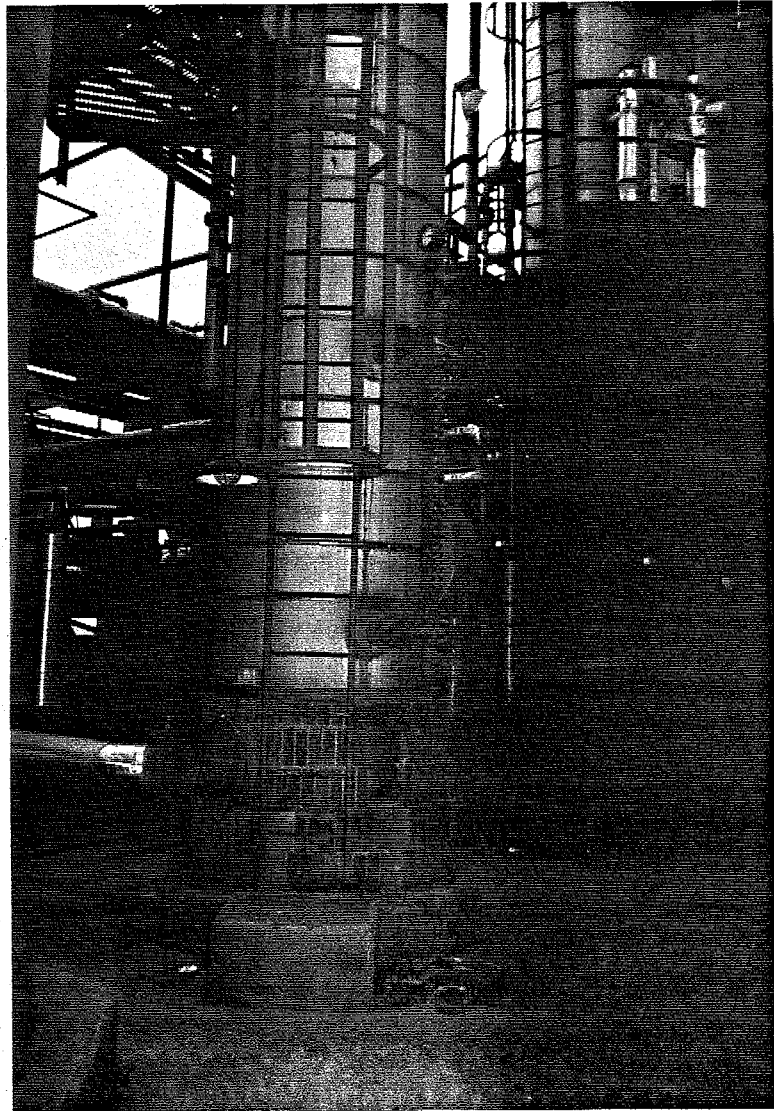
Figure 5.2 Dislodged fire brick from distillation tower.

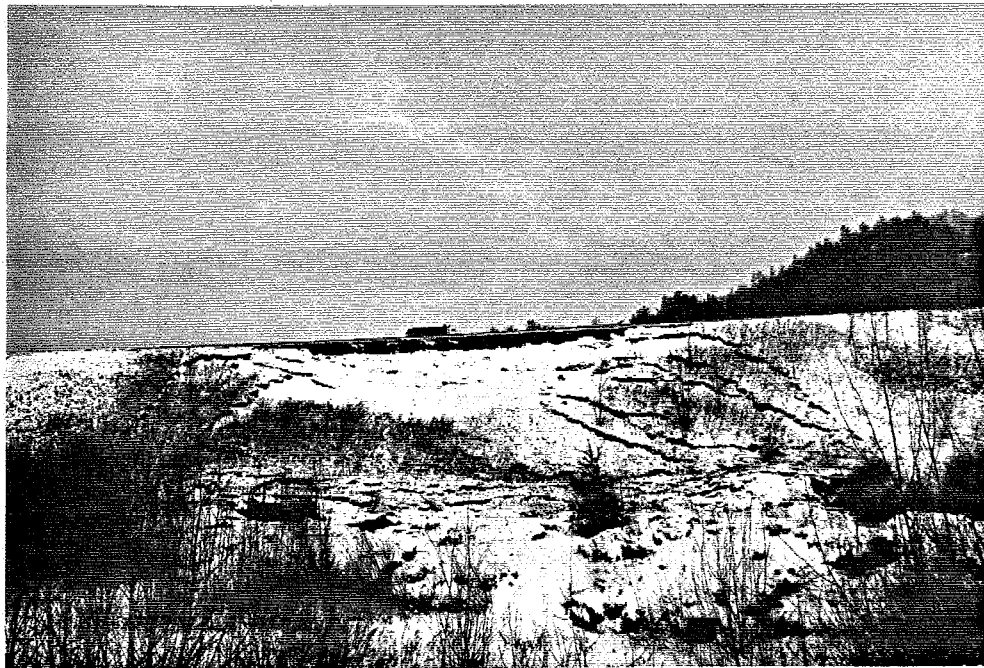
Figure 6.2 Overall view of embankment failure.

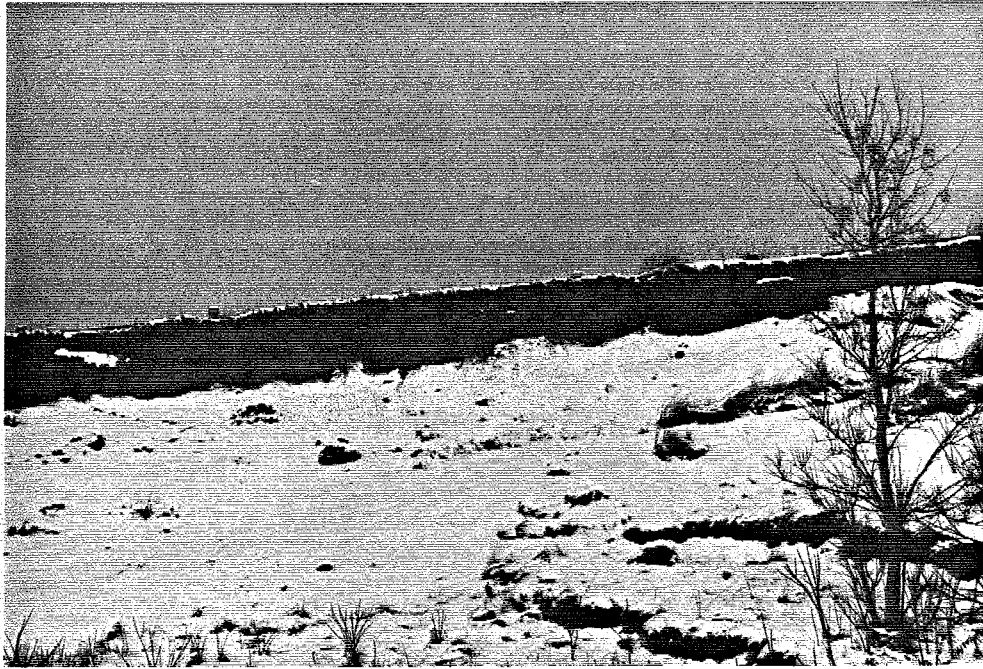
Figure 6.3 Close-up view of embankment failure.

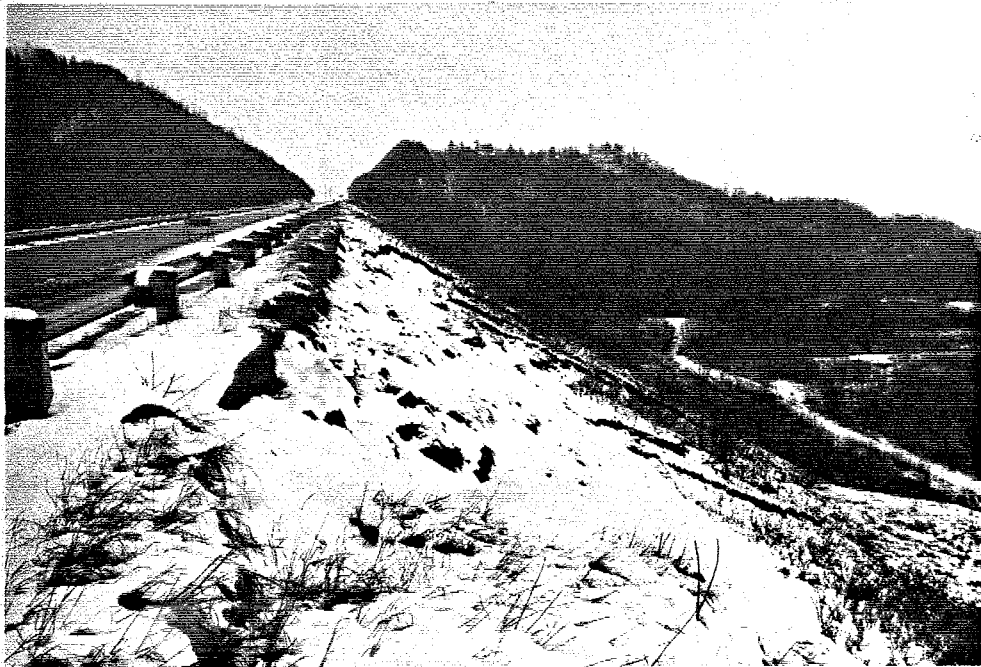
Figure 6.4 View of embankment failure from shoulder of highway.

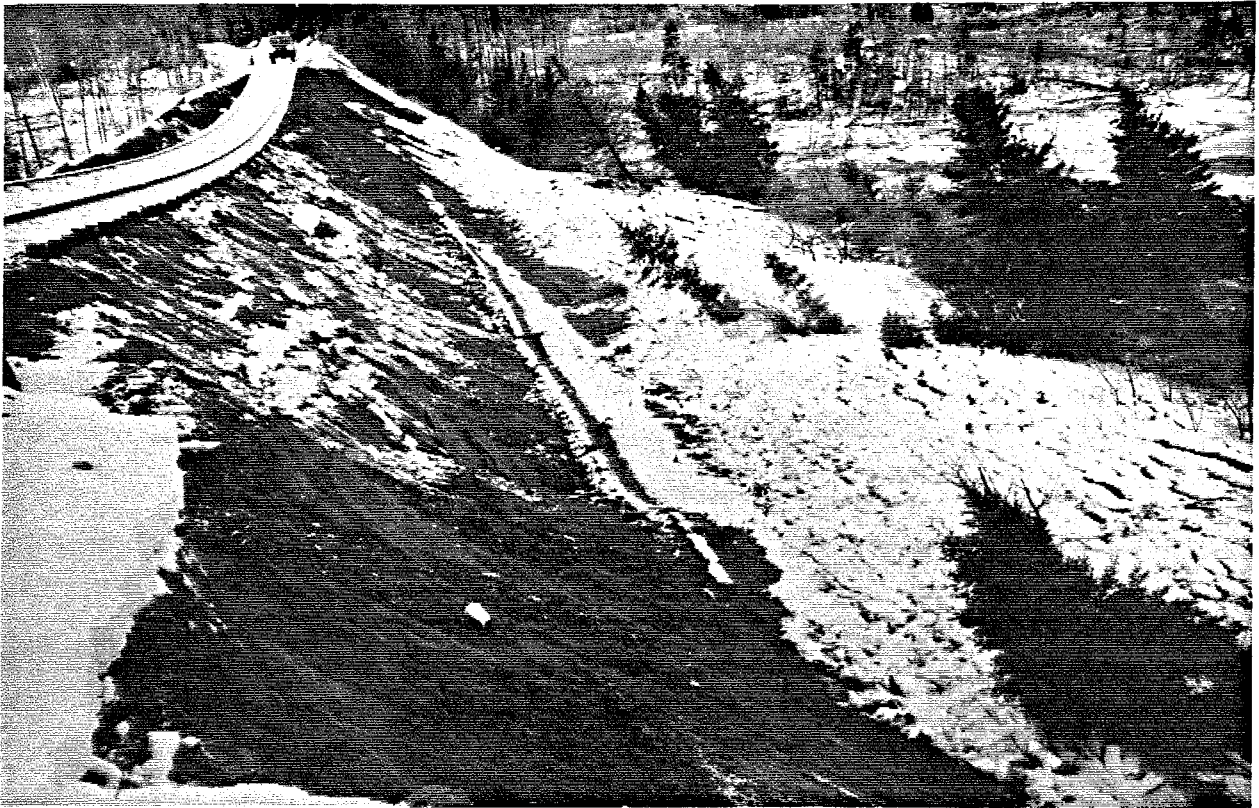
The second failure, shown in Fig. 6.5, took place 10 miles north of Hervey Junction. The 50 ft. high embankment consisted of fine to medium sand and therefore was well drained. The original slope of the embankment was 1.5 horizontal to 1.0 vertical. The total length of the slide was 300 ft. which left the rails suspended as shown in Fig. 6.6 and Fig. 6.7. The repair consisted of placing a berm at the bottom of the embankment to a height of about 30 ft. and then constructing a new embankment with a height of about 20 ft. and a new slope of 2.0 horizontal to 1.0 vertical. The railway line was closed for a total period of one week.

Figure 6.5 Overall view of railway embankment failure, photograph courtesy of Canadian National.

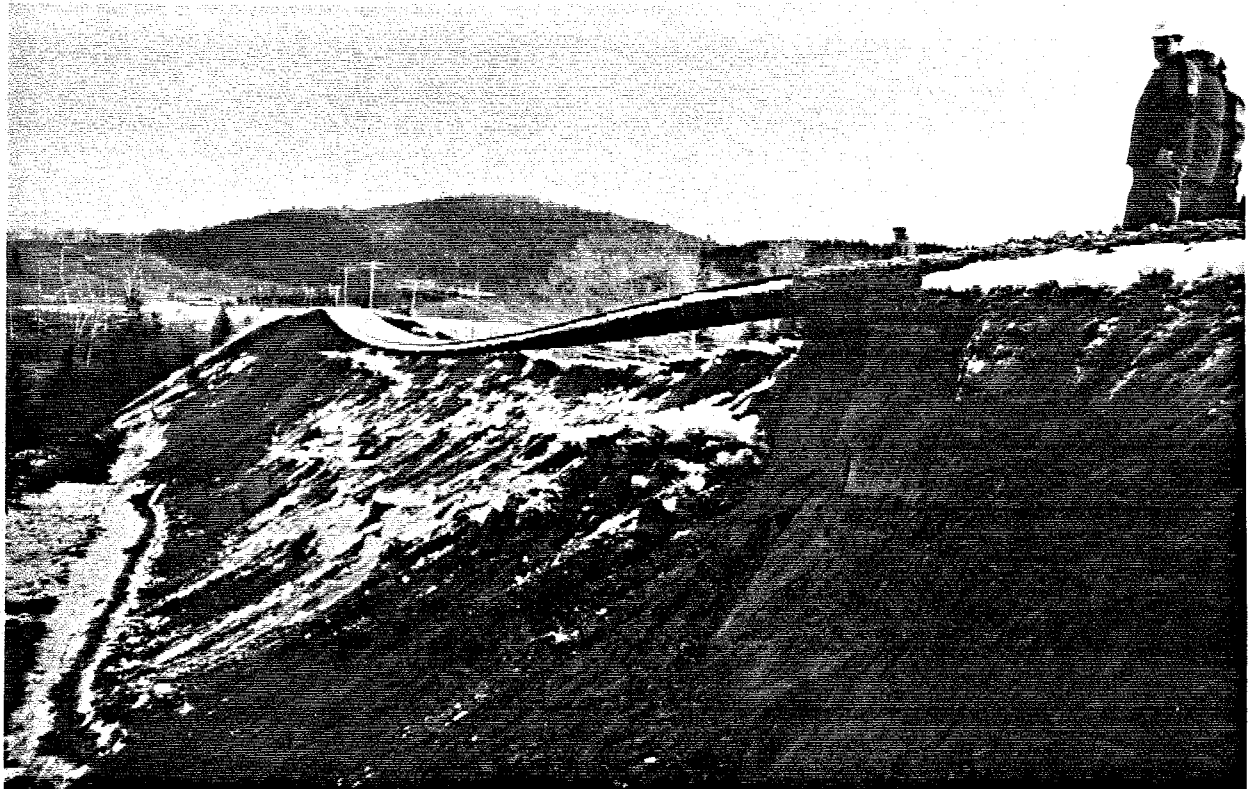
Figure 6.6 Railway embankment failure, photograph courtesy of Canadian National.

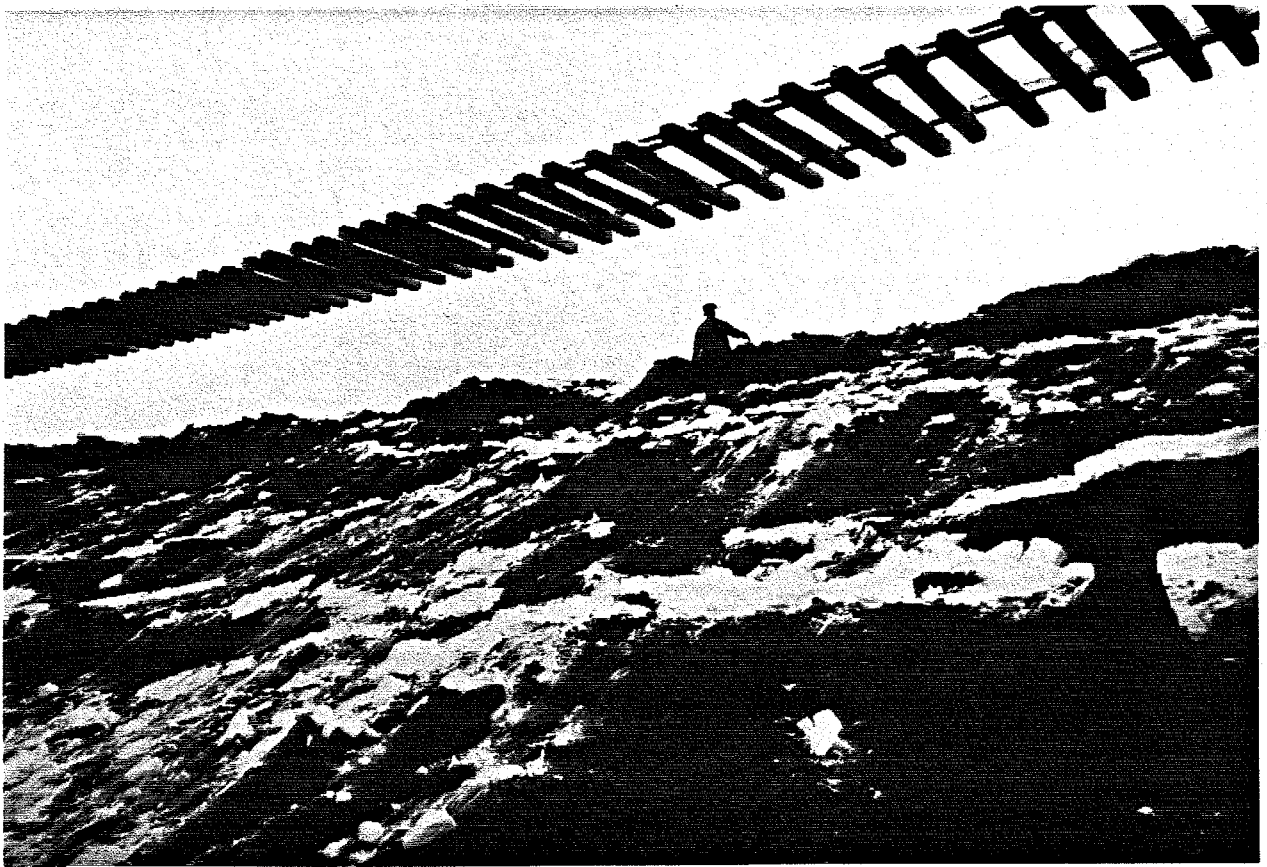
Figure 6.7 Railway embankment failure, photograph courtesy of Canadian National.
