Hot spots on wood chip insulated slopes,
Norman Wells Pipeline,
Northwest Territories

**HOT SPOTS ON WOOD CHIP INSULATED SLOPES,
NORMAN WELLS PIPELINE, N.W.T. :**

**Chronology of 1984 to 1993 observations and summary
of 1993 instrumentation program**

Burgess, M.M., Lawrence, D.E., MacDonald J., and Desrochers, D.T.

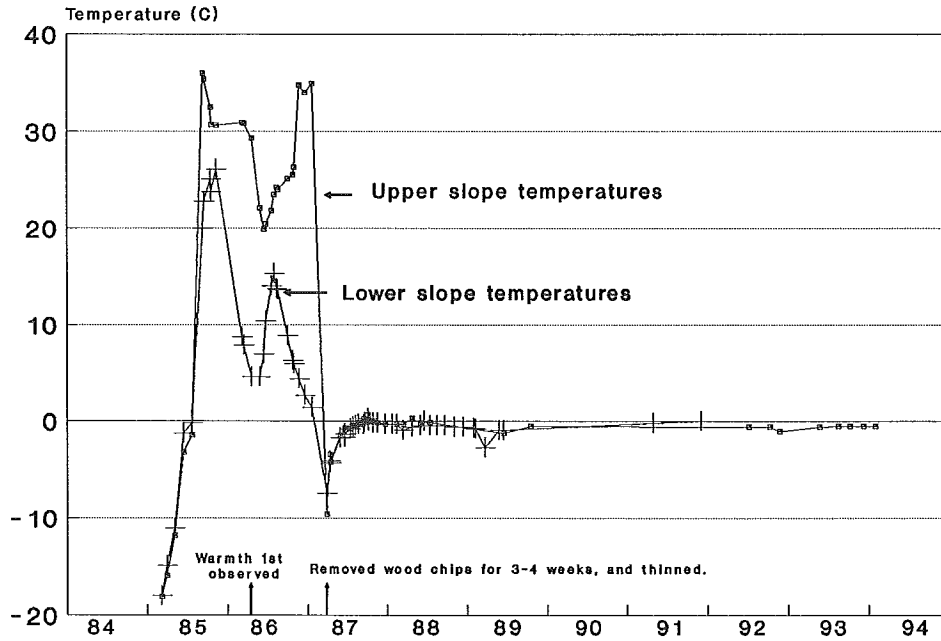
Figure 1 a) Slope 76, kmp 273.6
Wood chip / Soil Interface Temperatures

Other signs of persistent localized heating were recognized in the data obtained from the ground temperature cables installed on the slopes. For example, a hot spot developed at the location of one of the cables on slope 76. Temperatures within the chips at this location did not drop below 20°C in the first winter after their placement (Figure 1a). Thaw to a depth of about 2.5 m in the mineral soil underlying the chips (Figure 1b) was observed in January 1987 (the second winter). Wood chips were removed from this slope for several weeks during the winter of 1987 to allow the mineral soil to cool. The chips were also spread out to cool and arrest micro-biological activity before being replaced on the slope. Hot spots were once again recognized on the slope in 1992.

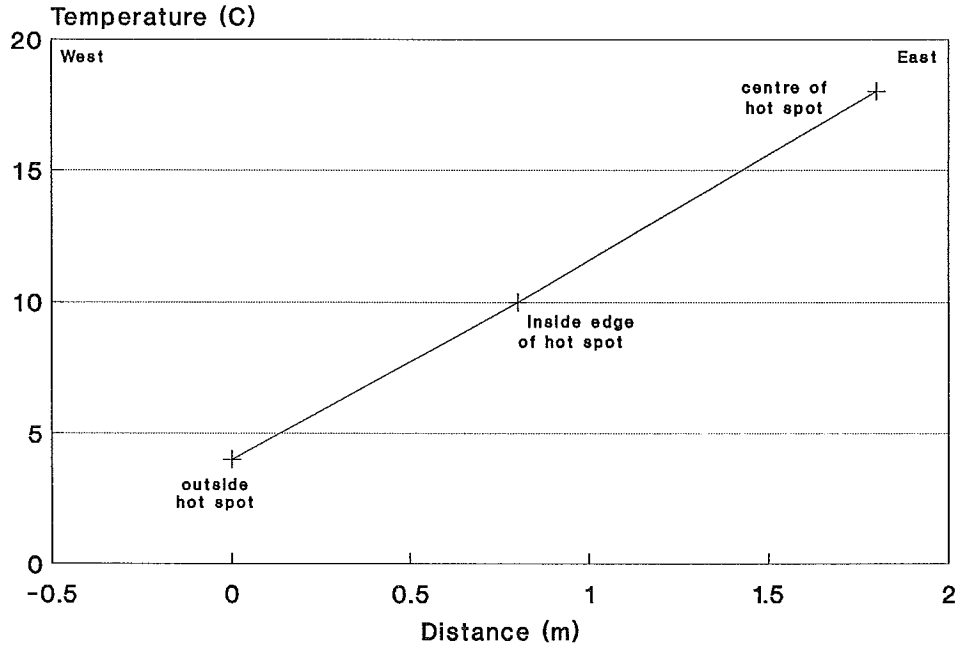
Figure 2. Hot Spot Temperature Transect
Slope 31A, kmp 84.5

Oct. 7/93 temperatures at 30 cm depth

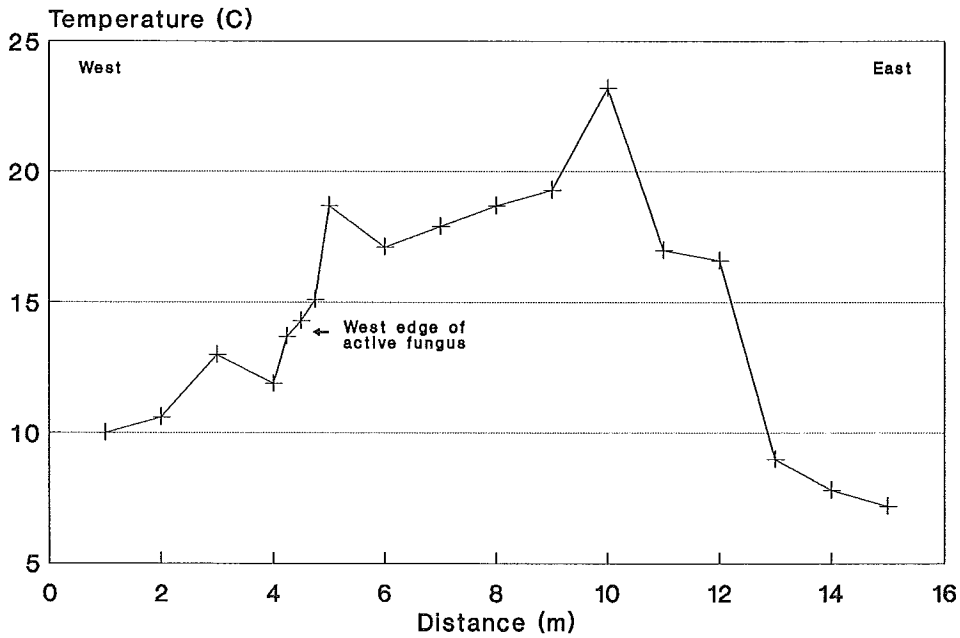
Figure 3. Hot Spot Temperature Transect
Slope 45, kmp 113.7

July 28, 1993, temperatures at 30 cm depth, at instrumented area.

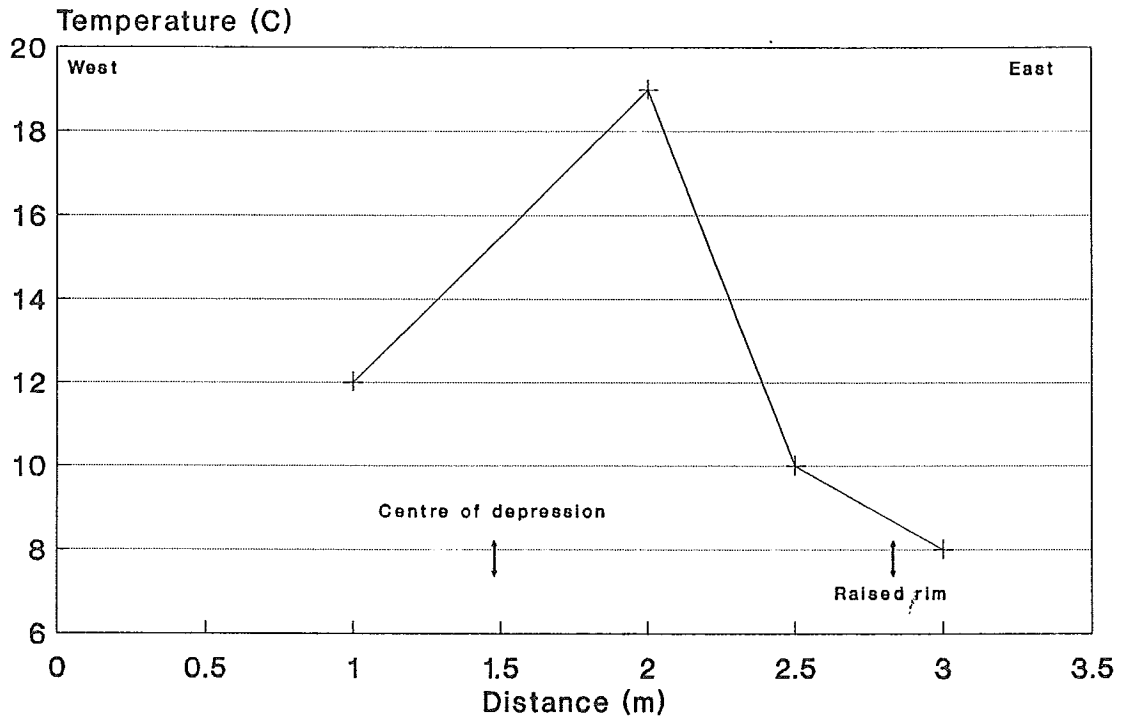
Figure 4. Hot Spot Temperature Transect
Slope 112, kmp 352.3

Oct. 6, 1993 temperatures from location of Hobo-Temp loggers, at 30cm depth.

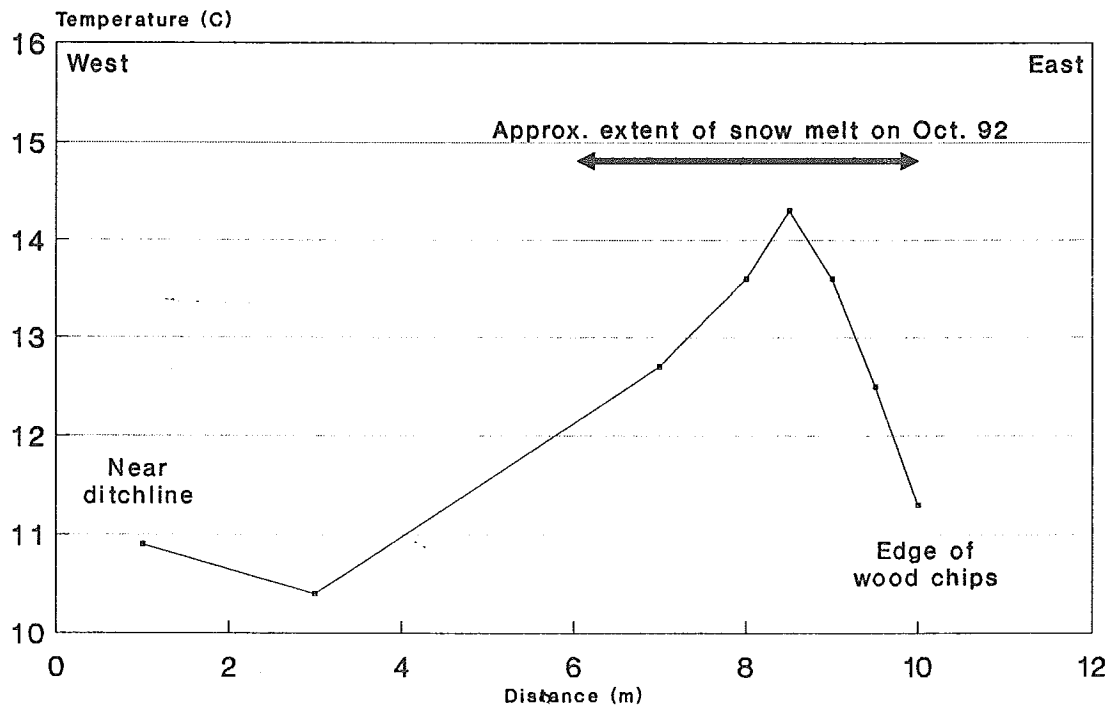
Figure 5. Hot Spot Temperature Transect
Slope 123, Km 403.7

July 24, 1993, Centreline to west edge. Temps from hot spot at edge of slope, 30cm depth. Distances are approximate.

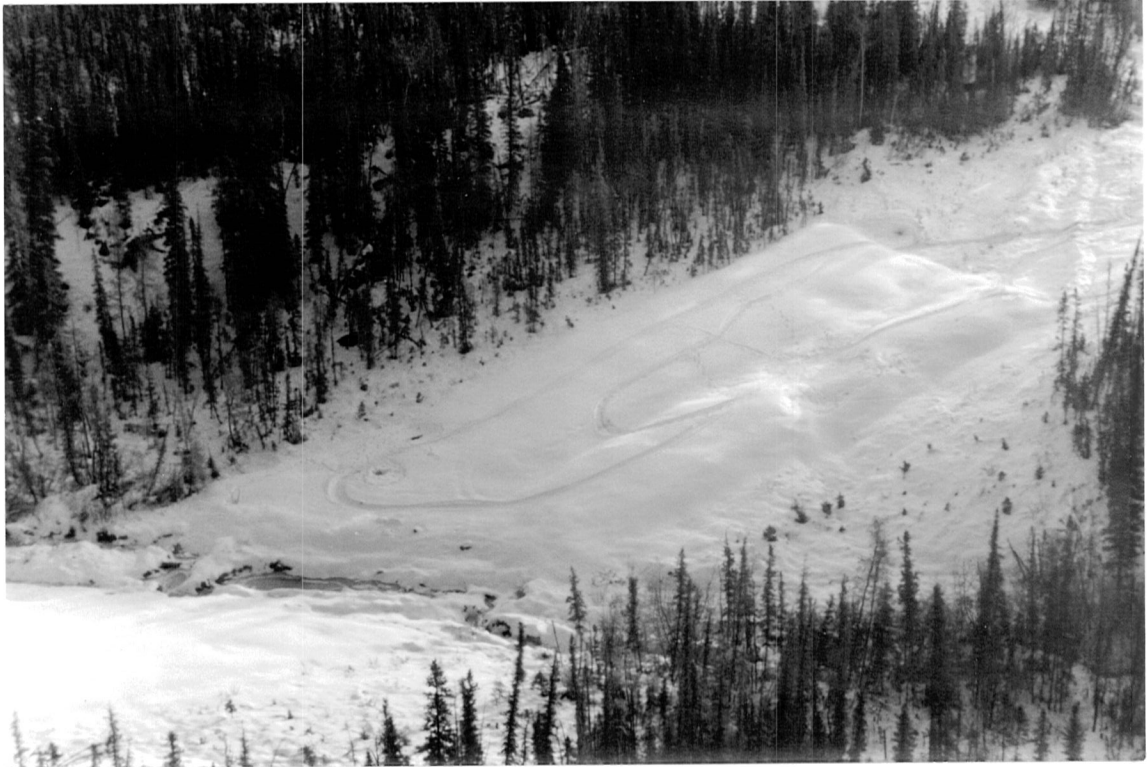
Plate 1. Slope 31A, KmP 84.5, Unnamed Creek South, Oct. 1992. Snow covered wood chip insulated slope. Surface inspection indicated hot spots extended across two-thirds of the ROW.

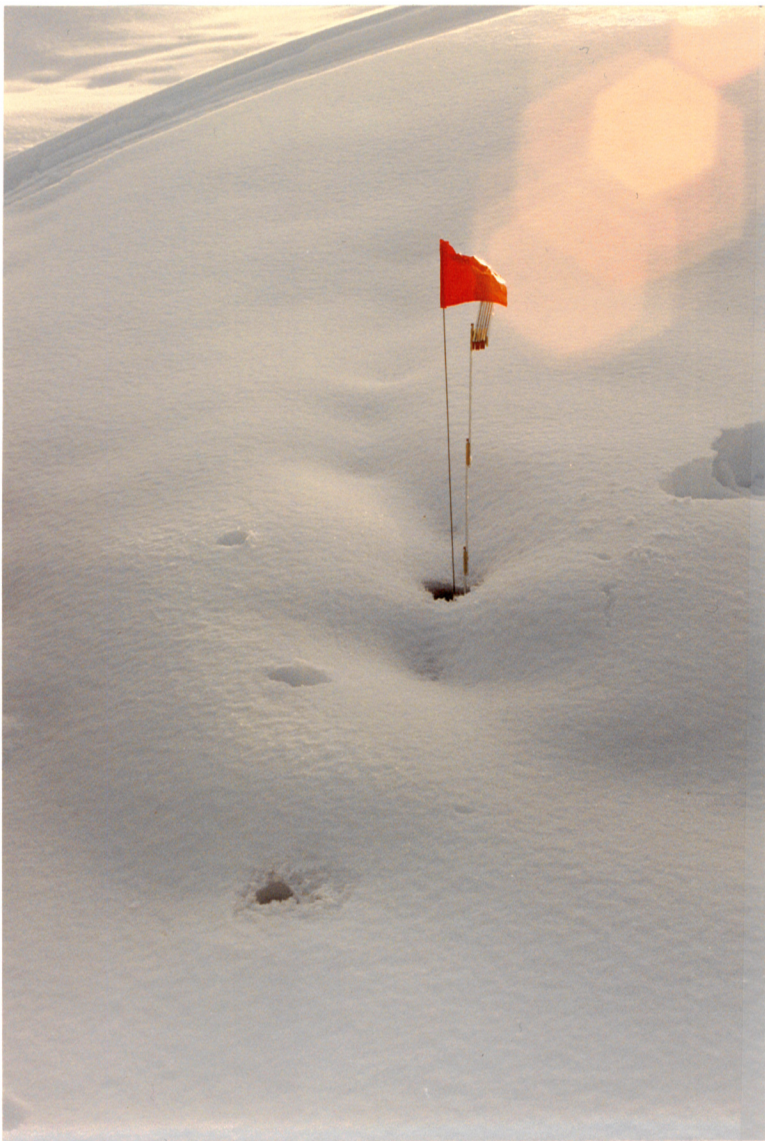
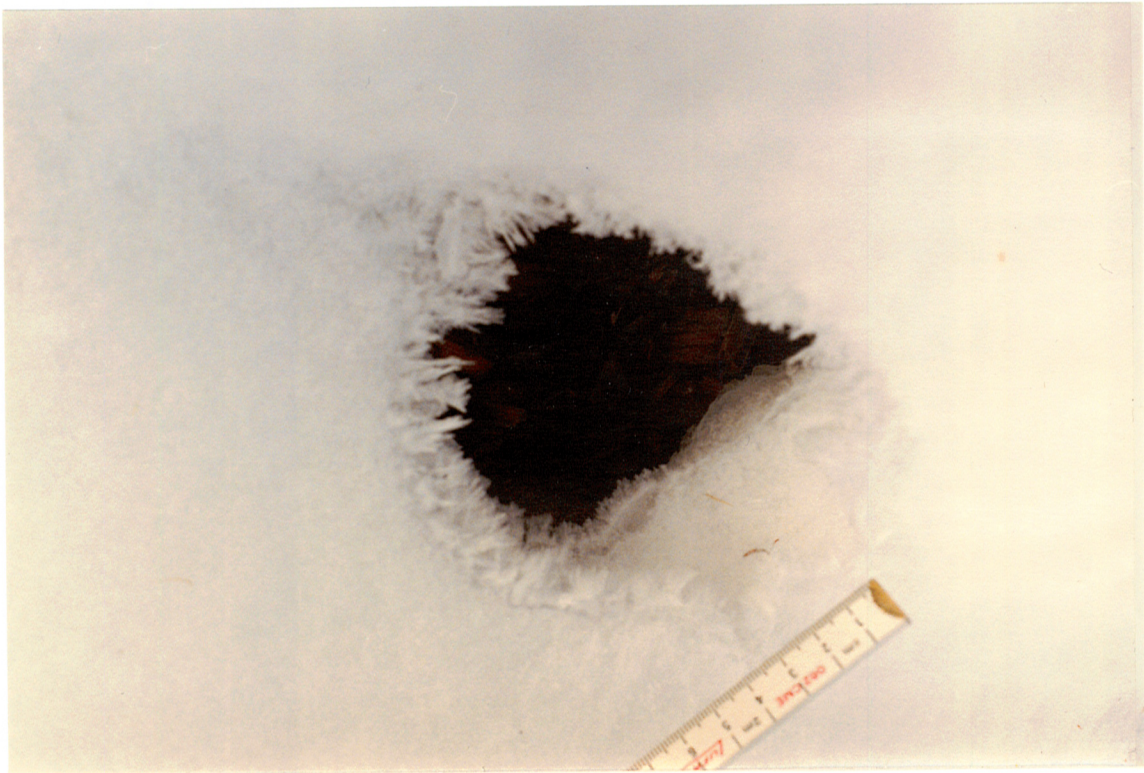
Plates 2,3.

Slope 31A, Unnamed Creek
South, KmP 84.5, Oct. 1992.
Warm air ventilates through
the snow from the wood chip
layer melting the snow and
often exposing wood chips.

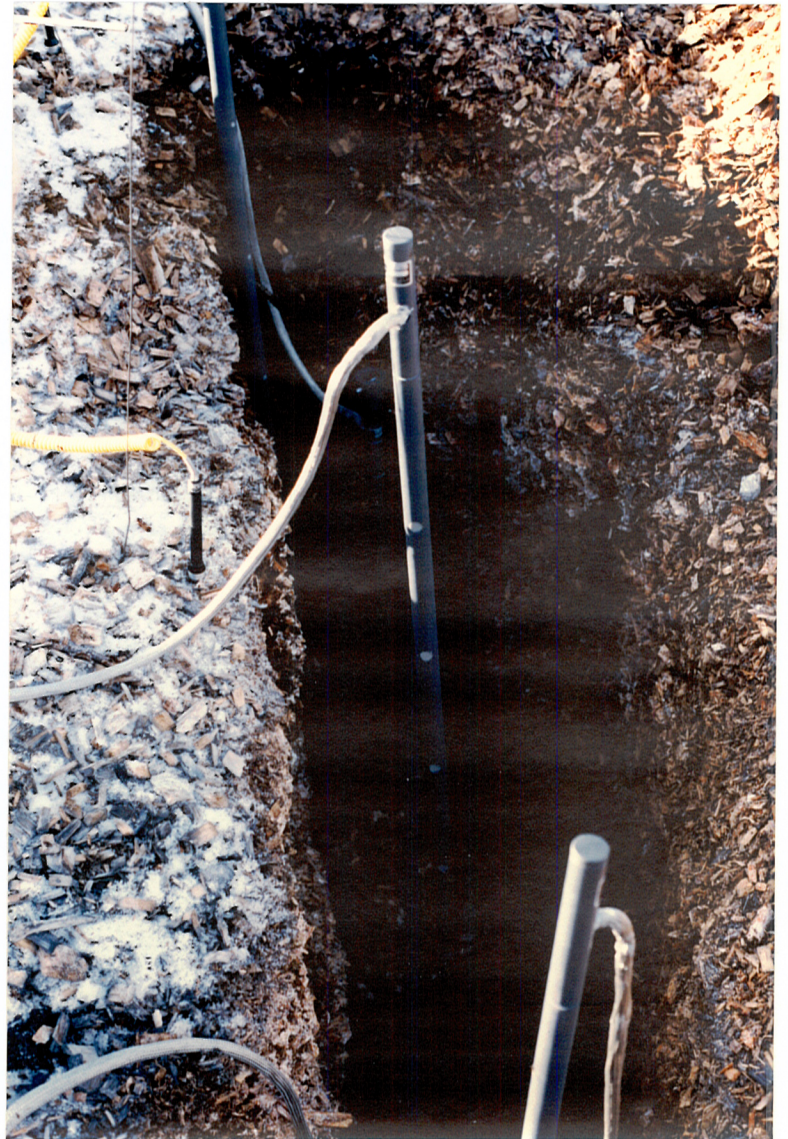
Plate 6.

Slope 31A, Unnamed Creek South, KmP 84.5, Oct. 7, 1993. Four Hobo-Temp loggers were installed at the base of the wood chip layer between the soil probes in a transect across the hot spot.

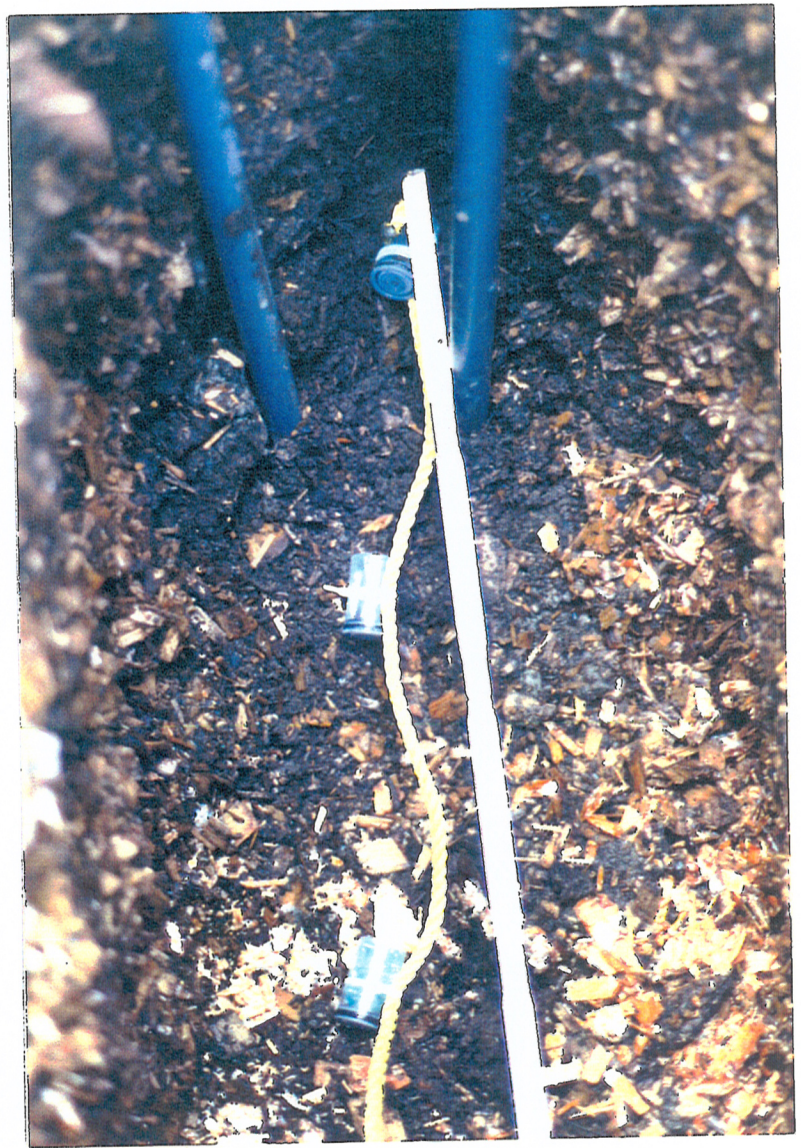
- Plate 7. Slope 31A, Unnamed Creek South, KmP 84.5. Oct. 7, 1993. Hot spot instrumentation set-up. Subsidence at hot spot location is influenced by the ditchline. Note tension crack which has developed to the west edge of the hot spot.

Slope 31A, Unnamed Creek South, KmP 84.5. Oct. 7, 1993. Hot spot instrumentation set-up. Subsidence at hot spot location is influenced by the ditchline. Note tension crack which has developed to the west edge of the hot spot.

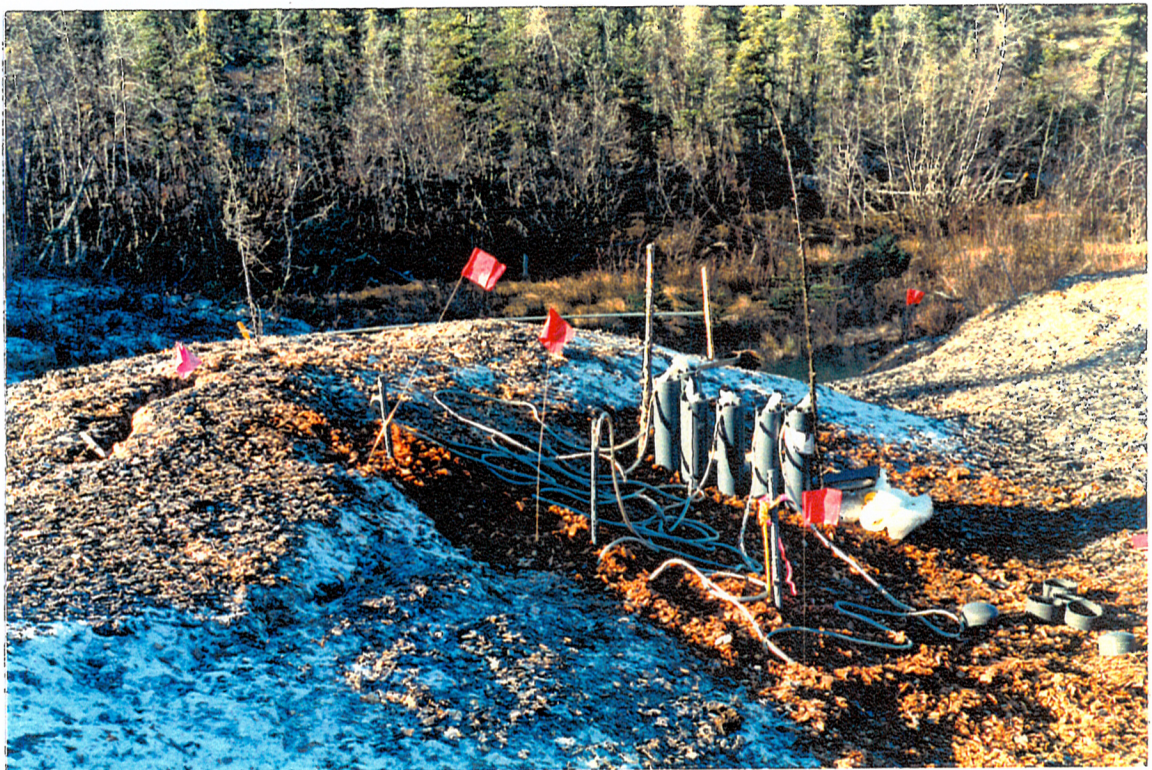
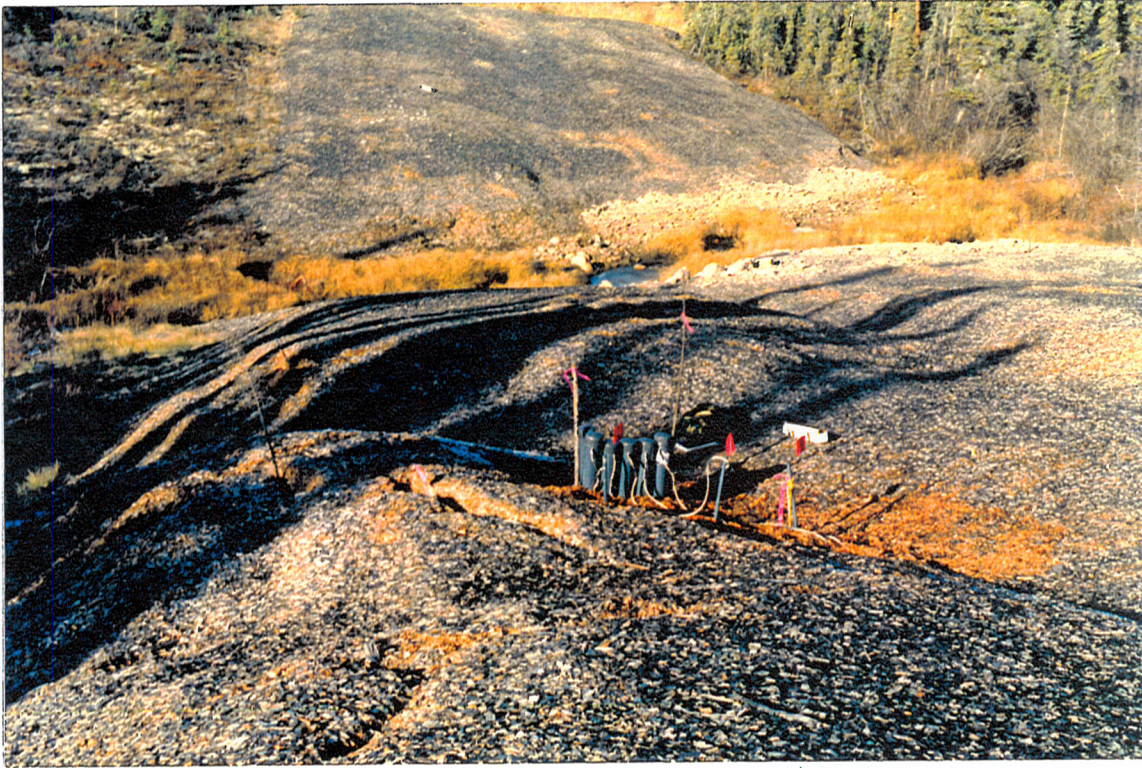
Plate 8. Slope 31A, Unnamed Creek South, KmP 84.5, Oct. 7, 1993. Northward view of slope with hot spot instrumentation. Note subsided hot area and ditchline, and tension cracks in the wood chips.

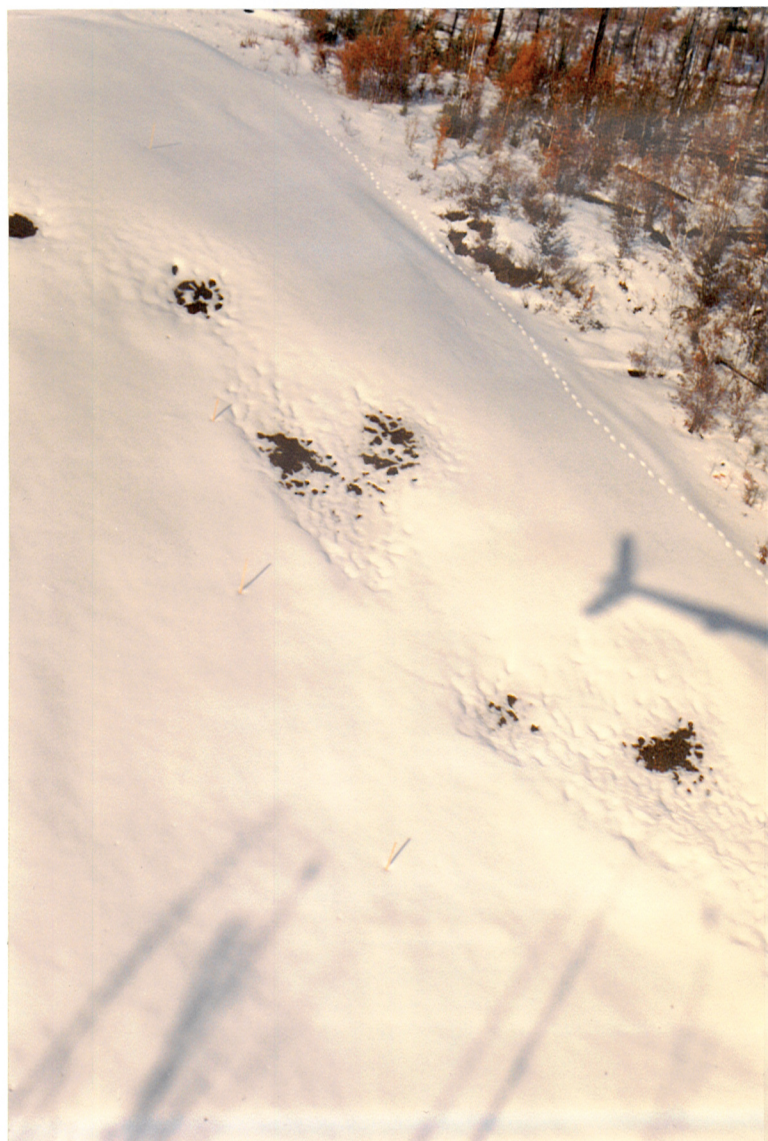
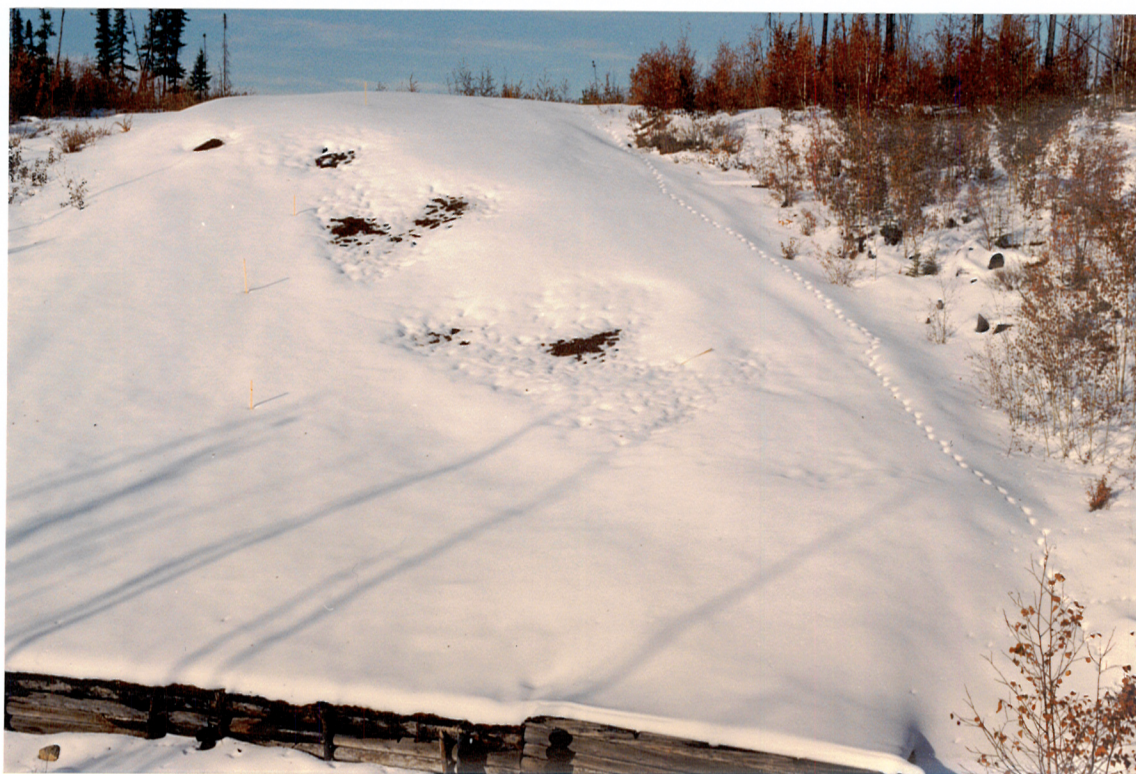
Plates 10, 11.

Slope 44, Unnamed Creek North, KmP 133.6, Oct. 92. Aerial photograph of differential snow melt on the wood chips showing the extent and location of hot spots. Areas of most intense heat expose bare wood chips. Partial snow melt over the hot spot forms a hummocky surface.

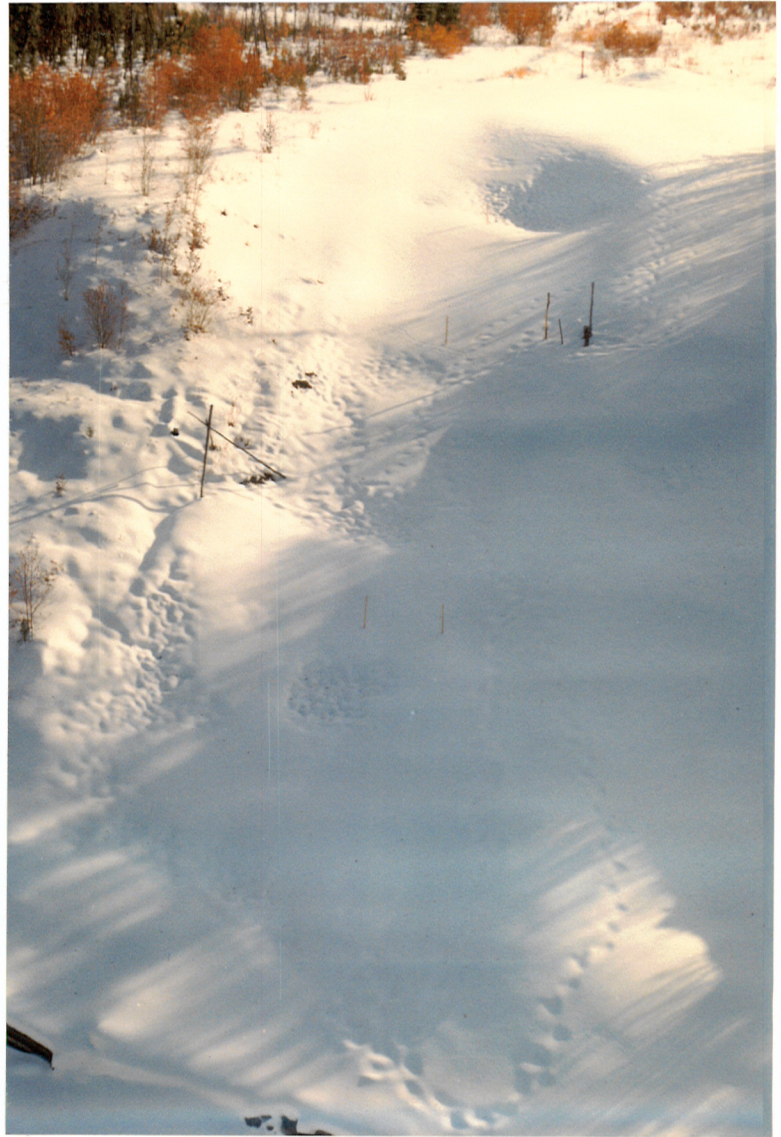
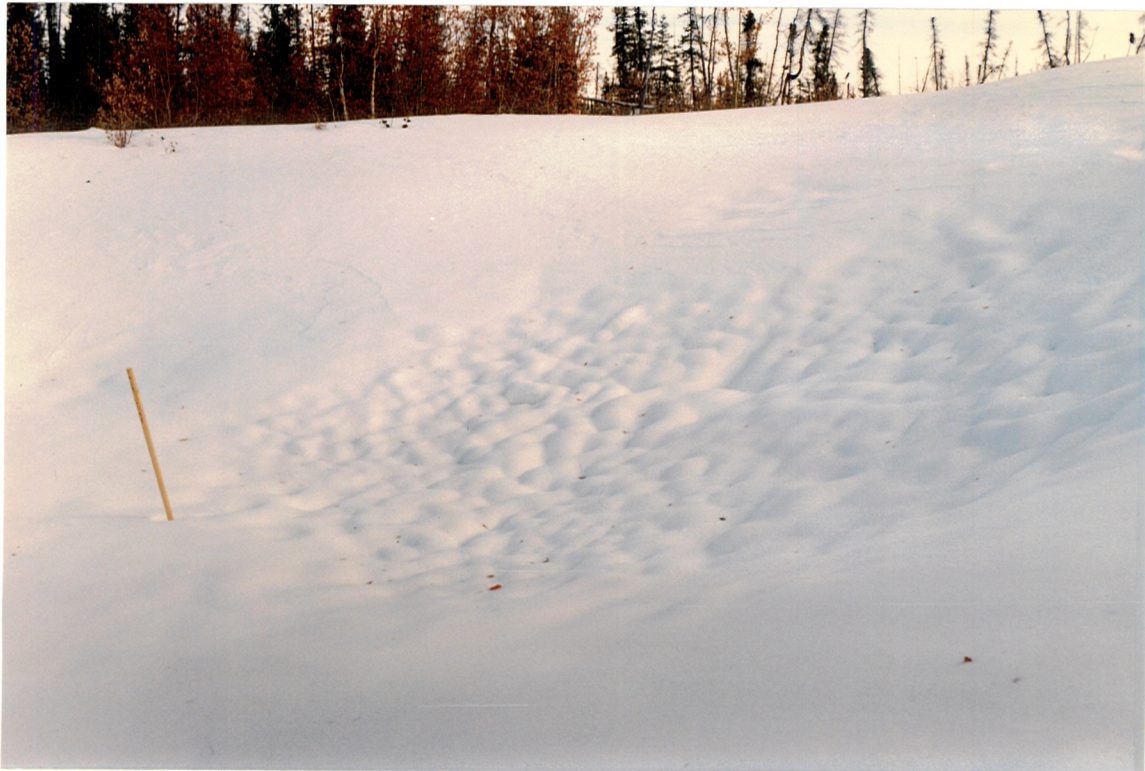
Plates 12,13.

Slope 45, Unnamed Creek South, KmP 133.7, Oct. 92. Snow melt patterns indicate both local and extensive hot spots in the wood chips. A hummocky and saturated snowpack indicates high surface temperatures in the wood chips.

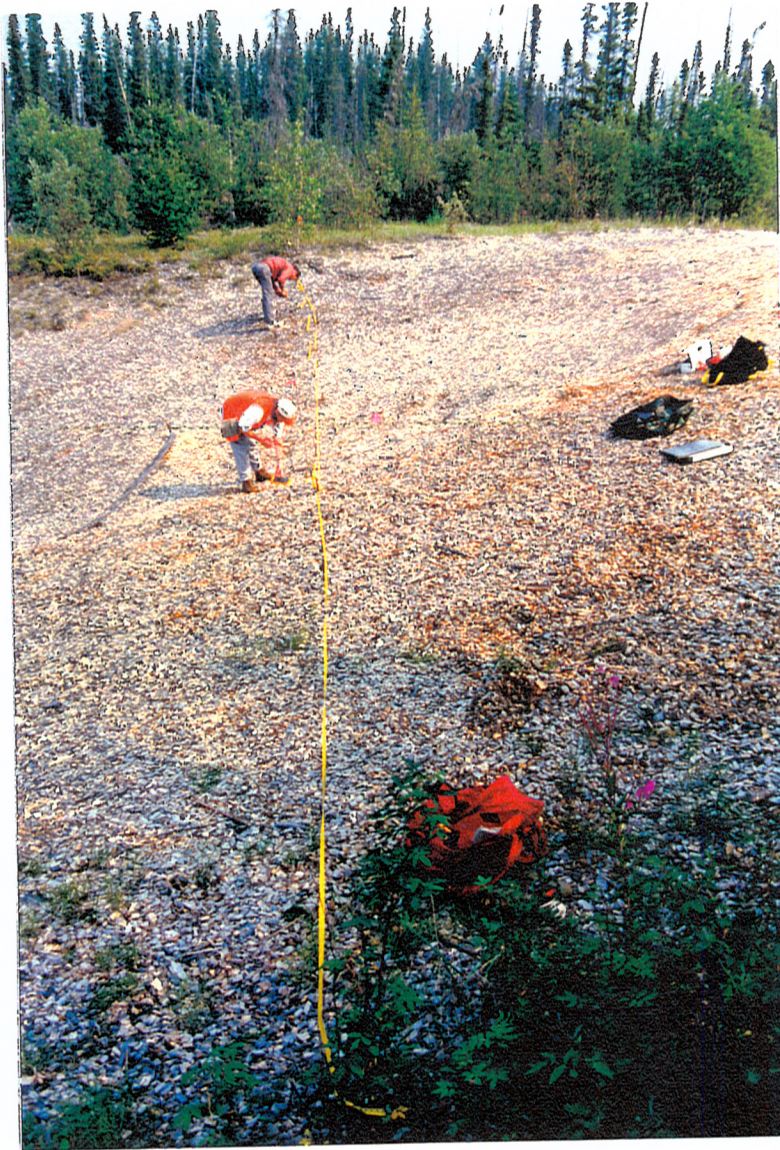
Plate 15. Slope 45, Unnamed Creek South, KmP 133.7, July 1993. Vertical zone of active fungus at edge of hot spot is 10 to 15 cm wide.

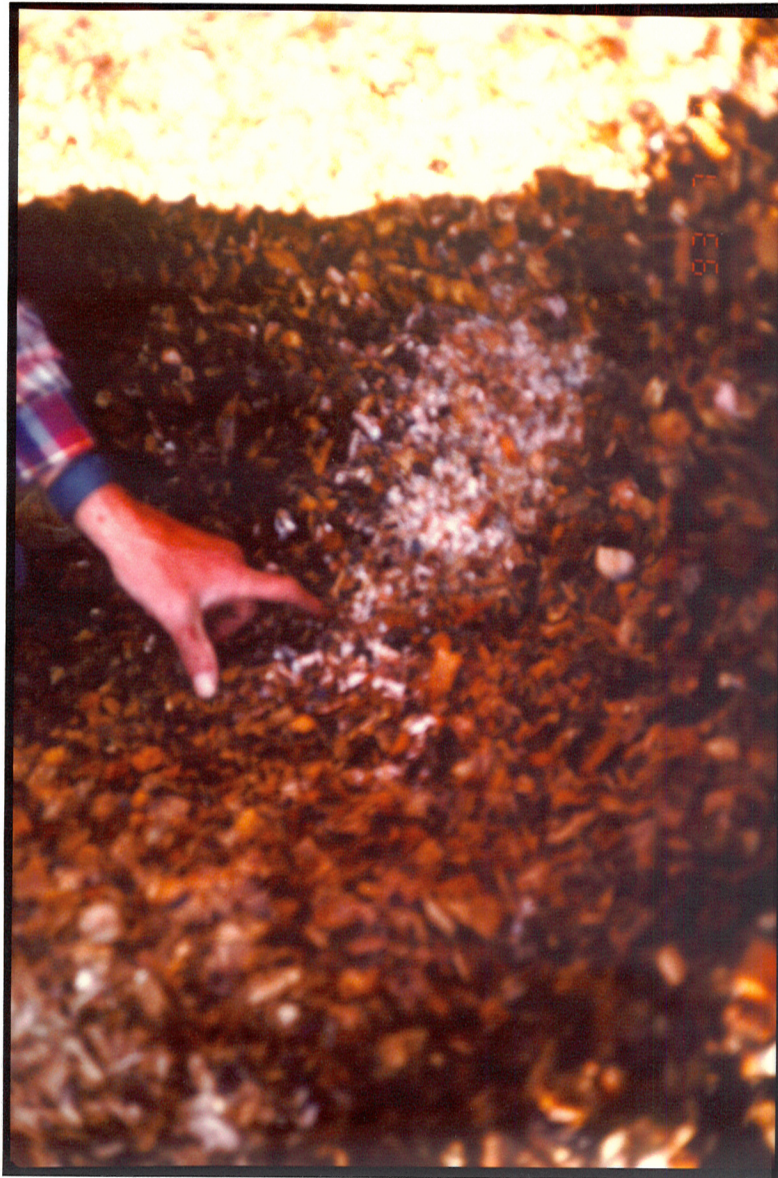
Plate 16.

During installation of the instruments in a trench through the hot spot on slope 45 in July 1993 the following observations were noted. The fungi in the wood chips were white in colour and have a soft, dense (shortening-like) consistency in the warmer/active zone around the rim. This dense matrix contained fresh chips and formed a vertical band approximately 20 cm wide (Plate 15). In the centre of the hot spot the wood chips were degraded and appeared wet, slimy, and partially decomposed. Similar conditions were observed during instrumentation on slope 31A in October 1993.

Slope 45, Unnamed Creek South, Kmp 133.7, July 1993. Trench dug across one edge of hot spot to investigate hot spot and install instrumentation.

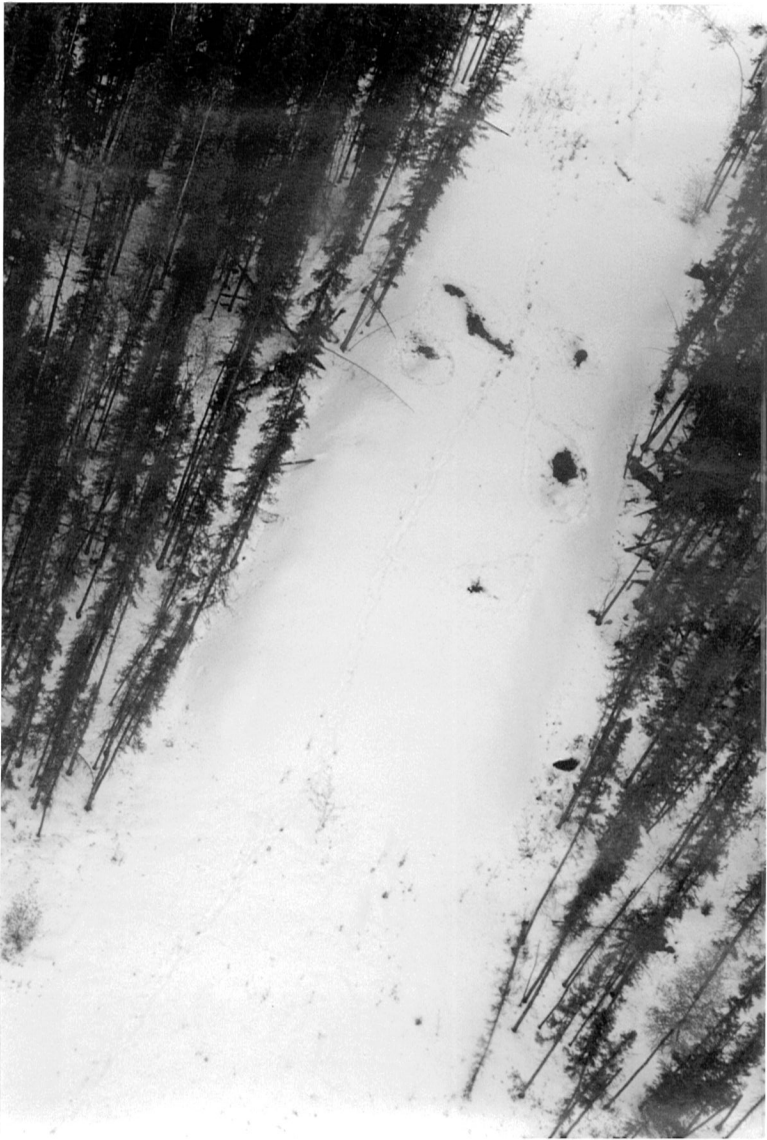
Plate 19. Slope 63, Steep Creek South, KmP 194.9, Oct. 6, 1992. Extensive hot spots were recognized from ground inspection of the slope.

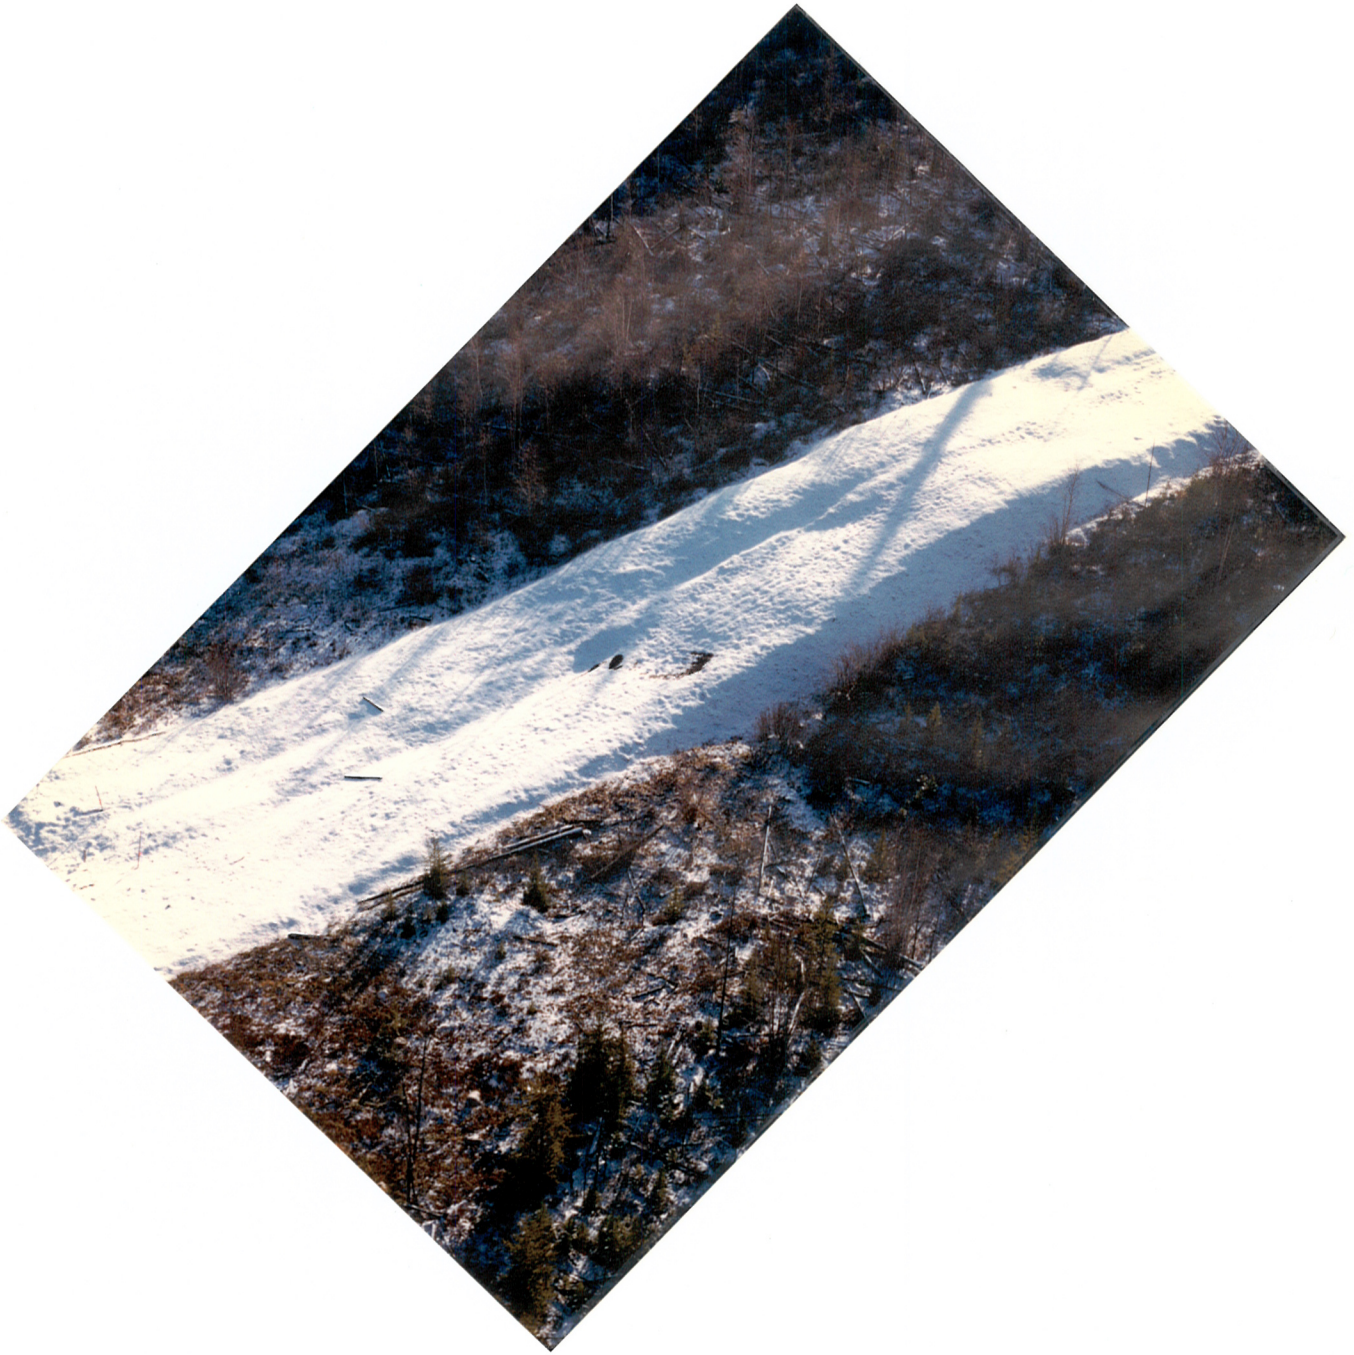
Plate 21. Slope 66, Blackwater River North, KmP 224.4, Oct. 1993. Aerial photograph of differential snow melt on wood chip slope indicating hot spots.

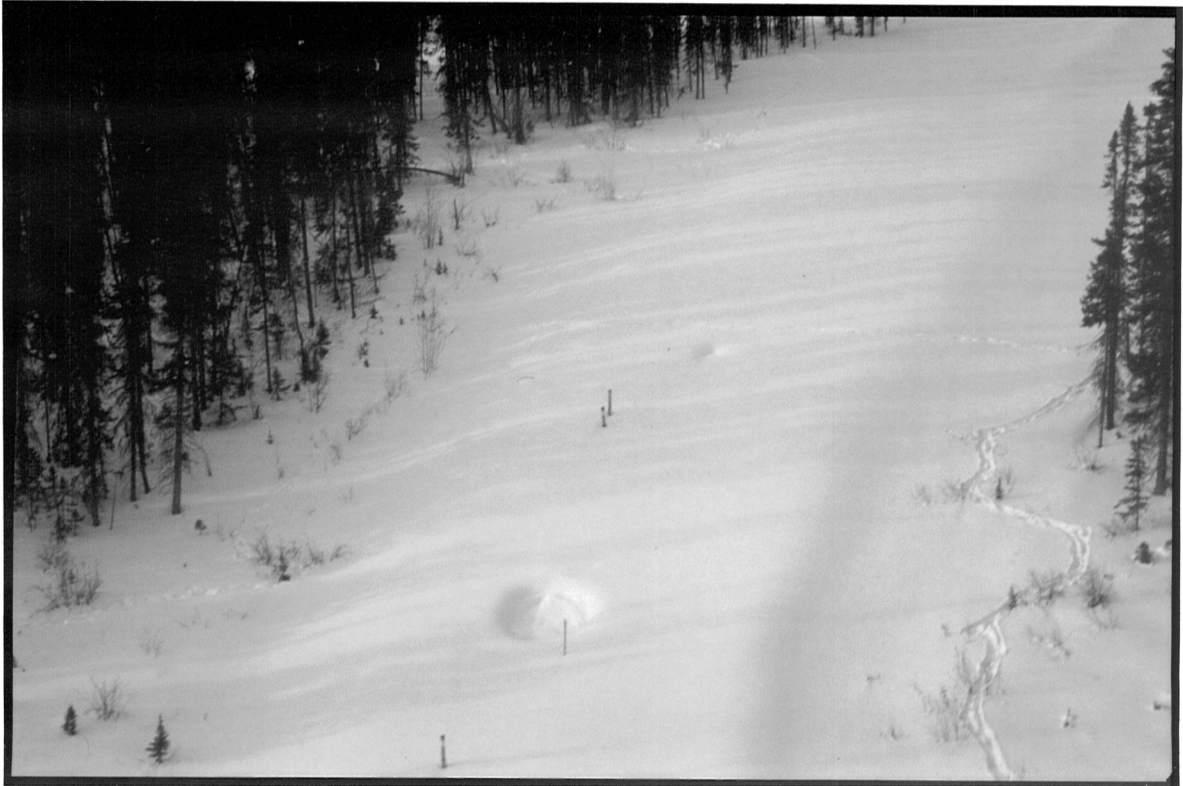
Visible snow melt patterns also persisted through the winter of 1992/93, unlike previous winters (Plate 22). In the summer of 1993, the GSC as a component of an Industrial Partnership with IPL, instrumented several hot spots to assess their thermal regime and their potential contribution to thaw of the underlying permafrost. Thermal instrumentation was installed on slopes 31A, 45, 79 and 112. While the details of the instrumentation are presented in section 4, temperature measurements and visual observations are reported here.

Plate 22. Slope 76, Unnamed Creek South, KmP 273.6, March 1993. Depressions on the wood chip slope indicate hot spots.

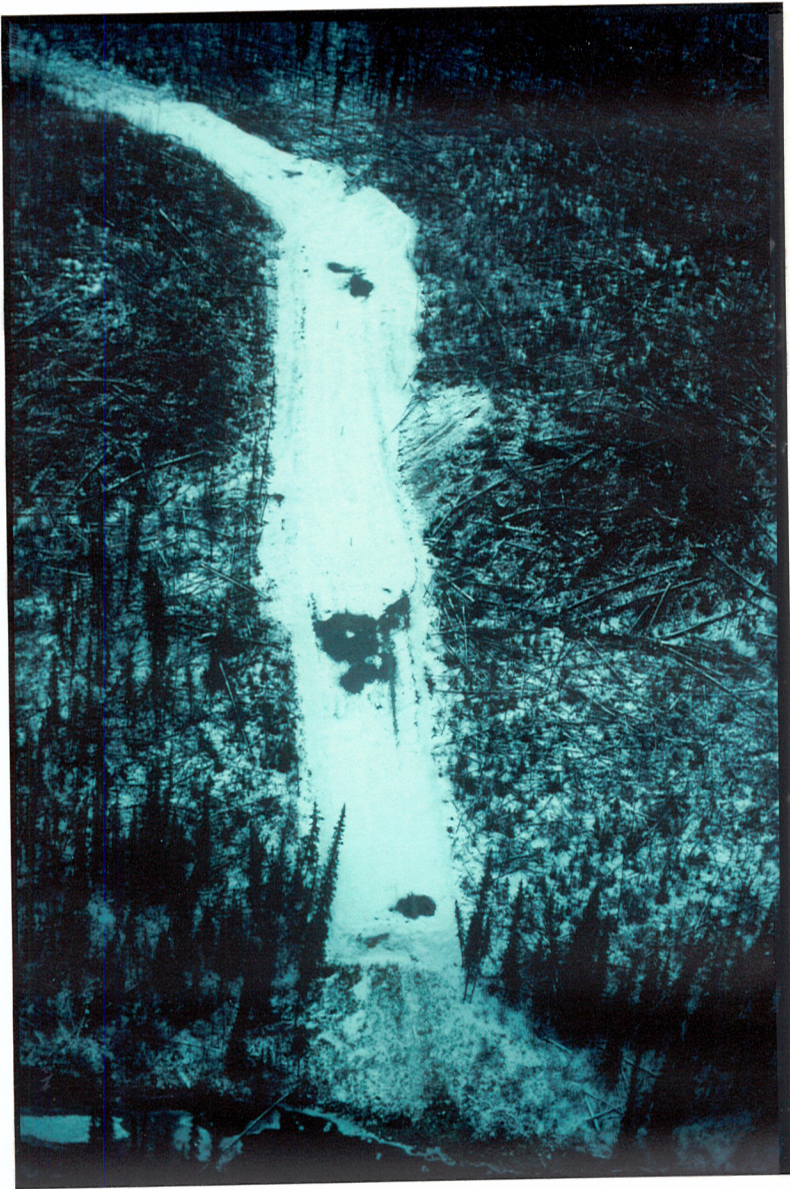
Plates 23, 24.

Since 1990, particular attention has been paid to snow melt patterns indicative of hot spots. In October 1990, PTRM noted differential snow melt suggesting wood chip heating on 8 slopes (see for example Plate 23 in Appendix A). IPL reported 6 slopes affected by wood chip heating in the fall of 1991. PTRM identified three slopes with hot spots in May 1992. In October 1992, PTRM clearly identified hot spots on 23 slopes, and noted their possible existence on two additional slopes.

Slope 79, Whitesand North, KmP 279.0, Oct. 1990. Aerial photographs showing large areas of melted snow due to heat generated in the wood chips.

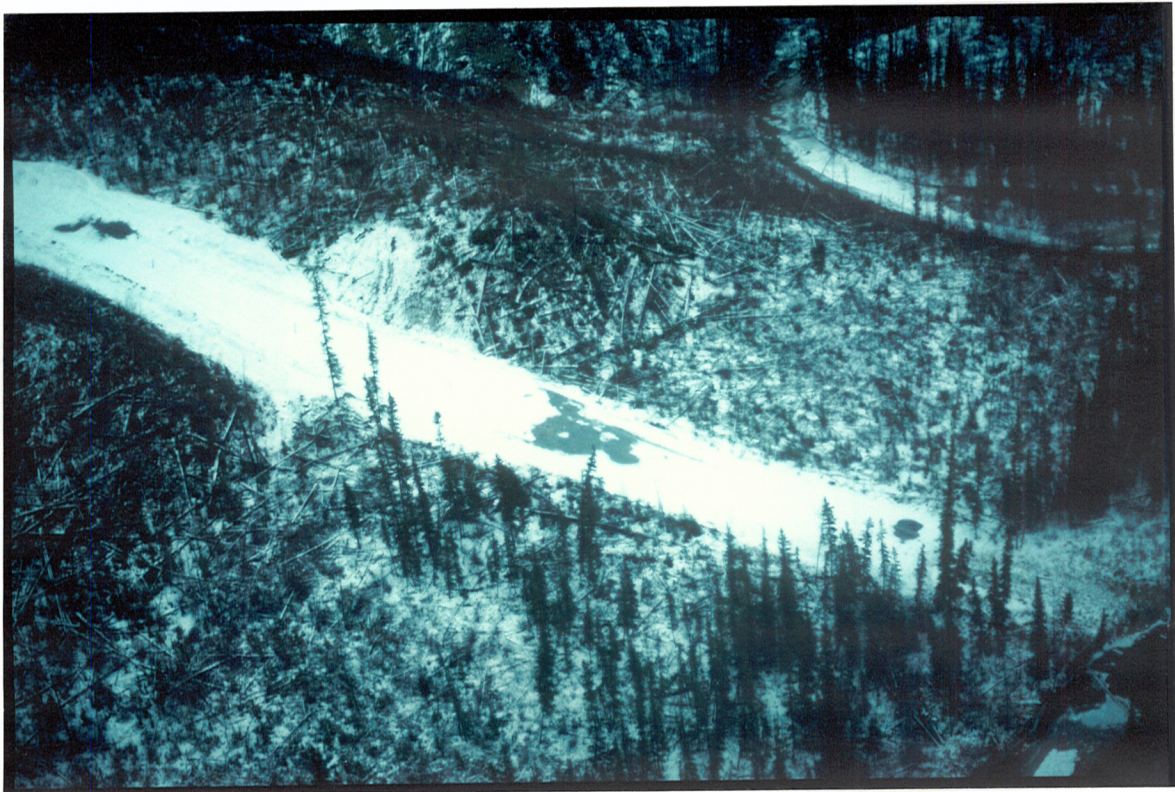
Plate 25.

Slope 79, Whitesand North, KmP 279.0, Oct. 1992. Patches of melted snow over hot areas in the wood chips. Some of the larger hot spots appear to be cooler in the centre since snow has melted in a ring-like pattern.

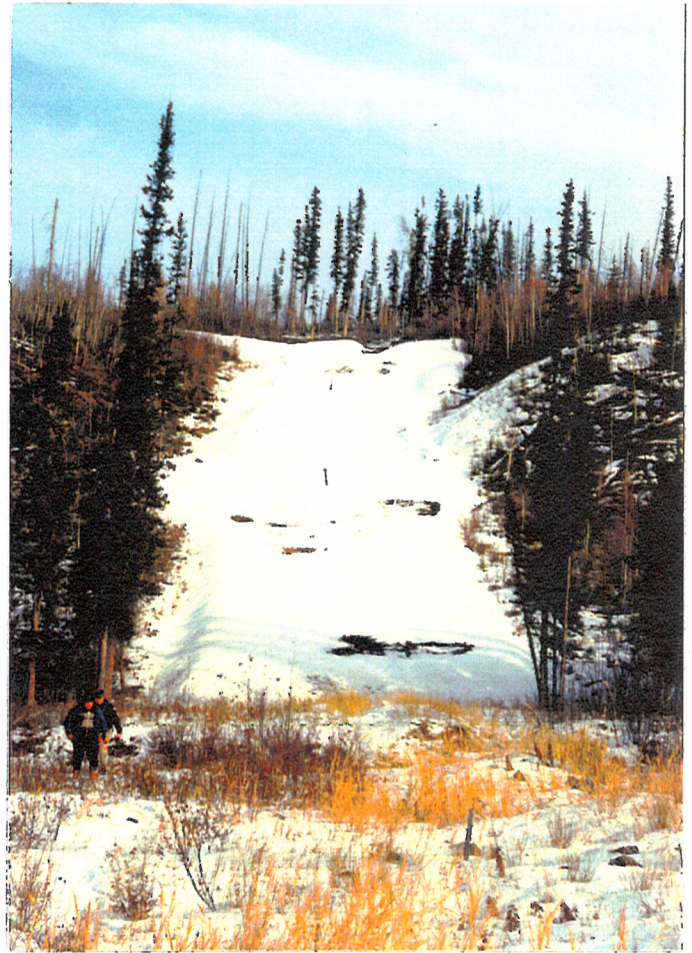
Plate 26.

Slope 79 and 80, Whitesand North and South (in the foreground), KmP 279.0 - 279.3, Oct. 1992. Standing on Slope 80 facing north to Slope 79. Snow melt indicating areas of hot spots on both slopes.
