Hot spots on wood chip insulated slopes,
Norman Wells Pipeline,
Northwest Territories

**HOT SPOTS ON WOOD CHIP INSULATED SLOPES,
NORMAN WELLS PIPELINE, N.W.T. :**

**Chronology of 1984 to 1993 observations and summary
of 1993 instrumentation program**

Burgess, M.M., Lawrence, D.E., MacDonald J., and Desrochers, D.T.

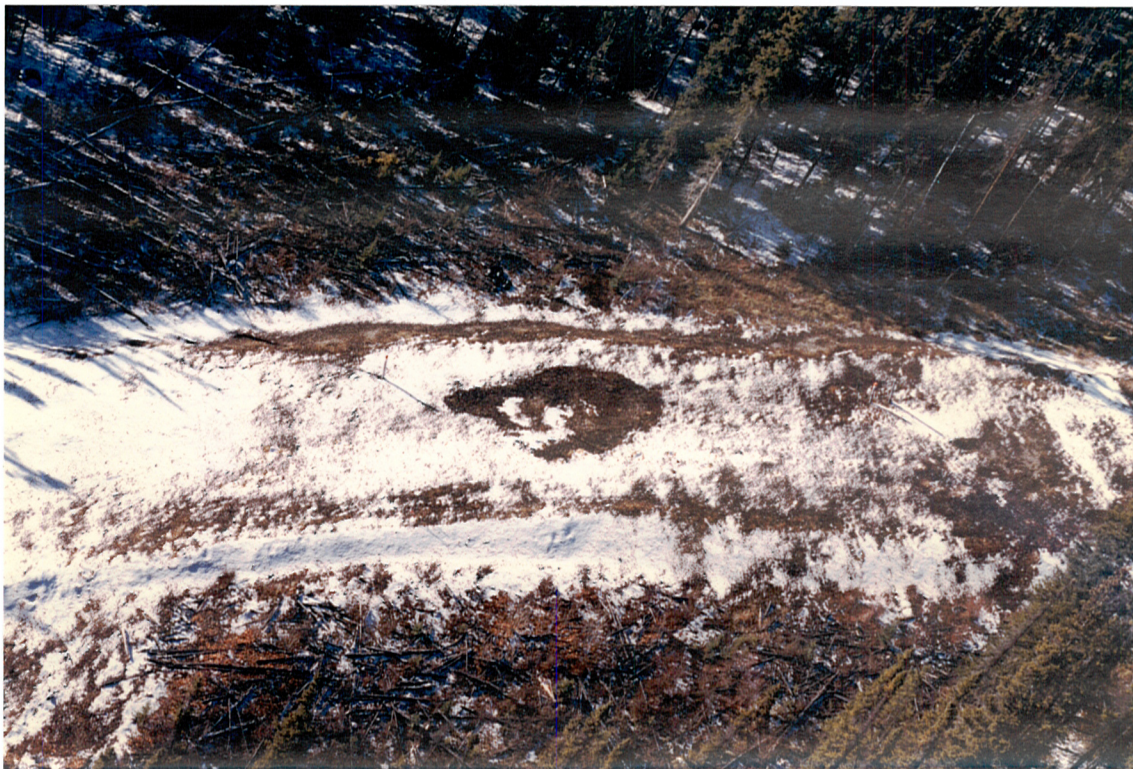
Plate 28. Slope 79, Whitesand North, KmP 279.0, Oct. 6, 1993. Aerial view of hot spot in the wood chip layer.

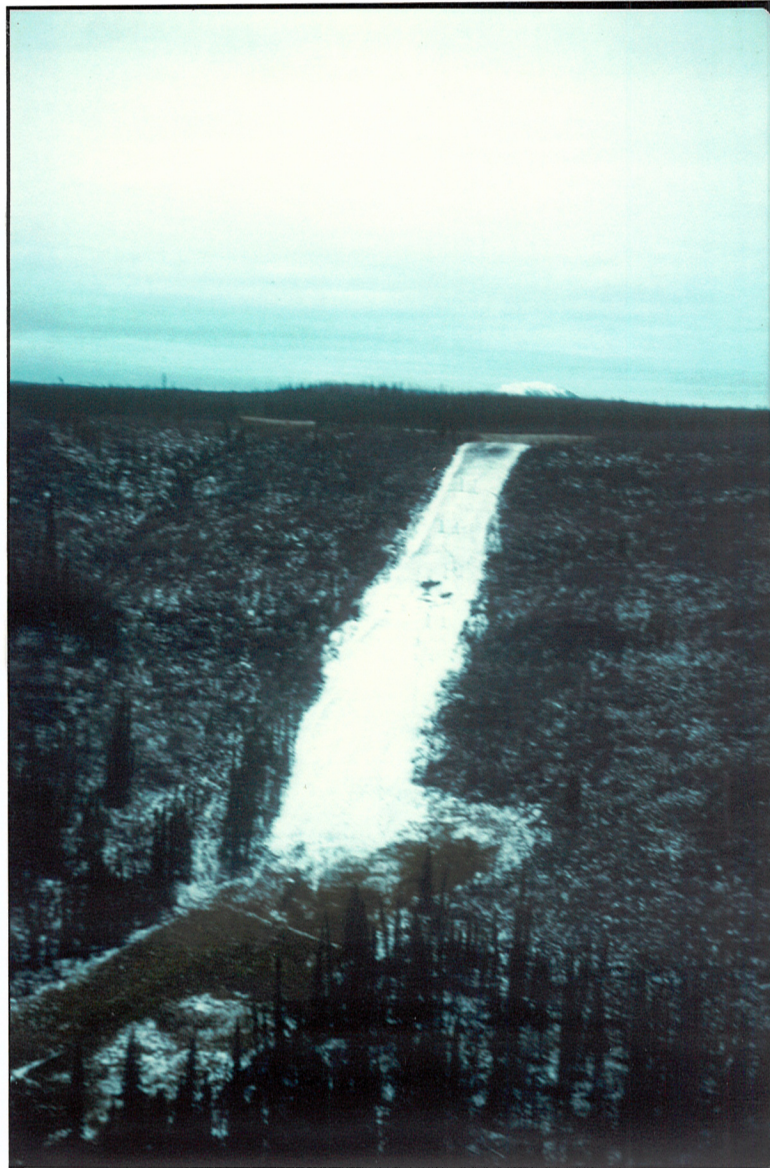
Plate 31. Slope 82. Ochre River South, Kmp 286.6, Oct. 1990. Extensive hot spots at mid-slope.

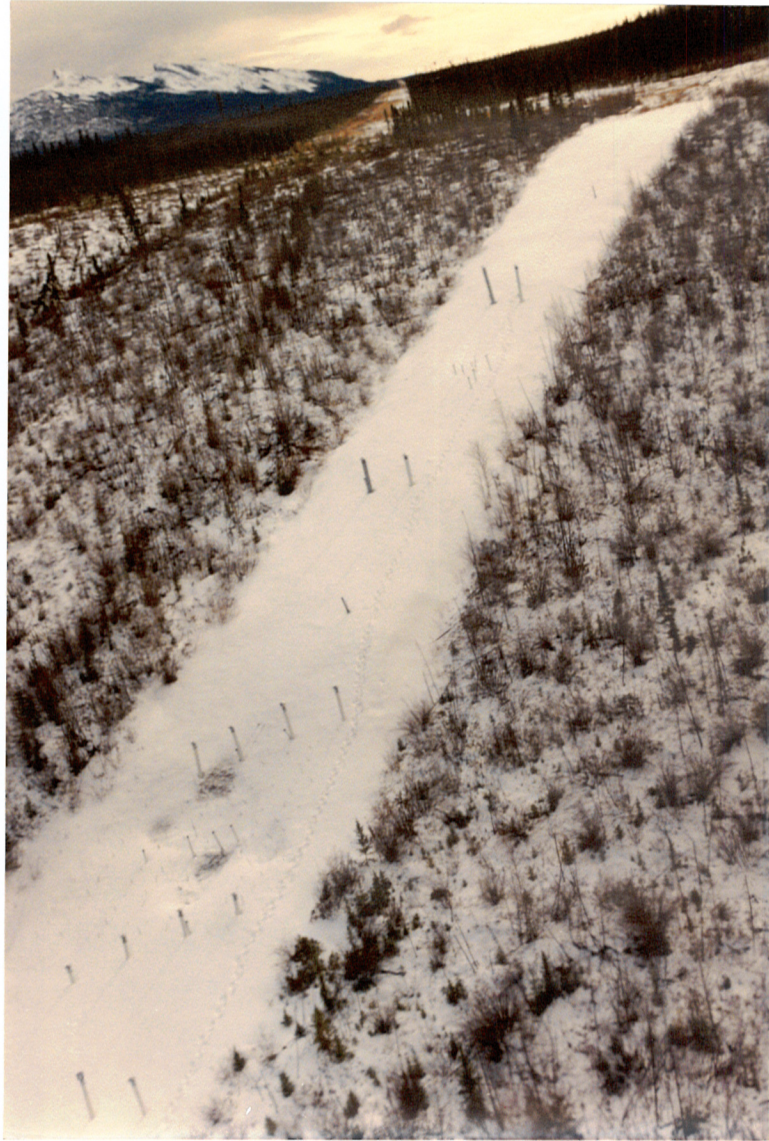
Plate 32. Slope 82, Ochre River South, KmP 286.6, Oct. 1992. Extensive hot spots at mid-slope.

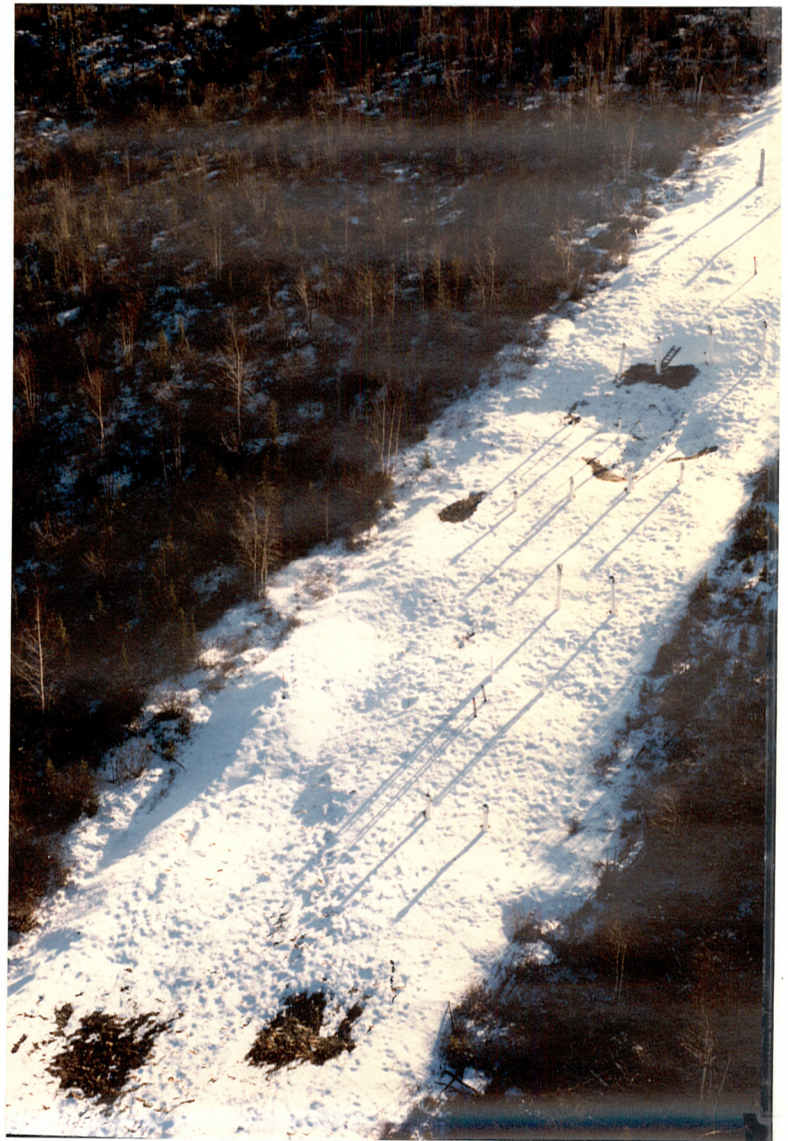
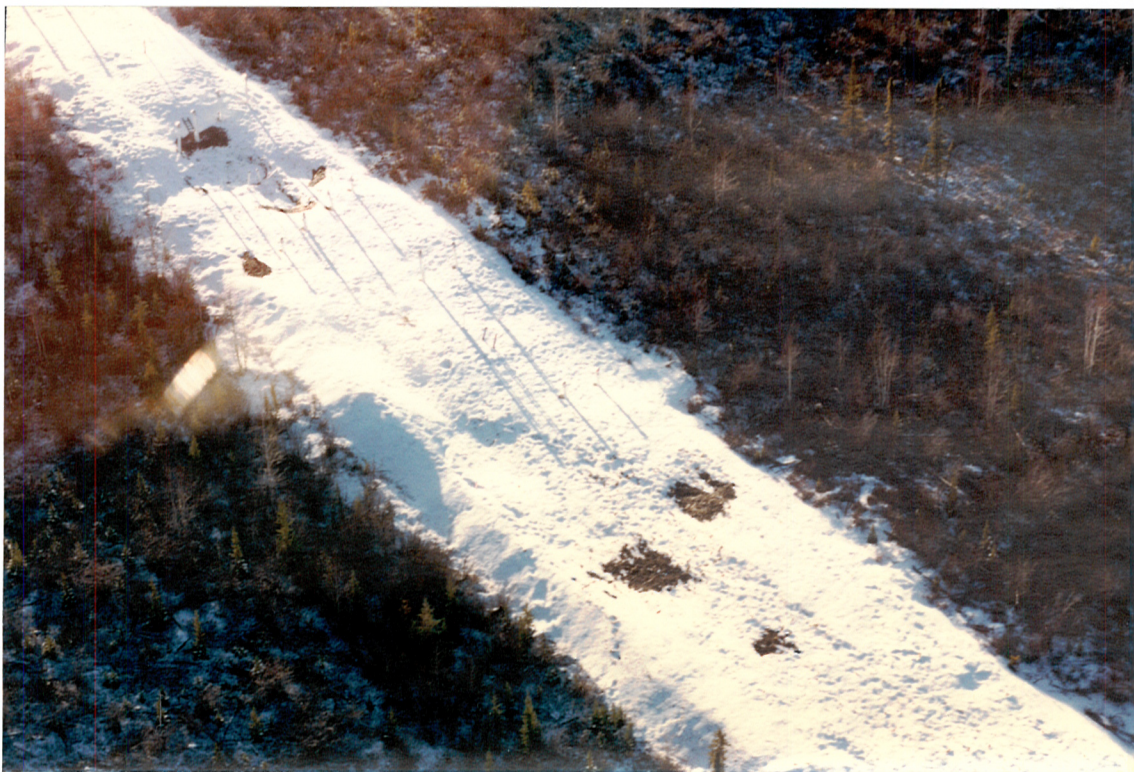
Plates 33, 34.

Slope 82, Ochre River South,
KmP 286.6, Oct. 1993. Aerial
view of hot areas on the wood
chip slope, recognized by
patches of exposed wood
chips.

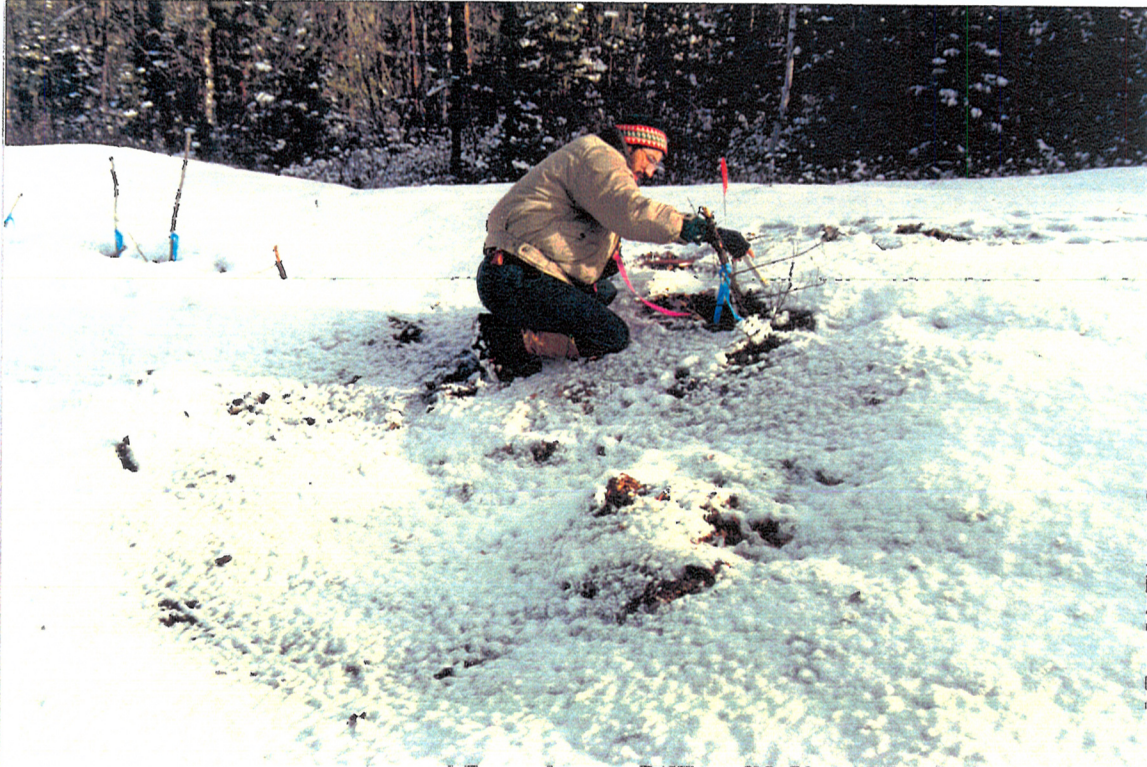
Hot spots were first suspected in the fall of 1992. In October 1993 numerous hot spots were visible, many over the subsided ditch and snow melt patterns indicated heat loss from tension cracks. HOBO-TEMP logger #4430 was installed at a depth of 20 cm in a 10 cm wide tension crack adjacent

to a hot spot on the west side of the slope. Another HOBO (#4433) was installed at a depth of 30 cm in a 14 cm wide tension crack adjacent to a hot spot on the east side of the slope.

Plate 35. Slope 109, Unnamed Creek South, KmP 351.9, Oct. 6, 1993. Hobo-Temp logger installation at 30 cm depth in a tension crack located near a hot spot. Two tension cracks were instrumented with Hobo's at this slope.

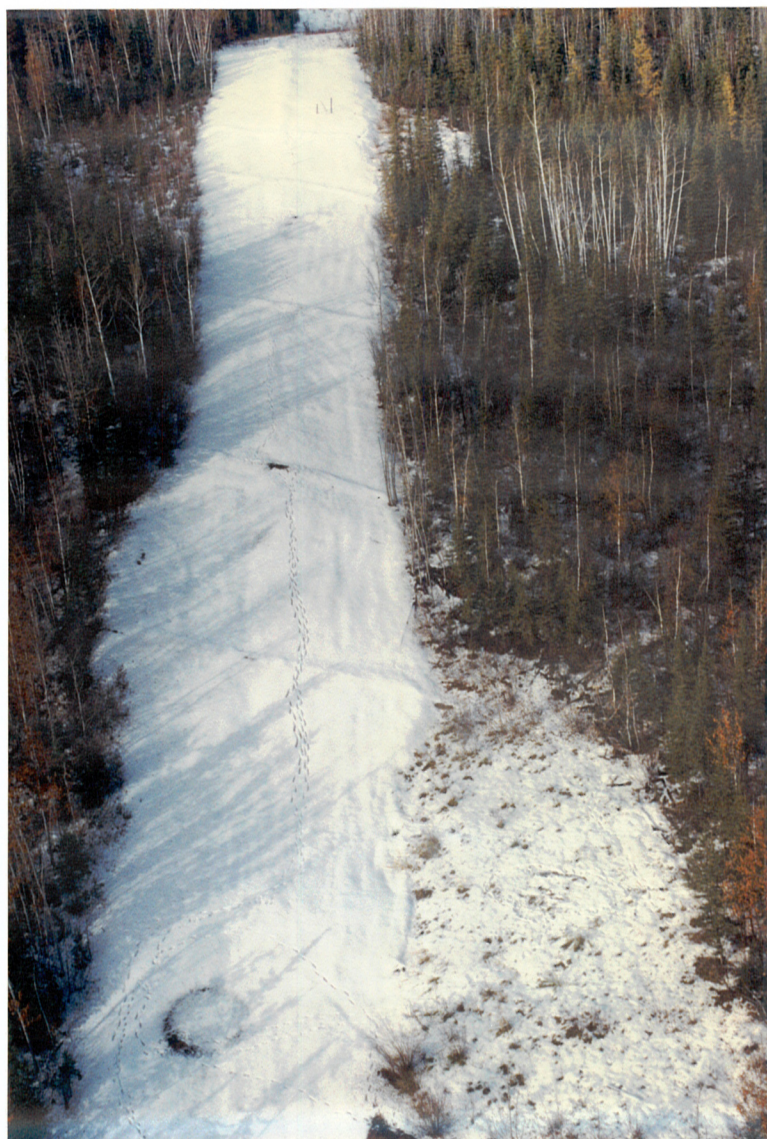
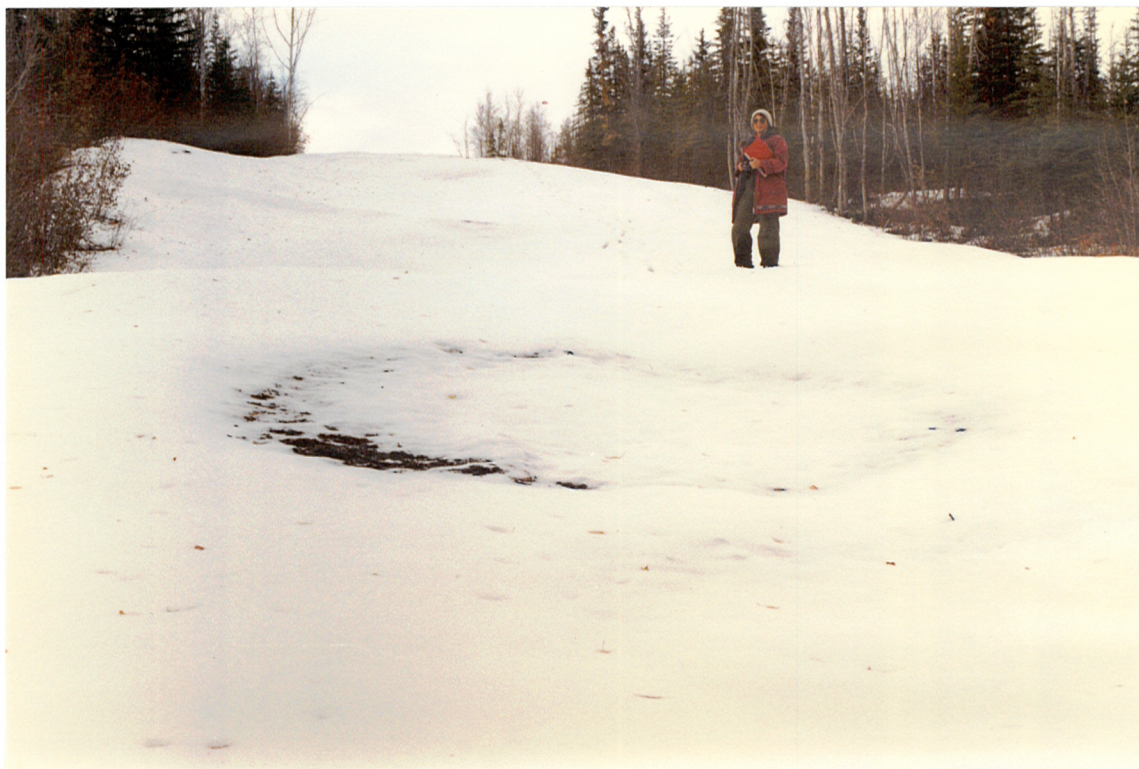
Plates 36, 37.

This slope was insulated with a 80 cm thick layer of wood chips during the 1984 construction season. One temperature cable was installed by IPL at that time. An additional cable was installed by IPL in 1991 as part of their program to reassess the factor of safety of select slopes. Hot spots were first noted in October 1992. Five or more small to medium size hot spots were exposed on the slope. One hot spot located below the piezometer, was almost a perfect circle in form. This hot spot appeared to be warmest around its edge where bare wood chips were exposed, and cooler in the middle where snow remained (Plates 36, 37).

Slope 112, River Between
Two Mountains, KmP 352.3,
Oct. 1992. Circular snow melt
patterns indicate hot spots in
the wood chips.

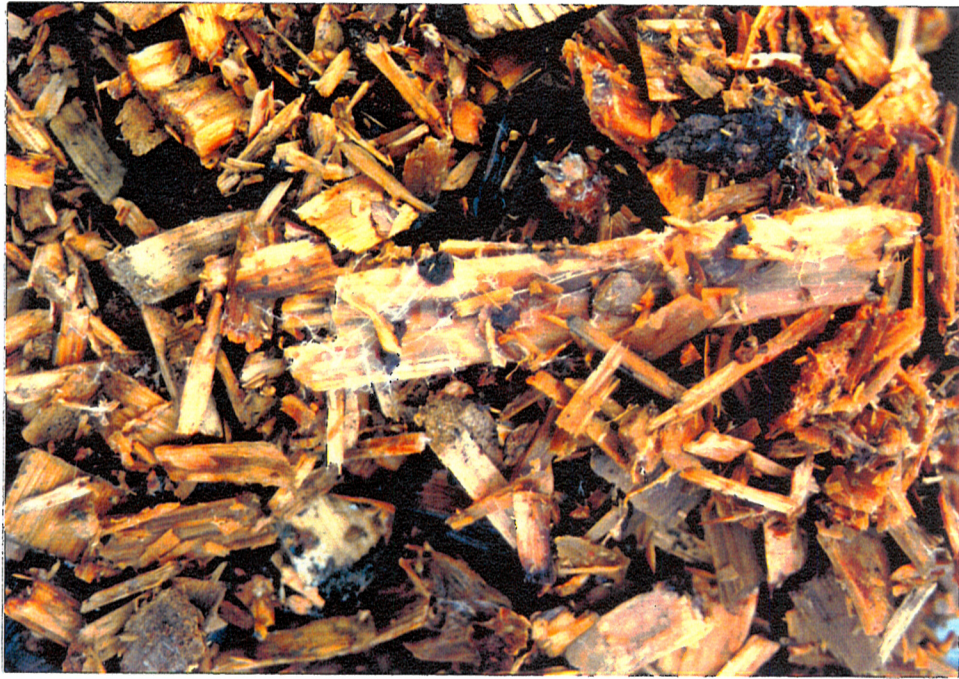
Plate 42. Slope 112, River Between Two Mountains, KmP 352.3, Oct. 6, 1992. Fungal material in the wood chips.

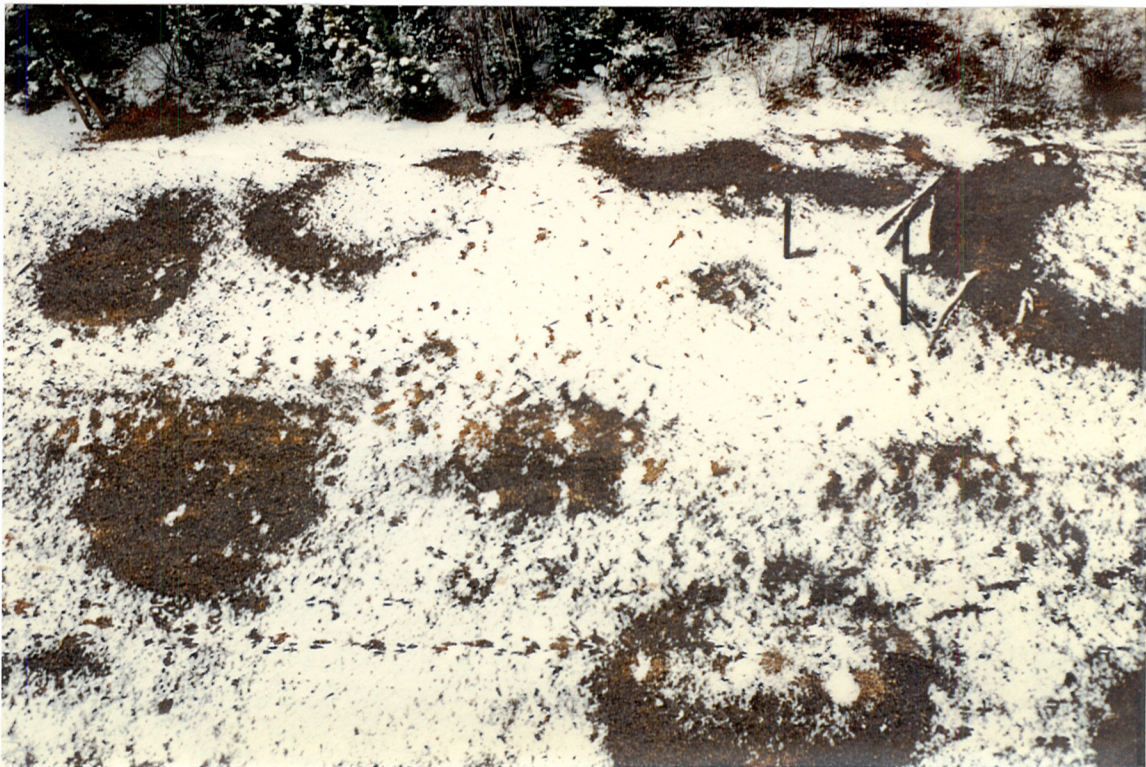
Plate 43. Slope 112, River Between Two Mountains, KmP 352.3, Oct. 6, 1993. Aerial view of circular snow melt patterns indicating several hot spots. A ring-shaped snow melt pattern suggests cooler temperatures in the centre of the hot spot. Hottest temperatures are generated at the rim of the hot spot where active fungus thrives.

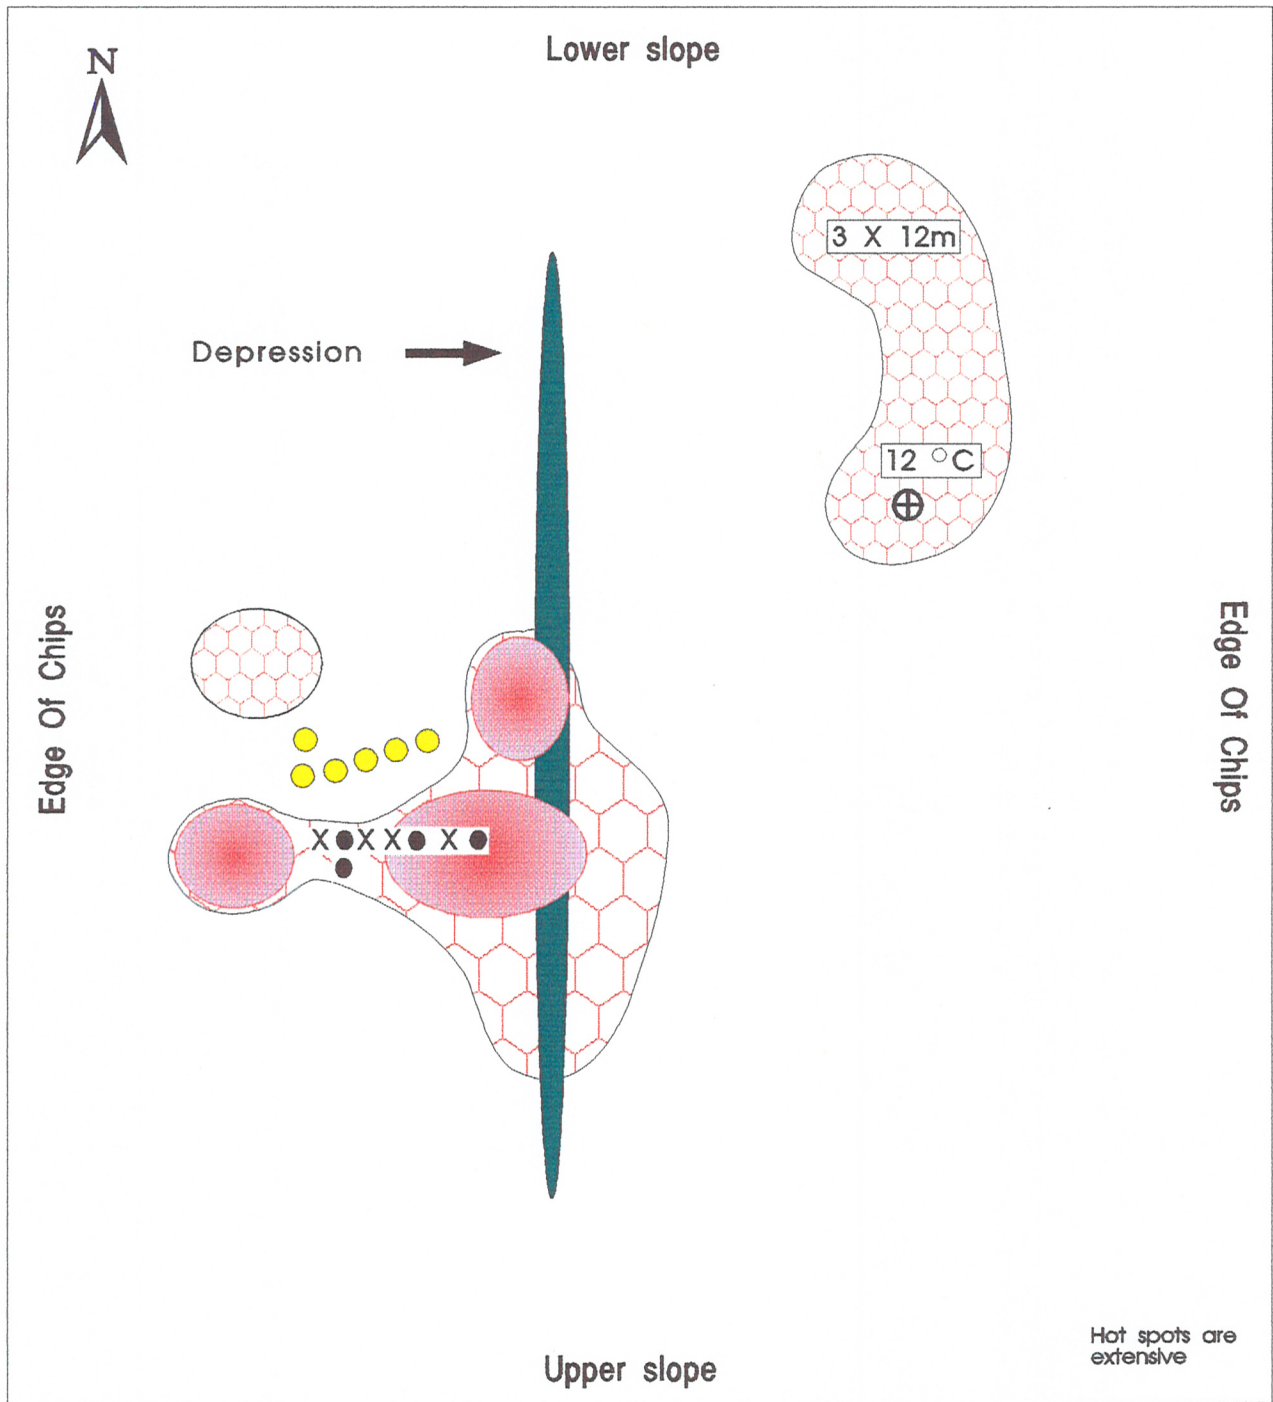
Slope 31A, Kmp 84.5 Location of hot spots, October 1992

This slope was insulated with wood chips during the 1984 construction season and did not have any instrumentation installed prior to 1993. Extensive hot spots were first noted during the October 1992 PTRM field trip (see sketch of differential snow melt pattern in Appendix B). Instrumentation was installed in October 1993 at the large hot spot located mid-slope on the western side of the right-of-way. Wood chip thickness at this location ranged from 120 to 145 cm.

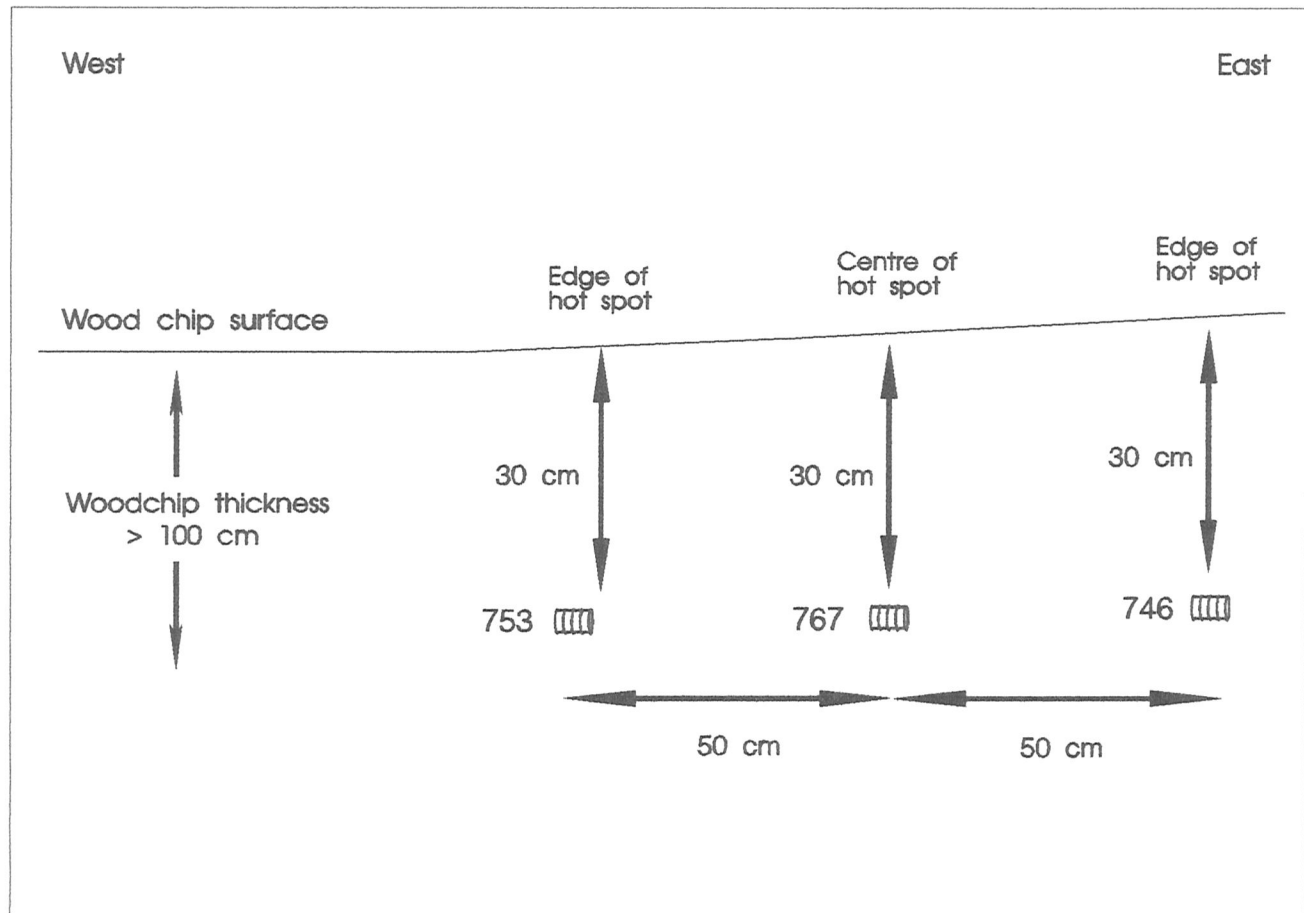
Slope 79, Kmp 279.0 Cross-Sectional View of Hot Spot Instrumentation, October 3, 1993

Note: The area of melted snow over the instrumented hot spot coalesces with snow melt from other hot spots to the west. There will be a thermal influence on Hobo-Temp logger #753 from the adjacent hot spots.
