# Seabed Characterization and Soil Response at the Terra Nova O-90 Glory Hole: Observed Changes, 1990-1995

GSC OPEN FILE # 3681

April, 1996

**G.V. Sonnichsen<sup>(1)</sup> and John Zevenhuizen<sup>(2)</sup>**

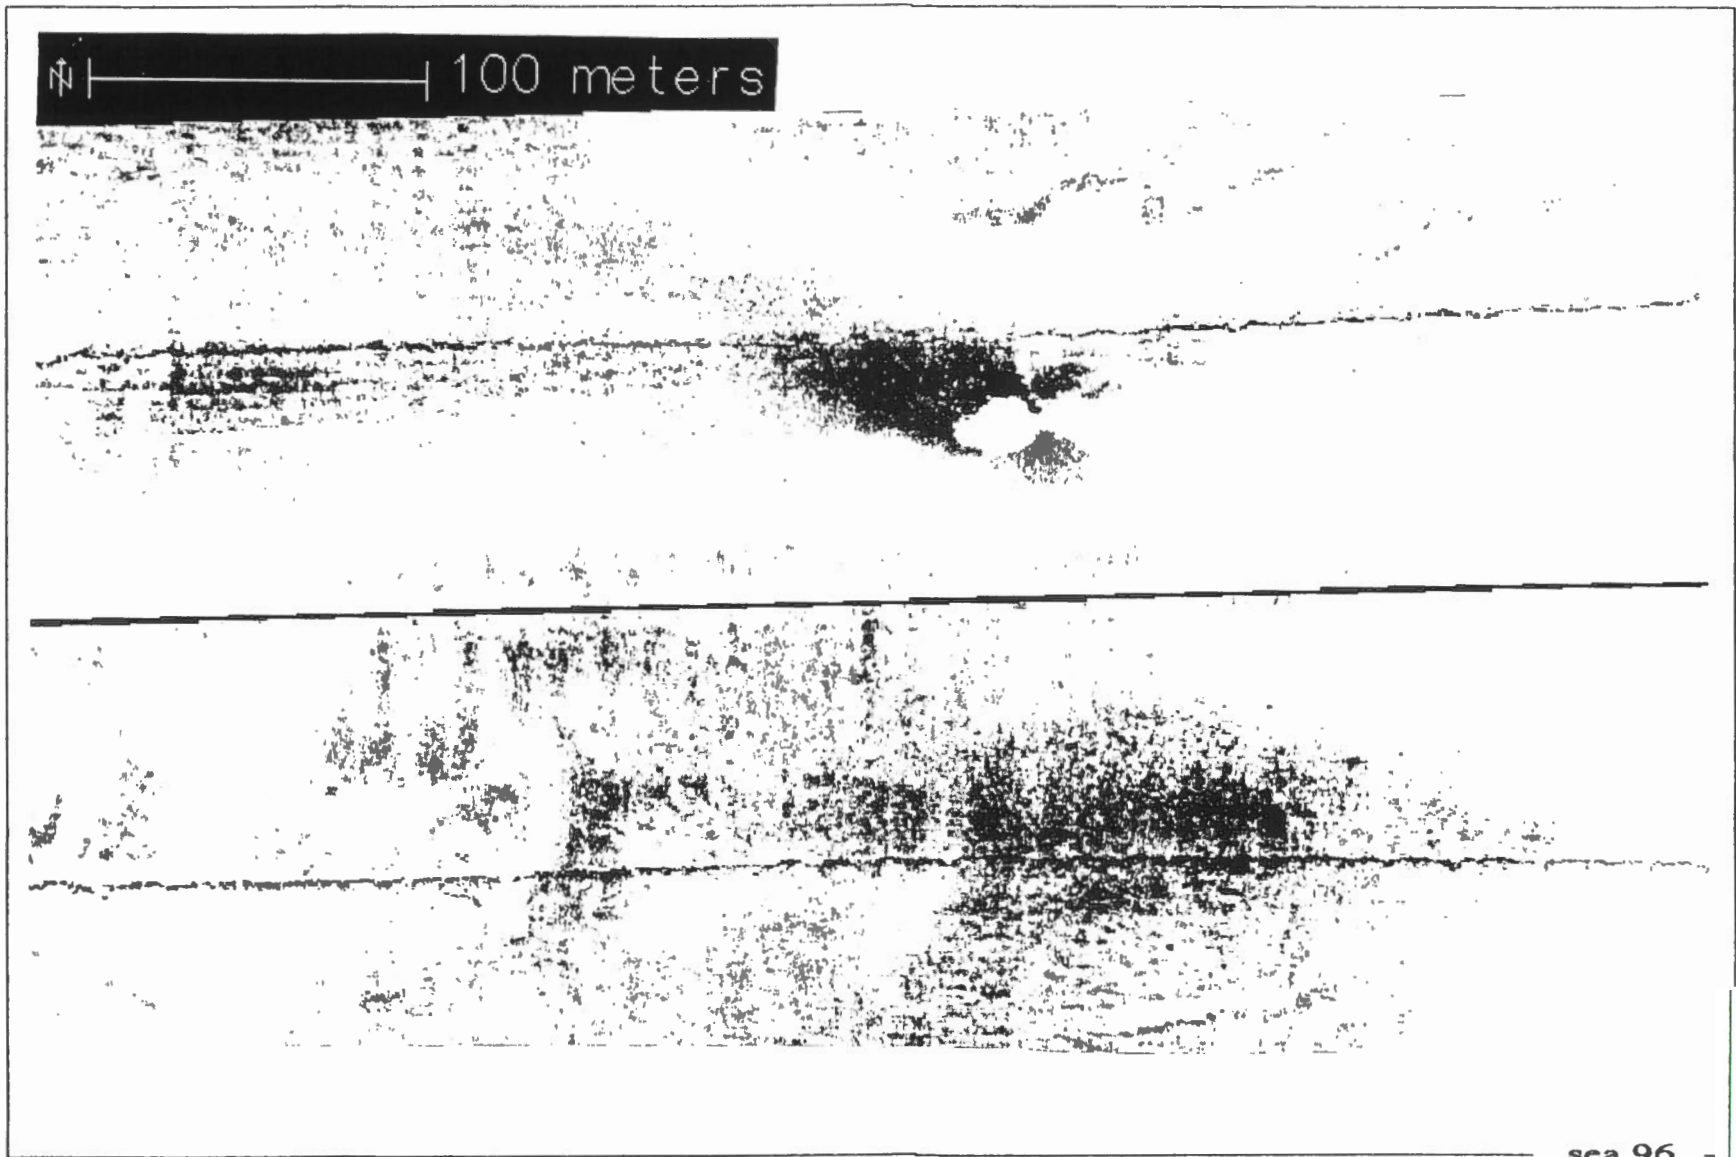
Figure 17

- Reflective areas are seen at the base of the southern scarp face.
- A few highly reflective features are observed toward the centre of the hole suggesting either blocks of excavated material or boulders.

- Some cobbles and pebbles were identified on the SIT near the base of the hole.

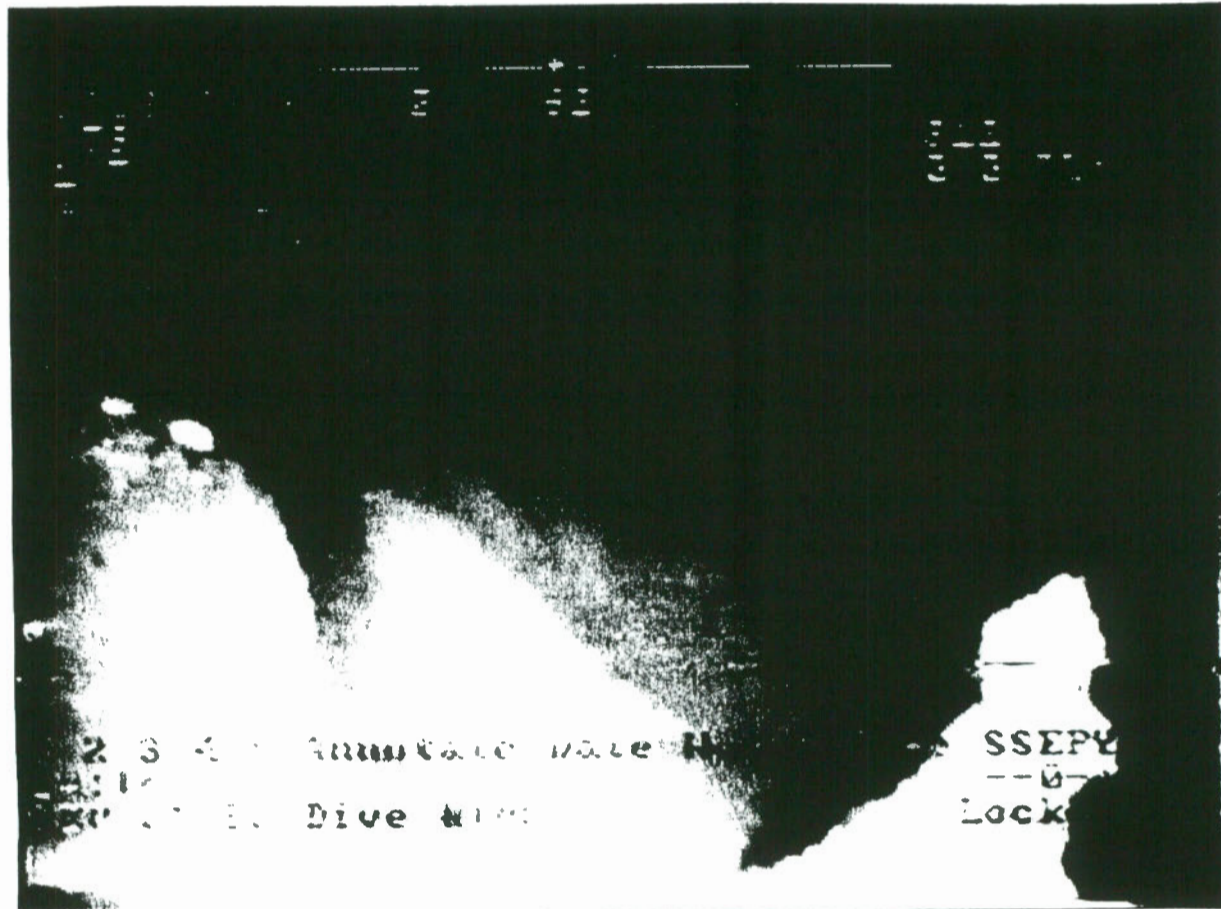
Figure 23

As observed the edge of the excavation is sharp (Figures 23 and 24). The unconsolidated upper unit grades at a steep angle ( $20^{\circ}$ - $40^{\circ}$ )(Figure 24) into the hole and unconformably overlies the near vertical, fresh looking and angular "hardpan" scarp. This scarp is frequently dissected by both large and small "crevasse splays" where the unconsolidated sediments of the upper unit have slumped and formed debris fans. There are angular blocks present around both the perimeter of the "hardpan" scarp and towards the centre of the hole. Video observations indicate that these are semi-consolidated sediment blocks and not angular boulders. The glory hole has not been colonized by larger sessile benthic organisms and the centre of the hole appears to have been slightly infilled when compared to the immediate post-excavation data (Figure 22).

**Figure 23:** Very angular distinct cusp like feature protruding from the middle of the northern edge of the excavation displays Unit 2 outcrop fractured into a series of large blocks sloping down towards the base of the hole. Image collected using the ROV SIT camera and derived as a frame grab from original video tape (August, 1990).

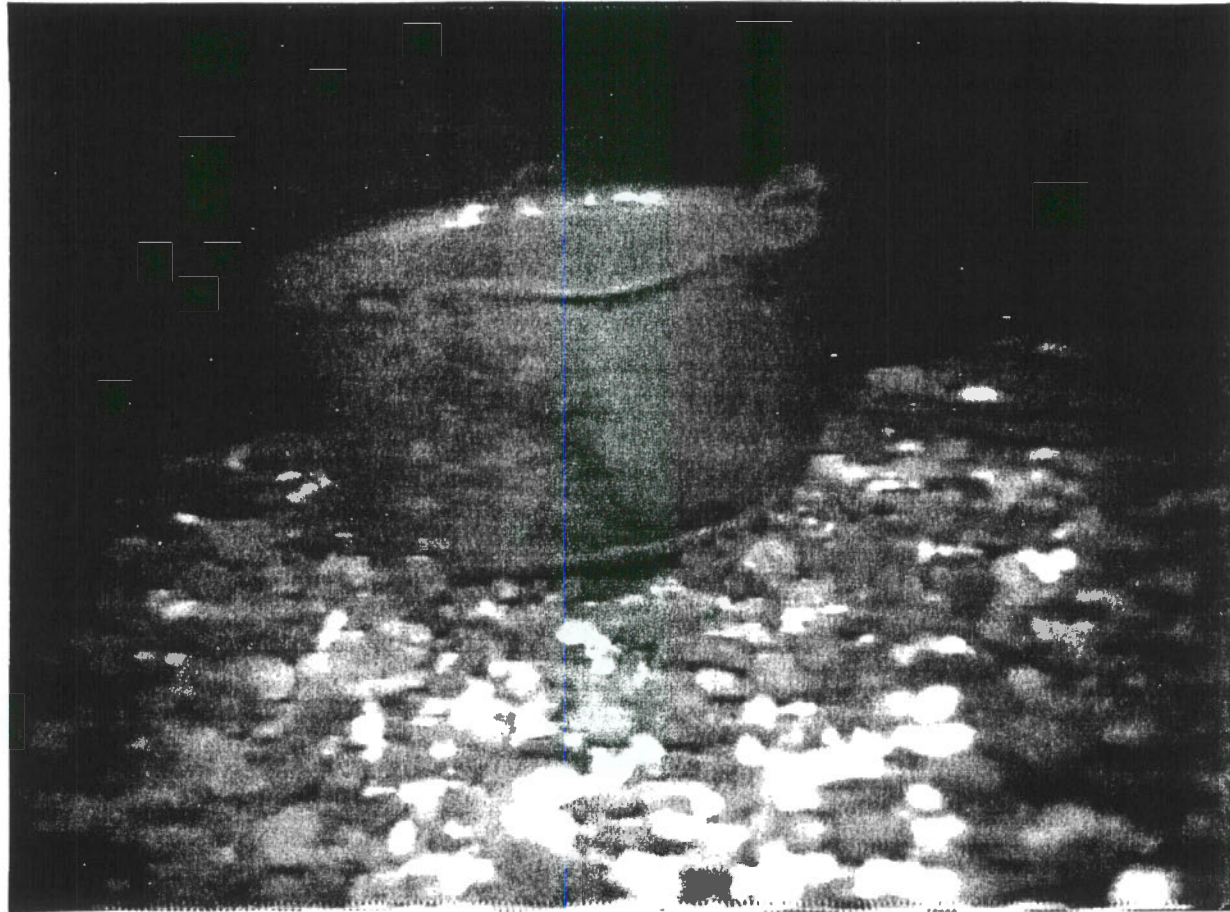
Figure 25

**Figure 25:** Image of a bucket resting on what is interpreted as a thin accumulation of gravel overlying the original substrate of unconsolidated sandy material (unit 1). The gravel is interpreted to represent the coarser component of the material jetted out during the excavation. Note that the material all appears to be of a uniform gravel size with no larger cobbles or boulders present. Location is along the northwestern edge of the excavation. The gravel appears to extend right to the edge of the steep Unit 2 outcrop. Image is a frame grab from Hysub 5000 ROV VHS colour video (August, 1990). (Parrott and Sonnichsen, 1990).

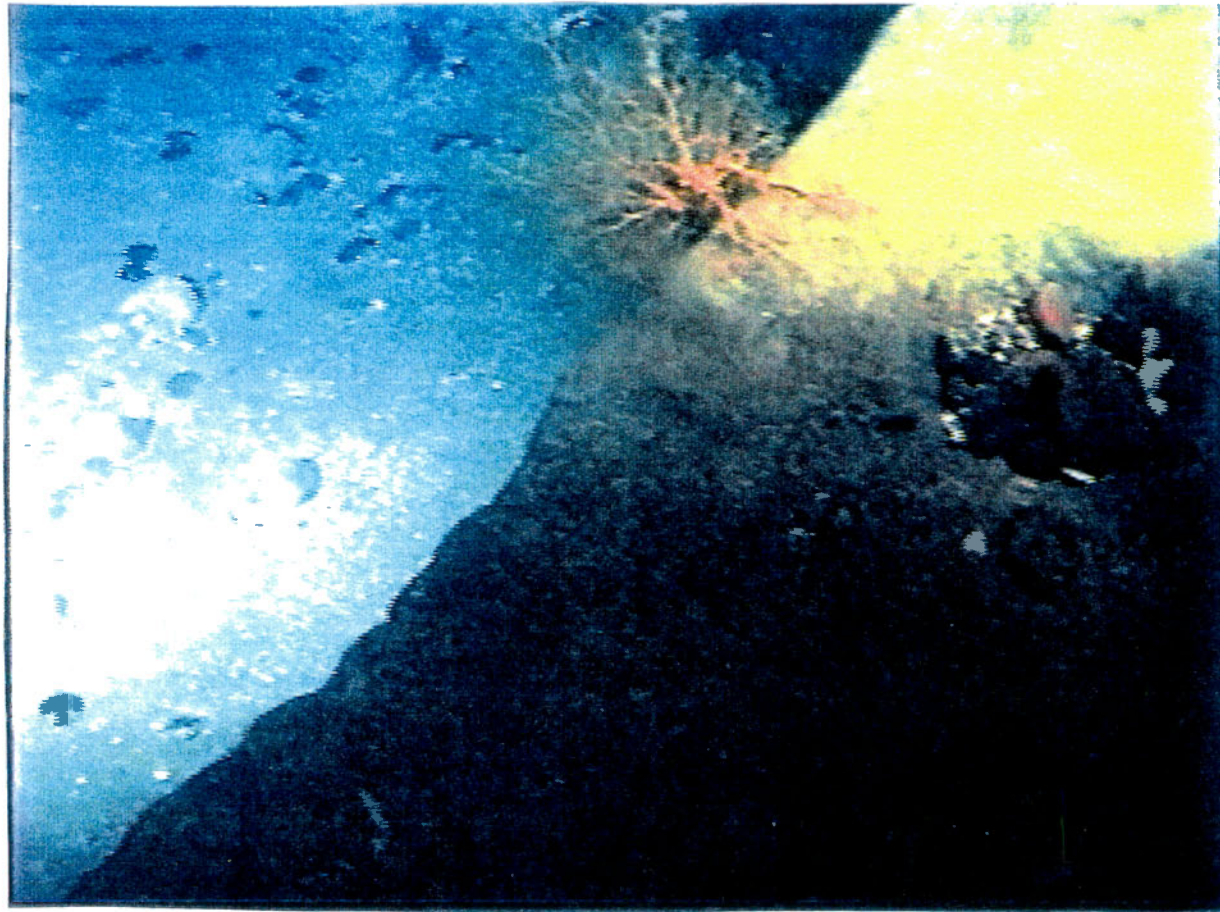
Figure 28

The migration of the upper unit away from the hole and the subsequent exposure of the upper surface of Unit 2 on the southwestern rim shows the presence of cracks, fissures, and dissolution holes (Figure 28). As this unit was up until 5 years ago blanketed by 1.5m of unconsolidated sediment these features are interpreted to have been formed prior to the emplacement of the upper unit. This surface could therefore represent a desiccated layer probably formed during subaerial exposure (Adshead, 1990,). Two "hardpan" outcrop sites were sampled during the SDL-1 dive (March 1995). One along the southwestern edge of the glory hole and the other along the northern edge. The material at the southwestern site had an angular fresh character and the northwestern sample displayed a more rounded (degraded) character.

**Figure 28:** The upper flat lying surface of the Unit 2 "hardpan" has cracks, fissures and dissolution holes that are interpreted to have formed prior to the emplacement of the upper unit. This surface may represent a desiccated layer probably formed during subaerial exposure or in a higher energy shallow water environment. Image scanned from 35mm still photograph collected using the SDL (March, 1995).

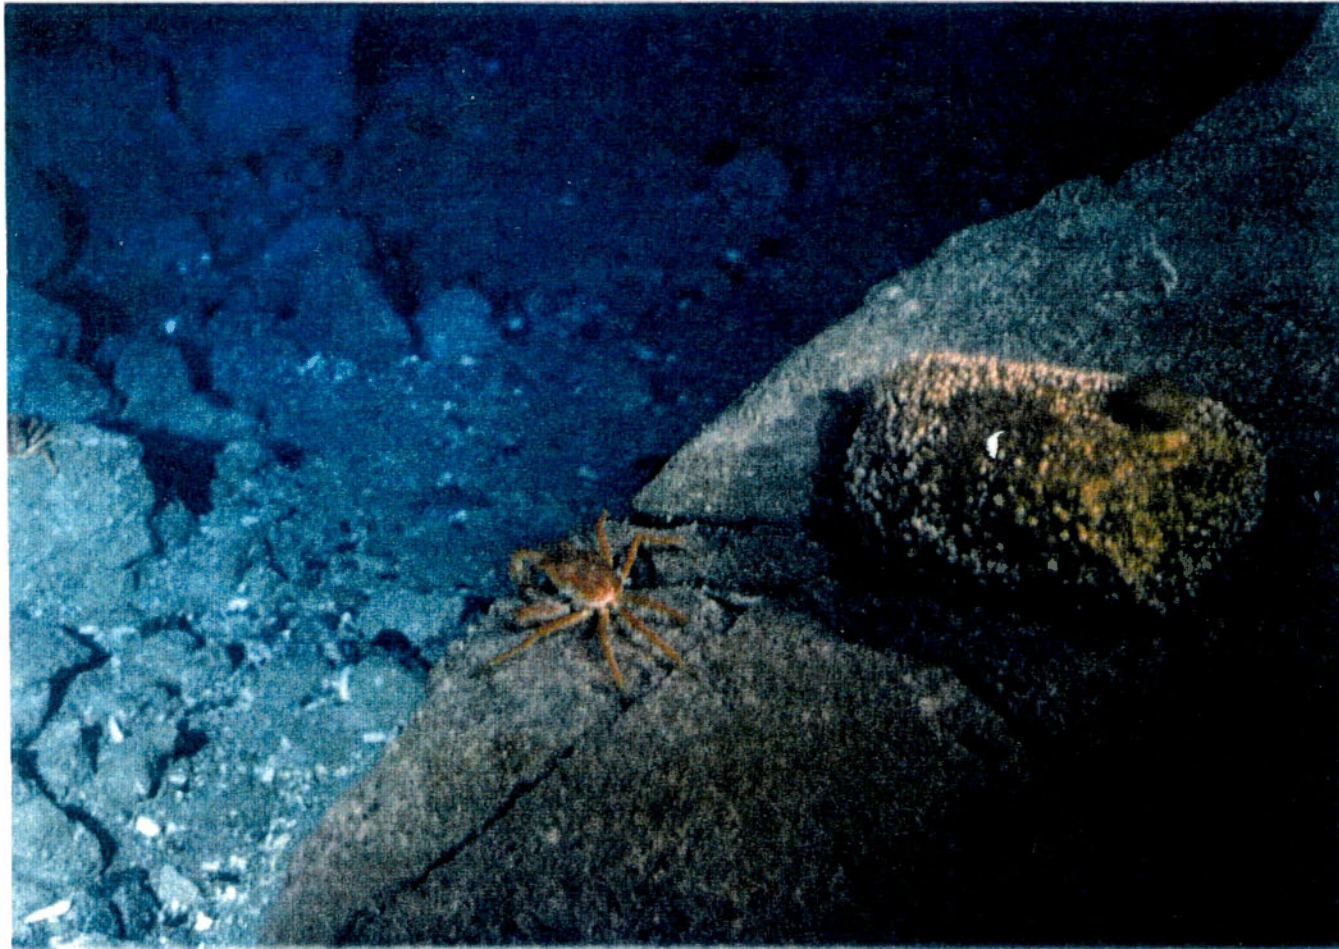
Figure 29

- By 1995 the edge of Unit 1 has retreated away from the hole, exposing a 1-2 m wide rim of the upper surface of Unit 2 (Figures 28 and 29). The 1995 data also show a more gradual angle of repose for Unit 1.

**Figure 29:** By 1995 Unit 1 has migrated back exposing 1-2m of Unit 2 and has stabilized at a substantially lower angle than observed during 1990 (from 40+ to ~15). Sub-angular boulders (0.1 to 0.4m diameter) along the exposed rim of the hole indicate that clasts larger than gravel were present during the excavation but were not lifted to where the coarser grained spoils were deposited (Figures 21 and 25). Image scanned from 35mm still camera photograph collected using SDL-1 (March, 1995).

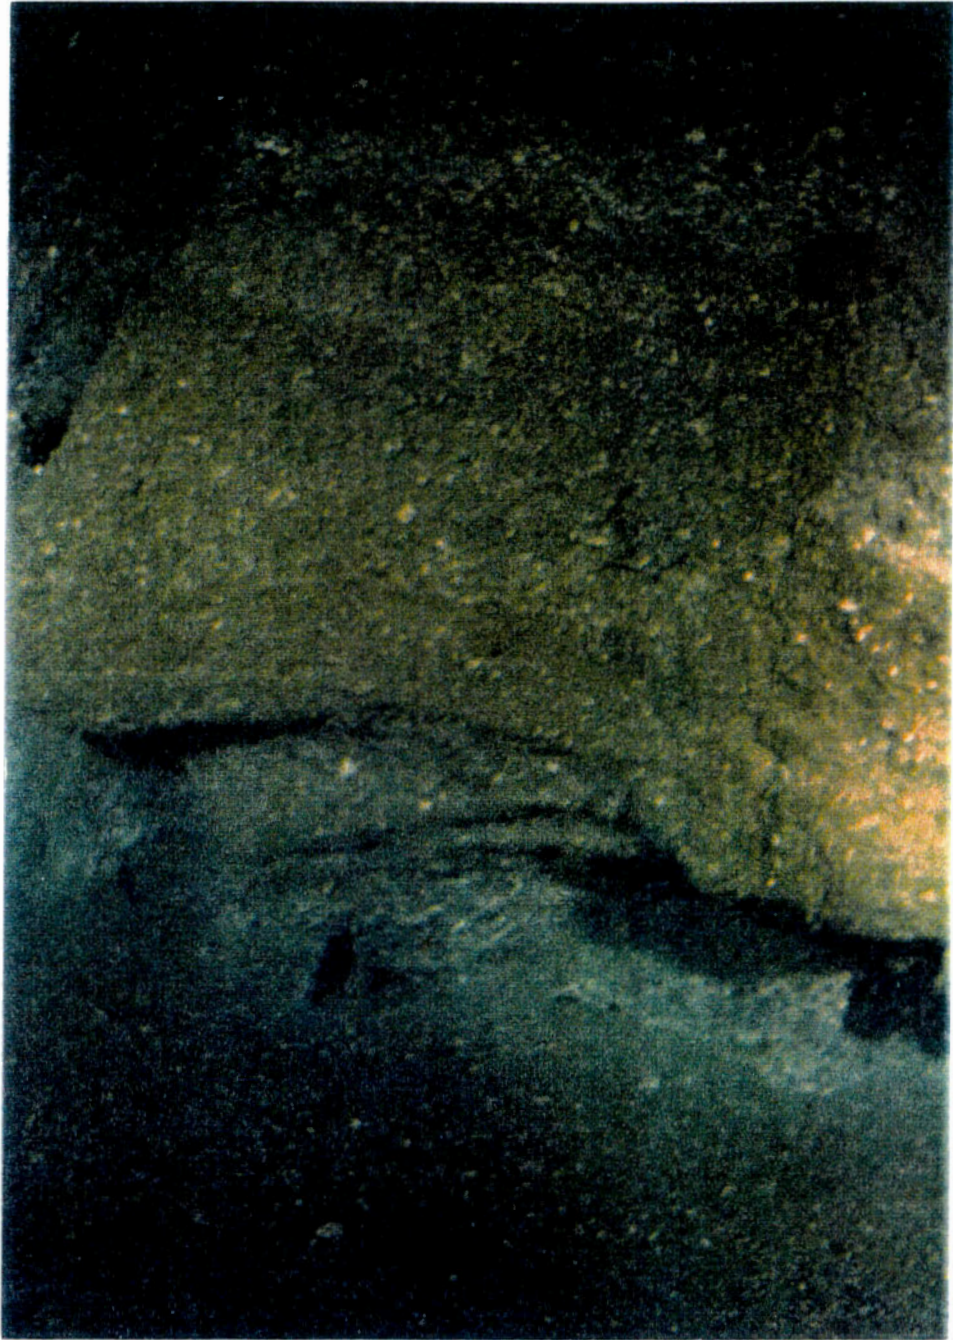
Figure 30

**Figure 30:** Along the base of the southwestern exposure of the "hardpan" scarp sediment removal by preferential excavation suggests prolonged hydraulic jetting at this level. This has produced an overhang of up to 0.2m. The material above and below this overhang appears to have the same composition and consolidation. Image collected using the SDL-1 externally mounted VHS colour camera and derived as a frame grab from the original video (March, 1995).

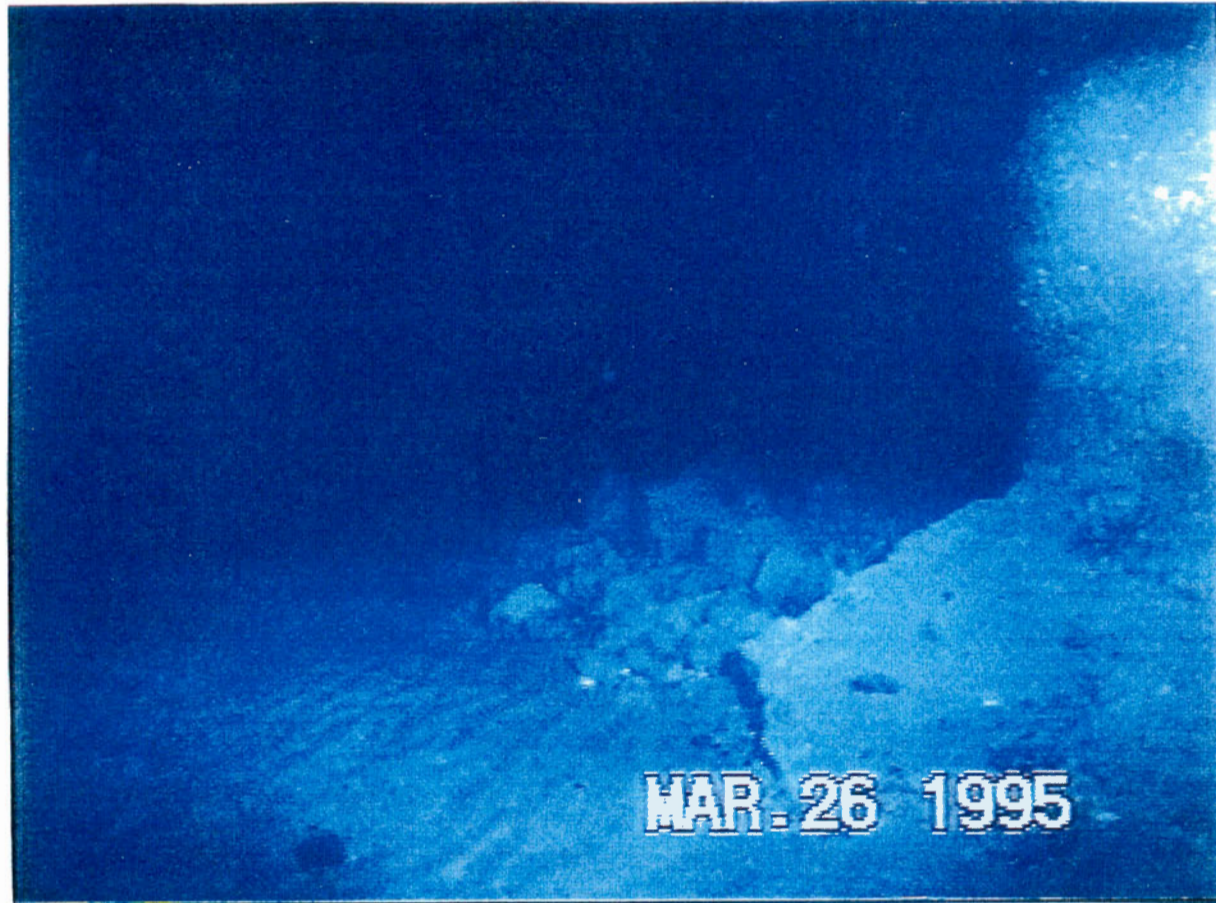
Figure 31

**Figure 31:** At the base of the southern edge of the sand ramp along the western side of the glory hole are blocks of Unit 2 material. Along the edge of the sand ramp and grading into the glory hole are bifurcating ripples with smaller 2nd generation ripples are oriented normal to and superimposed on the larger ripples. Image collected using the hand-held HI-8 video camera inside the SDL and derived as a frame grab from the original video tape (March, 1995).

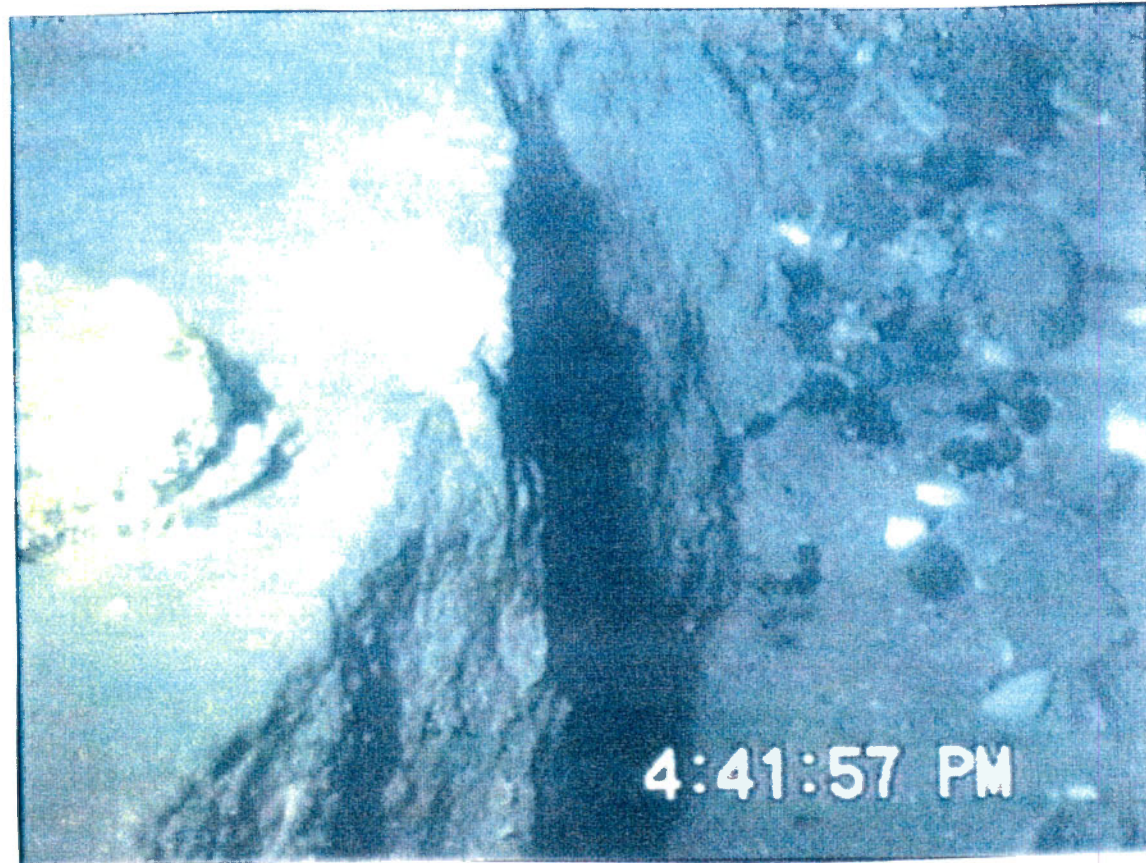
Figure 32

**Figures 32:** Shelly "hardpan" of Unit 2 was sampled at this site on the SW edge of the glory hole. Note the angular fresh character of the material. Cliff face could not be penetrated by sub's hydraulic samplers. Image collected using the SDL externally mounted VHS colour camera and derived as a frame grab from the original video tape (March, 1995).

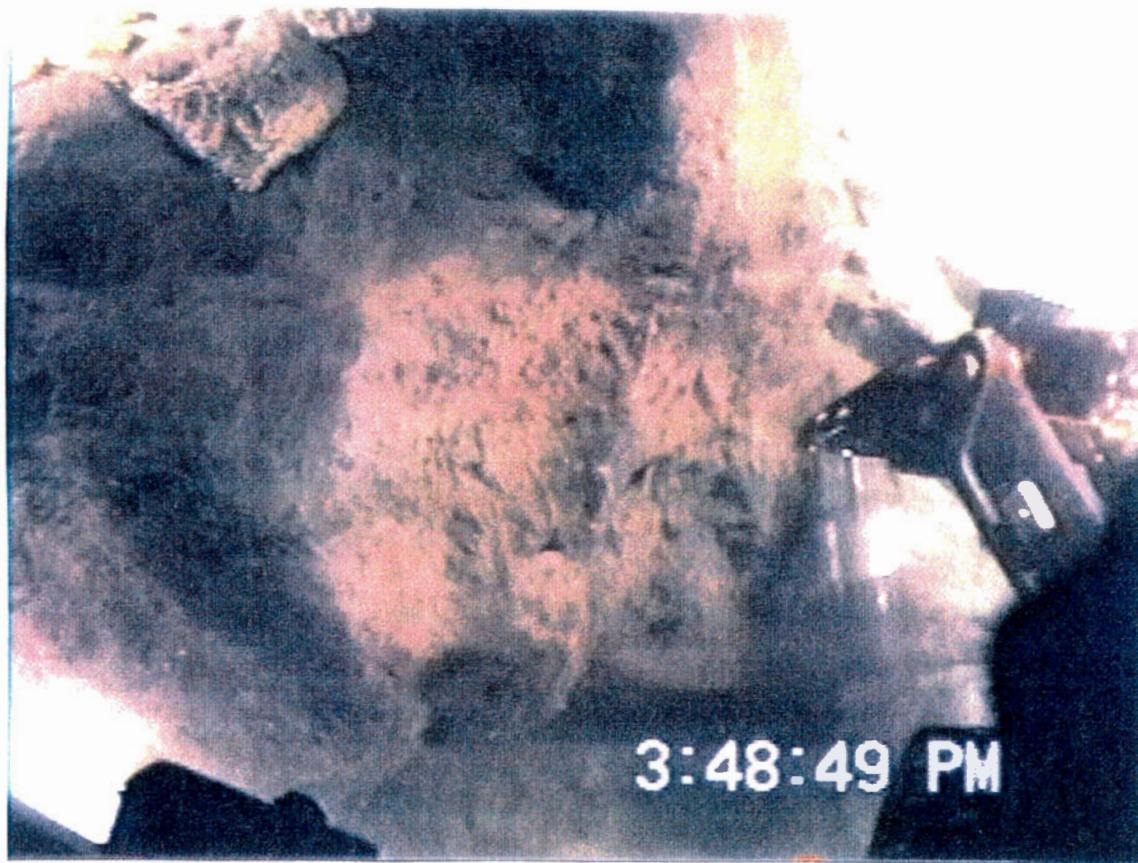
Figure 37

**Figure 37:** Close up of sample site 2 indicating the Unit 2 northwestern outcrop. Note degraded character and sub manipulator arm. Image collected using the hand-held HI-8 video camera inside the SDL and derived as a frame grab from the original video tape (March, 1995).

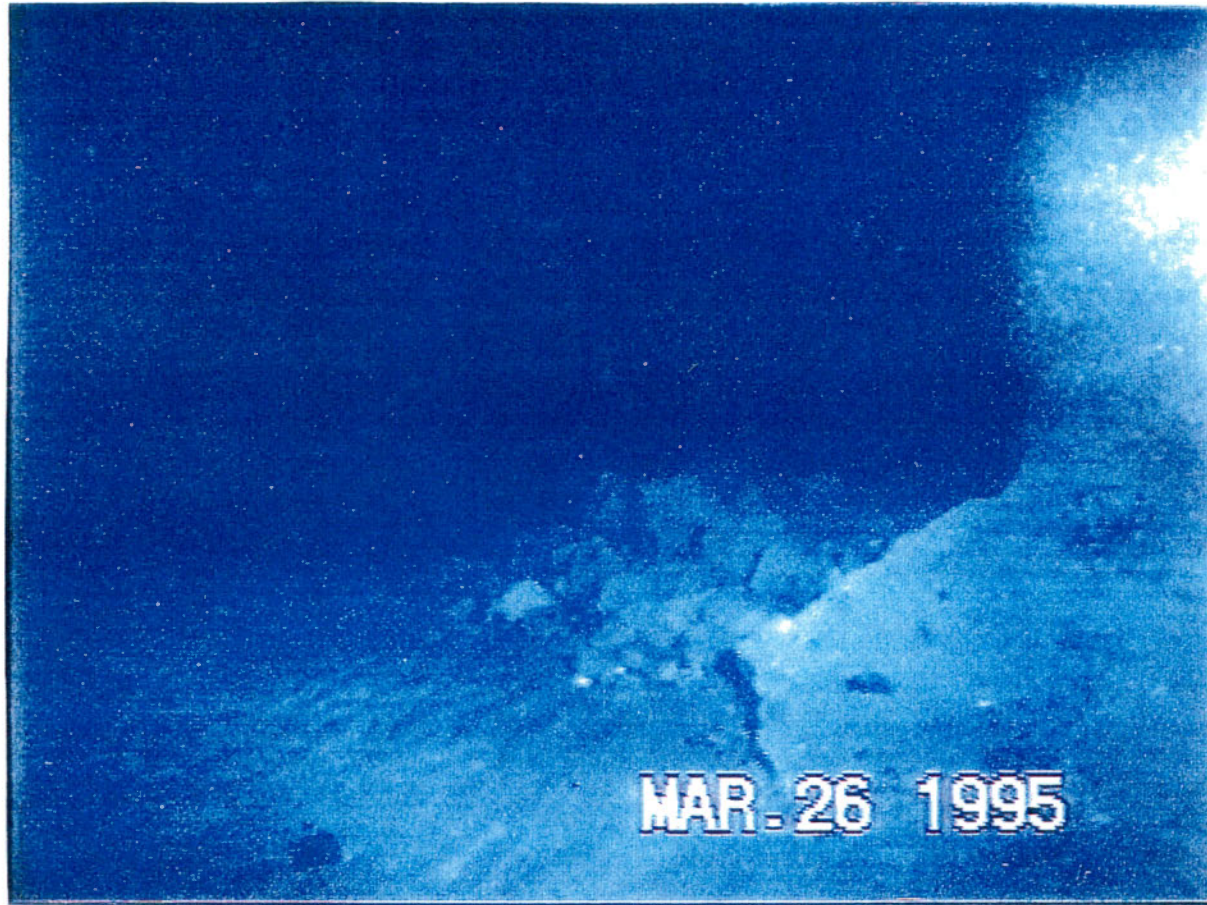
Figure 39

**Figure 39:** Bifurcating ripples with a 0.3-0.5 m wavelength with the crests trending downslope (0900) on the large sandy ramp on the W edge of the glory hole. Smaller 2nd generation ripples are oriented normal to and superimposed on the larger ripples. These bedforms were only observed in March, 1995 and not on any of the August data (1990, 1995). Image collected using the hand-held HI-8 video camera inside the SDL and derived as a frame grab from the original video tape (March, 1995).

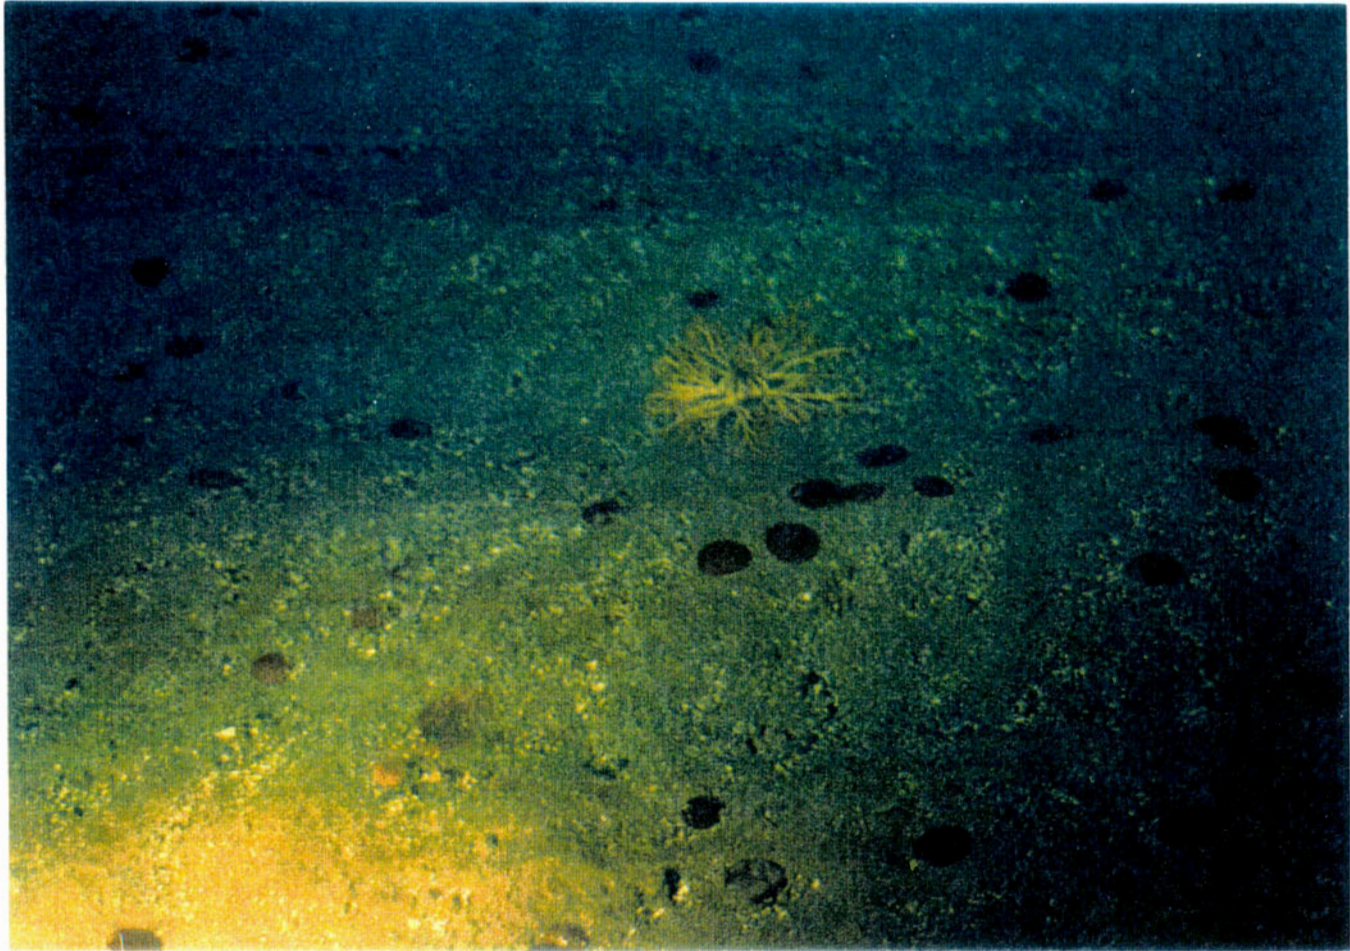
Figure 40

The megaripples were only observed in March, 1995 and not on the August 1990 or 1994 data. They are interpreted as having formed during the winter storm season with subsequent infill/degradation over the summer.

**Figure 40:** Large bifurcating wave-formed ripples ( $>0.5\text{m}$  wavelength,  $0.3\text{ m}$  amplitude) with crests trending downslope on a sand ramp along the N edge of the glory hole. They were observed only on the March, 1995 data. These features are interpreted as having formed during the winter storm season. Image collected using the SDL externally mounted VHS colour camera and derived as a frame grab from the original video tape (March, 1995).
