The East Gate Landslide, Beaver Valley, Glacier National Park, Columbia Mountains, British Columbia

OPEN FILE # 3877

Réjean Couture Eng. Ph.D.

May 2000

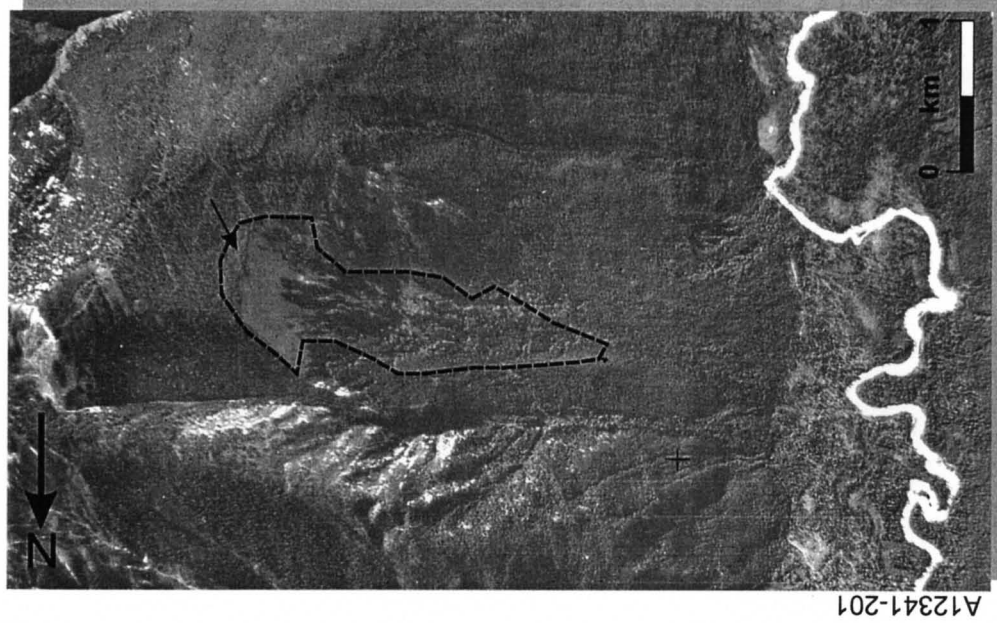
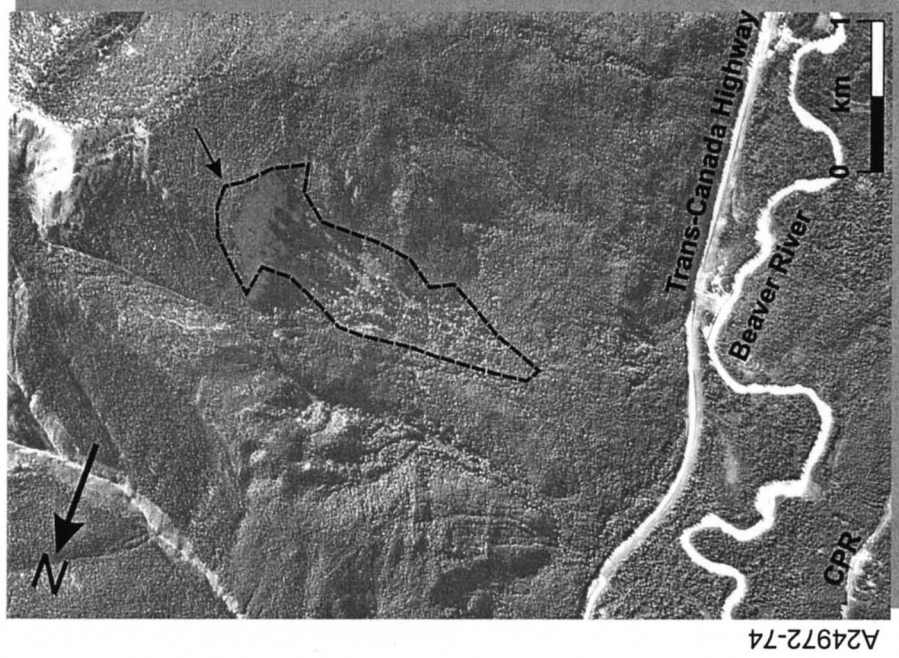
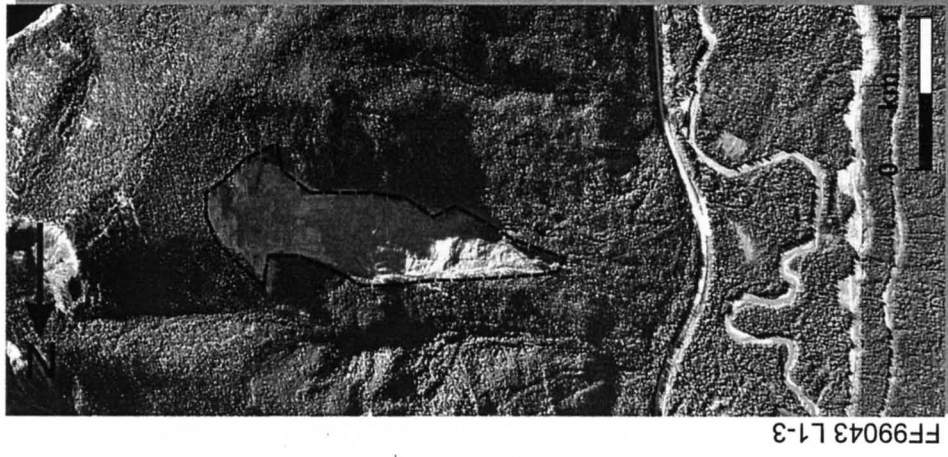
- 2.4 Airphotos taken in 1949 show clear indications of slope deformation in the East Gate landslide area (Figure 3). A failure plane that generated relatively small rock falls and debris flows is seen at

about 1950 m above the valley bottom. However, over a period of 29 years, as seen on 1978 airphotos, the slope did not show any obvious further degradation (Fig. 3). Marked degradation did not take place until noted in January 1997. Photos taken on January 30, 1997 (shown in EBA, 1999) show that the headscarp had retreated to a identified structural lineament (indicated by arrow on earlier photos, Fig. 3) parallel to the slope and two large debris flows had moved downslope to about 1450 m elevation (Fig. 4a).

Figure 3. Evolution of the East Gate landslide from 1949 to 1999 and approximate location of September 1999 limits of landslide. Before 1978, the upper slope was affected by limited slope failures including rockfalls, small debris flows and slow deformation above the headscarp (pointed by arrows). The size of the exposed headscarp is similar in 1949 and 1978. In mid nineties, the segment limited by the lineaments indicated by the arrow has failed (EBA, 1999). In 1999, this segment has been completely transformed into debris. In the last two years, the headscarp has extended towards the south, generating new debris.

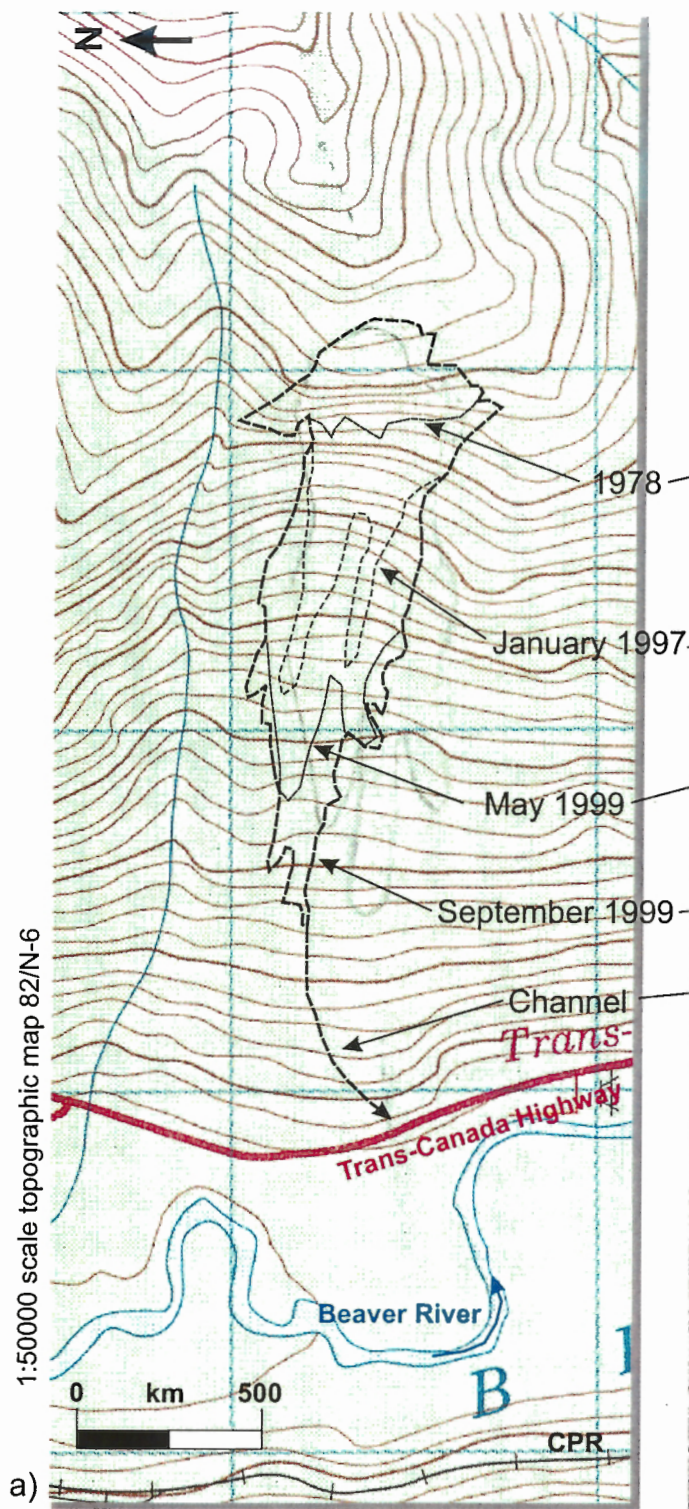
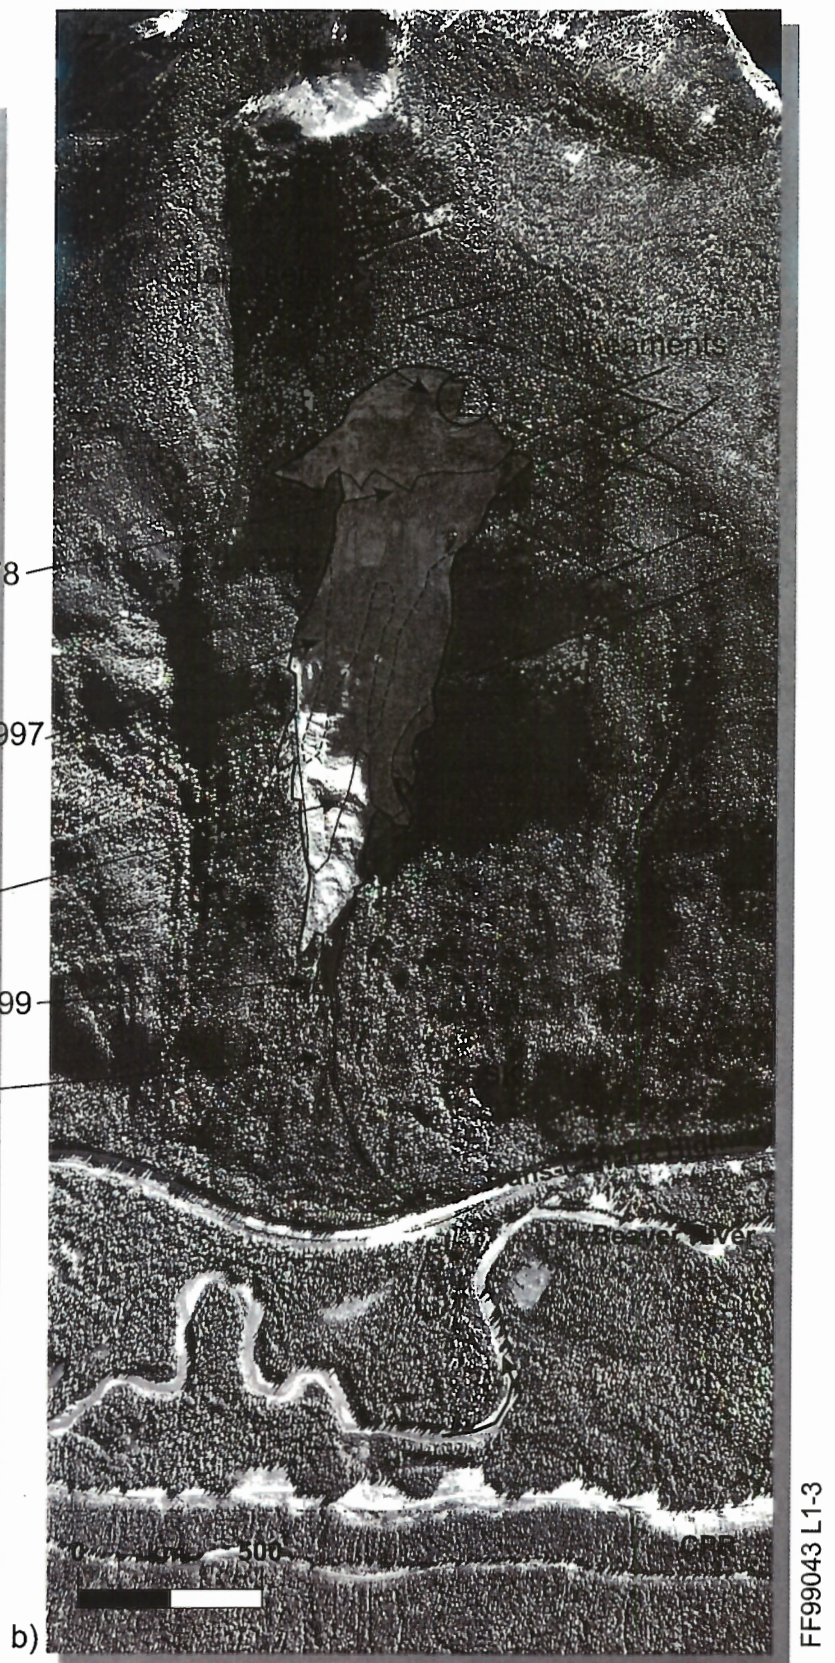
- 4.1.4. The south side of the headscarp is more affected by slope deformation since it shows a large concentration of structural lineaments. These structural lineaments, shown in Fig. 4b, are expressed in the field by cracks and opened fissures located on the south side of the headscarp (Fig. 7). These cracks define blocks within the slope; some of them show fresh displacements (Fig. 7). Once a block has failed, it disintegrates completely after less than few hundred meters of sliding, due to the high degree of fracturing and poor discontinuity cohesion.

Figure 4. Location of the East Gate landslide and evolution of the debris flow front on a) 1:50,000 scale topographic map and b) 8 September, 1999 airphoto. Joint sets are well represented at the headscarp. Structural lineaments are occasionally seen as opened cracks on the field. SK: Soup Kitchen debris flow area.

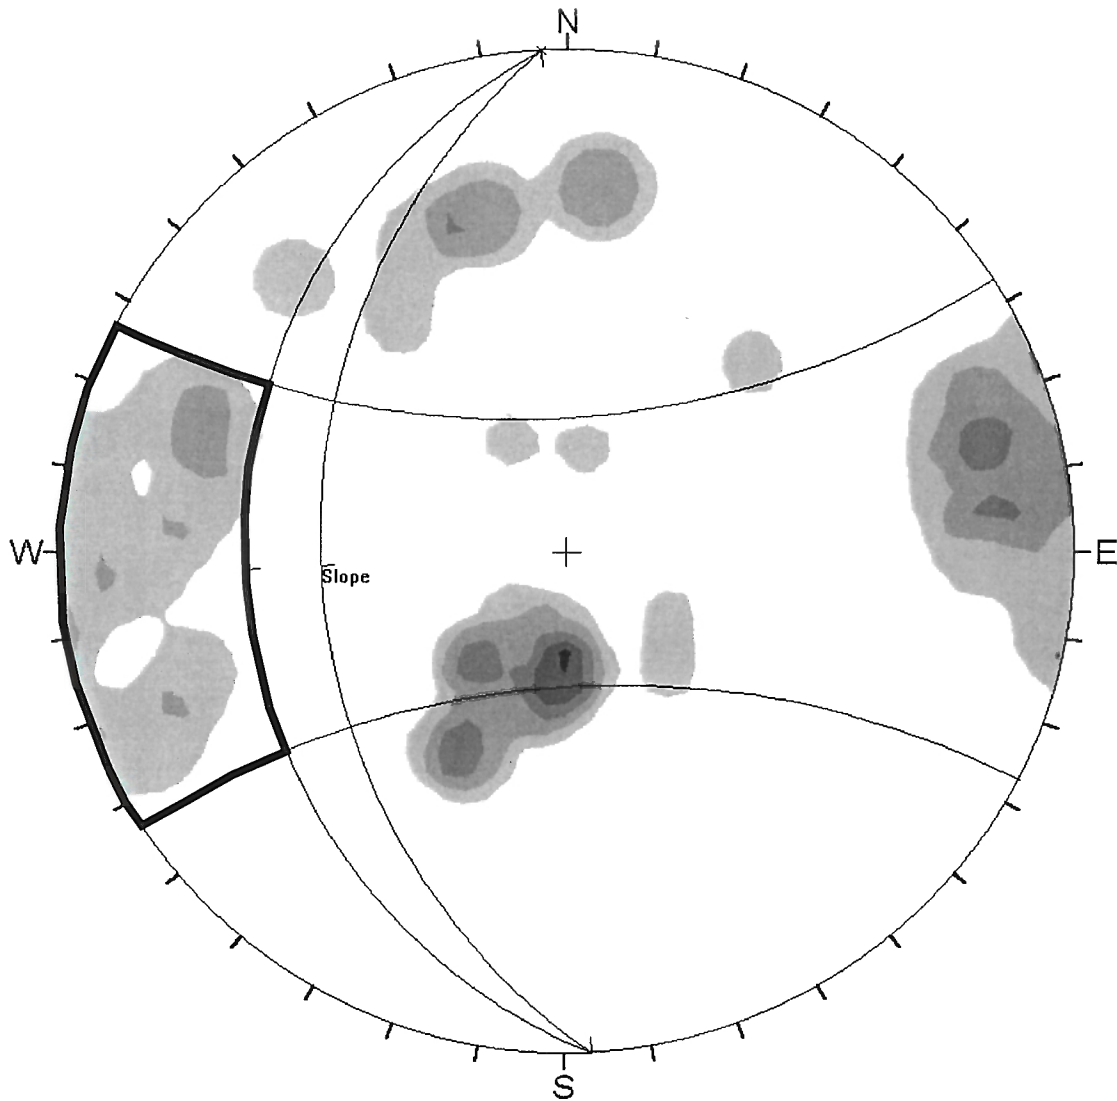
- 4.1.3. Field measurements and a kinematics analysis indicate that the initial rock failure is associated with a toppling mechanism (Fig. 6). The joint sets JS1 and JS2, oriented more or less parallel to the slope, cut the rock mass into blocks, which are subject to toppling (Fig. 6). Although the schistosity planes daylight in the slope, since they dip at a lower angle than the slope angle, they are more or less perpendicular to the slope face, and thus schistosity planes are not prone to rock-sliding. However, because the rock is so fractured, pseudo-rotational landslide occurs and the headscarp retrogresses by the failure of large blocks.

Figure 6. Lower hemisphere projection of contour plot for discontinuities measured at the headscarp of East Gate landslide. Kinematic analysis indicates that toppling is the main mechanism responsible for the slope instability. Pole of joint sets falling in zone limited by bold line show toppling mechanism. Slope strike and dip is $177^{\circ}/30^{\circ}$, while friction angle assumed for foliated sandstone is 25° .

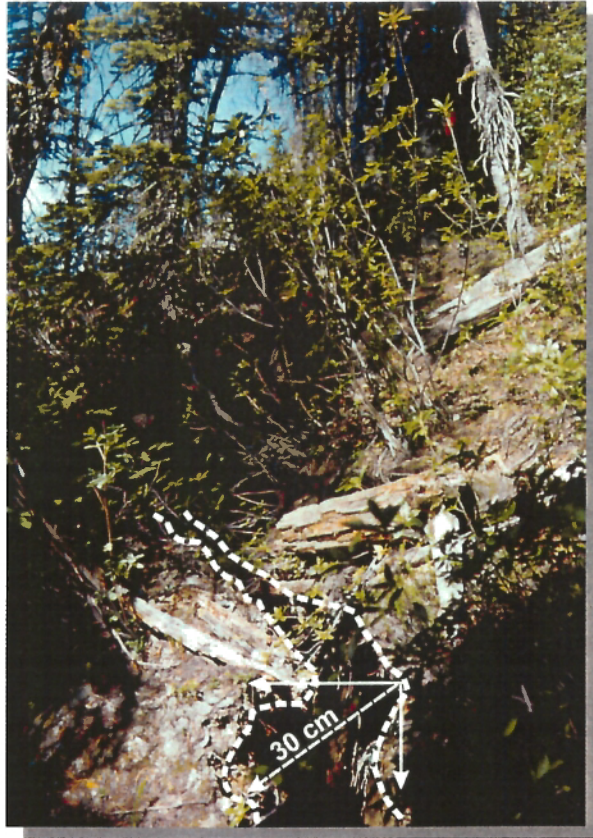
Figure 7. View towards north of an opened fissure located on the southern slope of the East Gate landslide at elevation about 1950 m (see Figure 8 for exact location). The fissure shows aperture up to 25 cm with relative displacement downslope. Note tilted trees above the fissure (August 24, 1999).

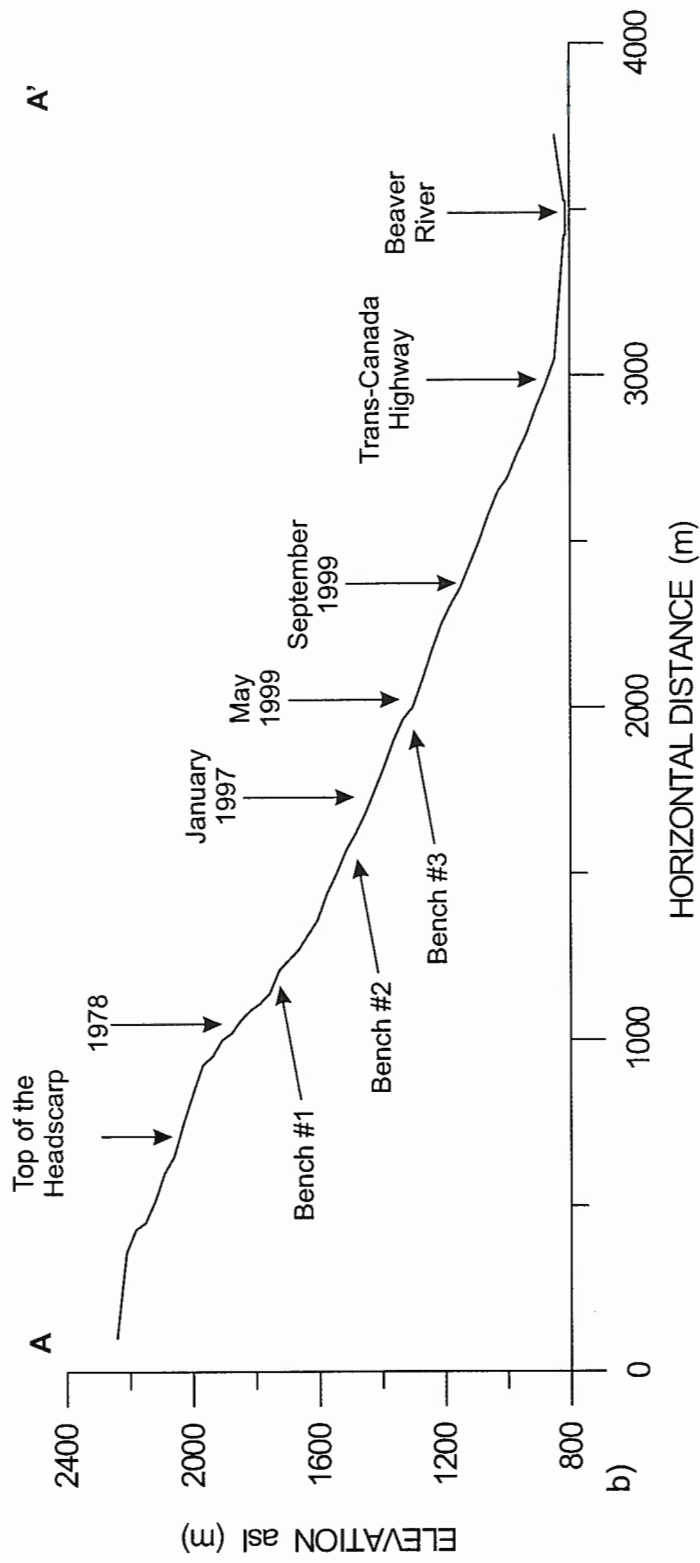
Figure 9. a) Location of East Gate landslide and evolution of debris flow front.
b) Profile through the East Gate landslide with locations of the debris flow front.

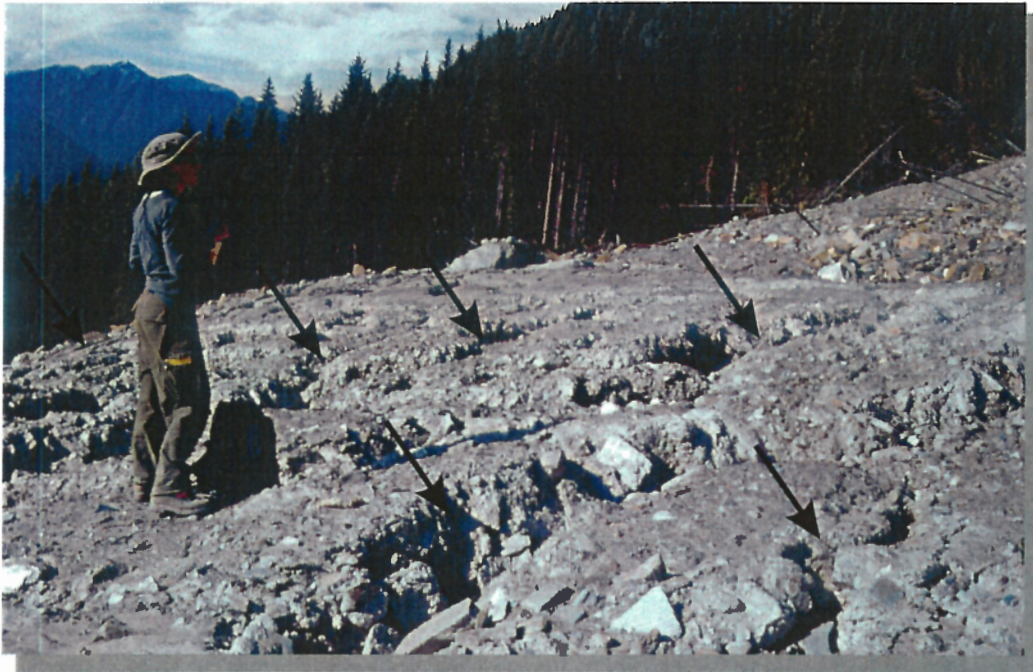
- 4.2.2 After a block fails and starts to slide down, it rapidly disintegrates and thus it transforms into a debris spread, then into a debris flow, and ends in a mud flow. Debris is now accumulating at different elevations on flatter, bench-like, parts of the slope. Three benches are identified and these debris accumulations, which can be clearly seen on Figure 8b, show a lower angle upslope and a very steep slope angle downslope. These benches are also associated with the mountain slope morphology (Figure 8b). The thickness of debris in the flow in the upper section is estimated to be at least 4 to 5 m and may be higher at the level of benches. On both sides of the flow path, levees up to 3 to 4 m high were noted. In many places on the upper section of these benches, fissures perpendicular to the flow direction indicate downslope displacement of debris (Fig. 10). Such a type of deformation is indicative of retrogressive failures within the accumulated debris that then can generate larger debris spreads and flows descending the mountain slope.

Figure 10. View towards north-west in opened fissures (indicated by arrows) in the debris located on bench #3 at elevation 1500 m (see Fig. 8). Fissures are perpendicular to flow direction and indicate downslope displacement of the debris. Such deformation involves a retrogressive failure within the debris accumulated at bench #3. Similar fissures are also seen on benches #1 and #2 (August 24, 1999).

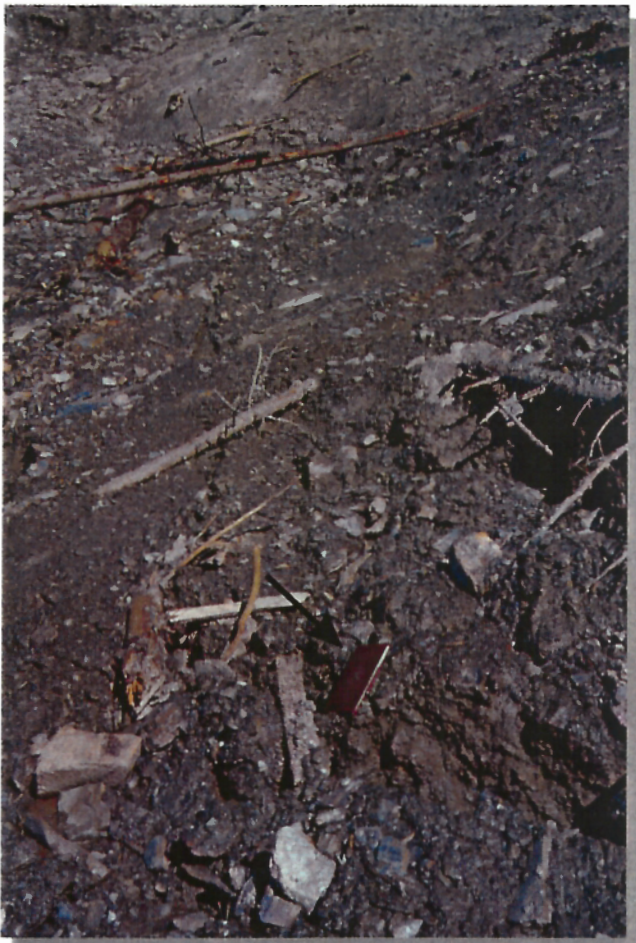
- 4.2.4 The debris is essentially composed of small rocks (average diameter = 0.30 m) with a matrix, which corresponds to 50% of the debris, composed of pebbles, gravel, and fine particles (Fig. 11). Organic matter is also incorporated into the debris. Grain size distribution curves of debris sampled at two locations are shown in Fig. 12. Sample #1, which was taken at about elevation 1350 m in the debris flow (Fig. 8), consists of 71.4% gravel, 17.6% sand, and 11% silt and clay. The debris that reached the highway was also sampled (Fig. 8). The material is much finer, consisting of 33% gravel, 22.7% sand, and 44.3% silt and clay (sample #2 on Figure 12). All along the debris flow path, the debris has a high moisture content.

Figure 11. The debris is essentially composed of small rocks (diameter = 0.30 m) with a matrix, which corresponds to 50% of debris, composed of pebbles, gravels and fine particles. The fine material, which corresponds to about 40% to 50% of the matrix material, shows a high percentage of water. Organic matter is also incorporated into the debris. Grain size distribution of the matrix is shown by sample #1 on Figure 12. A field book gives the scale. See Fig. 8 for exact location of photograph (August 24, 1999).

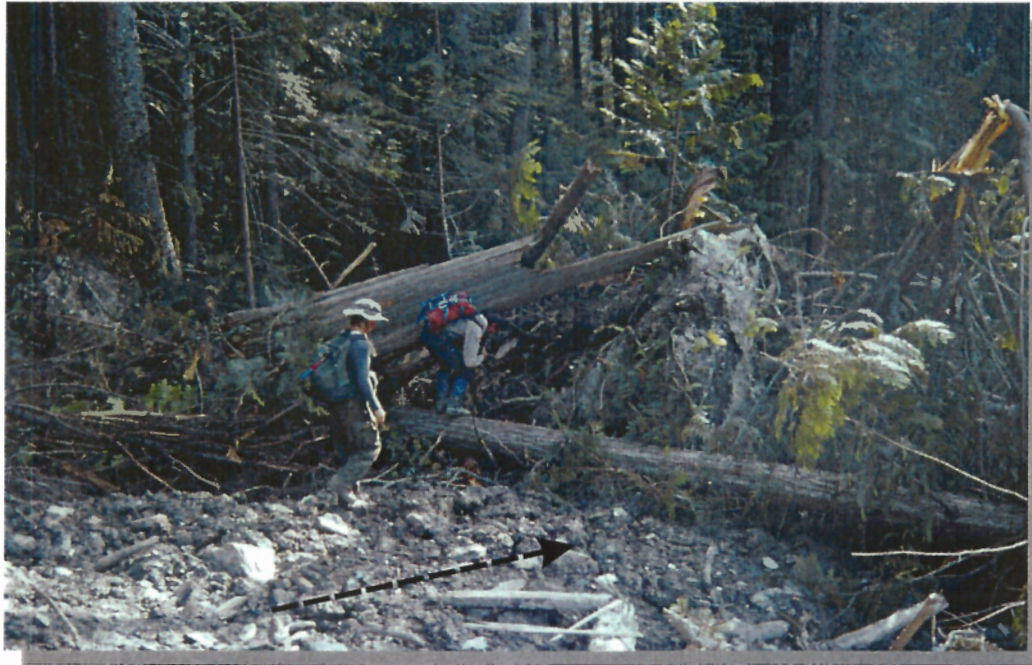
- 4.2.6 At least, three lobes are now formed by the debris flow (Fig. 8a). In September 1999, only one seems to follow the clearly defined stream channel, which descends directly down to the valley bottom. In their movement downslope, the debris flow lobes bulldoze trees, pushing them ahead until they form a plug. Then debris accumulates behind the plug which forms material for a downslope surge (Fig. 13). While the timber plugs slow down the velocity of debris flow, the

release of the plugs forms a more rapid surge, which moves downslope bulldozing more trees and thus forming a new plug.

Figure 13. Typical example of timber plug that blocks debris flow in the channel downstream of the debris flow front. Arrow indicates the direction of flow. Persons show the scale of fallen trees slowing down the debris flow. Once the dam breaks, debris and trees surge further downstream until another temporary dam forms. See Fig. 8 for exact location of photograph (August 24, 1999).

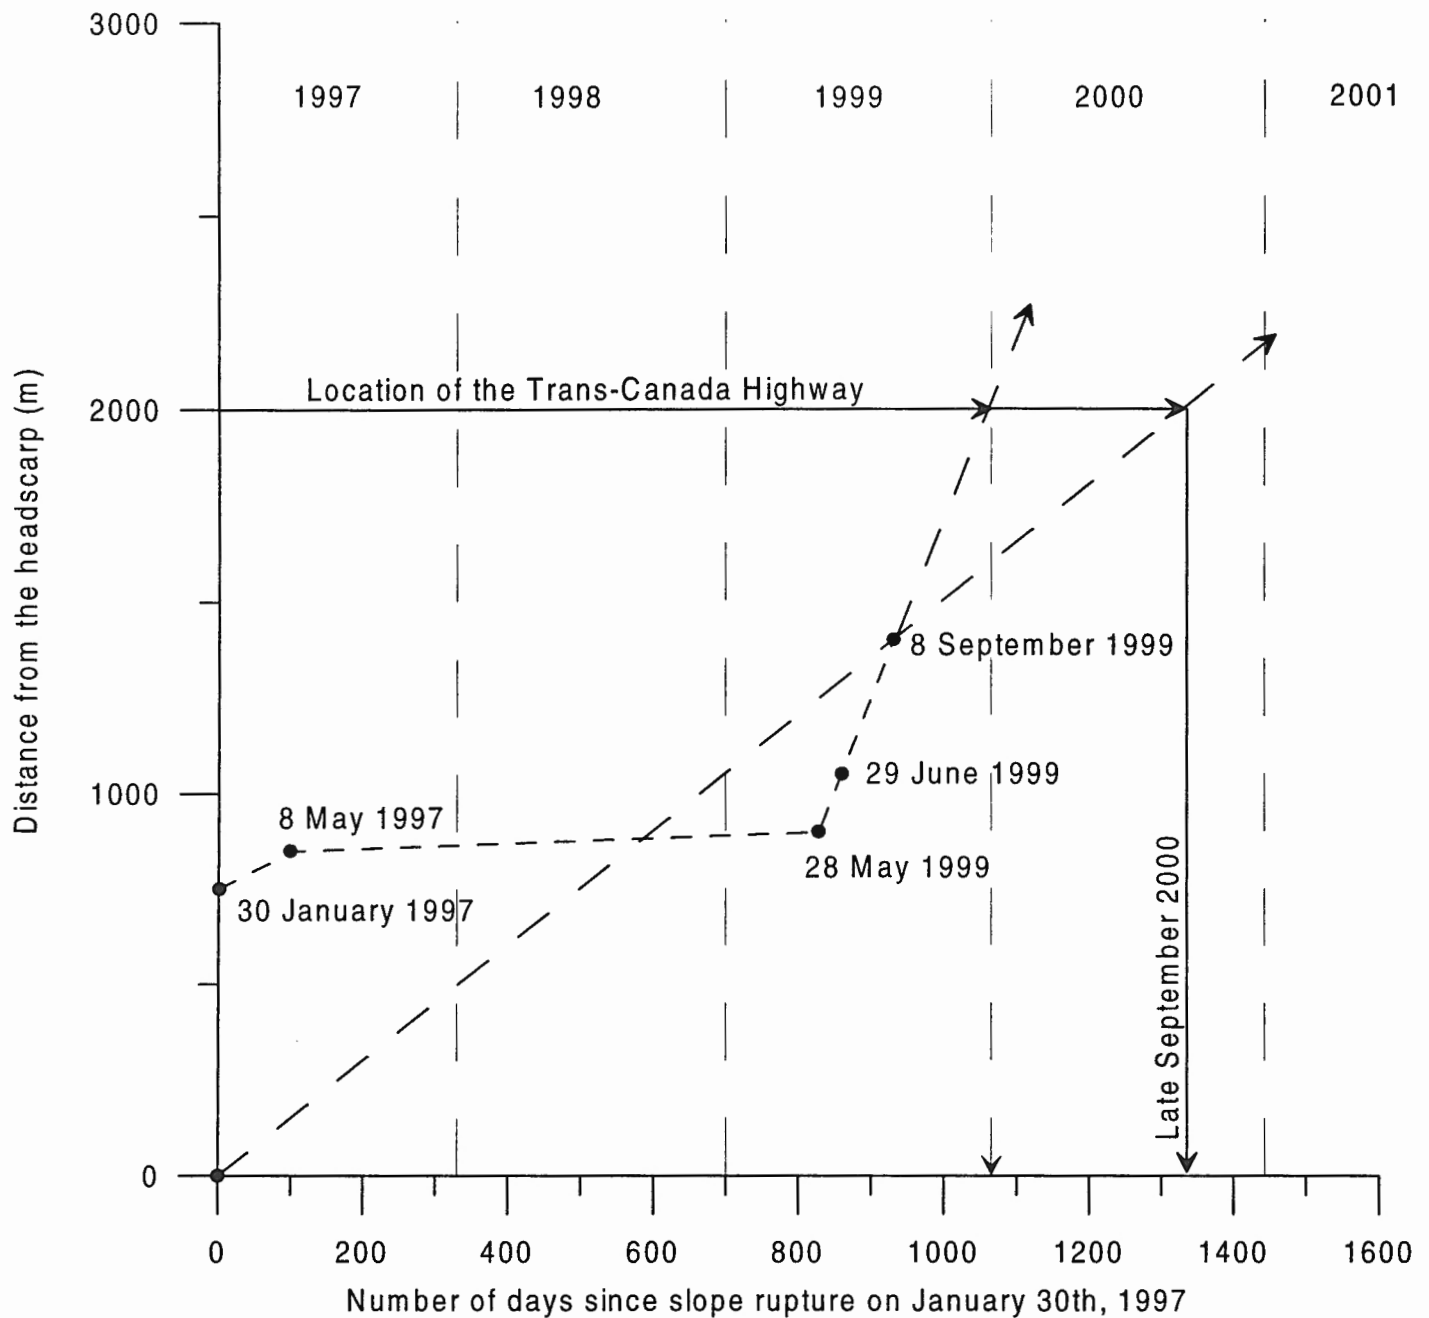
- 5.2 Because of the considerable amount of groundwater seepage in the slope and continuous displacement of debris, Glacier National Park authority must consider the possibility of a catastrophic landslide at East Gate landslide area. Other deep-seated landslides were recognized in the Beaver Valley (Pritchard et al., 1989), implying that a larger than expected volume of rock might be involved in a potential future slope failure. Based on the distance traveled by debris since the recognition of the slope failure on January 30, 1997, the average displacement rate of debris is 1.5 m/day. The relationship of time *versus* distance of the debris flow front is shown in Fig. 14.

The worst scenario anticipated indicates that the debris front would reach the highway by the end of December 1999. Winter months will certainly reduce the rate of displacement, but the motion of the debris flow front is closely dependent on spring 2000 climate conditions. General trend from January 30, 1997 indicates that debris flow front will hit the highway by late September 2000 (Fig. 14). Therefore, this landslide must be closely investigated and monitored to understand the failure mechanism(s) and potential impacts on the Beaver Valley sector and as well on the consequences to Glacier National Park activities, as well as wildlife, transportation activity and municipal economy. Based on field investigation and analysis of available documents, we propose the following recommendations.

Figure 14: Time *versus* distance relationship of the East Gate debris flow front displacement since the observed slope rupture on January 30, 1997. According to extrapolation of summer 1999 rate of displacement, the debris would reach the Trans-Canada Highway at the end of December 1999. This is the worst scenario anticipated. Winter months will certainly reduce the rate of displacement, but the motion of the debris flow front is closely dependent on spring 2000 climate conditions. The general trend of displacement from January 30, 1997 to September 8, 1999 indicates that late September 2000 would be the date when the debris flow front will hit the highway.
