Five-Mile Creek Debris Flow

Banff National Park, near Banff, Alberta

August 4th, 1999

OPEN FILE #3876

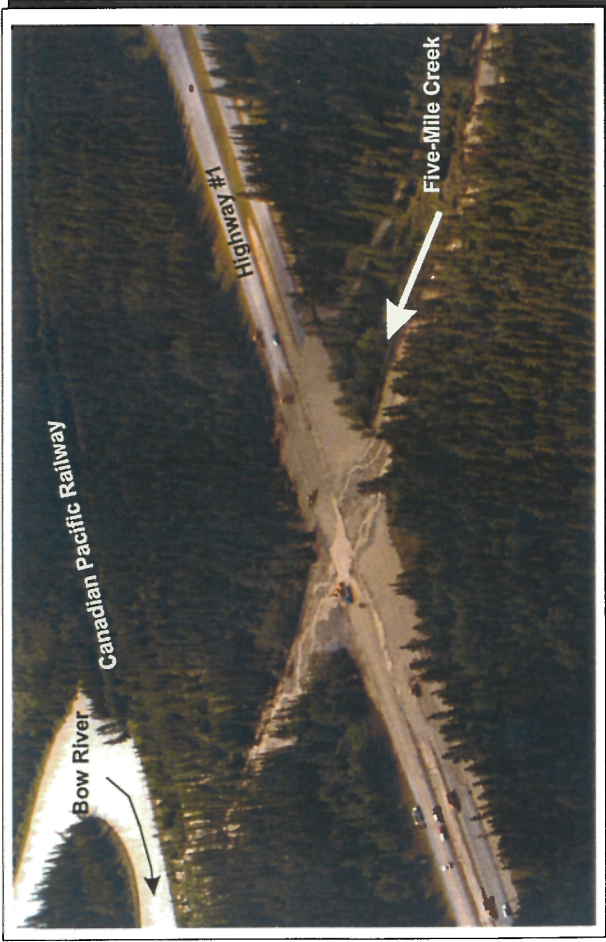
Figure 1.2 a) Five-Mile Creek debris flow overwhelming the highway #1, Banff (Alberta).
 b) Zoom-in on the debris over the highway, about 0.5 m of debris the eastbound lanes and about 2 m over the westbound lanes.
 c) Mudflow reached the CP track but without any damage, note that the culverts are not working the day after the debris flow event.

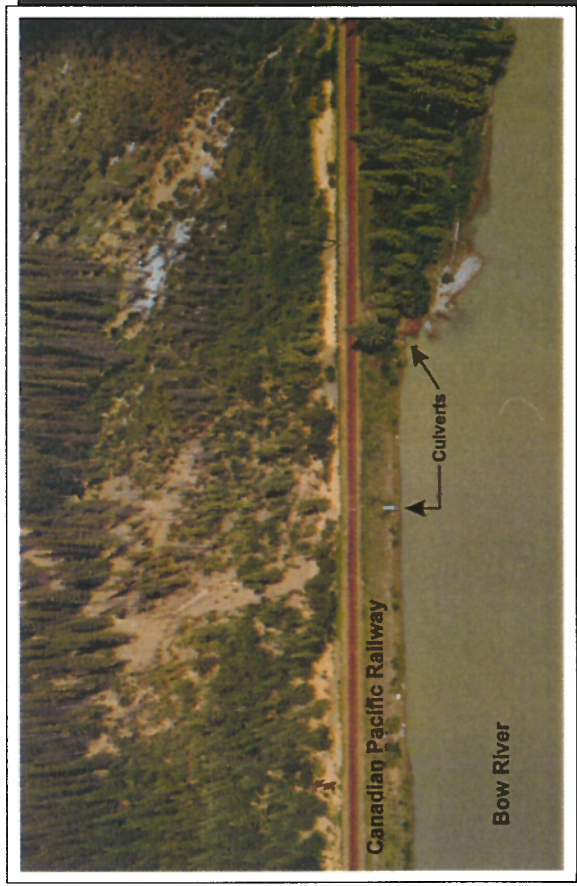
c)

Some debris, essentially mud and water, reached the Canadian Pacific Railway (CPR) but without any damage to the track (Figure 1.2c). The mud just spread out through the forested area; once a small culvert was reopened, the mud went down into the river. According to Highway Service workers, about 15,000 m³ of debris were removed from Five-Mile Creek downstream of the highway. In total, about 50,000 m³ of debris were removed, including the material covering the highway. According to Banff National Park wardens, this was the first time that a debris flow affected Five-Mile Creek. The 4-meter culvert had been blocked once in the past, four or five years ago (D. Kerr, personal communication). It is our understanding that the Five-Mile Creek area was not a problematic sector in the past.

In the southernmost part of the path, the debris flow, at this point composed largely of water and fines, reached the CPR track (Figure 1.2c) but without damaging the railway. The average thickness of debris beside the track is 0.15 m. Debris is largely sandy silt with gravel and organic matter (Figure 4.18 & 4.8). Sand and silt represent over 85% of the material, while the percentage of gravel and clay are 6.1% and 8.0% respectively (Table 4.6). It is also noted that coarser blocks are covered by mud (Figure 4.19). A New Jersey concrete fence was found about 200 m from its original location along the highway (Figure 4.19).

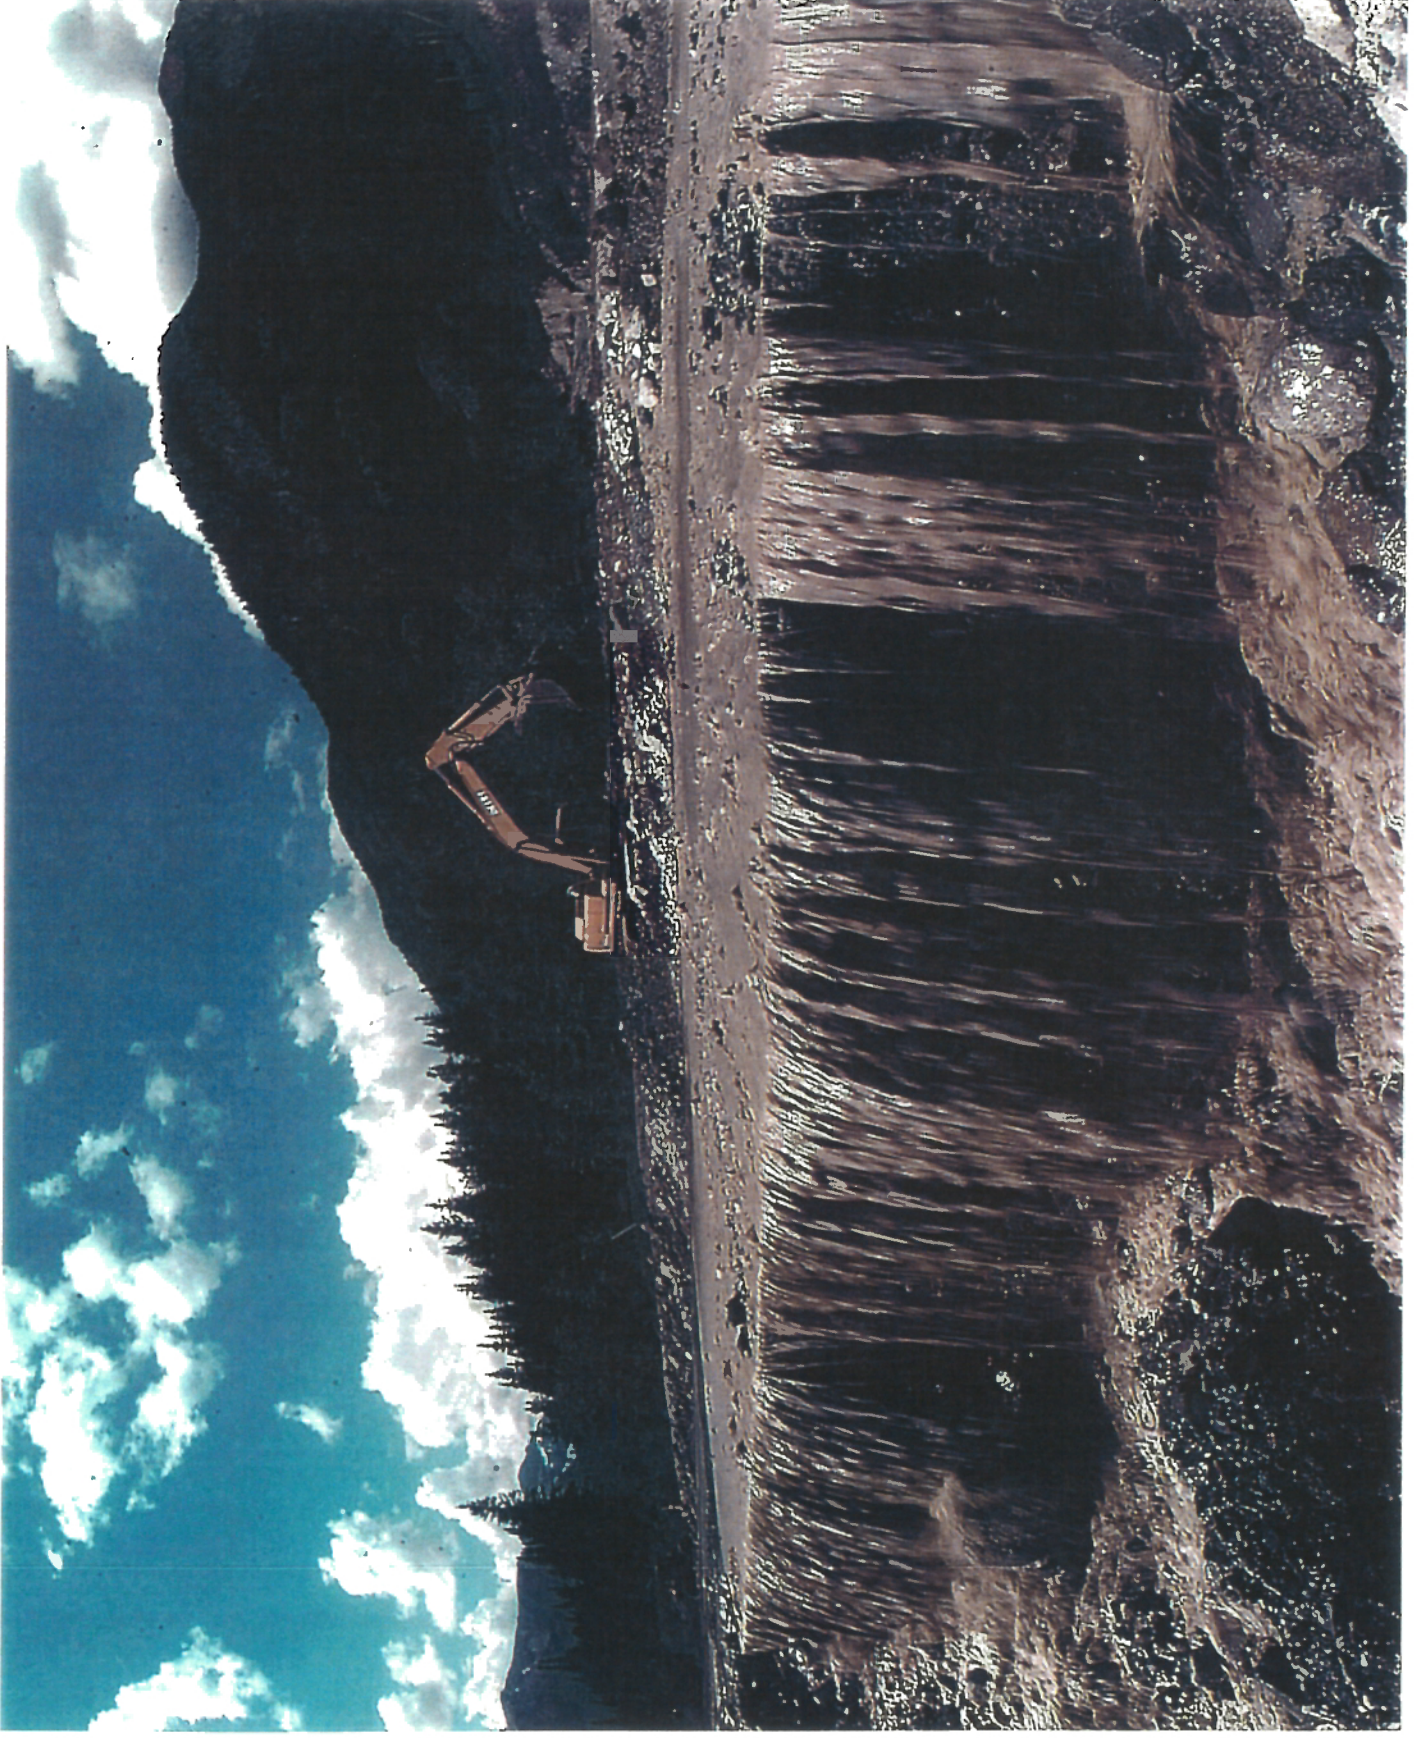
Figure 3.1 Machinery cleaning up the Trans-Canada Highway the day after the debris flow (Source: Calgary Herald).

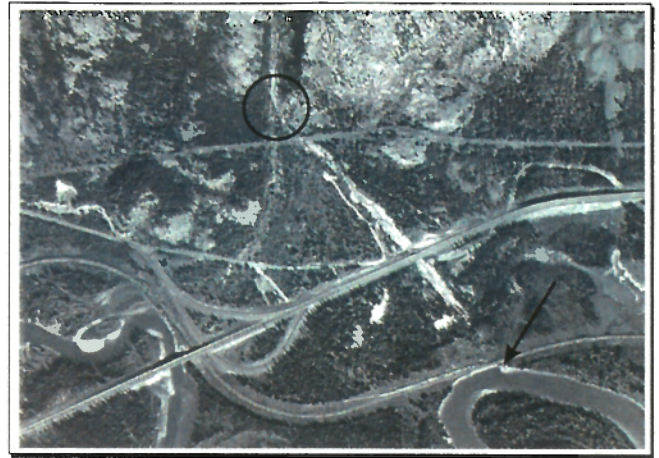
b) 1963

According to a park warden, C. Pacas (personal communication, Banff National Park, the Canadian Pacific Railway installed a small berm at the apex of the fan in the Fifties (encircled in Figure 3.7b), where Five-Mile Creek divided in two arms, forcing the Five-Mile Creek to flow only in the eastern arm. It is the author's understanding that occasional problems to the CP track caused by the creek surges forced the CP authorities to undertake this protective action.

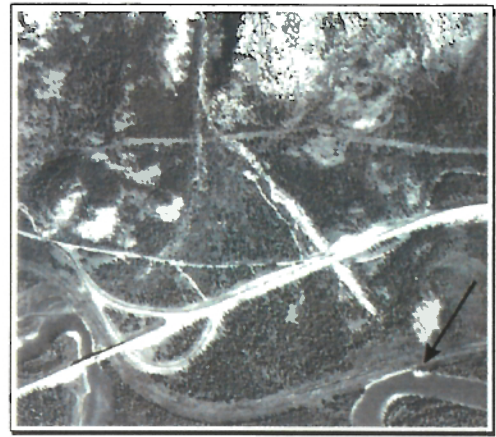
d) 1974

In the Seventies, the small culvert installed in the Sixties through the CP track foundations seems to have been blocked, since the evacuated deposits did not extend any further in the river (arrow in Figure 3.7d), runoff was going towards the Vermilion Lakes.

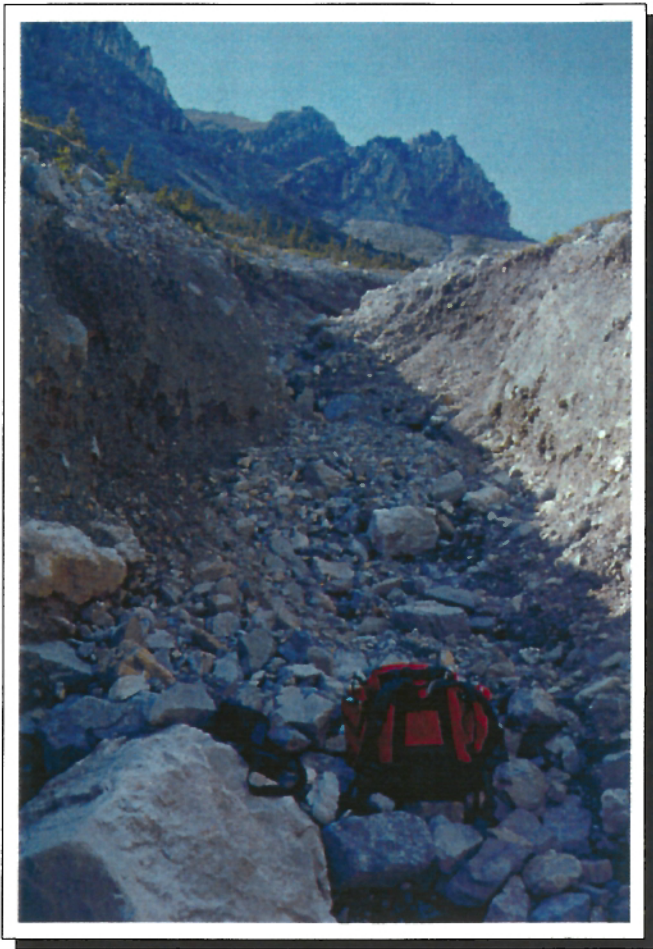
Figure 4.4 View upslope of a gully created by a small tributary at the elevation 2100 m on the western side of Mount Edith. The gully is about 1.5 m deep and 3 m wide. A back pack gives the scale. See Figure 4.3 for location of the photograph.

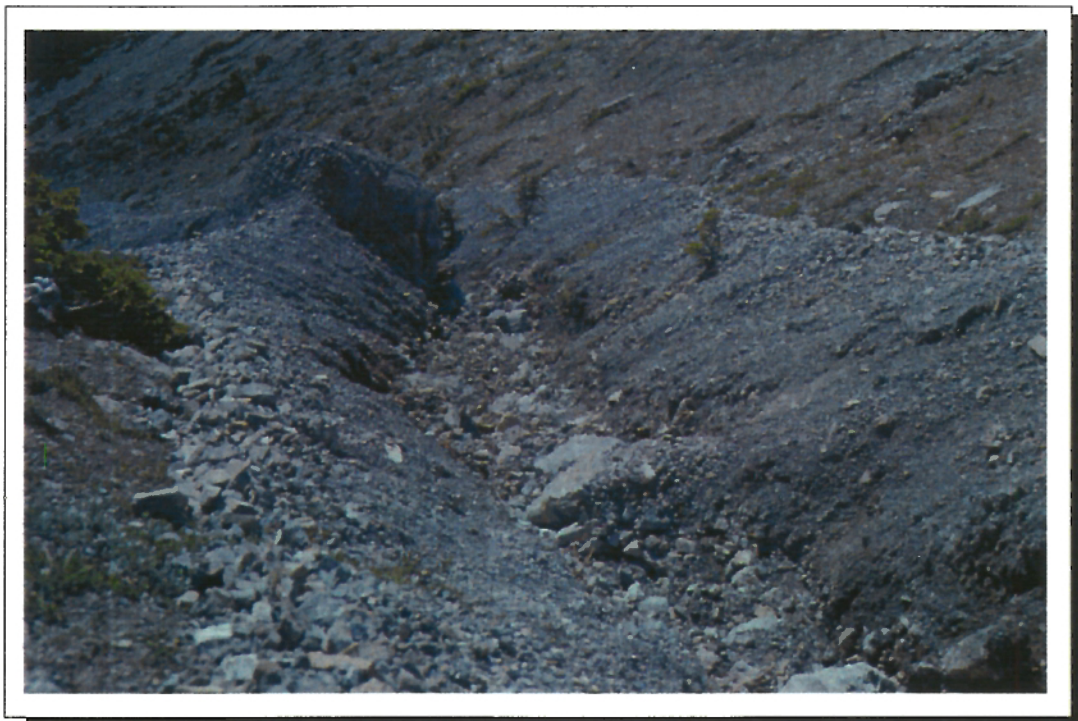
Figure 4.5 View down slope of one of the small tributaries located at the elevation 2130 m on the eastern side of the Five-mile Creek valley and showing levees. Particle size decreases from outer to inner sides of the gully. The gully is 0.5 m deep and 1 m wide. The depth of the gully is limited by the bedrock. See Figure 4.3 for location of the the photograph.

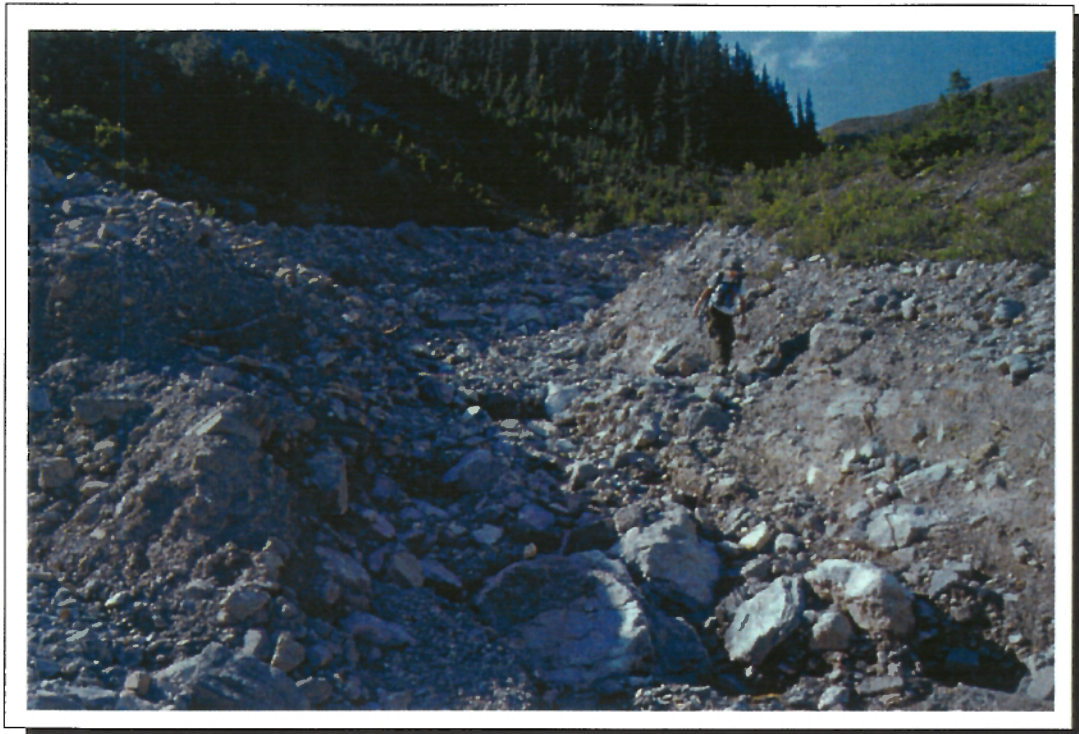
Figure 4.6 View upslope of a large gully that intersects the Five-Mile Creek at elevation 1975 m on the eastern side of the Five-Mile Creek valley . This gully is about 3 m deep and 5 m wide, and in which the material has been eroded and transported, as shown by levees, and where a small amount of material remains in place. A person gives the scale. See Figure 4.3 for exact location of the photograph.

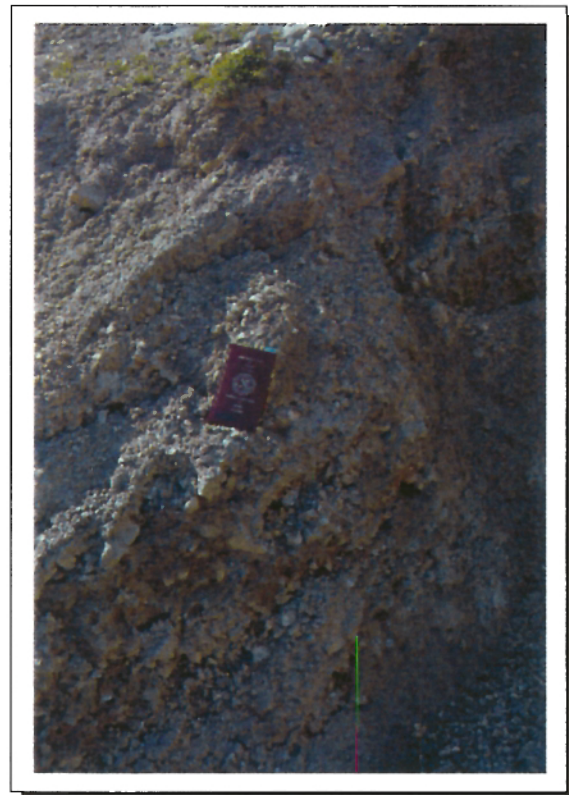
Figure 4.7 Close-up of the colluvial material eroded during the debris flow by a tributary on the eastern slope of the Five-Mile Creek valley. Sample #1 was taken in this deposit at elevation 2100 m. The material is mostly pebble, gravel, with sand and silt. See Figure 4.3 for location of the photograph. A field book gives the scale.

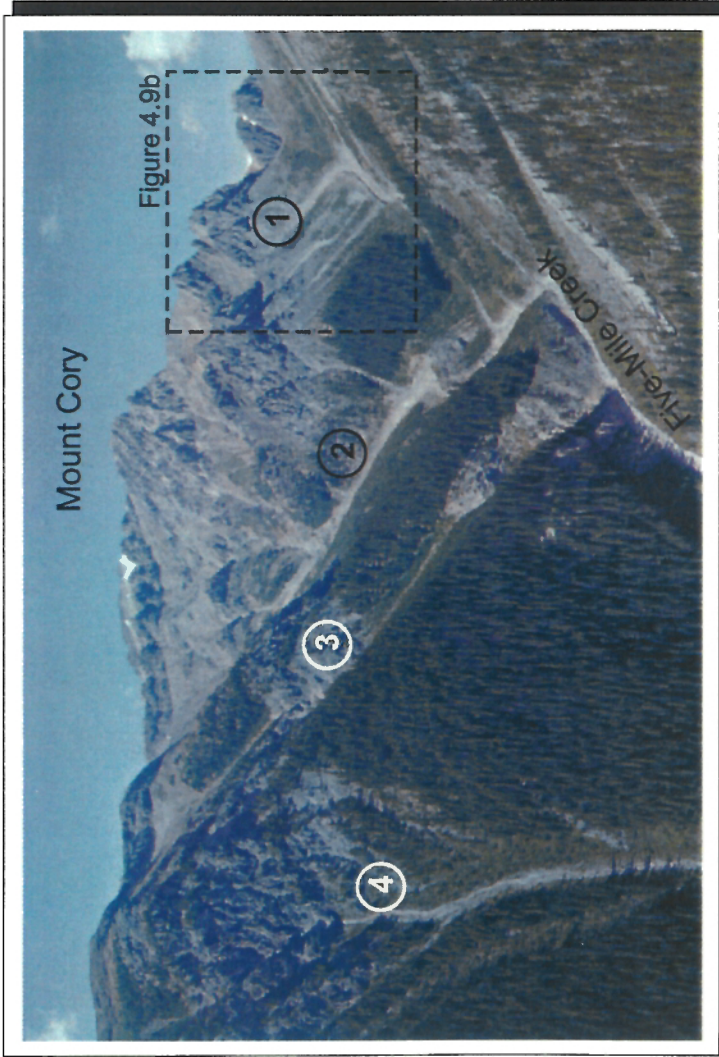
western slopes. These deposits are the main source of sediment for the debris flow that fed the Five-Mile Creek through several streams and gullies. Almost all the surface of the source area is underlain by bedrock, resulting in very poor water infiltration and high runoff. The rainfall event on August 4th, 1999 provided an extraordinary amount of runoff, which mobilized colluvium stored on the slopes and was transported down to Five-Mile Creek.

Figure 4.9 a) Oblique aerial view of the western slope of Five-Mile Creek valley showing four major tributaries. Note that the upper slope is mainly bedrock. See Figure 4.2 for location of numbered major tributaries.
 b) Close-up on the upstream section of Five-Mile Creek. Note that some of the tributaries on the eastern slope of the valley are well grooved (right-hand side of the photograph). Cory Pass is in the background.

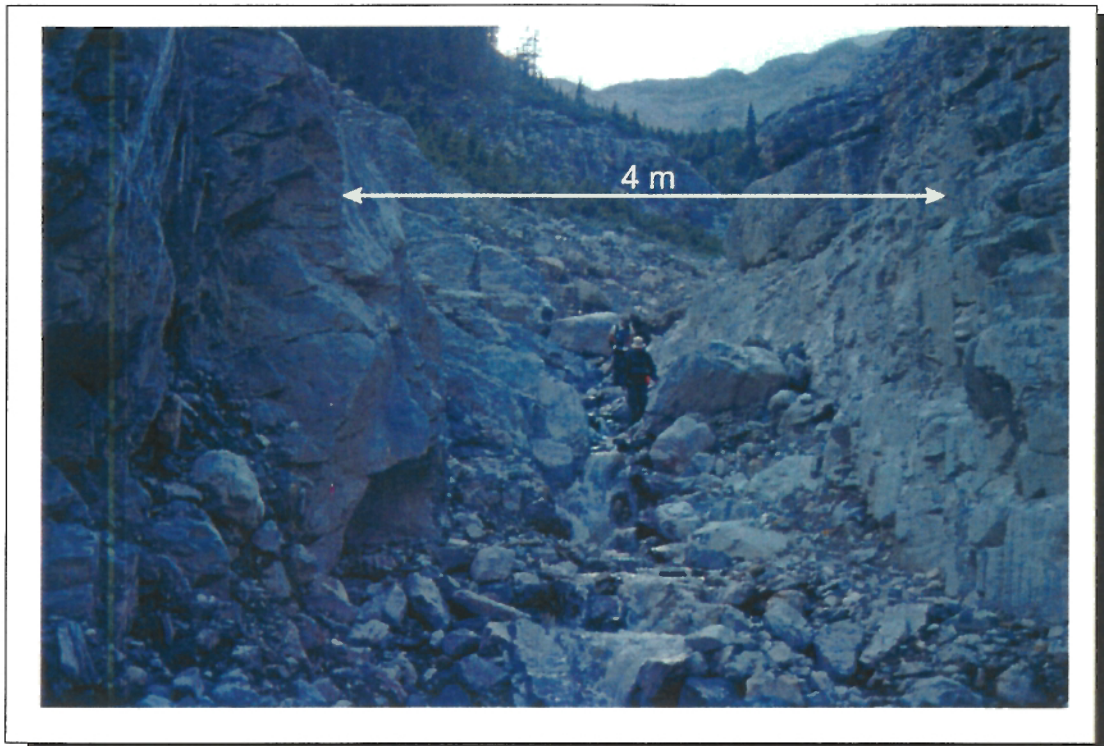
Figure 4.11 View upslope of a narrow section in the Five-Mile Creek bed due to incision into the bedrock at elevation 1725 m (see Figure 4.3 for location of the photograph). Fluvial material has been removed by the debris flow. Distance between rock walls is about 4 m.

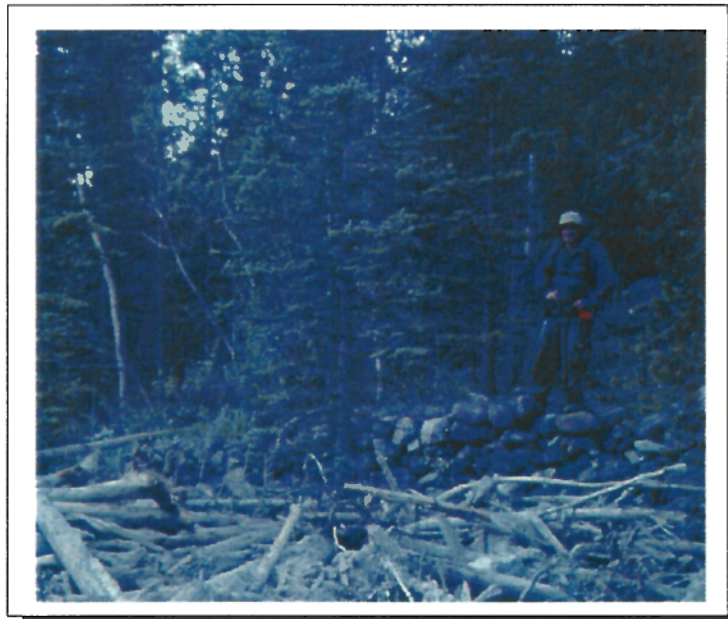
Figure 4.12 A section of a berm installed by Canadian Pacific Railway in the Fifties to deviate water flow through the middle of the fan. The berm was partially destroyed by the 1999 debris flow. Note the accumulation of wooden debris beside the berm. The berm is formed by man-made cemented pebbles and rounded boulders smaller than 30 cm. The berm was about 1 m high and 100 m long. A person gives the scale. See Figure 4.3 for location of the photograph.

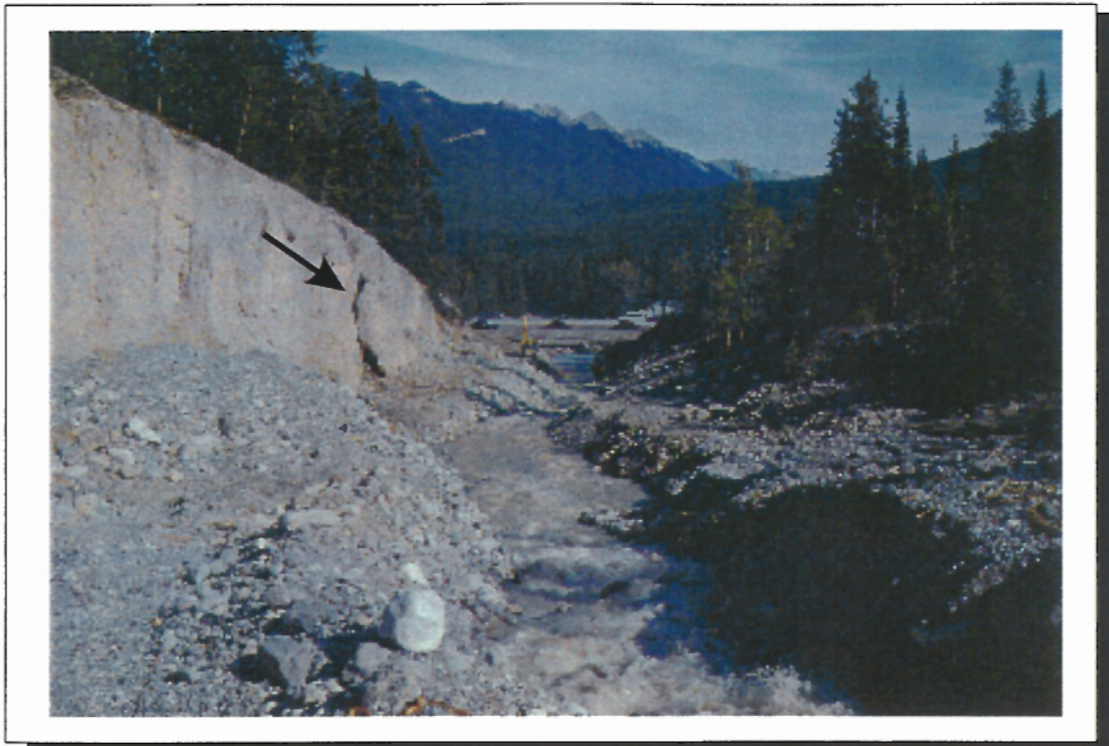
On both sides of the main creek, the debris flow eroded the creek bed and adjacent creek banks, creating unstable slopes (Figure 4.13). The newly eroded creek banks show failures that occurred during and after the debris flow. A small bridge located in a narrower section of the creek was washed out few meters upstream of the power line, but power line posts were not affected by the debris flow (Figure 14).

Figure 4.13 View downstream of the Five-Mile Creek section showing the first 150 m upstream from the Trans Canada Highway partially cleaned by machinery about three weeks after the event. Debris flow has eroded material that was in the creek bed and on the banks, and thus created unstable subvertical slopes as shown by arrow. The photograph was taken at an elevation of 1430 m (see Figure 4.3 for location of the photograph).

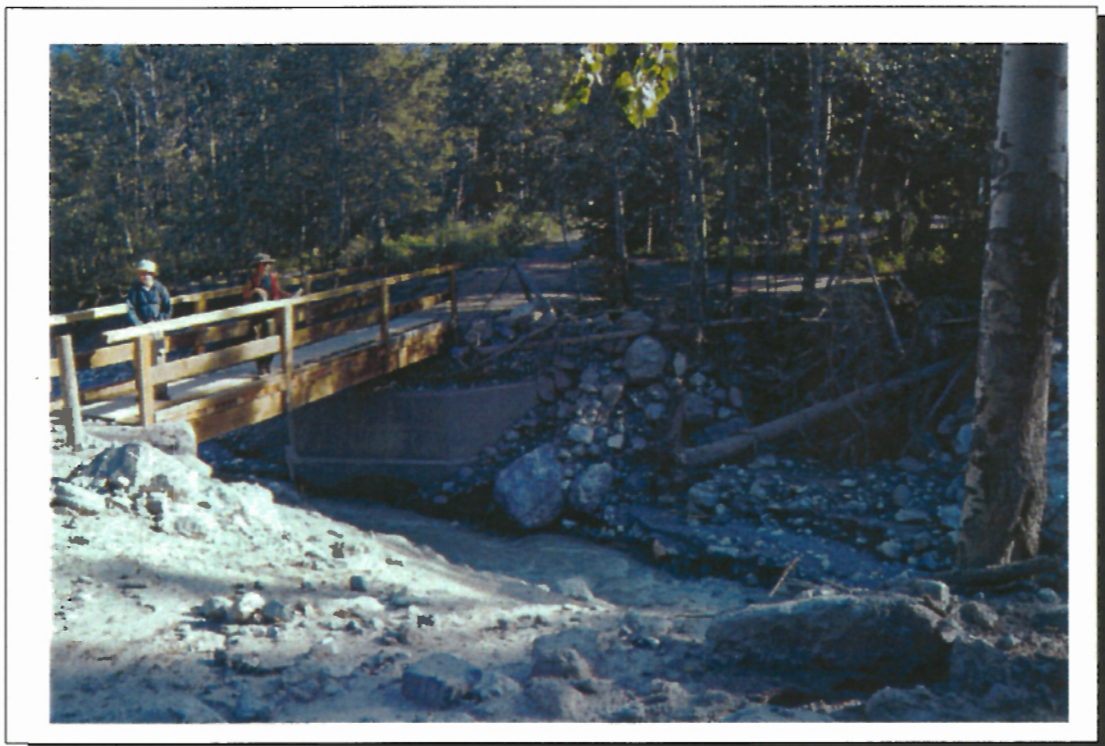
Figure 4.14 The photograph shows a temporary wooden bridge installed over the Five-Mile Creek for hikers. The debris flow undermined the creek bed and completely destroyed the former bridge. Debris flow deposits can be seen on background and foreground.

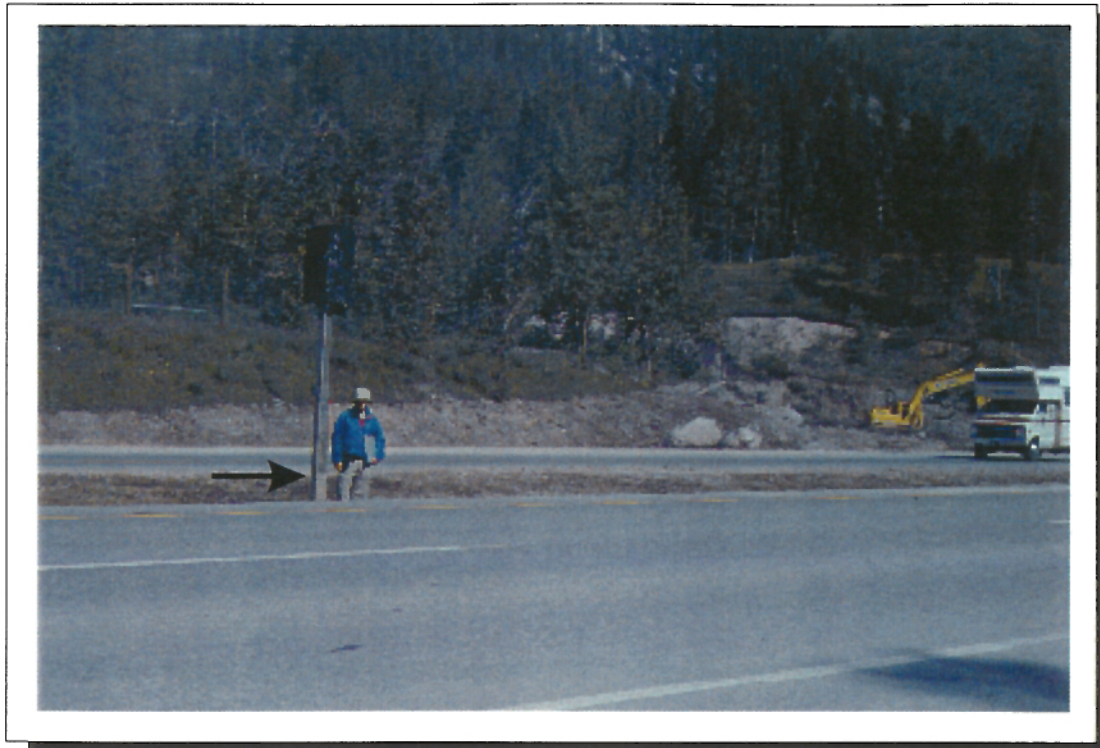
Figure 4.15 The debris flow overwhelmed the four-lane Trans Canada Highway. Three weeks after the debris flow all the debris was removed from the highway. Mud on a sign post indicates how thick the debris cover was over the highway, (about 30 cm, as pointed by the arrow). See Figure 4.3 for location of the photograph.

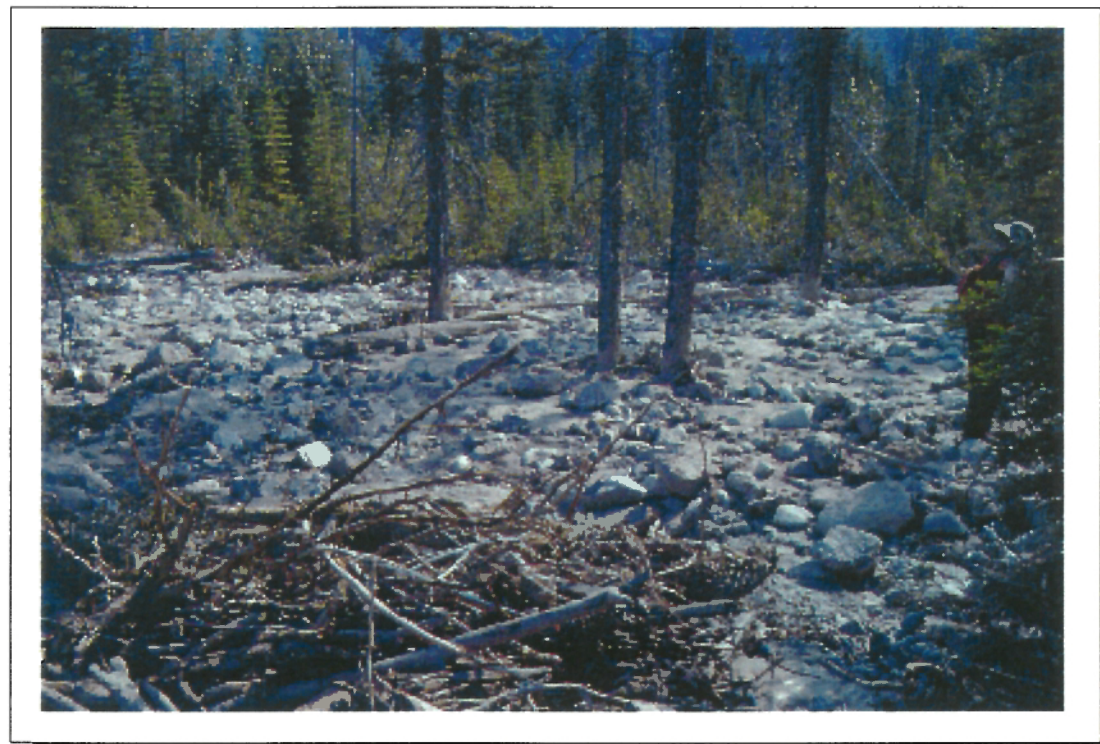
Figure 4.16 The debris flow went through a forested area downstream the highway. Debris shows an average size about 0.30 m, ranging between 0.10 to 0.50 m, with an average thickness varying between 0.30 to 0.50 m. Trees are about 20 to 30 cm in diameter. See Figure 4.3 for location of the photograph.

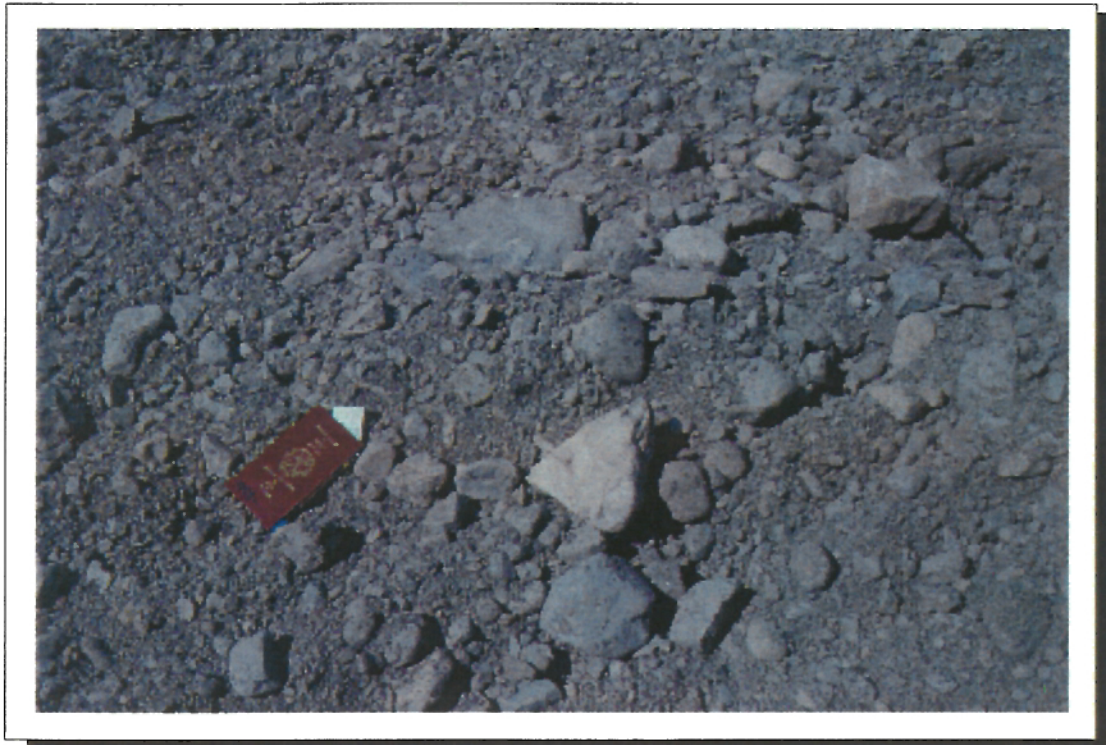
Figure 4.17 Photograph of debris sampled (sample #4) downstream the Trans-Canada Highway. The shape of coarse blocks is sub-angular. The matrix, which corresponds to 25% to 30% of debris, is coarse sand with gravel and clayey silt. The field book gives the scale. See Figure 4.3 for location of the photograph.

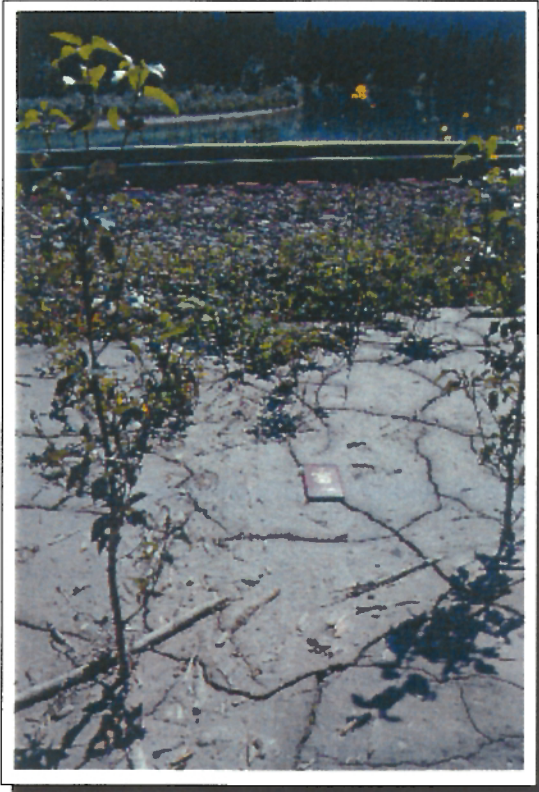
Figure 4.18 Photograph showing debris deposited beside the CP track. The average thickness of debris is 0.15 m, but can be thicker at some locations. Debris is essentially silty clay with gravel and organic matter. The field book gives the scale. See Figure 4.3 for location of the photograph.

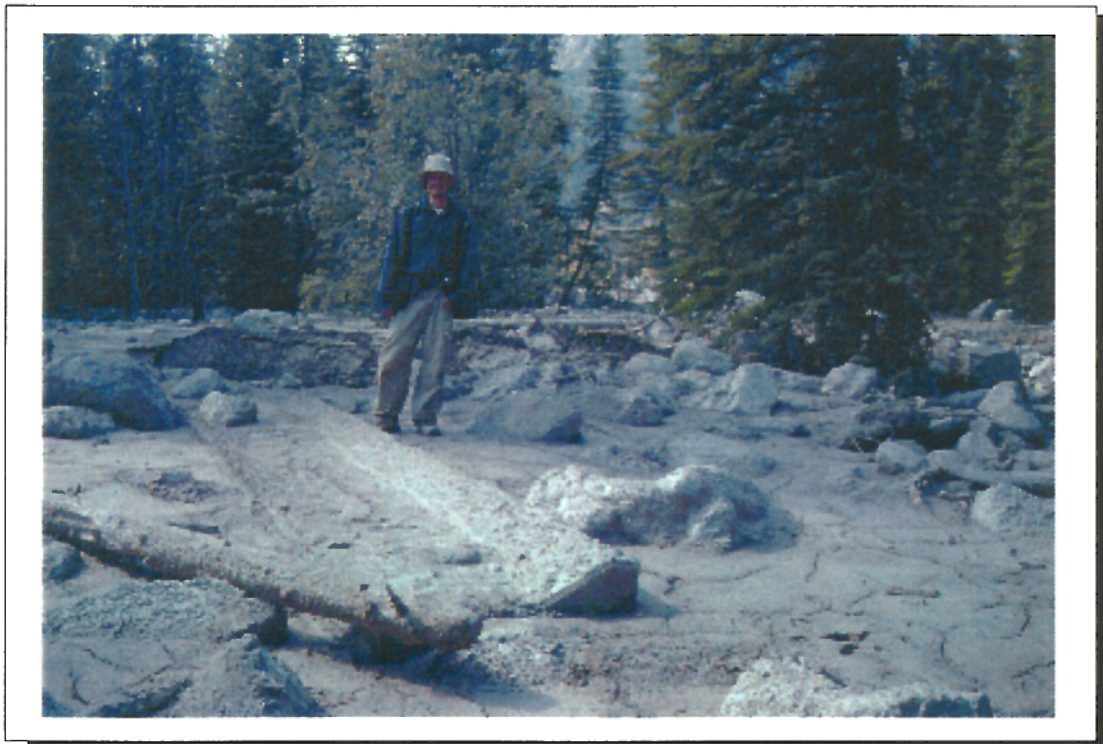
Figure 4.19 Photograph showing a section of a New Jersey concrete fence transported 200 m by the debris flow from its original location along the Trans-Canada Highway. Notice that coarser blocks are entirely covered by mud or fines (sample #5). See Figure 4.8 for grain size distribution. Figures 4.2 and 4.3 give respectively the location of the sample and the location of photograph.

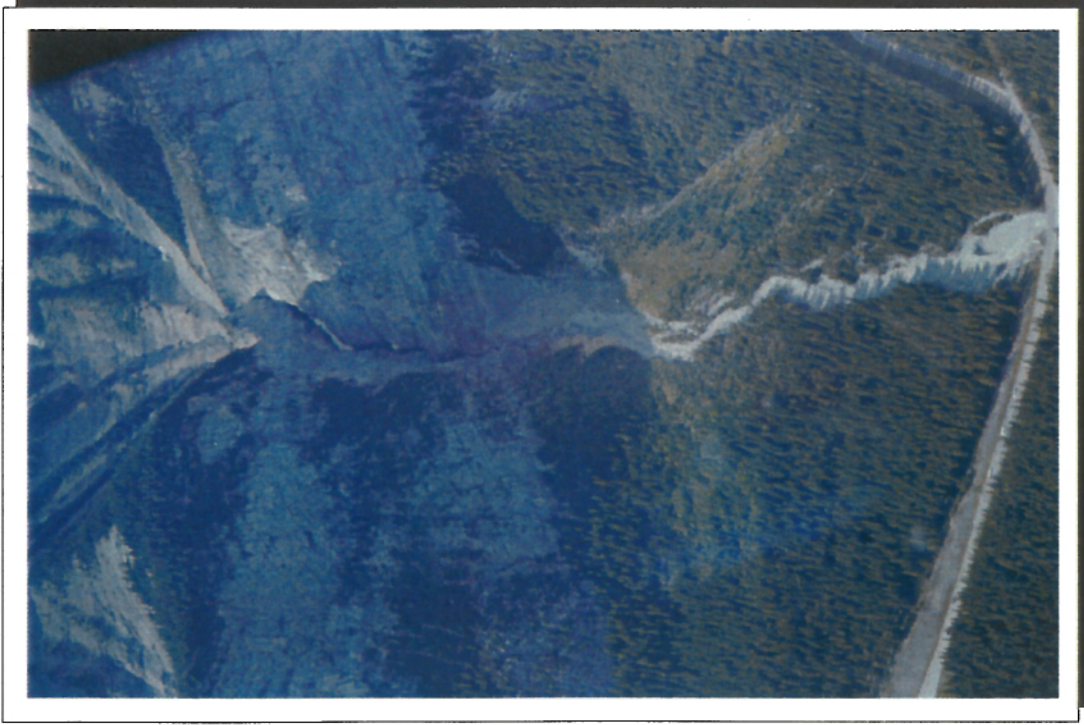
Figure 4.20 Example of potential site for debris flow located about 4 km north-east of Banff. The section above the cliff is charged with colluvium, and the creek itself, downstream the cliff, is also charged with debris. The road could easily be blocked or damaged by a debris flow. This site is indicated by a blue star on Figure 1.1.

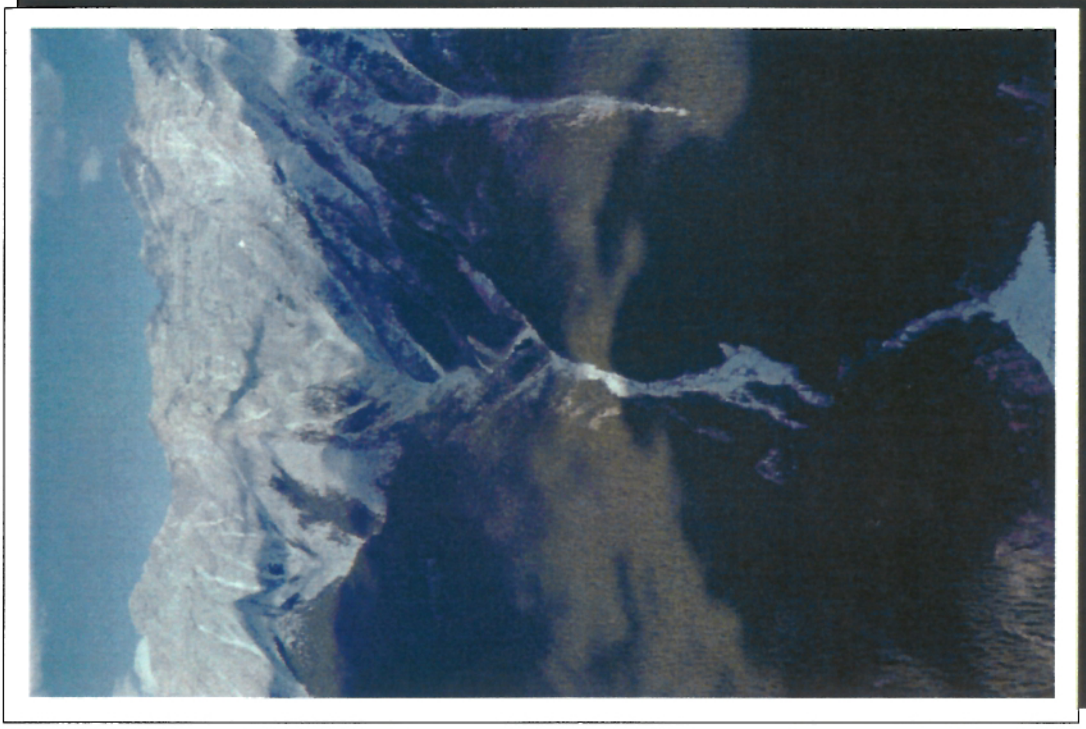
Figure 4.21 Oblique aerial view of the one of the two debris flows that occurred on July 31st, 1998 in the Spray River valley. Note the large fan deposit that blocked the Spray River and impounding a lake upstream. This site is identified by a green star on Figure 1.1.

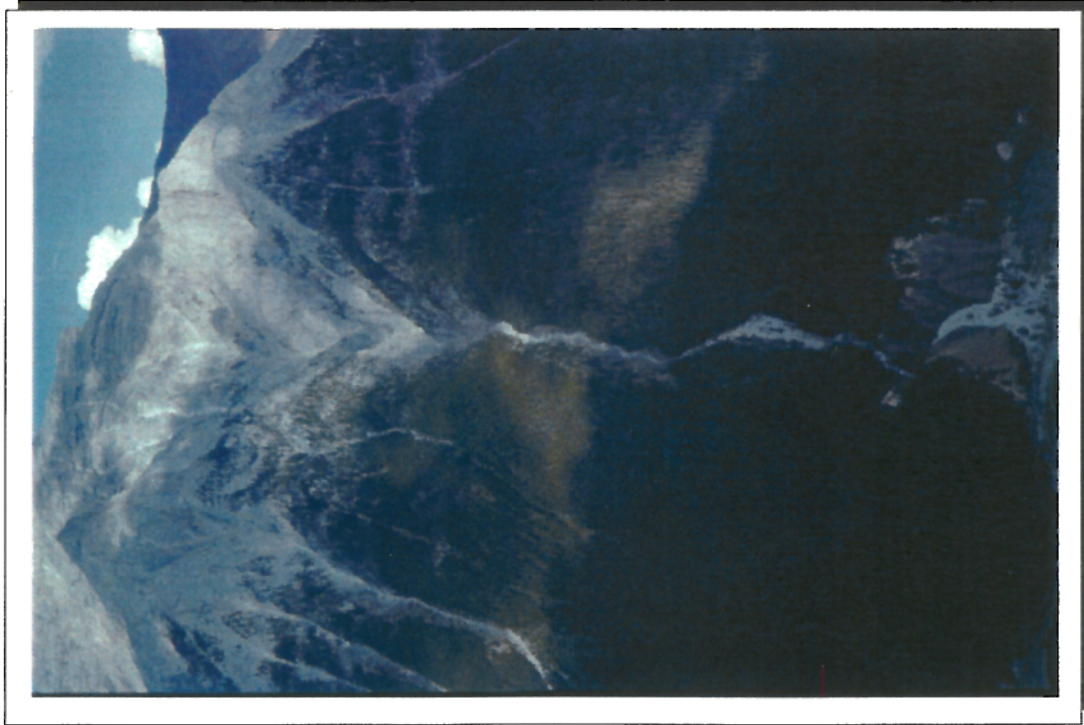
Figure 4.22 a) Oblique view of the second debris flow that occurred on July 31st, 1998 in the Spray River valley.
