GEOLOGICAL SURVEY OF CANADA
TOPICAL REPORT NO. 97

REPORT ON INVESTIGATION OF RADIUM HOT SPRINGS,
KOOTENAY NATIONAL PARK,
BRITISH COLUMBIA

BY
R. O. VAN EVERDINGEN

OTTAWA
1964

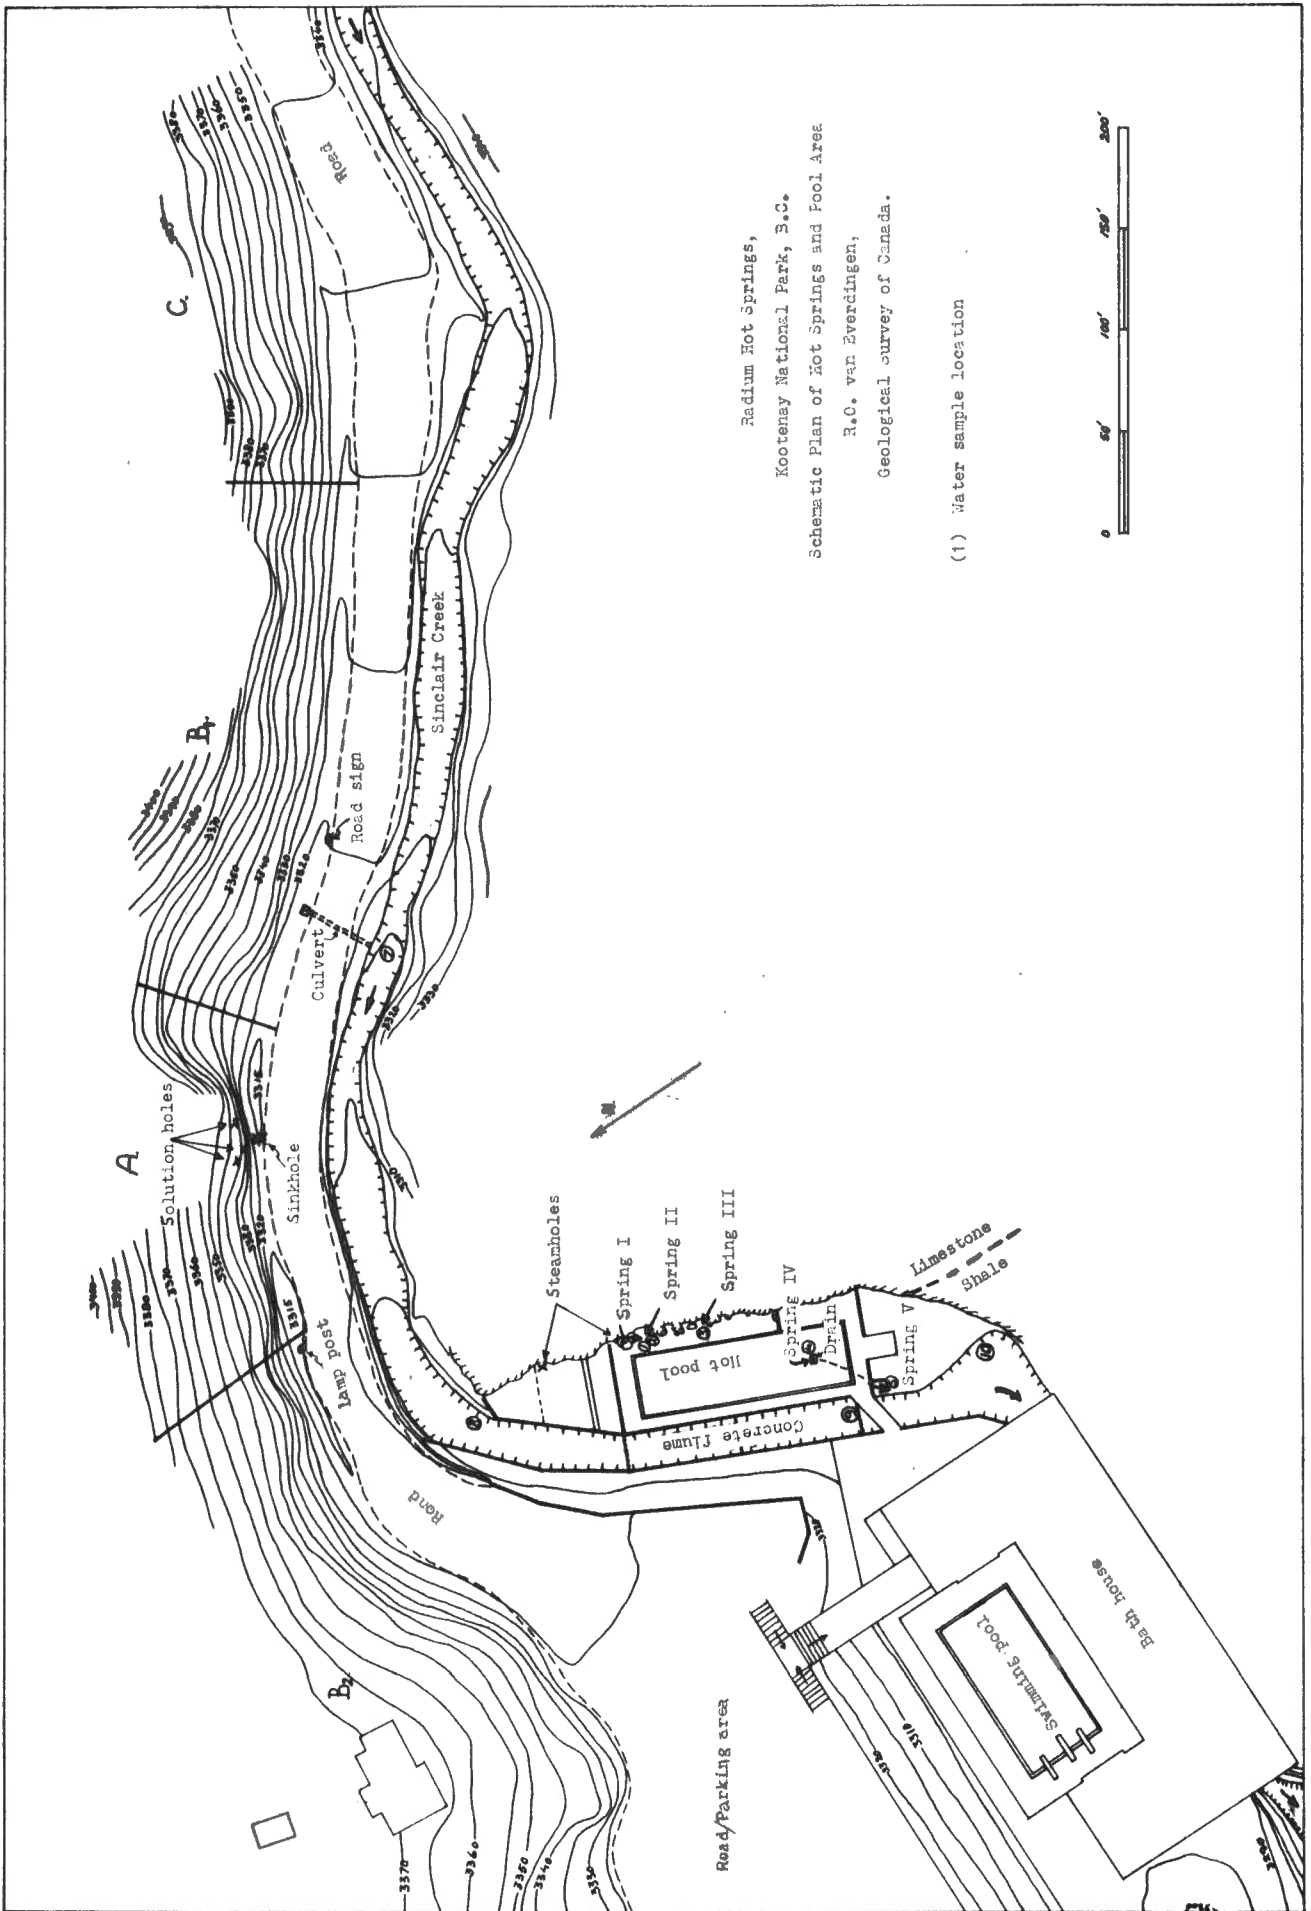
Radium Hot Springs,
 Kootenay National Park, B.C.
 Schematic Plan of Hot Springs and Pool Area
 R.C. van Everdingen,
 Geological survey of Canada.

After a heavy rainstorm on June 13 the spring water became extremely muddy in the late afternoon of that day. Investigation revealed a "sink-hole" in the highway drainage-ditch on the north side of Highway No. 93. The sink-hole was taking in water from both east and west. The temperature in the springs dropped from 114° to 85°F, a drop of 29°F.

It was found that water was again disappearing through the bottom of the highway drainage-ditch, close to the original sink-hole. Some more extensive measures were taken; a low retaining wall was built in the ditch, approximately 100 feet upstream from the trouble spot, and the ditch was thoroughly cleaned from the retaining wall to below the first lamp-post, approximately 250 feet.

Analyses 8 and 9 indicate that the flow under the hot pool drain is derived from one or possibly two additional spring channels. The spring designated as IV shows higher NO_3 and Cl contents than the others; the spring designated as V shows lower F and higher SO_4 values than any of the others. Analysis 14 shows the influence of spring-water, discharging from the hot pool, on the composition of the creek water, by the increase in the values for Ca, Mg, Na, SO_4 , Cl and SiO_2 . Analysis 13 might indicate some leakage from cracks in the concrete of the hot pool, by the somewhat increased content of SO_4 , Cl and SiO_2 .

1. The highway drainage-ditch and the creek bed should be made impervious.

2. The area to be treated extends at least from the new culvert (see location plan) to where the creek enters the present concrete flume beside the hot pool.

2. In area 'A' under no conditions should any bedrock or well cemented rubble be removed; no blasting should be allowed at all. Loose rubble might be removed by hand if necessary. The area 'A' extends from the lamp-post to approximately 60 feet west of the new culvert under the highway (see map).

3. In areas "B₁" and "B₂" loose material and cemented rubble should be removed by methods not involving blasting. No bedrock should be removed.

4. In area "C" bedrock to be removed could be worked by blasting, provided minimum charges are used. Loose material in this area should be removed without blasting.
