THE 1985 MEXICAN EARTHQUAKE - A SITE-VISIT REPORT\*

Ottawa, Canada February 1986

EARTH PHYSICS BRANCH OPEN FILE REPORT NO.: 86-2

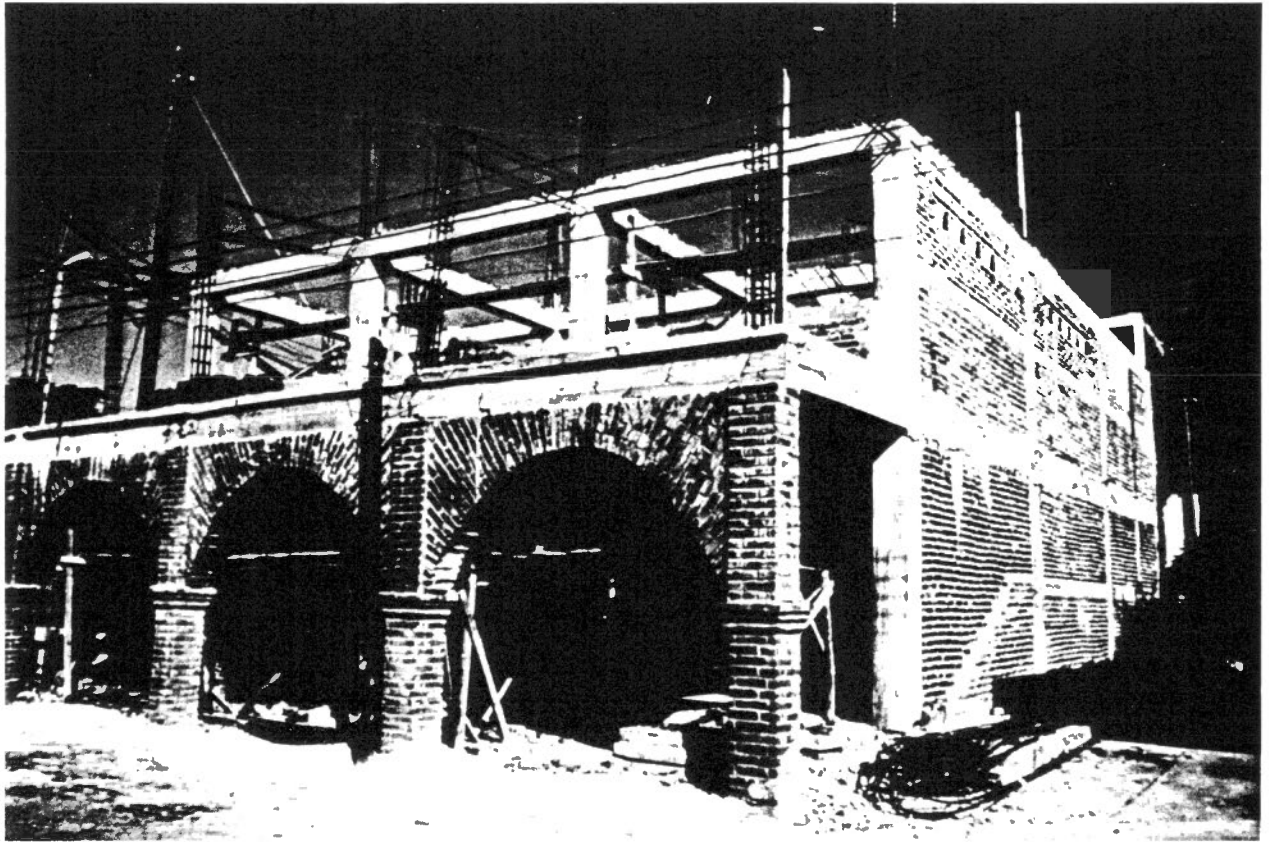
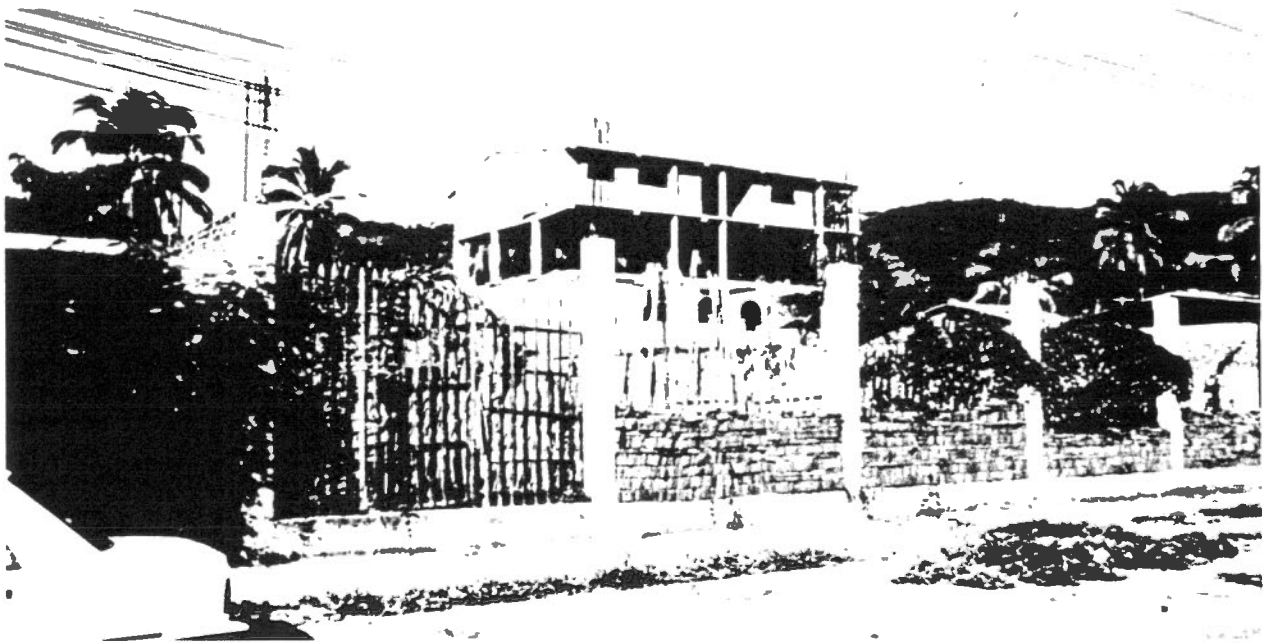
Fig. 3.1a, b Two examples of residential construction in Zihuatanejo:  
(a) typical, (b) unusual structure with "soft storey".

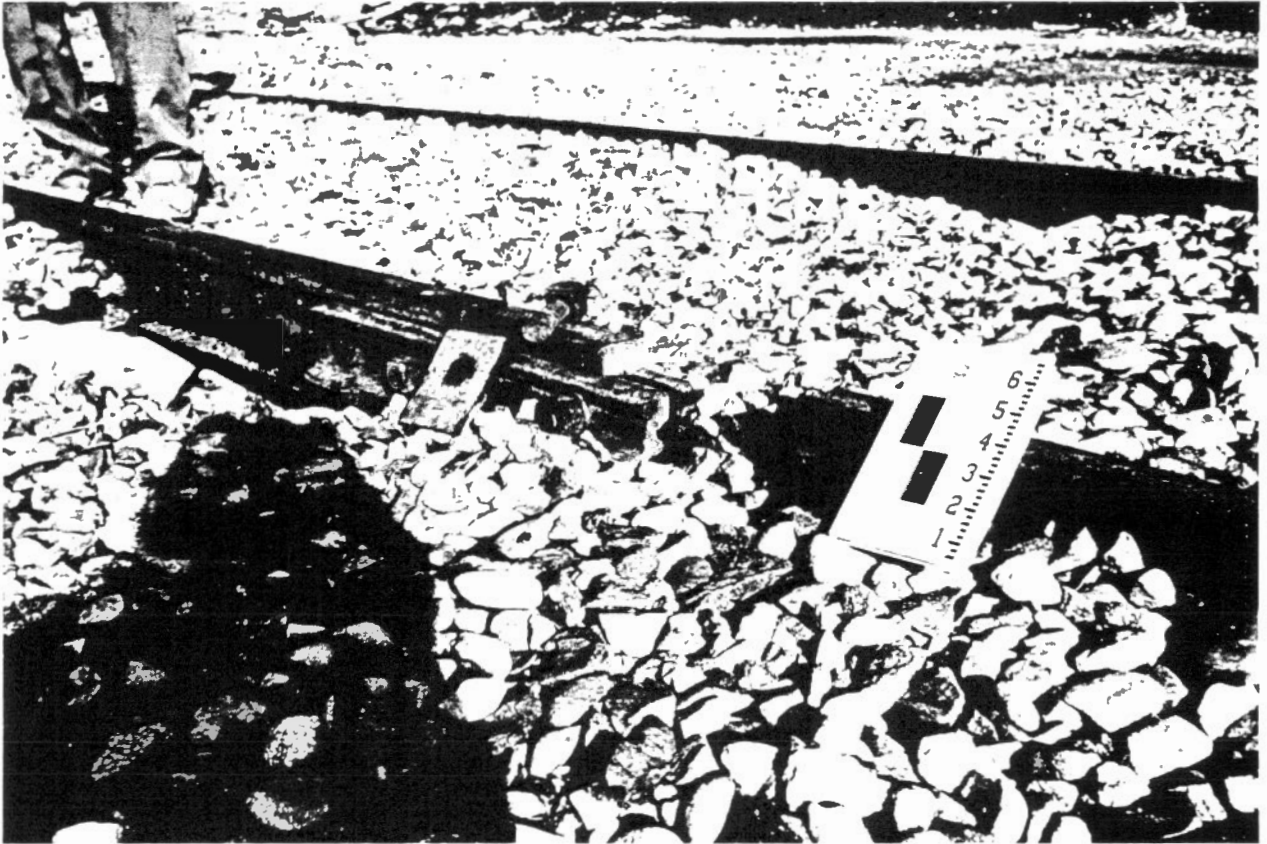
Fig. 3.2 Ruptured E-W rails on periphery of the Fertimex plant, Lazaro Cardenas. Both rails had ruptured at the same place, this one at a connector hole, and the other through the entire rail.

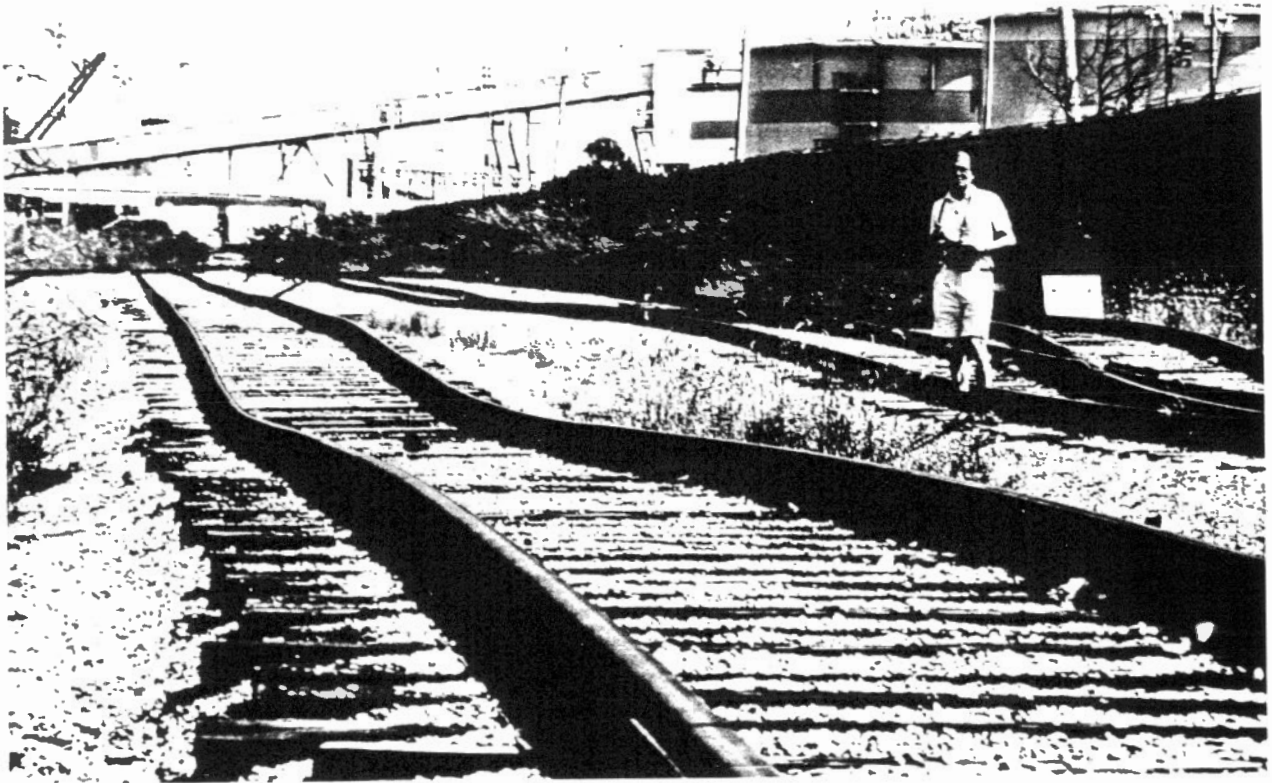
Fig. 3.3 Distorted N-S rails on periphery of Fertimex plant.

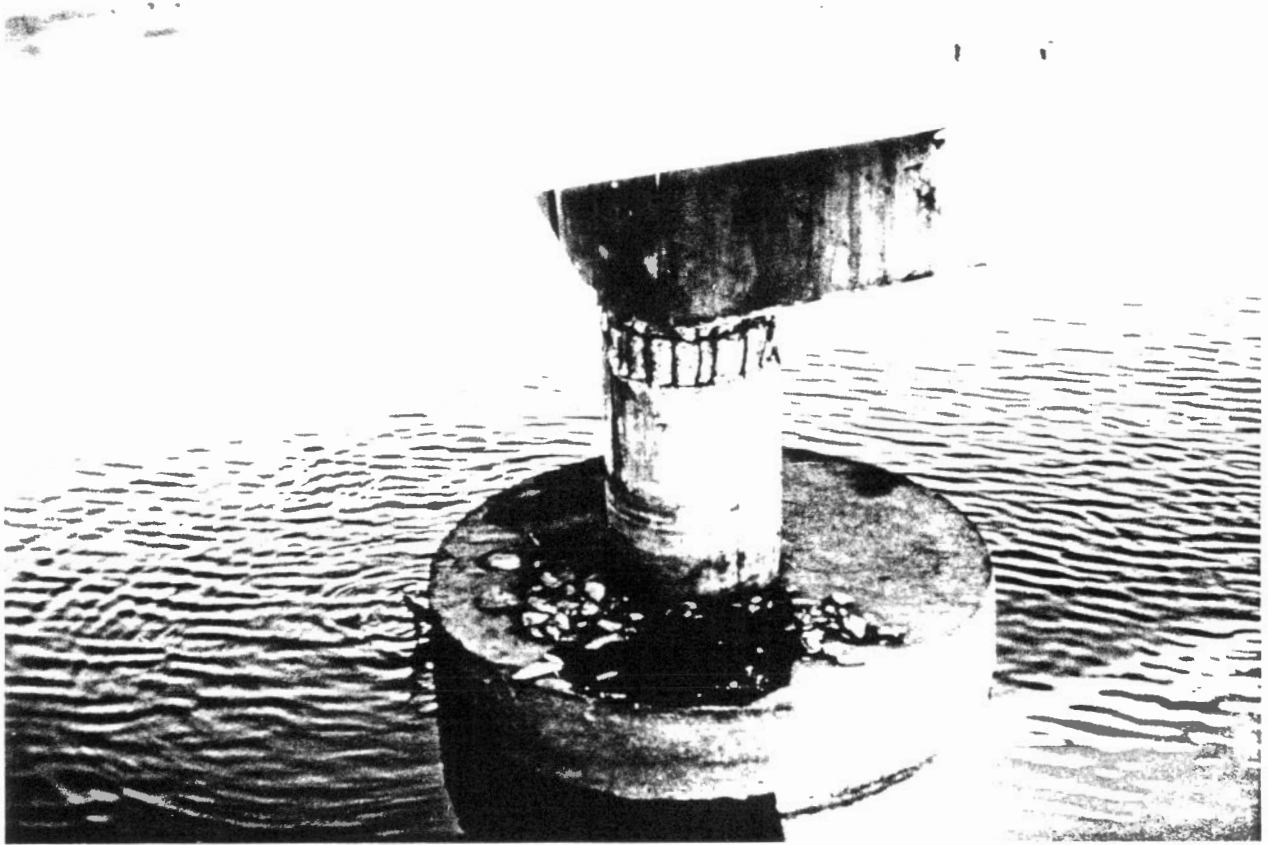
On the road to the Port of Lazaro Cardenas, a pair of modern concrete bridges had suffered heavy spalling to the pier tops (Fig. 3.6). Nearby, a 1.5 m diameter concrete water pipe had buckled underground, indicating compression in the NS direction (Fig. 3.7). On top of a 10-storey reinforced concrete silo building, a 5-storey superstructure had sheared off its base (Fig. 3.8, 3.9). On the adjacent wharf, the east-west part of a reinforced concrete conveyor loader failed at the base of the reinforced concrete supporting piers and toppled to the north, but the

Fig. 3.6 Spalling at top of reinforced concrete bridge pier, port of Lazaro Cardenas access road. All 5 piers on each of the two parallel bridges showed the same damage. Some hammering damage was noticeable at the expansion joints in the bridge superstructure. There was also minor settlement of the bridge approaches, which were fill embankments.

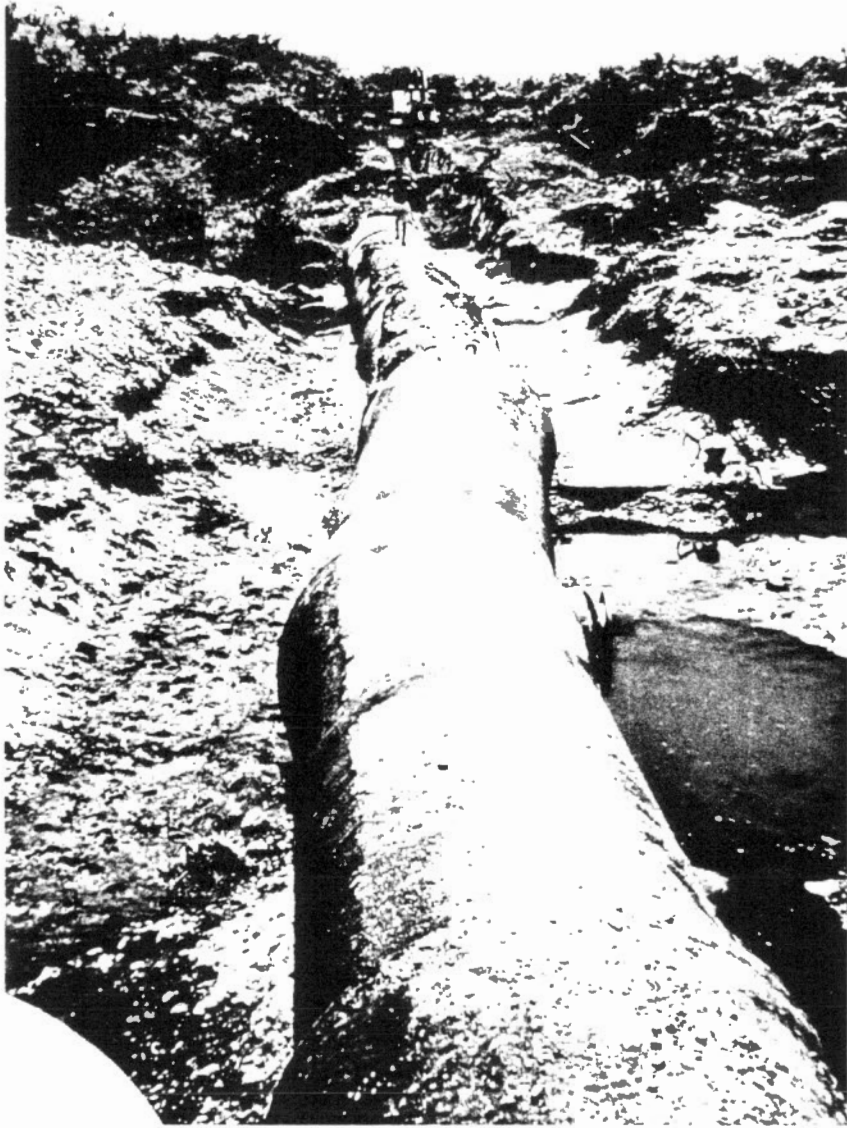
Fig. 3.7 Damage to 1.5 m diameter water pipe near bridges in Figure 3.6.  
The pipe had been dug out to examine the damage.

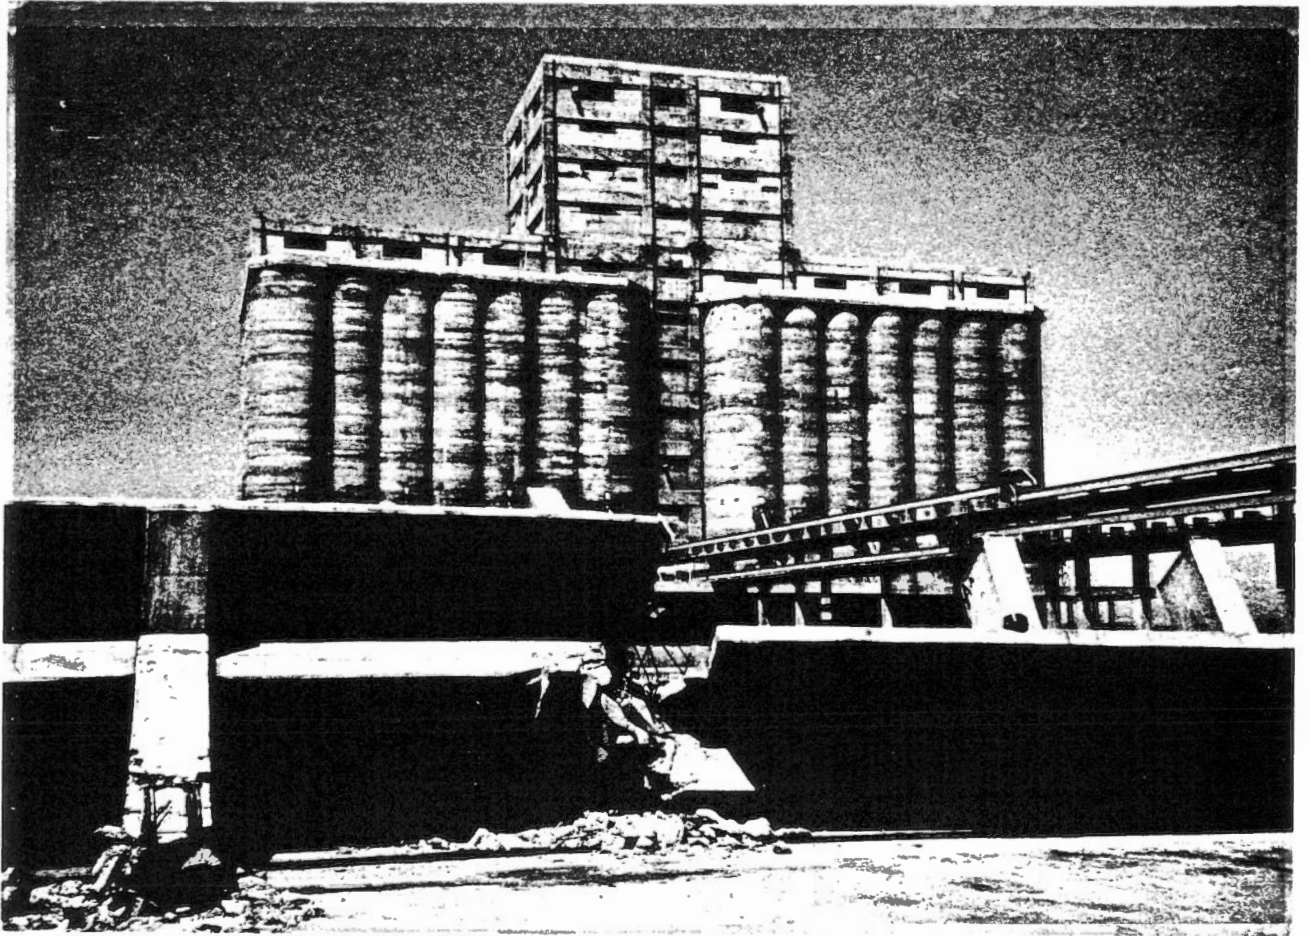
Fig. 3.8 Silo building and conveyor loader structures, port of Lazaro Cardenas. The east-west part of the reinforced concrete conveyor structure (foreground) which ran along the wharf has collapsed, falling to the north, the north-south part was twice as high but was not damaged (centre right). Both of these top-heavy structures were supported by central piers. The east-west structure may have failed because of its orientation or different natural period. Note the 5-storey penthouse, on the 10-storey silo structure, which failed at its base (see detail in Fig. 3.9).

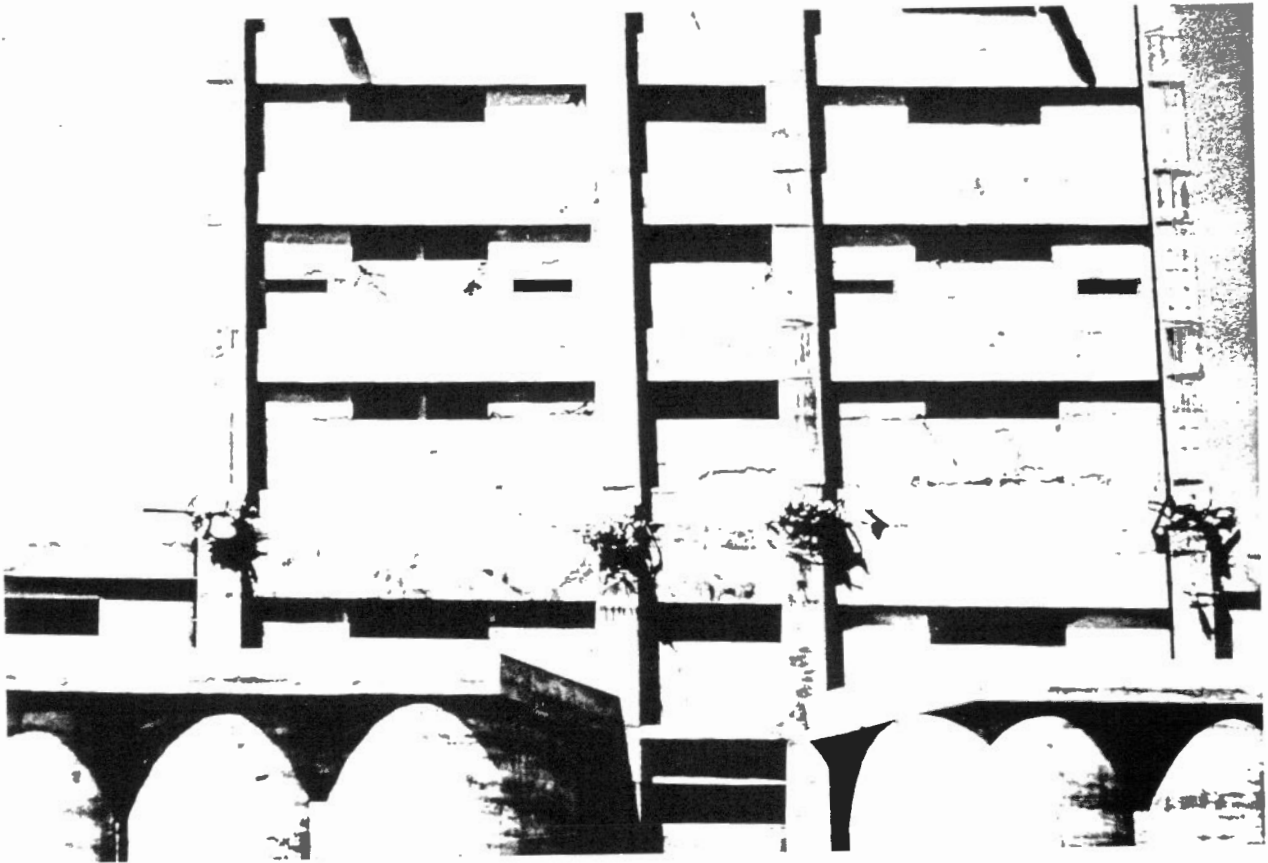
Fig. 3.9 Detail of failure at base of silo penthouse. The penthouse block has dropped and rotated slightly as shown by the column offsets and the protruding reinforcing steel. The structure was only a few years old.

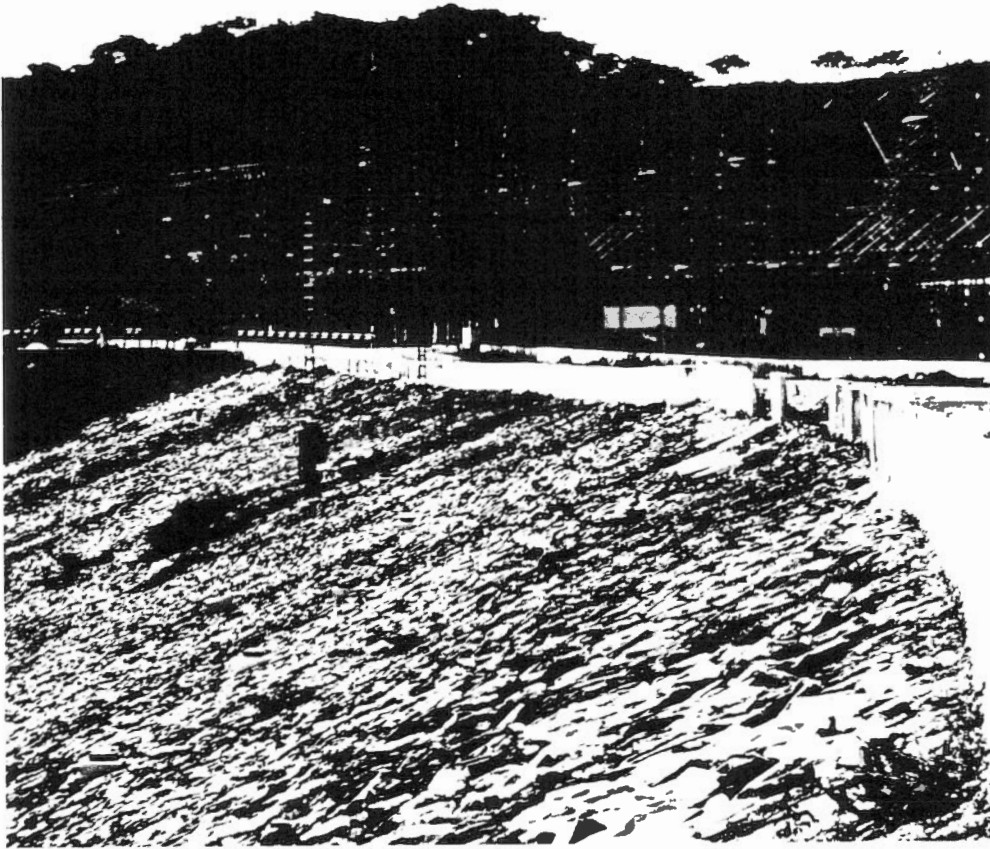
Fig. 3.11 Concrete barrier panels tipped over on crest of Morelos Dam. Dam settlement reached 320 mm on the crest together with outward displacement of 160 mm on the upstream shoulder and 100 mm on the downstream shoulder. Longitudinal cracks up to 150 mm wide formed on both shoulders. Note transformer yard in background.

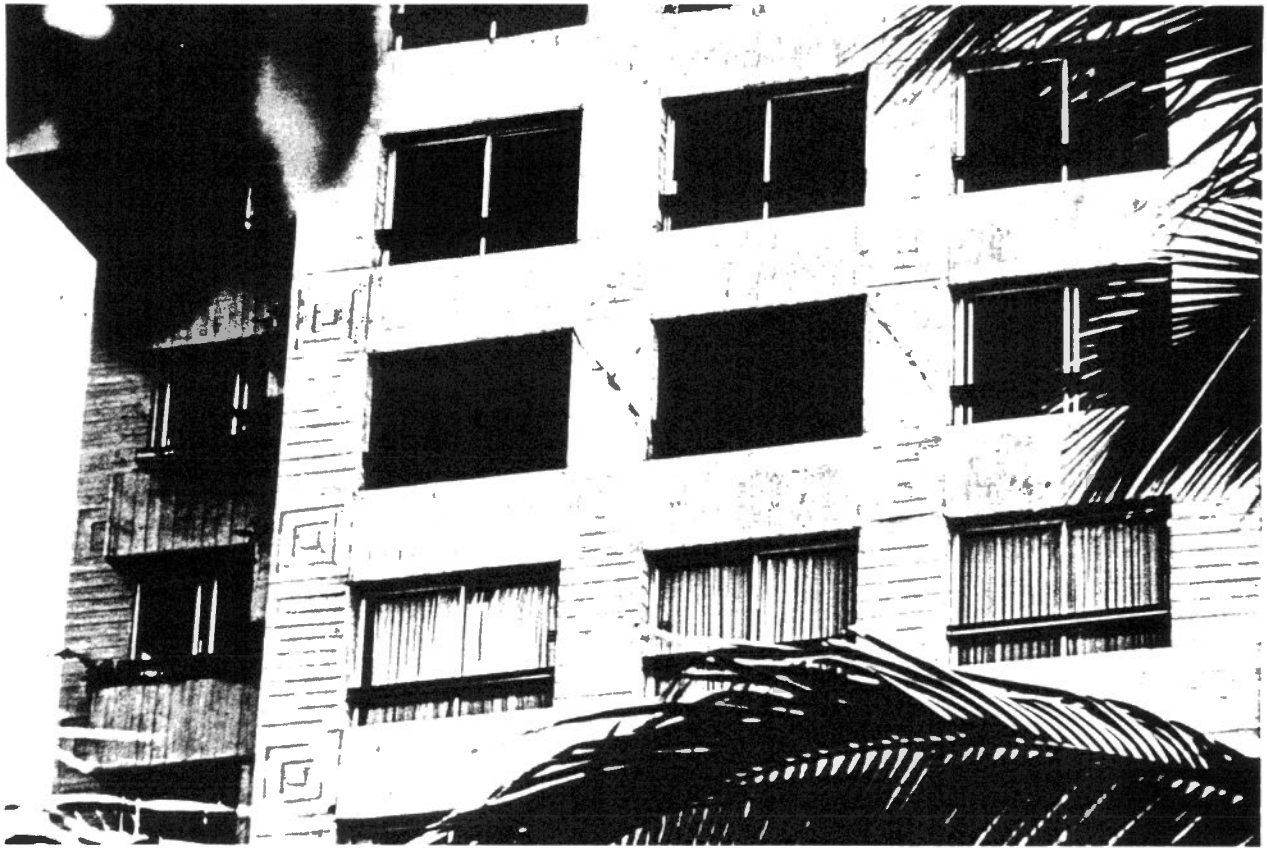
Fig. 3.12 Shear cracking of columns, Holiday Inn, Ixtapa. This cracking occurred only at this intermediate storey, and only at the 2nd and 3rd columns from each corner.

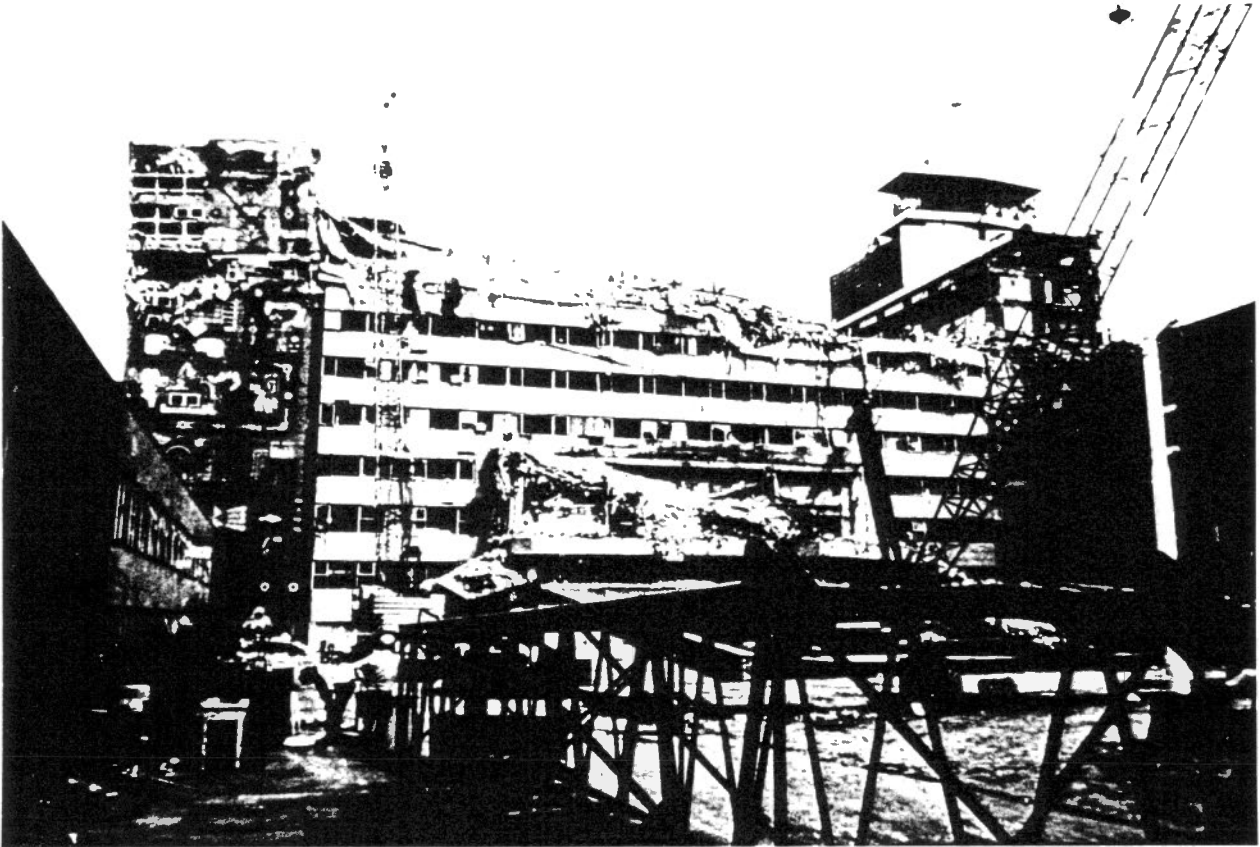
Fig. 6.5a SCT Communications Building

The loss of life of the skilled telecommunications personnel and the damage to telecommunications equipment including transmission towers resulted in the loss of long distance telecommunication for several weeks.

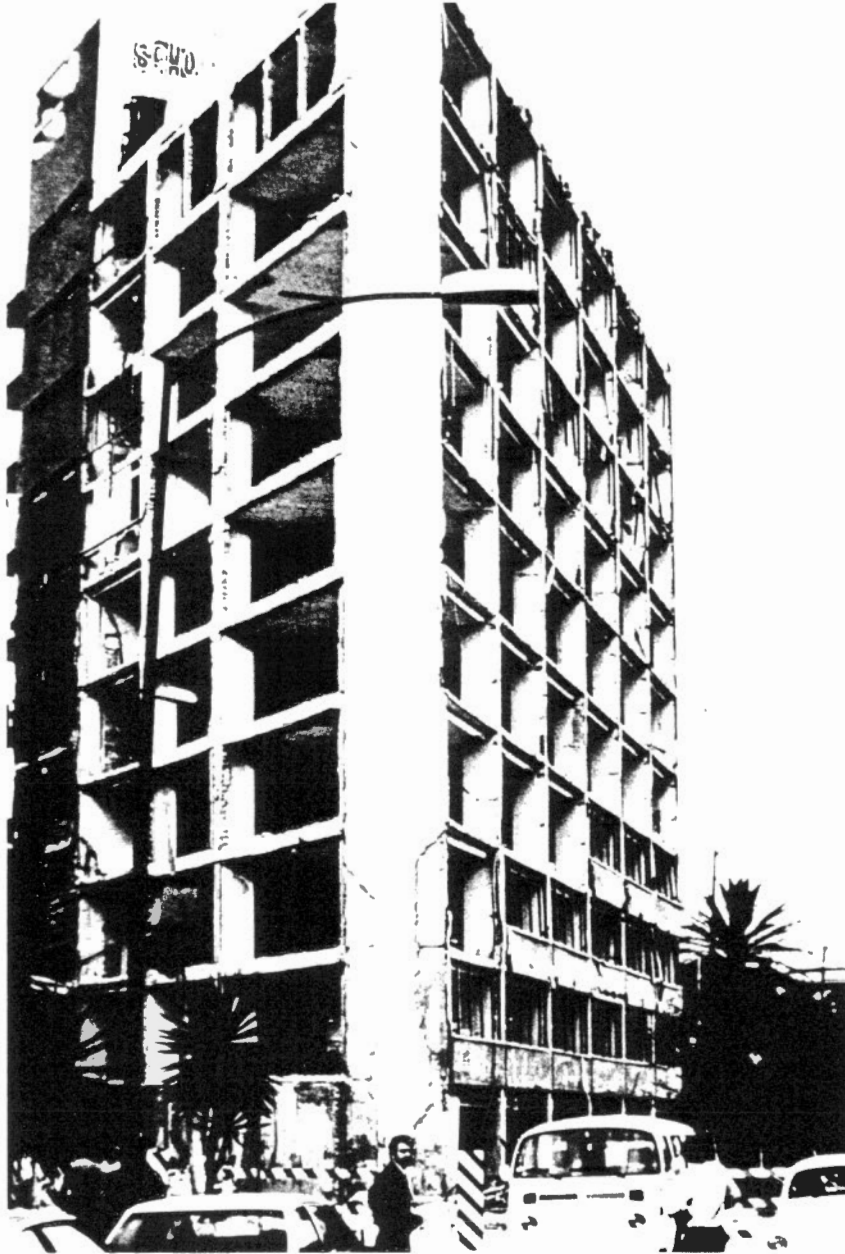
Fig. 6.6a Triangular-Shaped Reinforced Concrete Building

Due to the large number of diagonal streets there are many irregular building lots and therefore many structures with unusual shapes in plan. This triangular-shaped building is a reinforced concrete frame with infilled masonry walls. The masonry infilled shear wall is eccentrically located. Fig. 6.6b shows the failure of an infilled wall framing into a corner column which has lost its vertical load carrying capacity together with another corner column which has completely lost its core concrete. This structure is located across from the SCT building. The severe ground motions together with the large torsional eccentricities and poor confinement of the columns probably led to the severe damage.

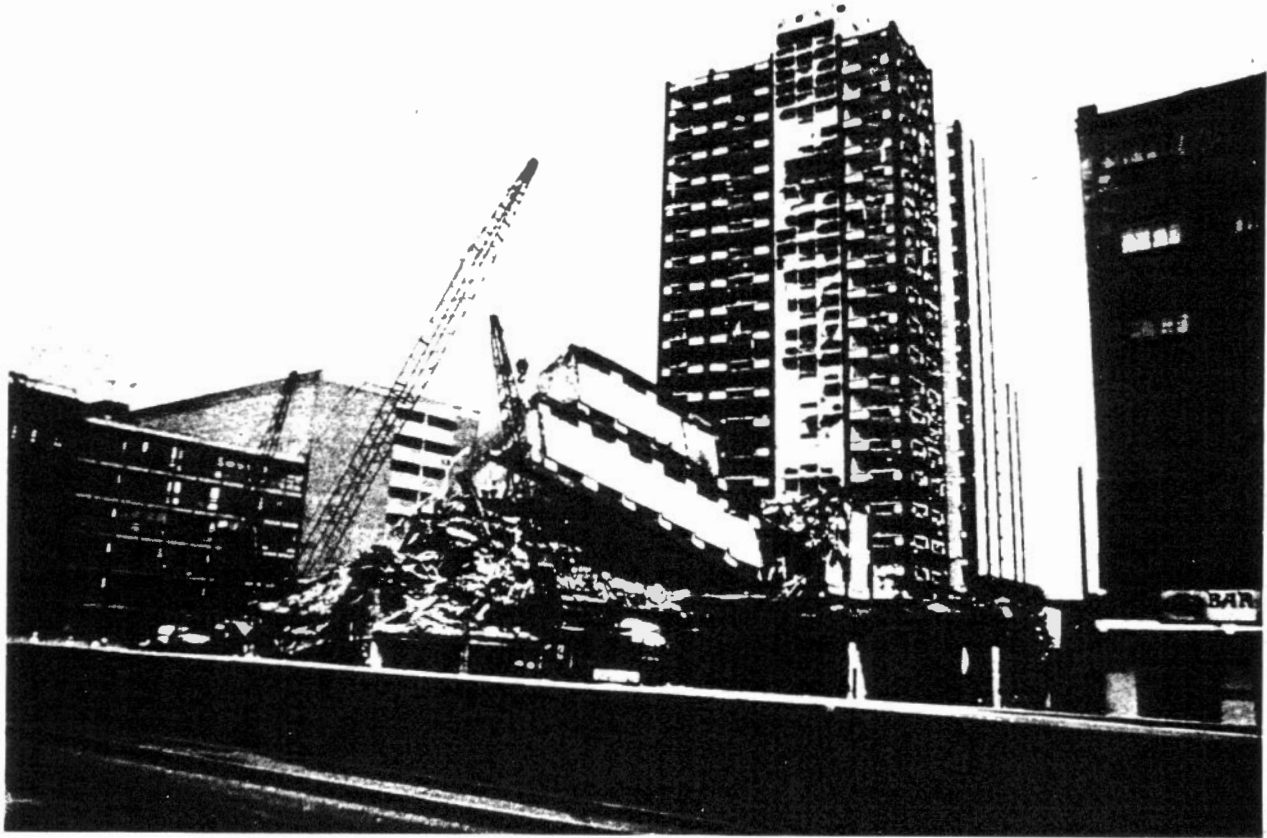
Fig. 6.7a Collapse of 21 Storey Steel Structure

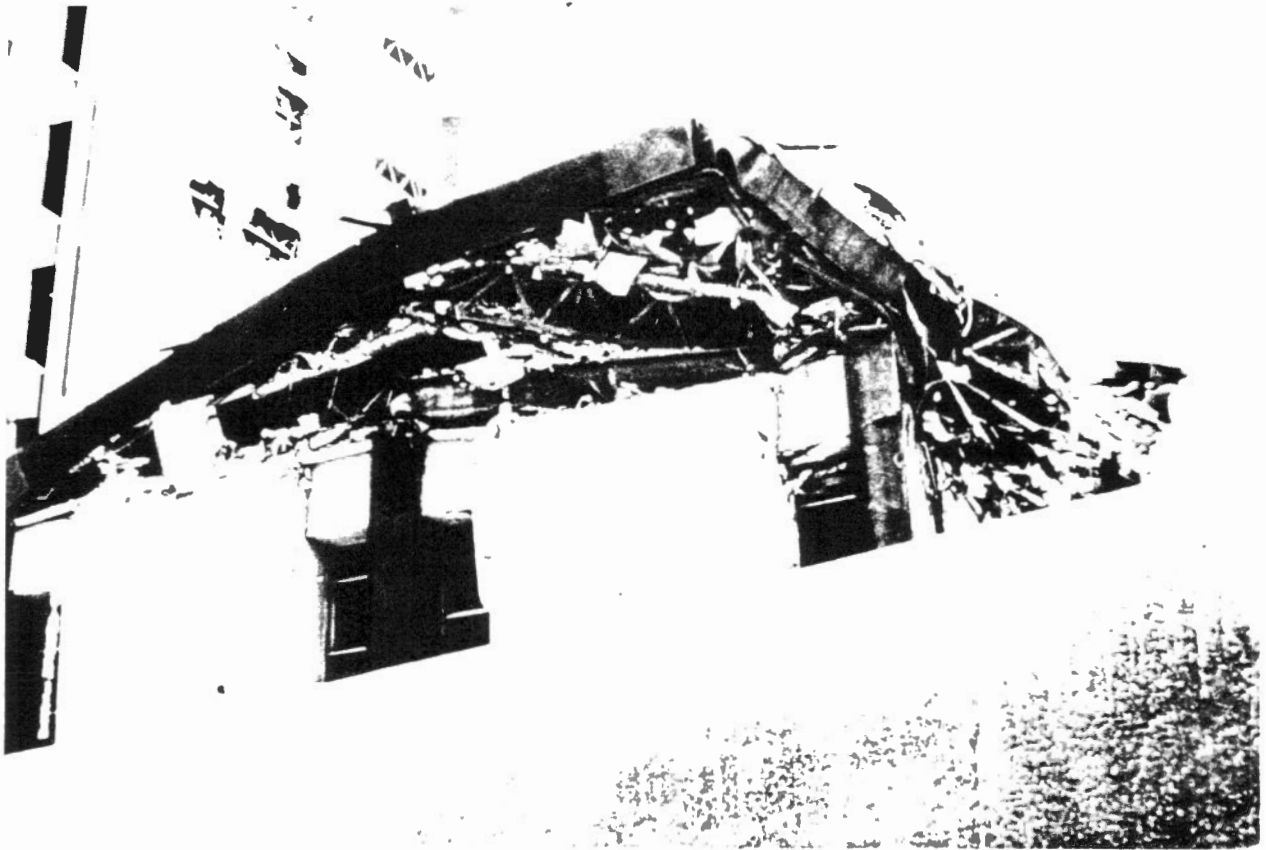
Fig. 6.7b Failure of Steel Building One Storey Above Plaza Level

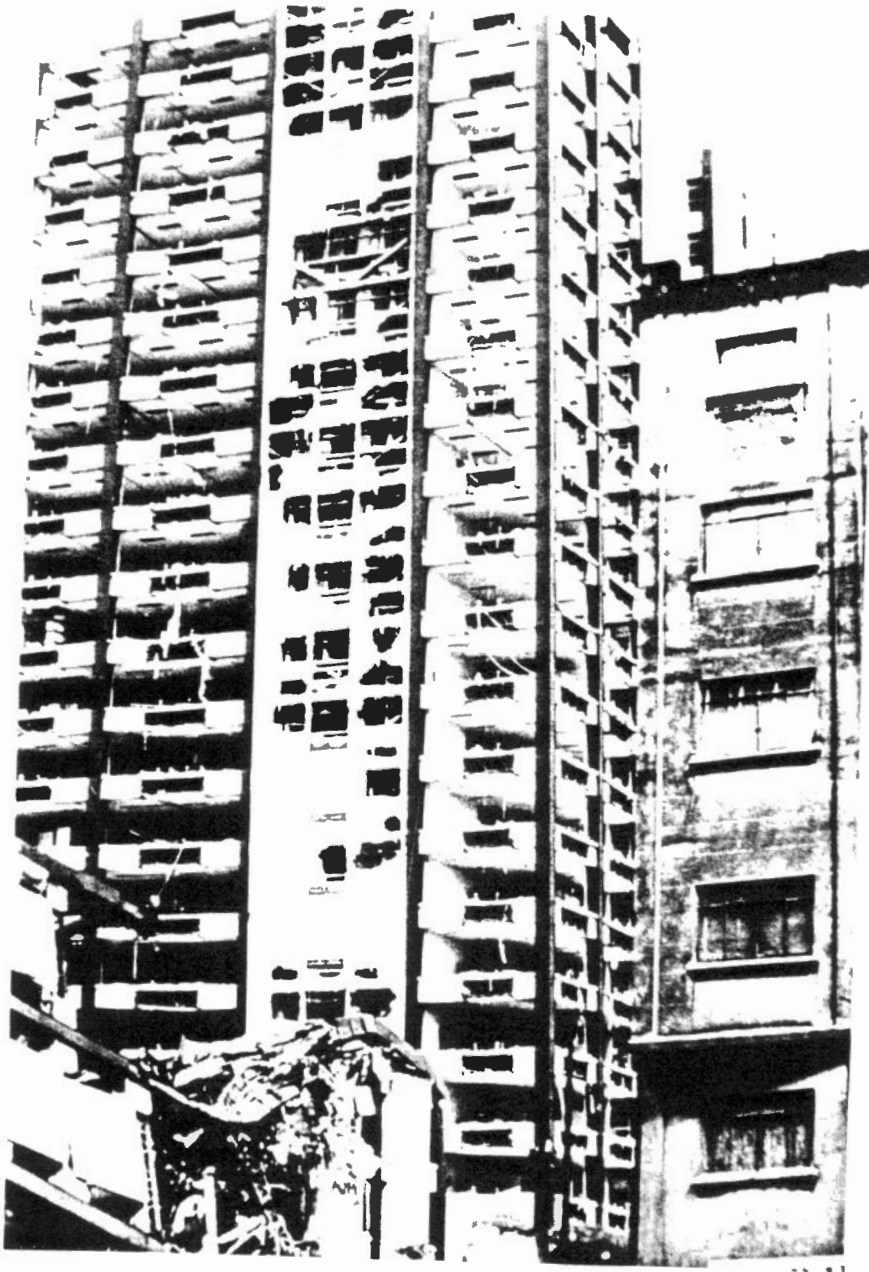
Fig. 6.7c Structural Framing of Severely Damaged 21 Storey Steel Building

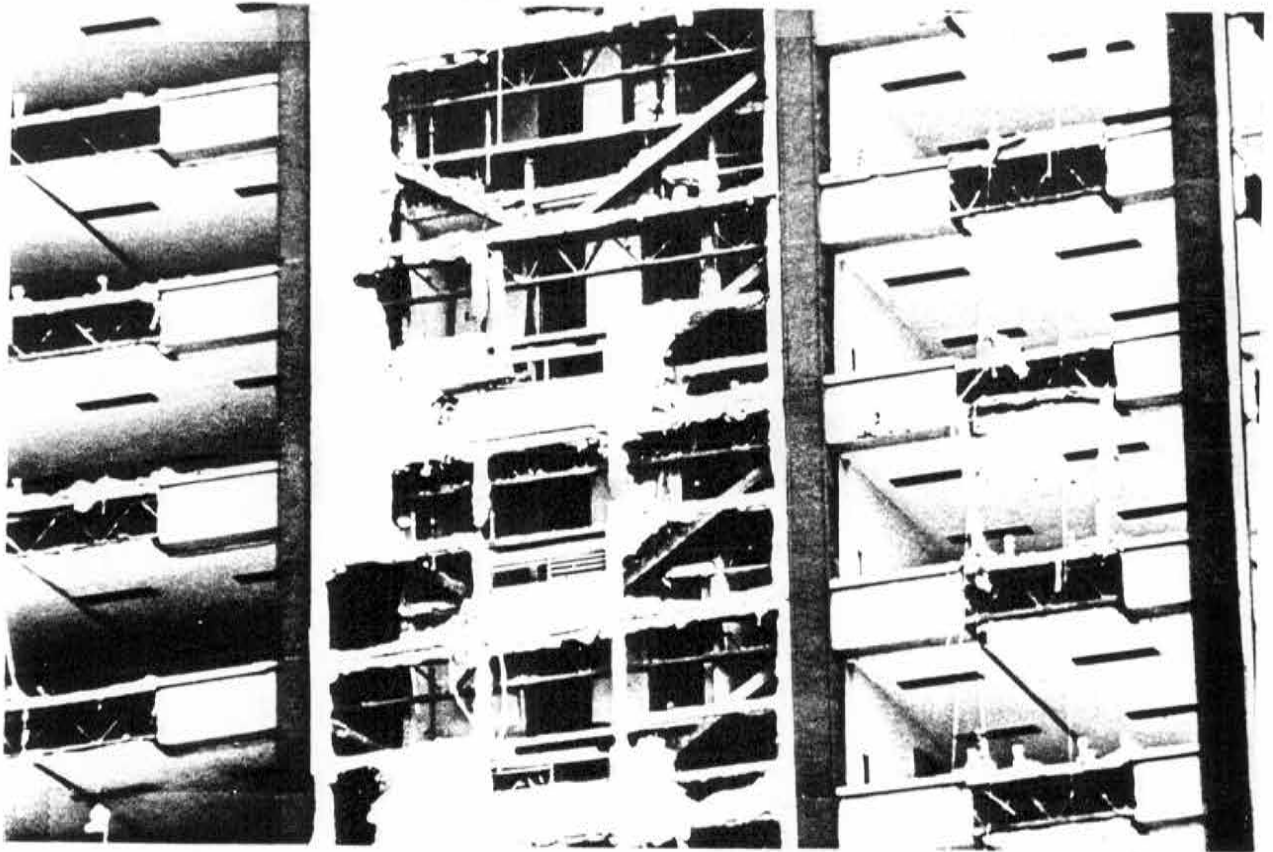
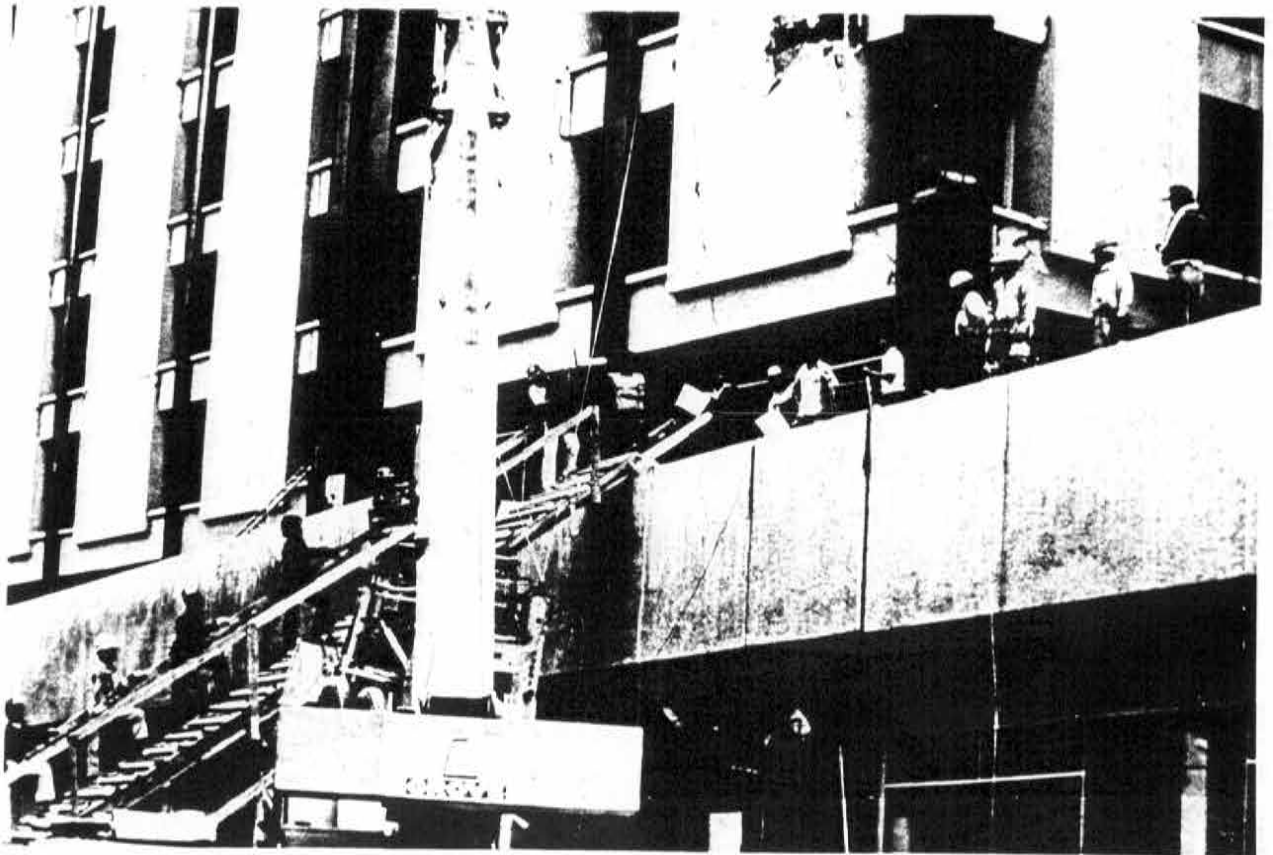
Fig. b.7d and b.7e Framing System and buckled corner column

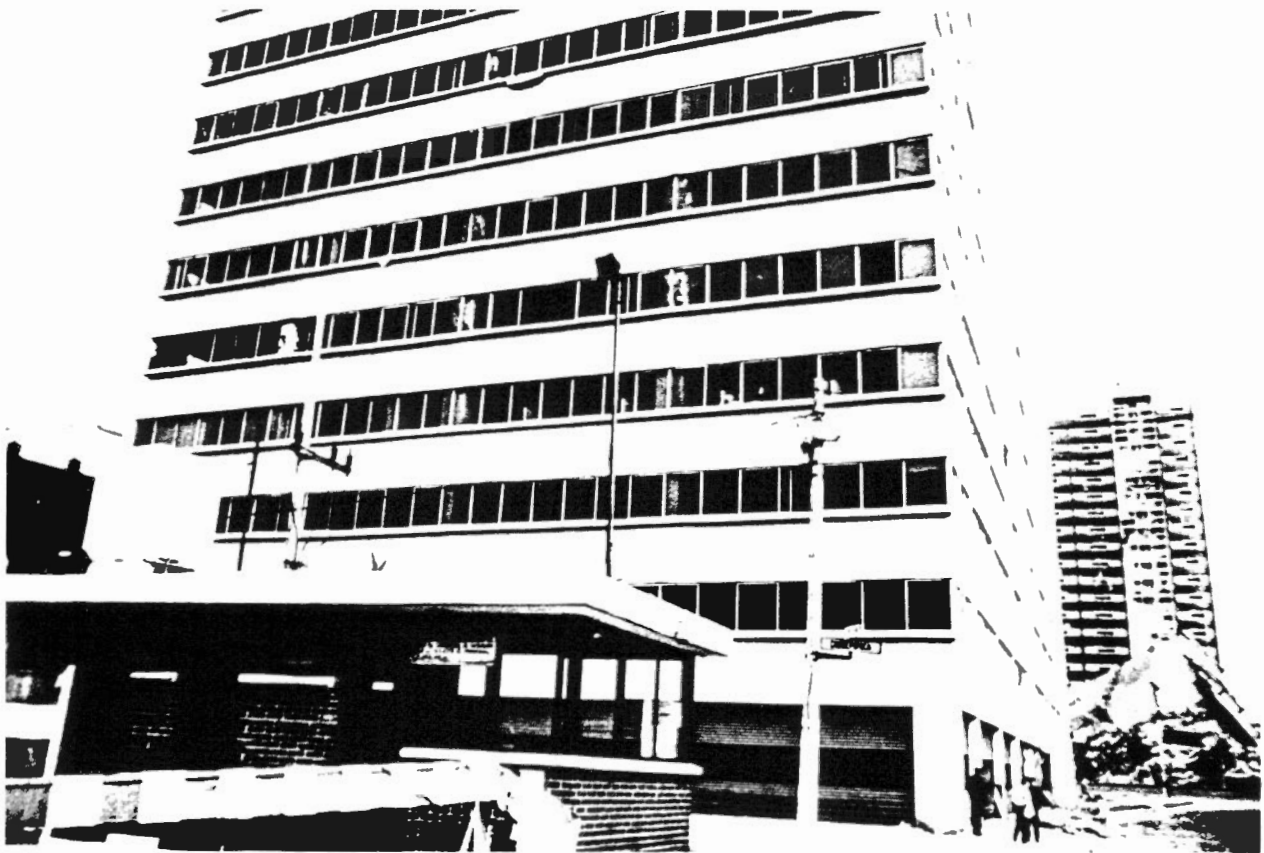
Fig. 6.8a Damaged 13 Storey Concrete Frame-Wall Structure

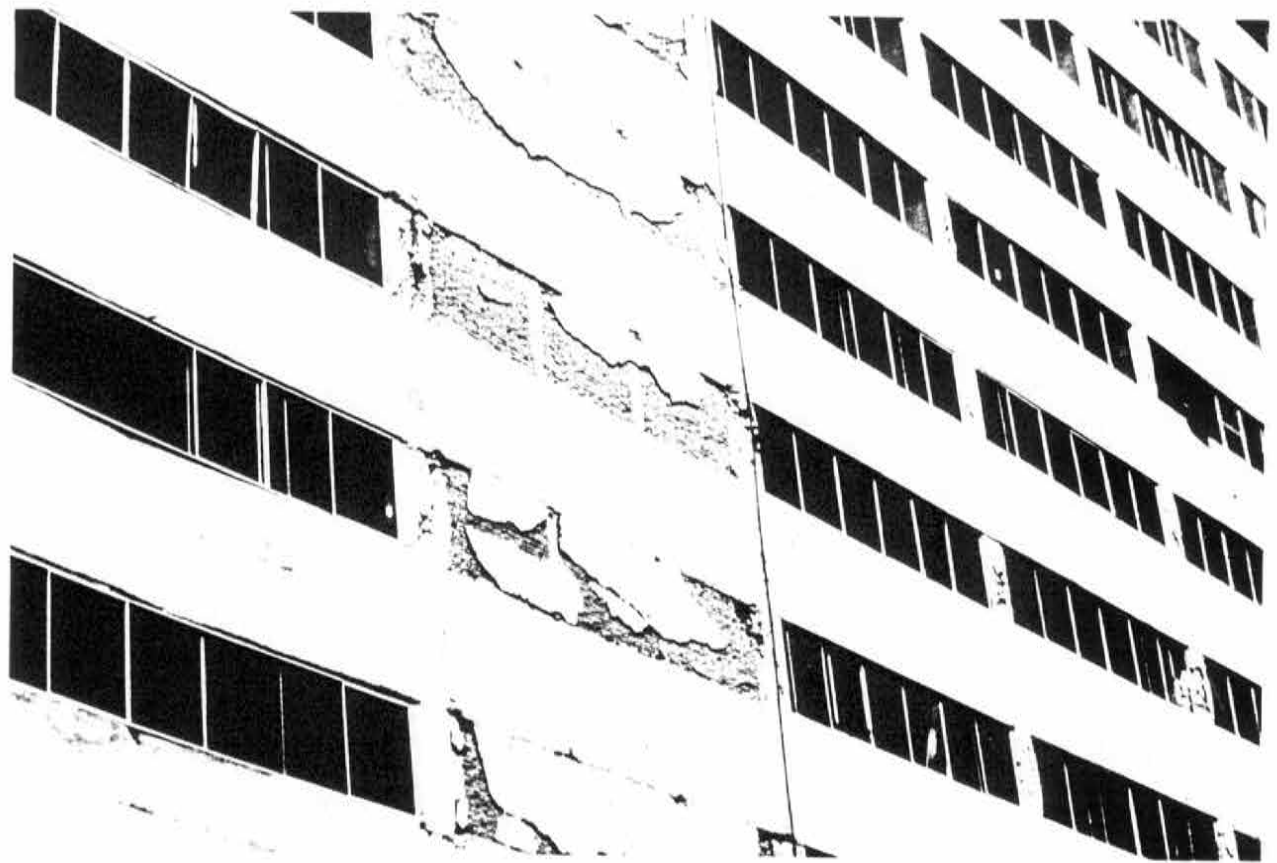
Fig. 6.8b and 6.8c Column Shear Failures in Reinforced Concrete Structure

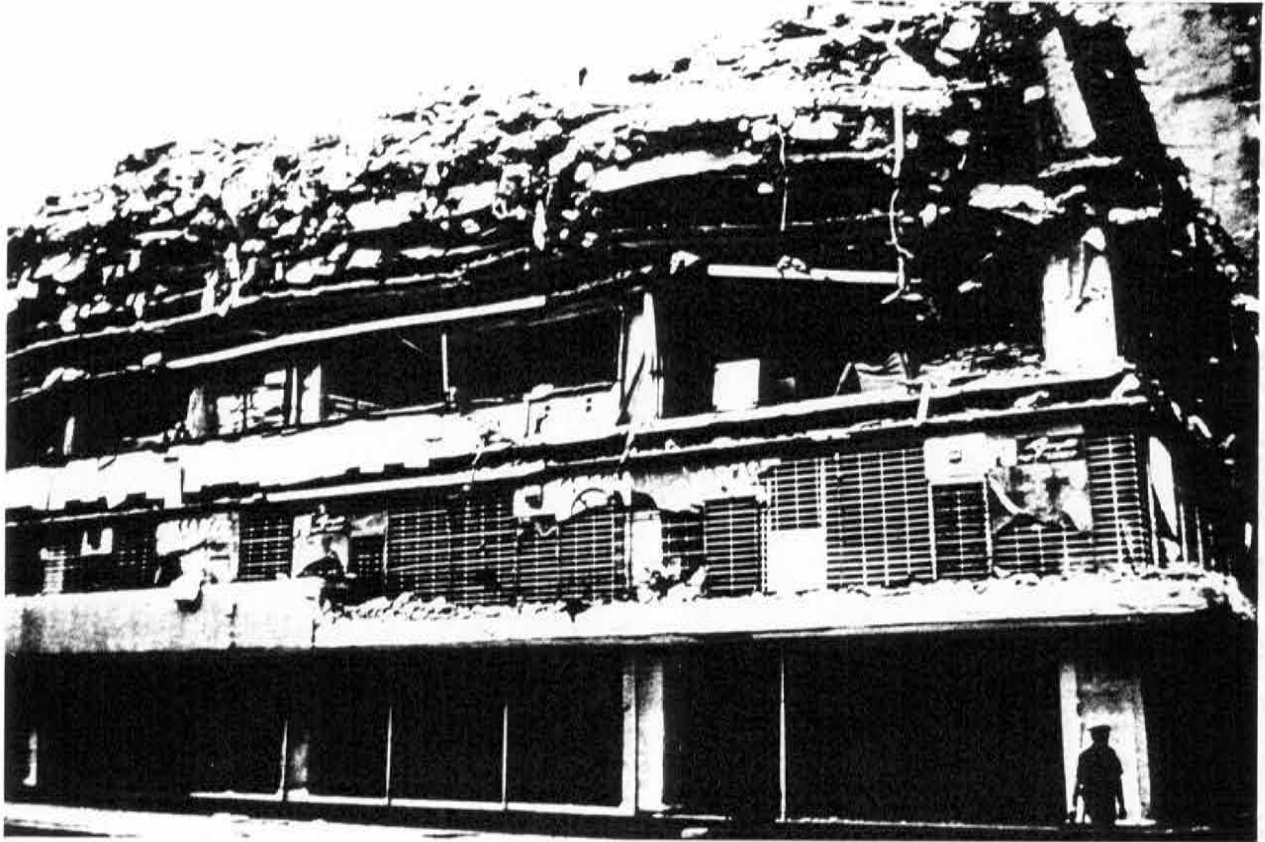
Fig. 6.9 Collapse of Top Storeys of Reinforced Concrete Flat Plate Structure
