THE 1985 MEXICAN EARTHQUAKE - A SITE-VISIT REPORT\*

Ottawa, Canada February 1986

EARTH PHYSICS BRANCH OPEN FILE REPORT NO.: 86-2

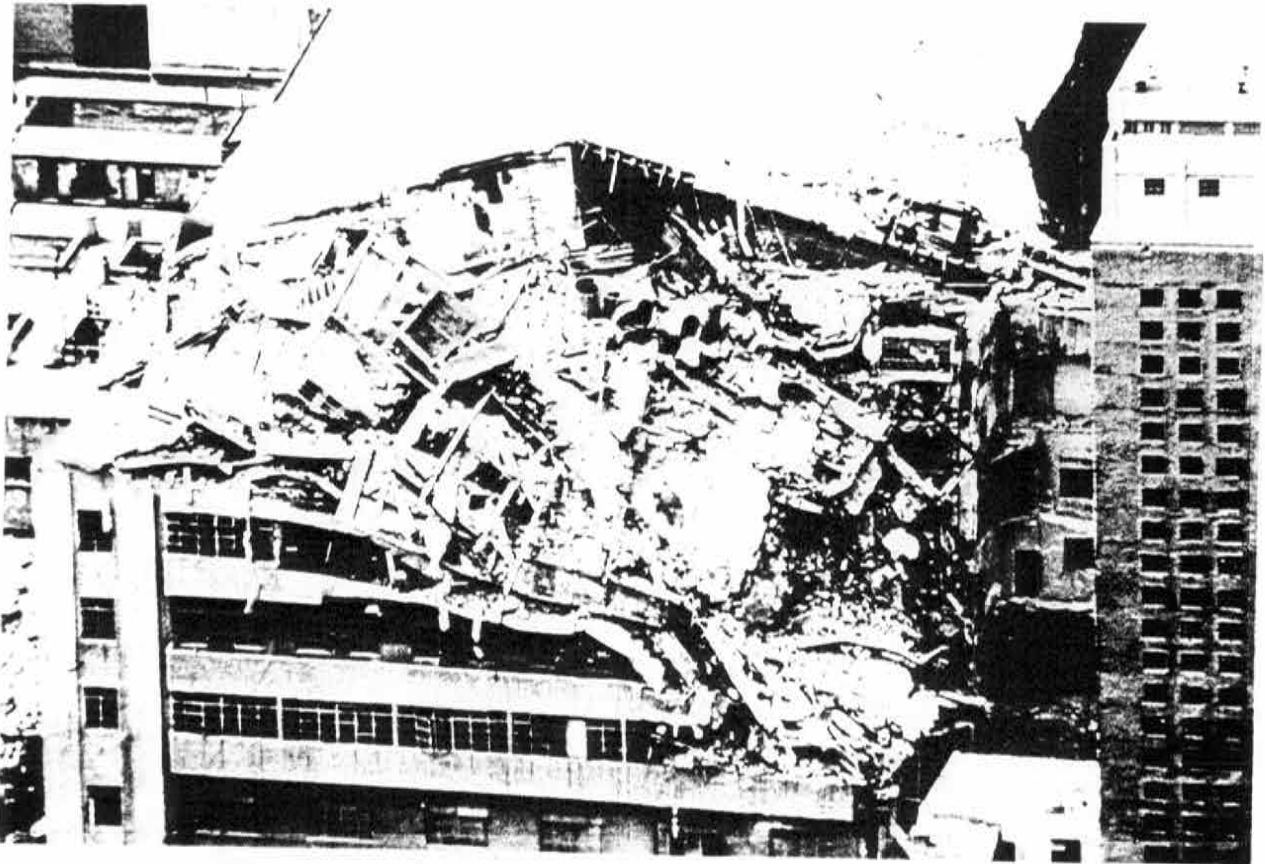
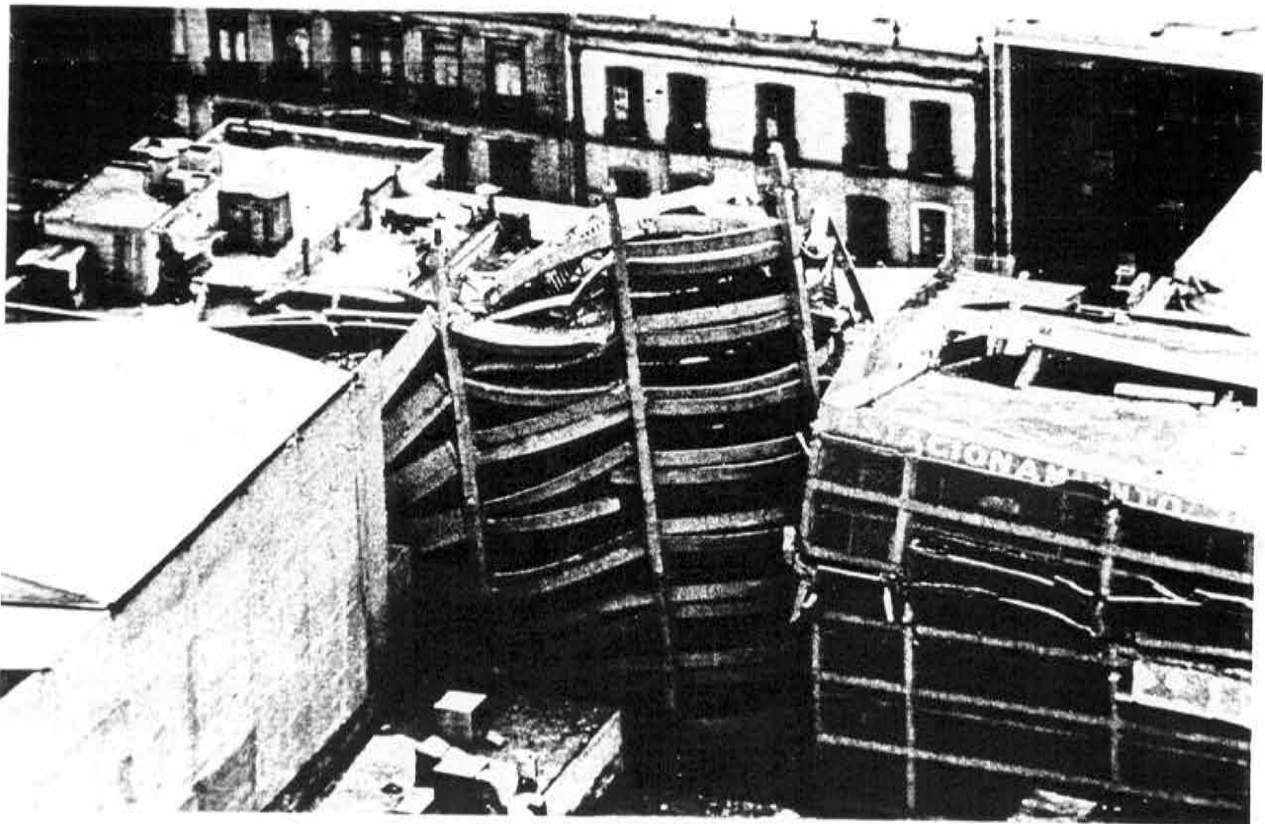
Fig. 6.10b and 6.10c Top Storey Collapse and Collapse of Precast Concrete Parking Structure

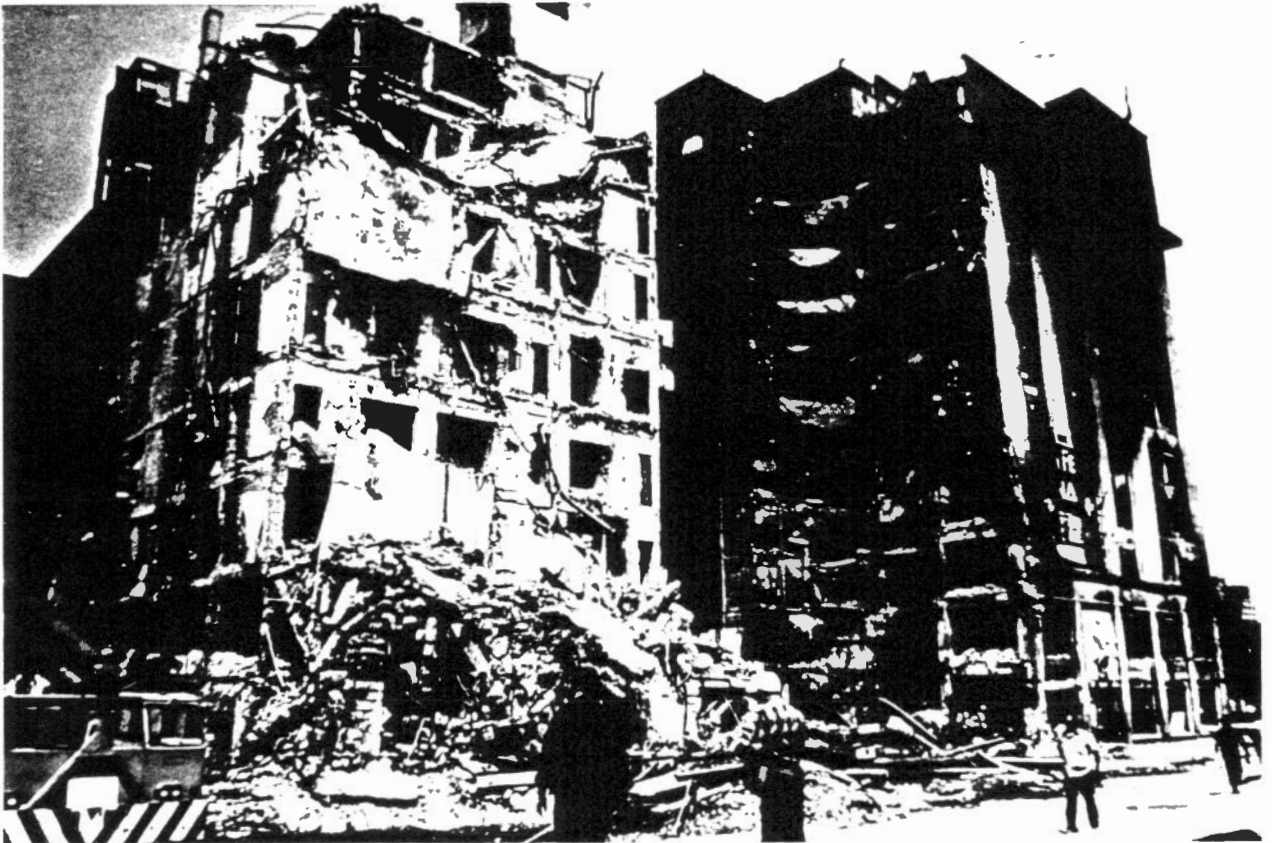
Fig. 6.11 Regis Hotel Collapse

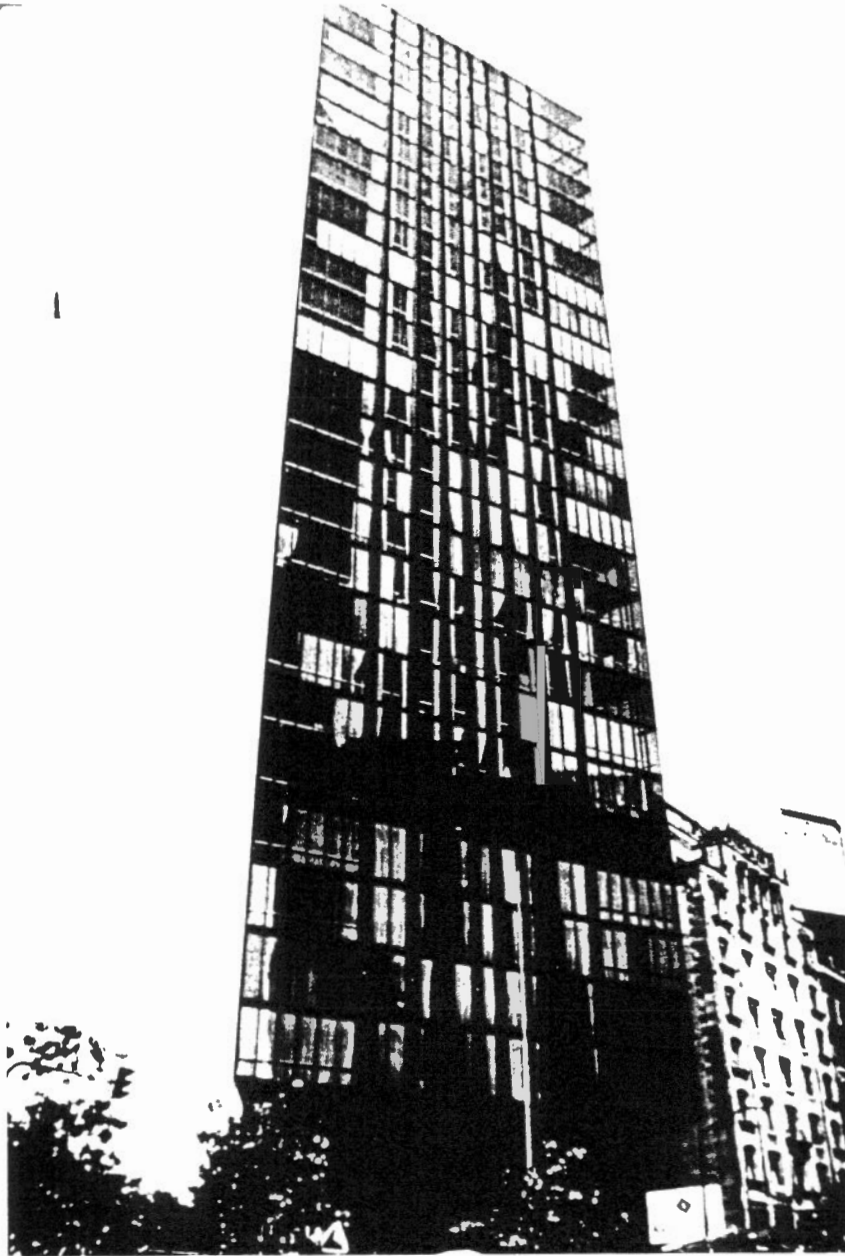
Fig. 6.12 Undamaged Triangular Building

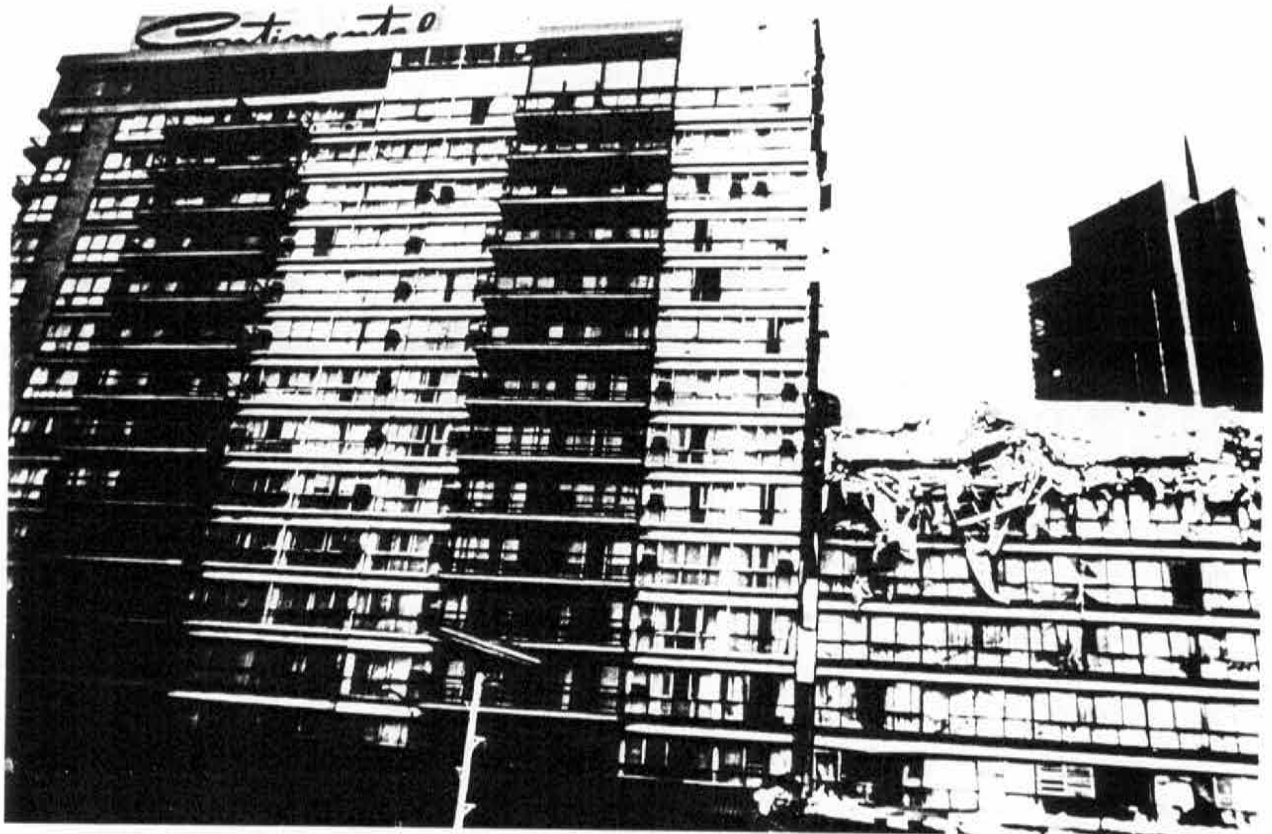
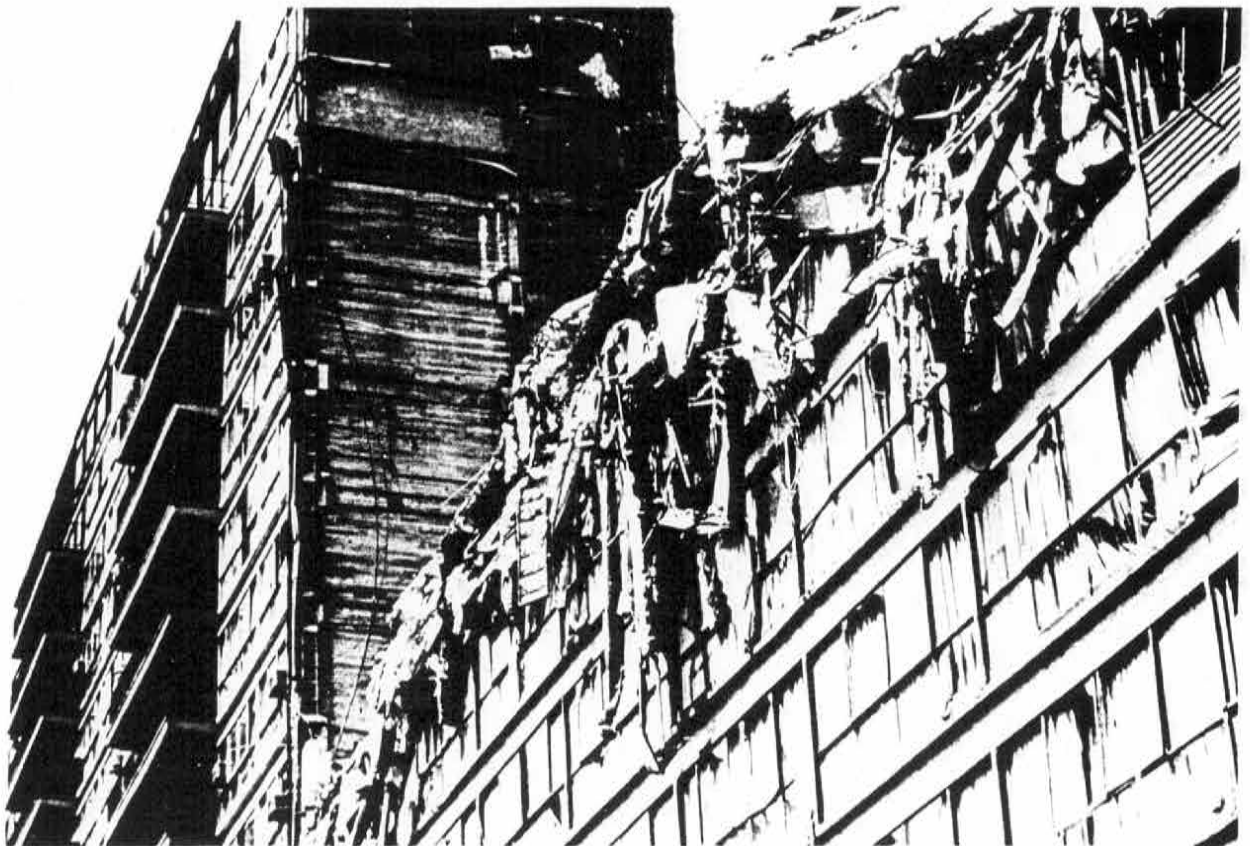
Fig. 6.13a and 6.13b Collapse of Top Six Storeys of Continental Hotel

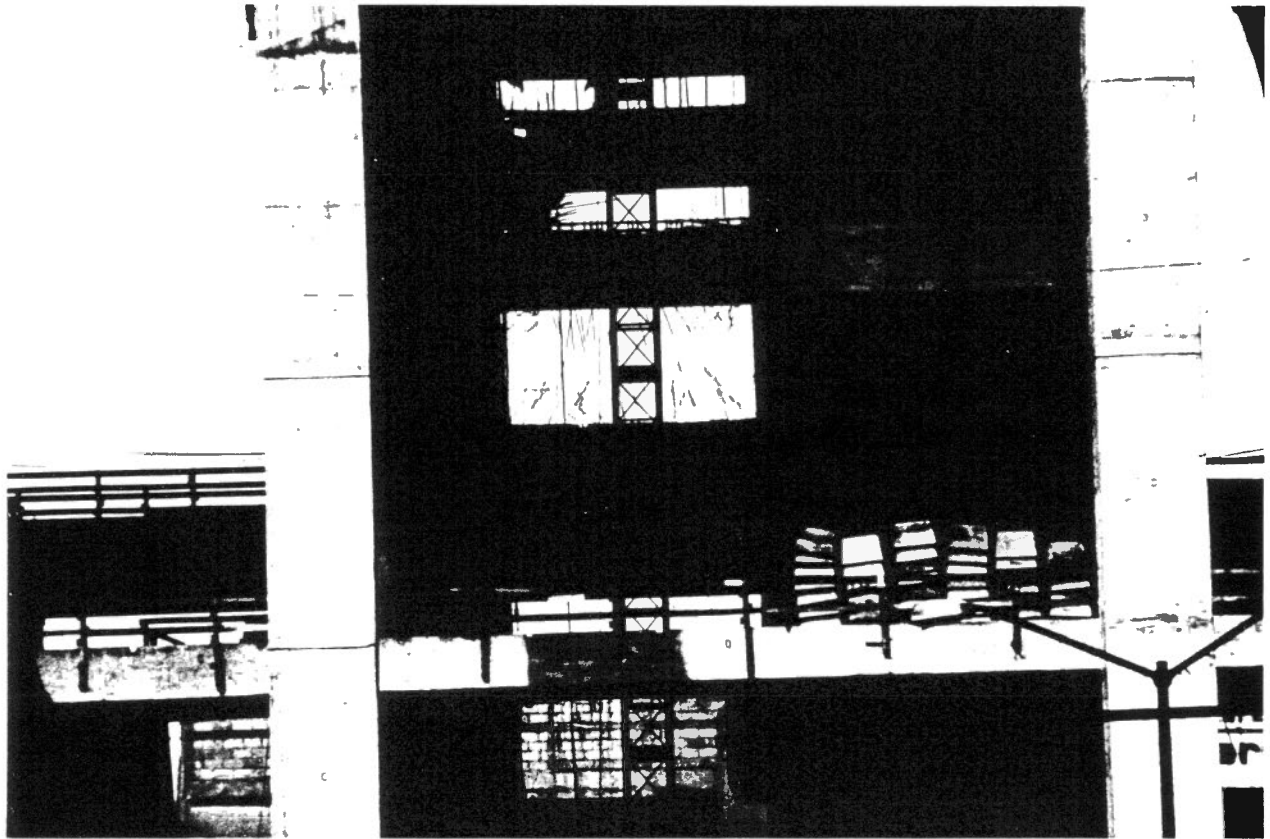
Fig. 6.14b Damage to Shear Wall Coupling Beams of Incomplete Intercontinental Hotel

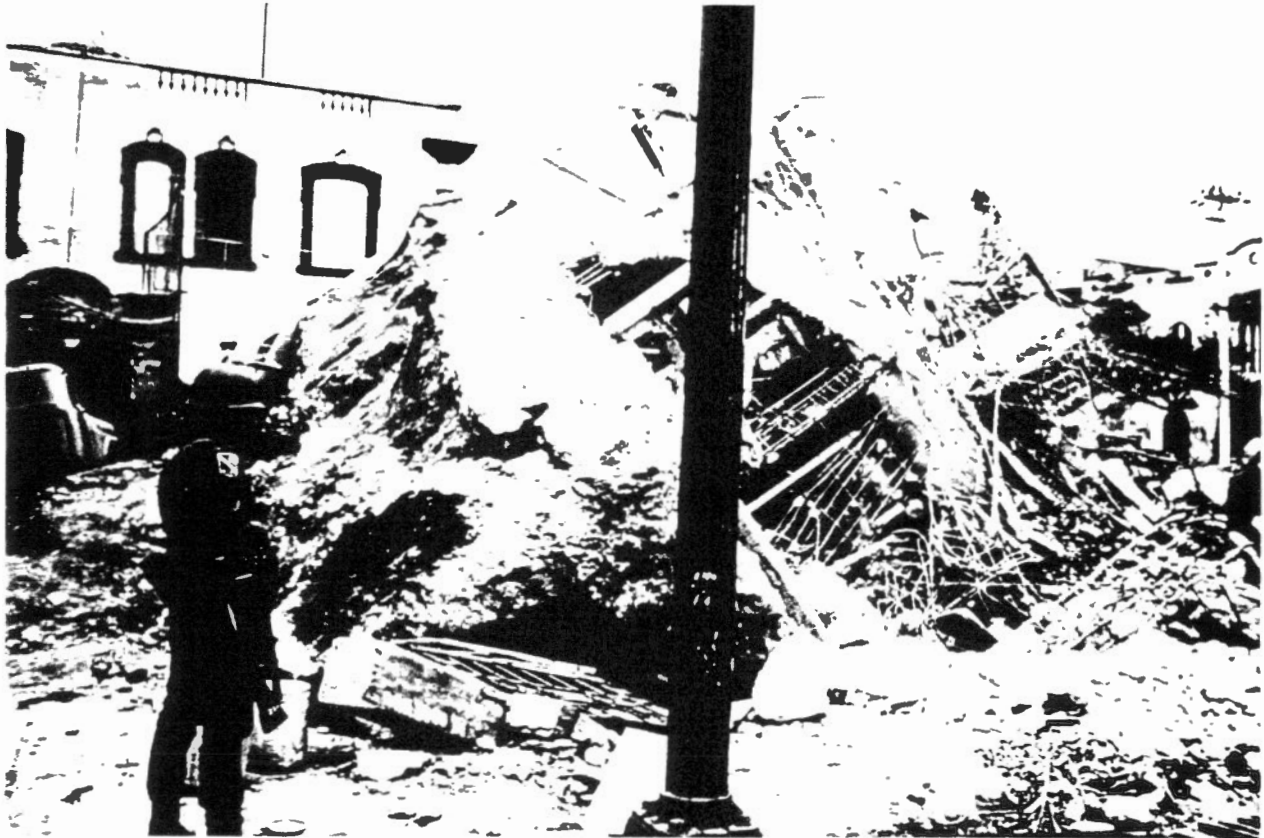
Fig. 6.15a Foundation Failure of Eight Storey Building

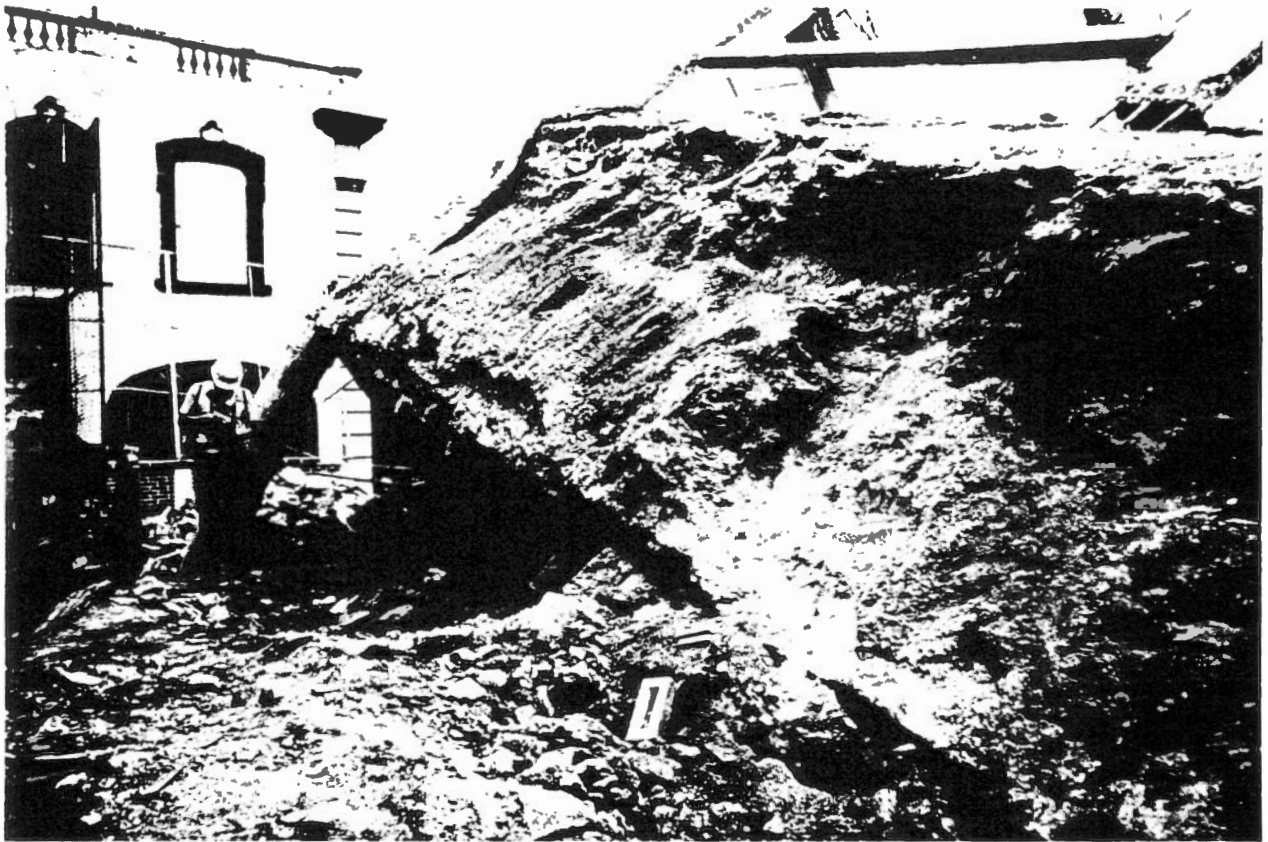
Fig. 6.15b and 6.15c Rotation of Foundation Mat and Pull-out of Piles

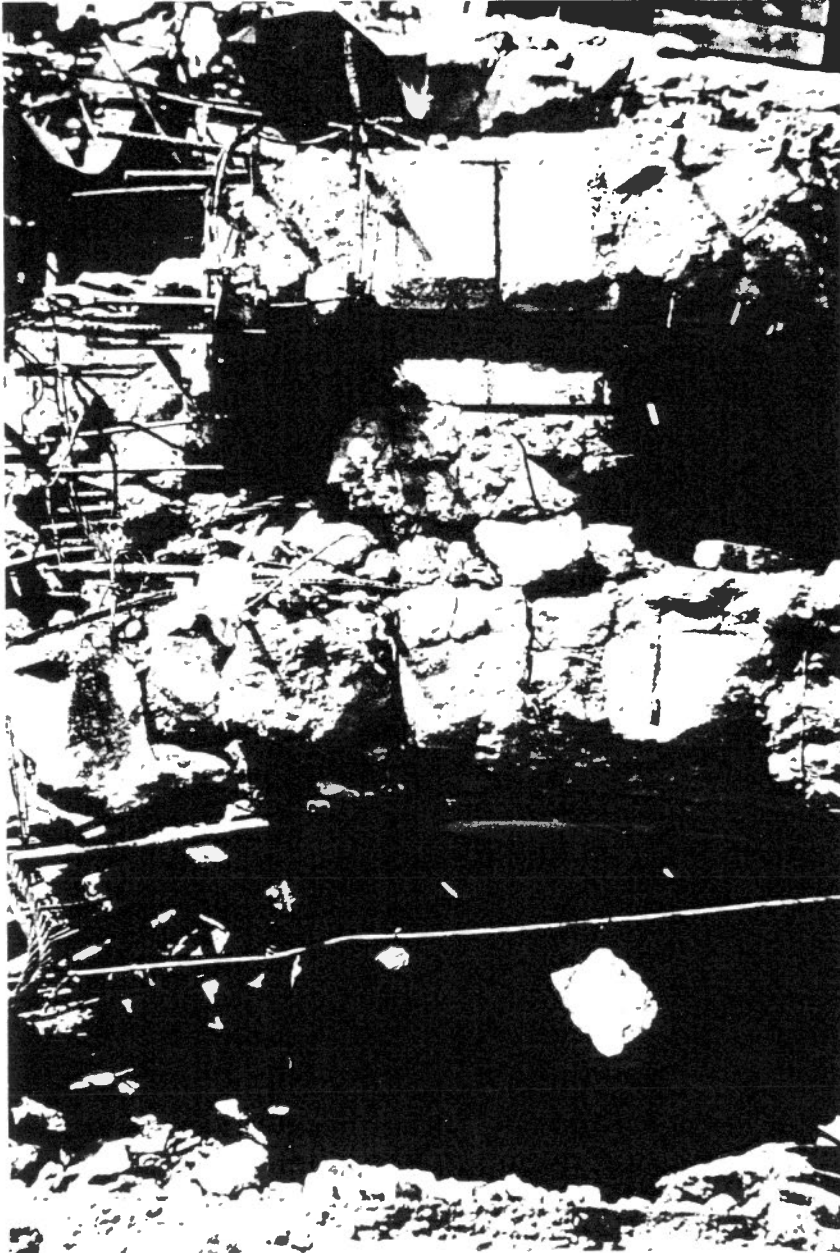
Fig. 6.16b Close-up of Punching Shear Failure in School Structure

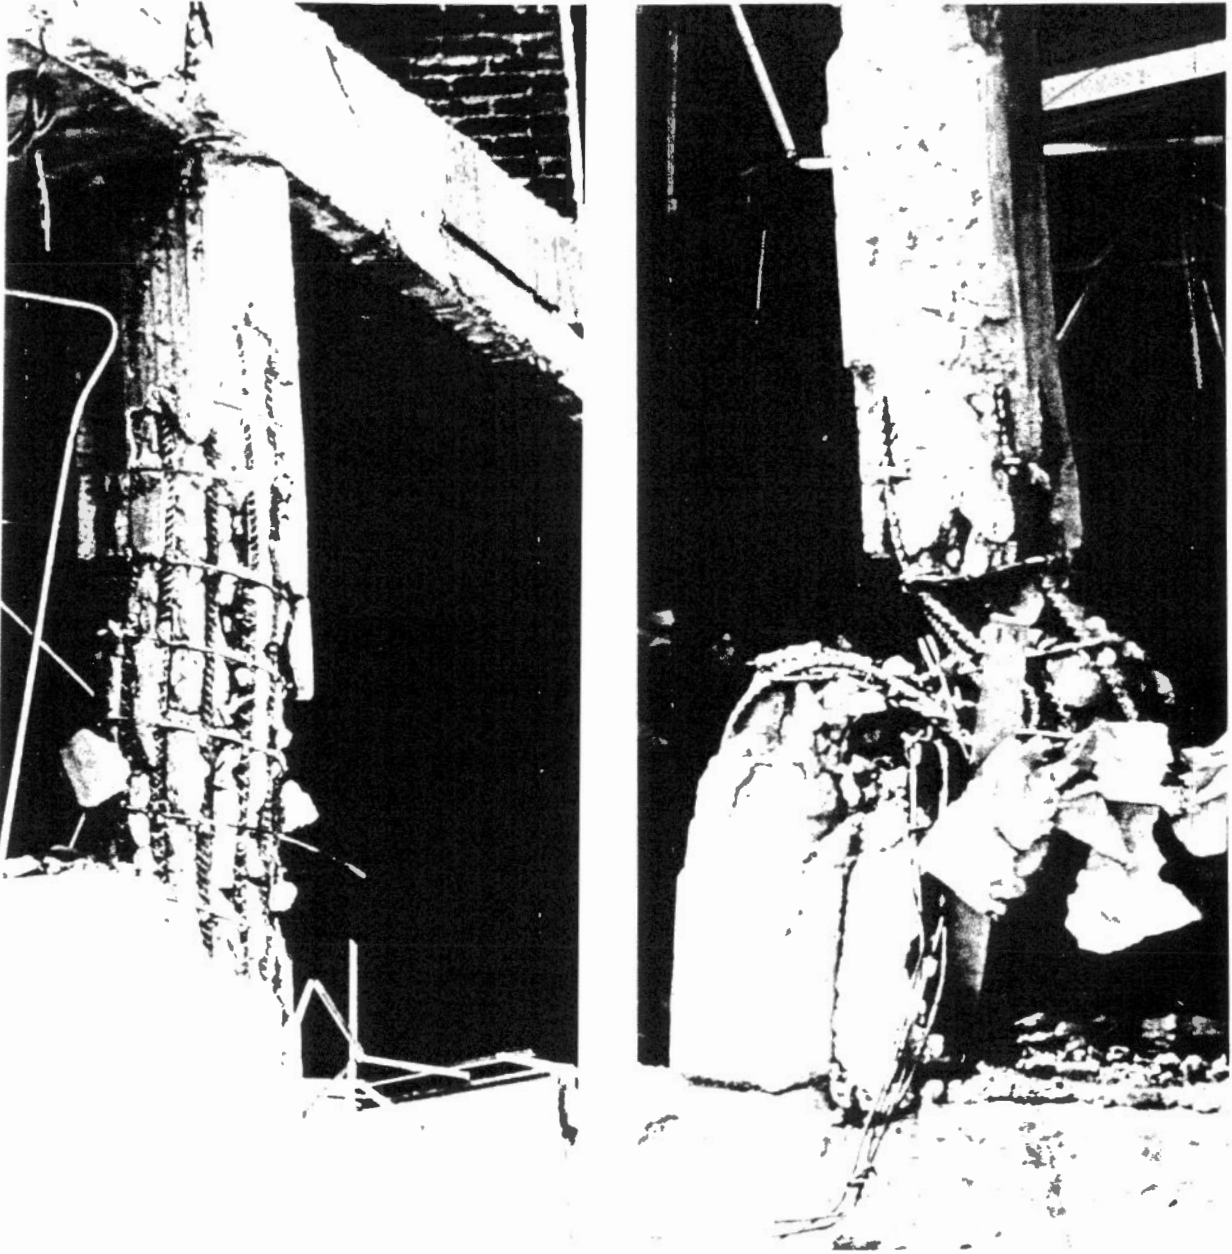
Fig. 6.19c and 6.19d Column Failures in Theatre (Televiteatro)

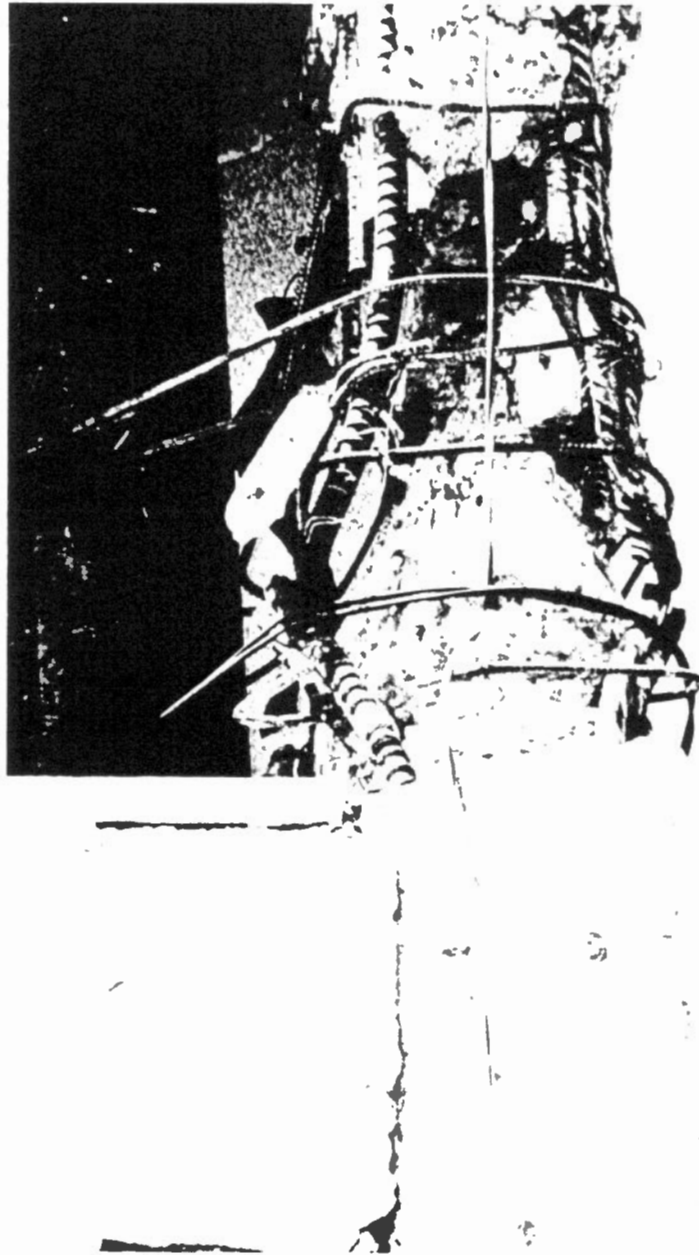
Fig. 6.21b Column Failure in Nuevo Leon Condominium Structure

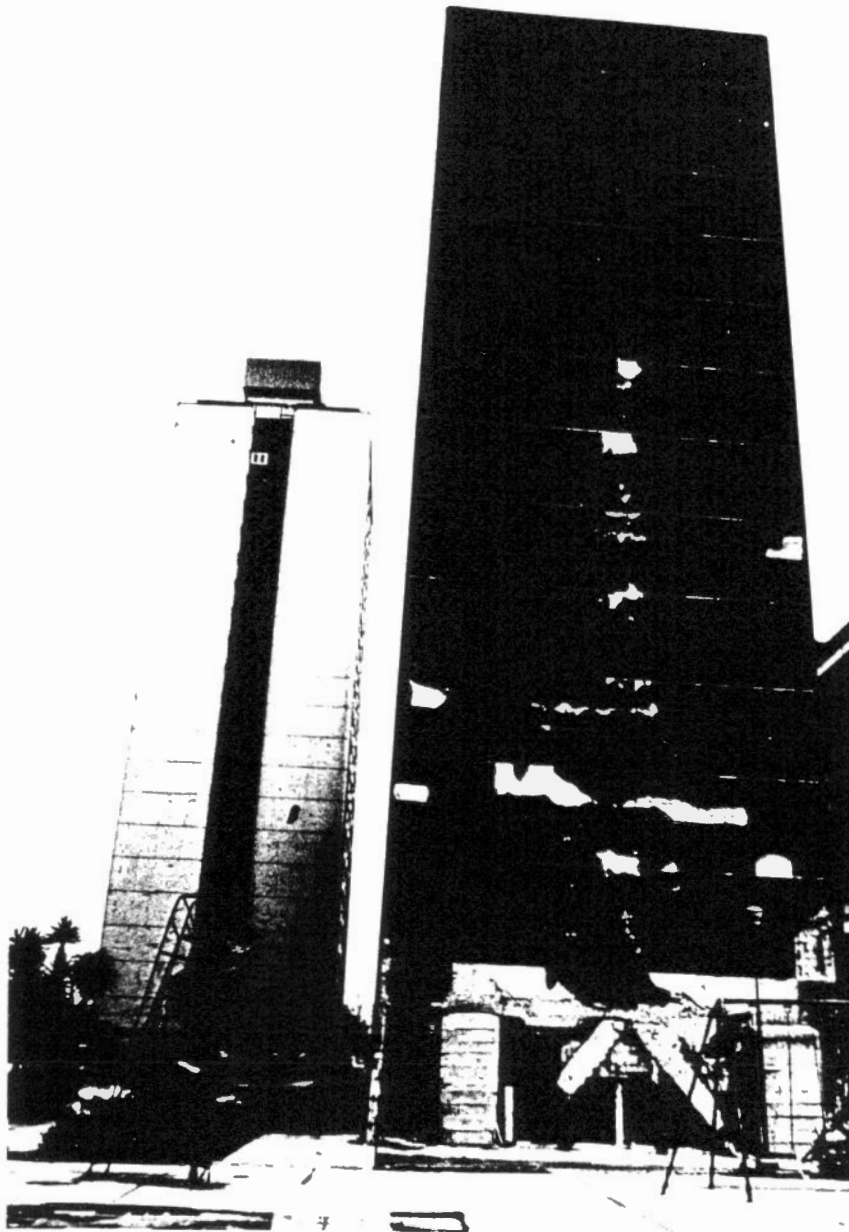
Fig. 6.22a Severe Damage to 13 Storey Apartment Structure

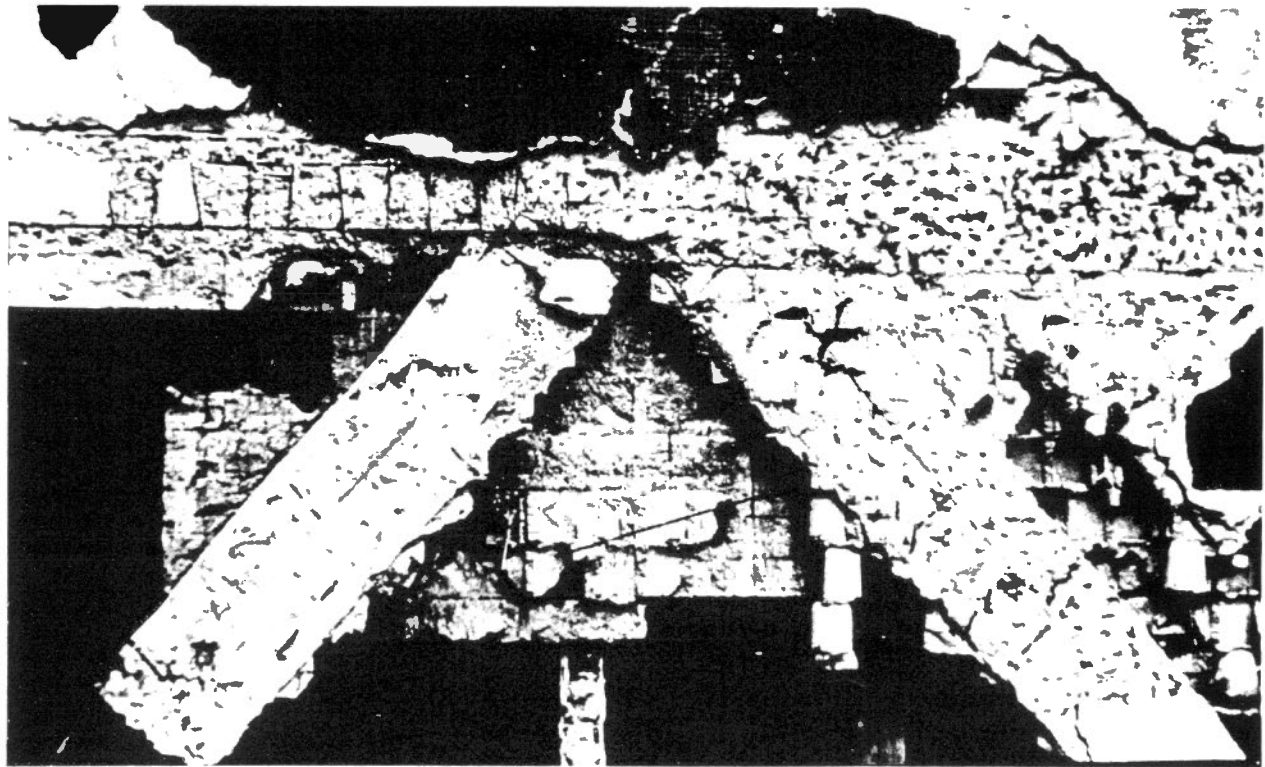
Fig. 6.22b and 6.22c Close-up of Failed Wall and Bracing Members

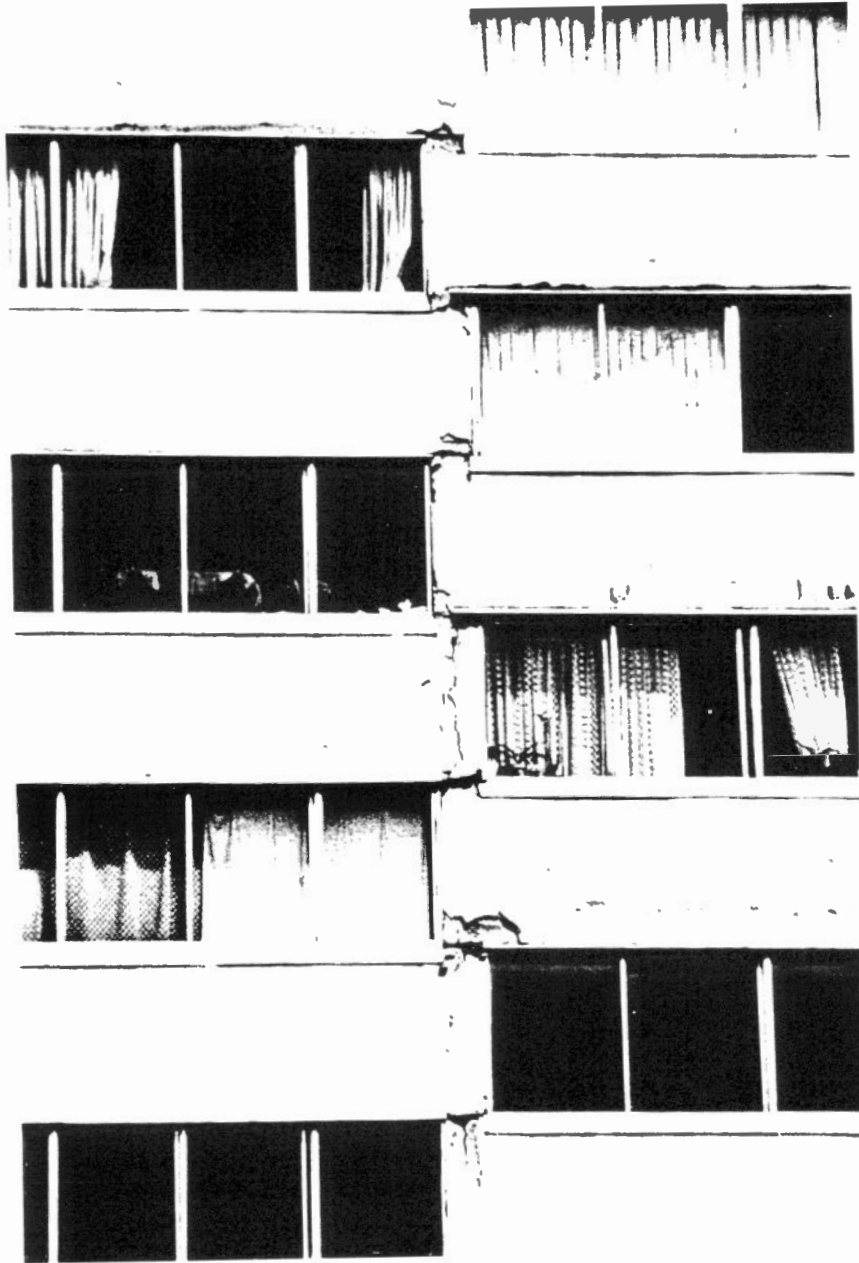
Fig. 6.23b Damage due to Offset Floors
