GEOLOGICAL ASPECTS OF THE BEACH RESTORATION
PROGRAMME IN CHEDABUCTO BAY,
NOVA SCOTIA, 1970.

E.H. Owens

Report to the
Scientific Coordination Team
Project Oil Task Force

September 1970.

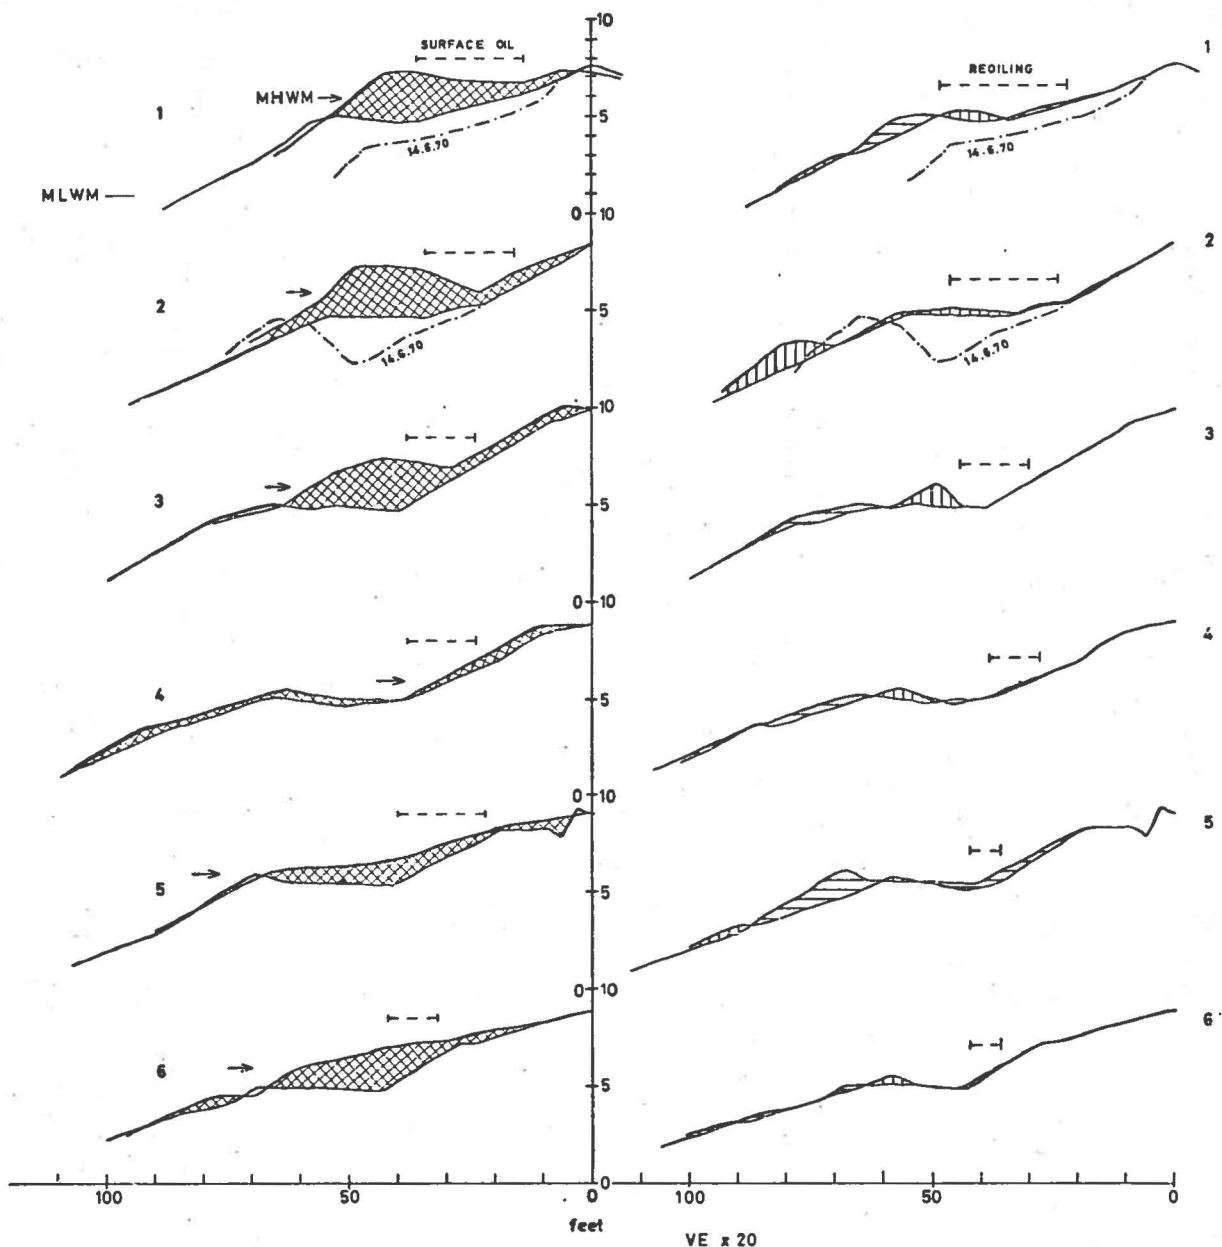
Profiles at Indian Cove

of the thick, continuous layer of oil on the beach are shown and it is evident that the beach had been able to clean itself except for those areas above the reach of normal wave action. Most of the sediment removal was from this zone and, as was noted earlier (see Section 4.2., page 23), this part of the beach is not a zone of accretion except during periods of storm waves or spring tides. Sediment replacement is, therefore, not rapid in this zone.

Parts of the east end of this beach lost as much as five feet of sediments. This is indicated on profiles 1 and 2 of 9A which show the beach on May 14 and June 14. Whether this material will be replaced is not known and these profiles are to be resurveyed to determine the long-term effects.

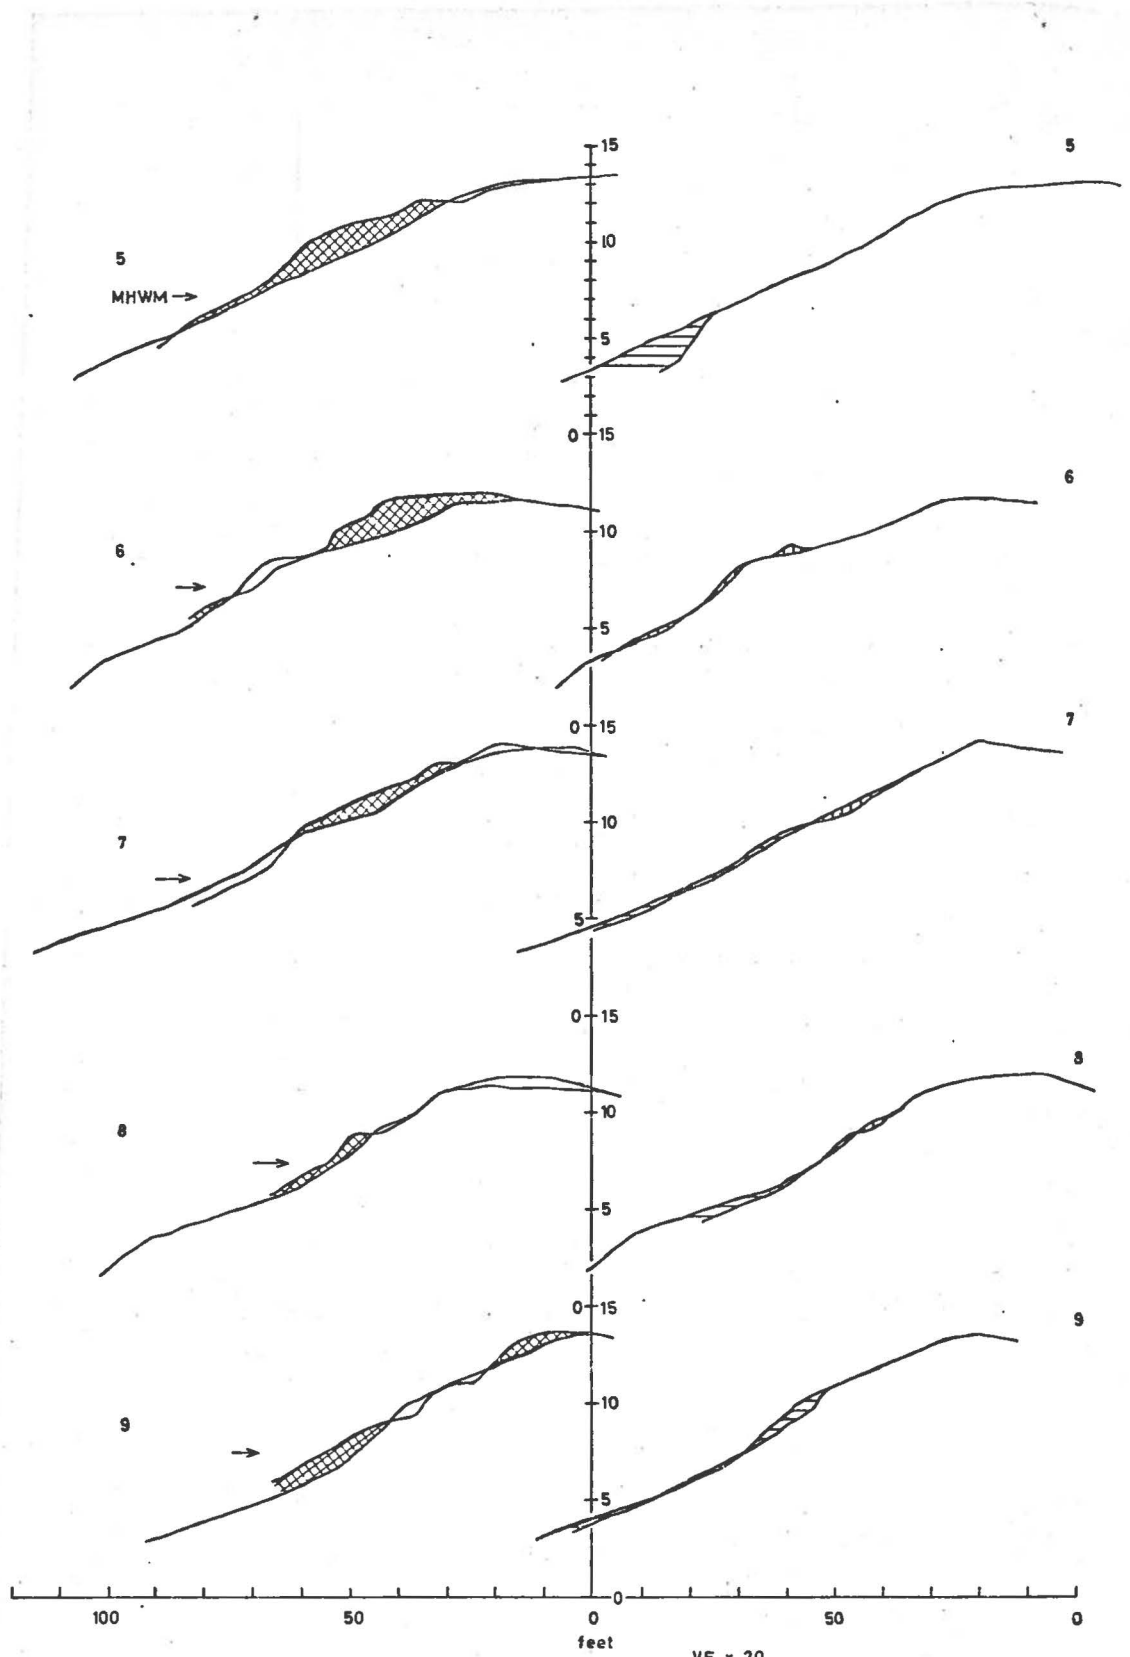
Profiles at Hadleyville #1.

One month after completion of the contract (Figure 10B) very little material replacement had taken place even though the rate of accretion is at its maximum during the summer months. Small net gains of sediment near the high water mark were often offset by sediment loss within the intertidal zone.

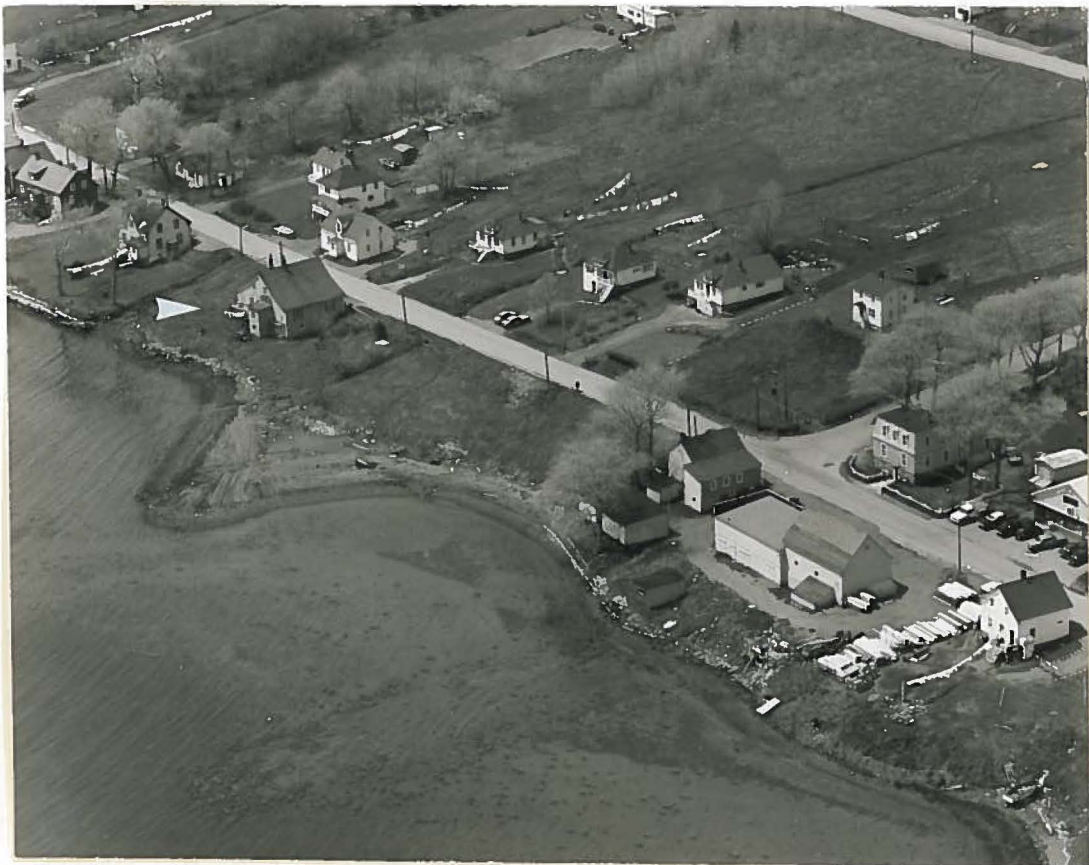
2

Air view of east section at high tide after restoration. Material was removed from the foreland areas but not from the beaches backed by cliffs or crib-work. The arrow indicates the location of a building as a point of reference between photographs 1 and 2.

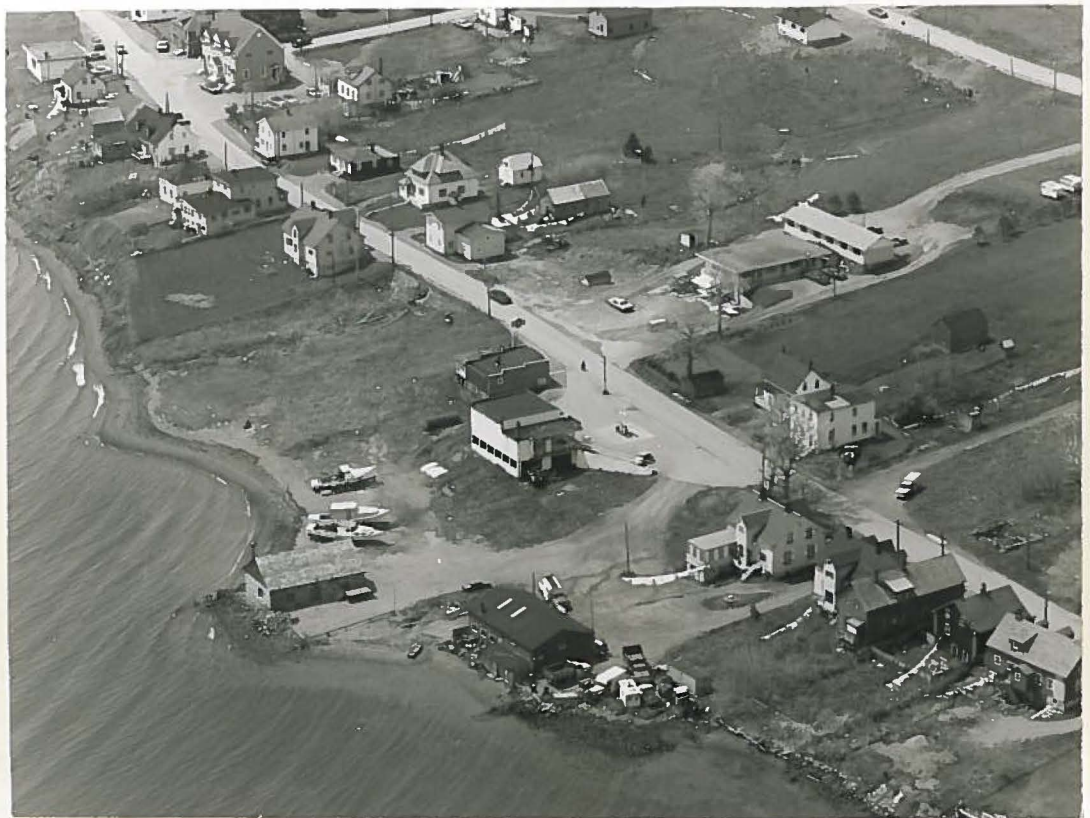
4

Air view of Noir Forge and west section near high tide after completion of the contract work. The dark line near high water on the west section is the reoiling of the material which was pushed against the cliff base. Boulders have been brought in at the right of the Forge as replacement for some of the removed material. To the east of the Forge certain sections were not cleaned because of the danger of erosion or inaccessability to heavy equipment.

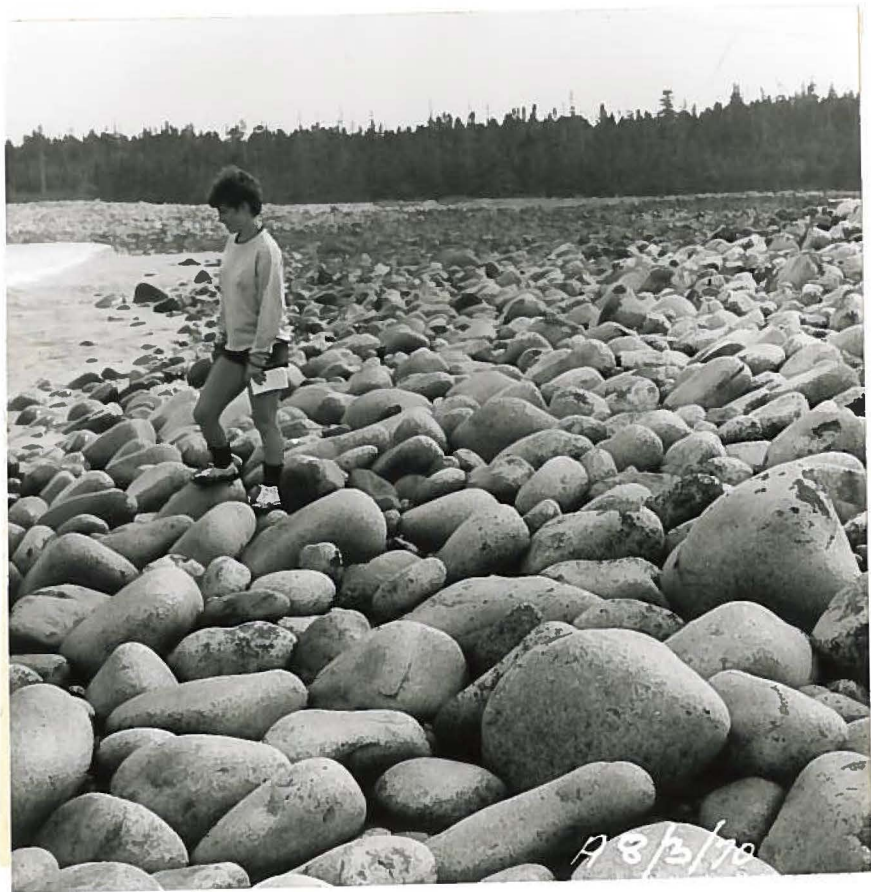
Drapeau also noted that within one month of contamination gravel bars directly exposed to wave processes cleaned themselves naturally and effectively, whilst in protected areas the beaches remained polluted. This is particularly evident in photographs 5 and 6 of Black Duck Cove. The lagoon remained heavily

The exposed side of the spit has effectively cleaned itself. Traces of oil are still evident in small amounts on the material where it has not been completely abraded. Despite the size of the beach material, this is a very active and mobile beach, during periods of storm waves these sediments were in constant motion.

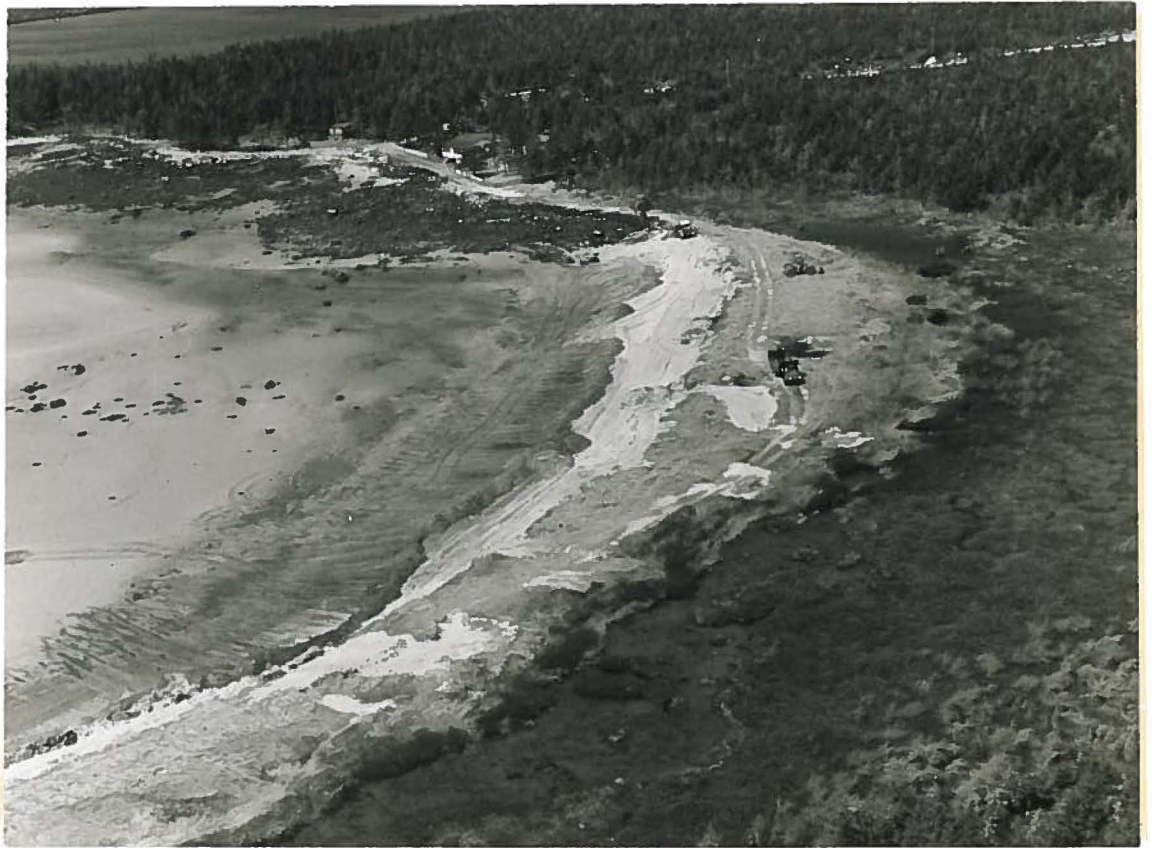
8

Air view of beach restoration work at low tide. A bulldozer shoved the contaminated sediments above the high water mark for subsequent removal by a front-end loader. The contaminated material along the edge of the vegetation was removed by the bulldozer scraping backwards down the beach in order to minimize damage to the backshore. For the same reason access to the beach from the backshore was carefully controlled to prevent the development of blow-outs.

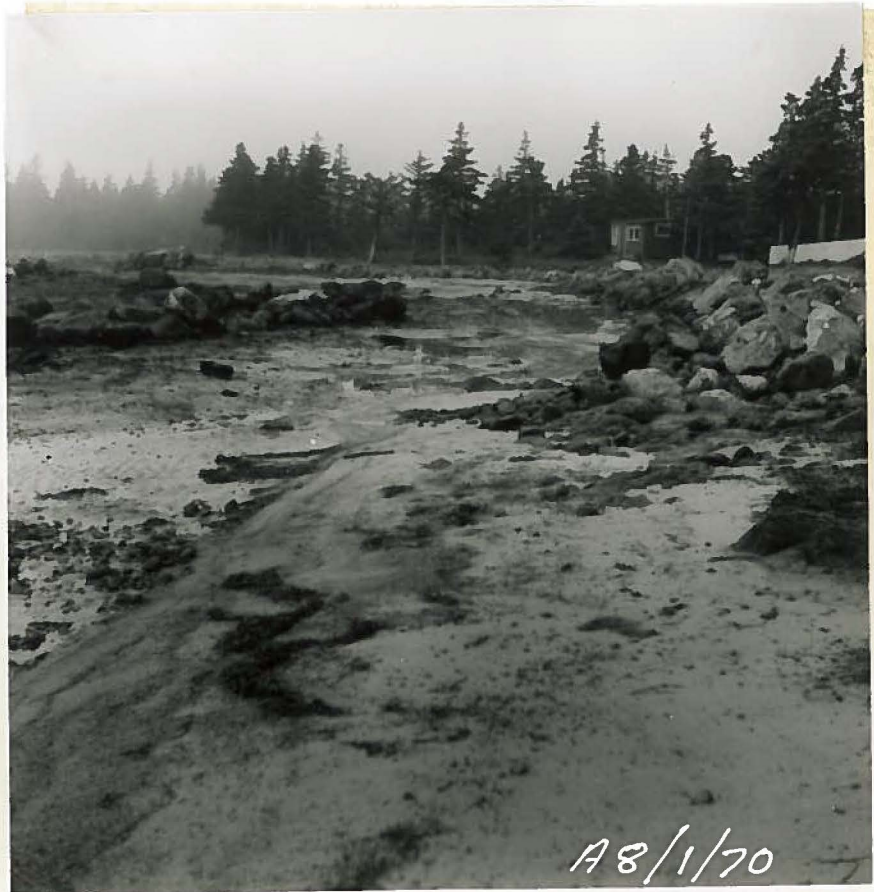
10

The sand section was cleaned by May 2 and work then began on the north shore. The contractor agreed to remove material only from the upper part of the intertidal zone. An agreement was reached to replace one section where the road on the backshore was left open to wave action by the removal of the boulders (Photograph 10).

Along the north shore of the cove most of the contaminated material, largely boulders, was removed from the upper part of the intertidal zone (c.f. photographs 7 and 8). The boulders on the right of the photograph were brought in as clean replacement to protect the road and cottages on the backshore. This material has been contaminated by oil moving alongshore from adjacent areas.

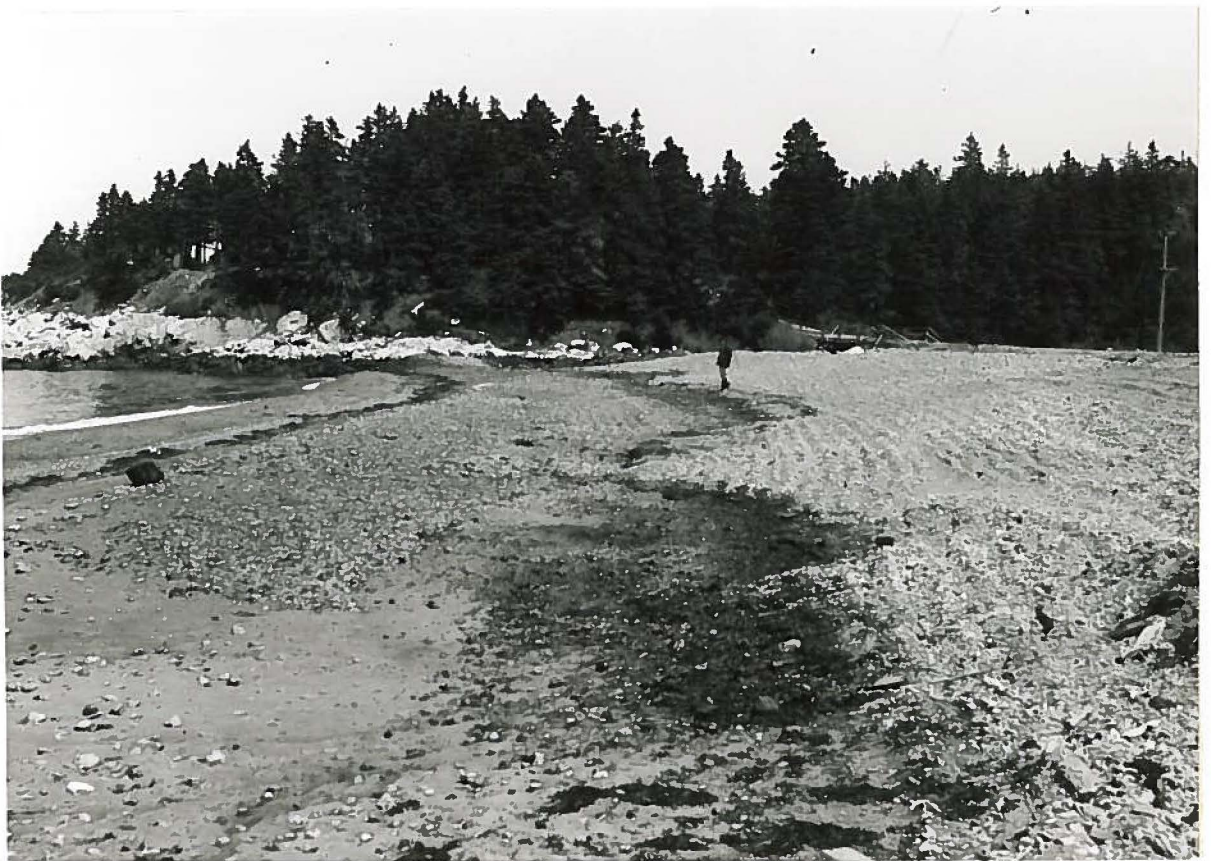
12

(e) Reoiling of the eastern section took place during a period of spring tides within 4 days as oil was released from pools and cracks in the adjacent rock areas (Photographs 12, 13, 14). High temperatures during the preceding week had encouraged the oil to collect in hollows and this was then easily washed out by the waves. The actual timing of the reoiling coincided with the spring tides so that the pools of oil had not been within the range of normal wave action for several weeks (see Section 5.4., page 35).

The same view as above at low tide four days later. The recontamination was from alongshore and the oil was concentrated at the high water mark.

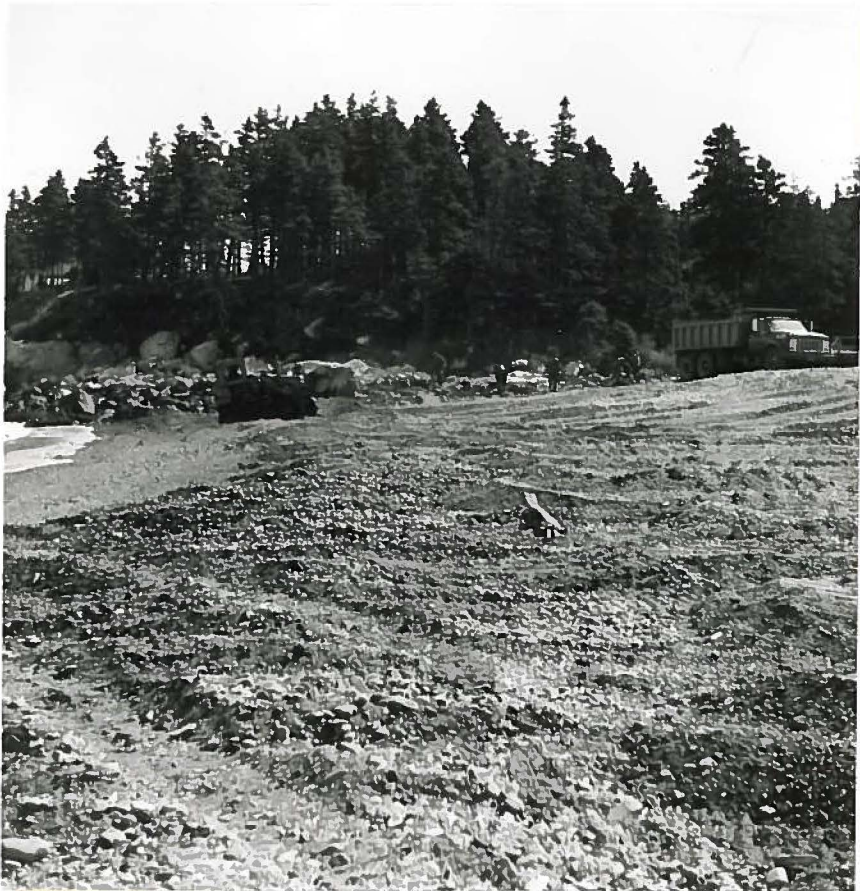
14

A tracked front-end loader is removing sediments from the east section at low tide. Oil was also removed manually from pools and hollows on the adjacent rock and boulder area which was thought to have been the source of recontamination.

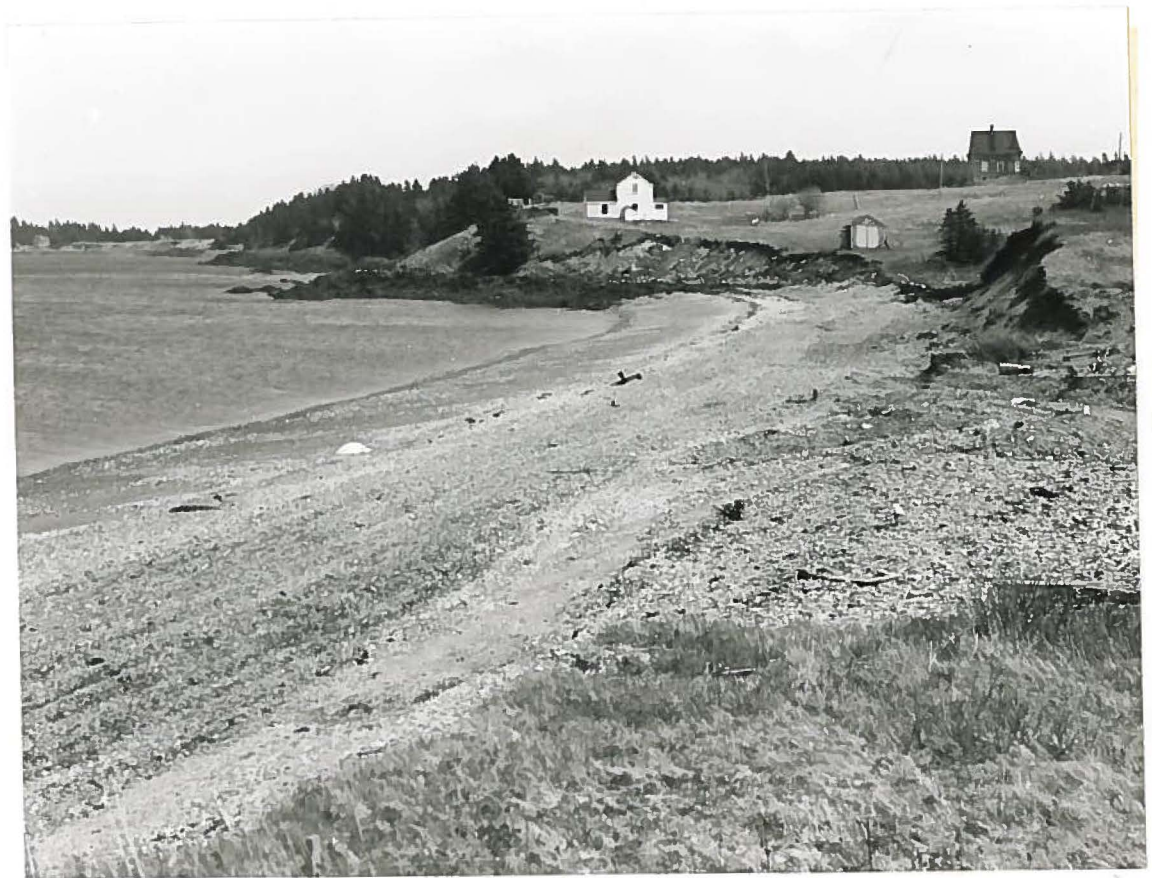
16

The same section of beach at low tide after completion of the contract work. The dark patches in the left foreground are contaminated sediments (see photograph 17). This beach exhibits a summer profile gradation of cobbles on the upper part of the beach and a mixture of coarse sand, gravel, and cobbles in the intertidal zone.

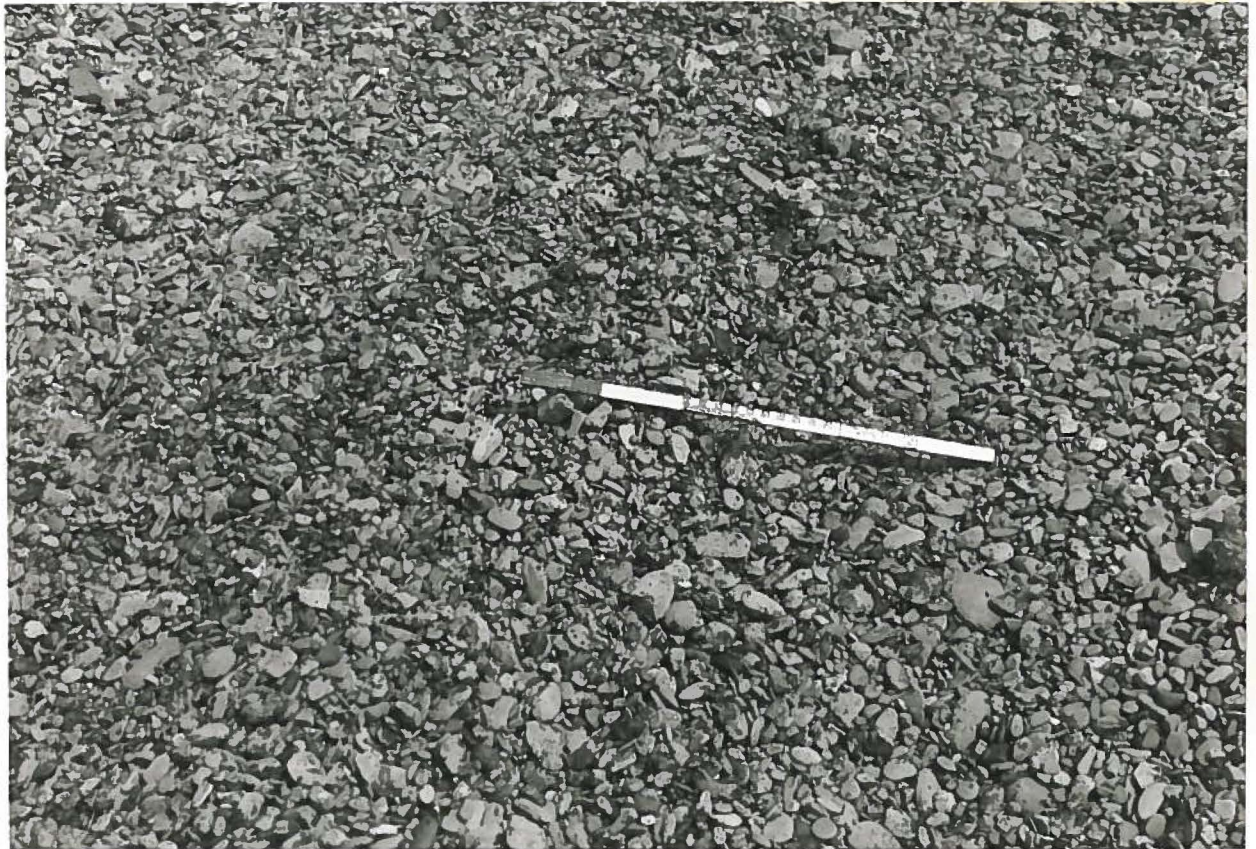
Close-up of contaminated cobbles after restoration. This may have resulted from spillage, mixing, or the exposure of buried oiled material.

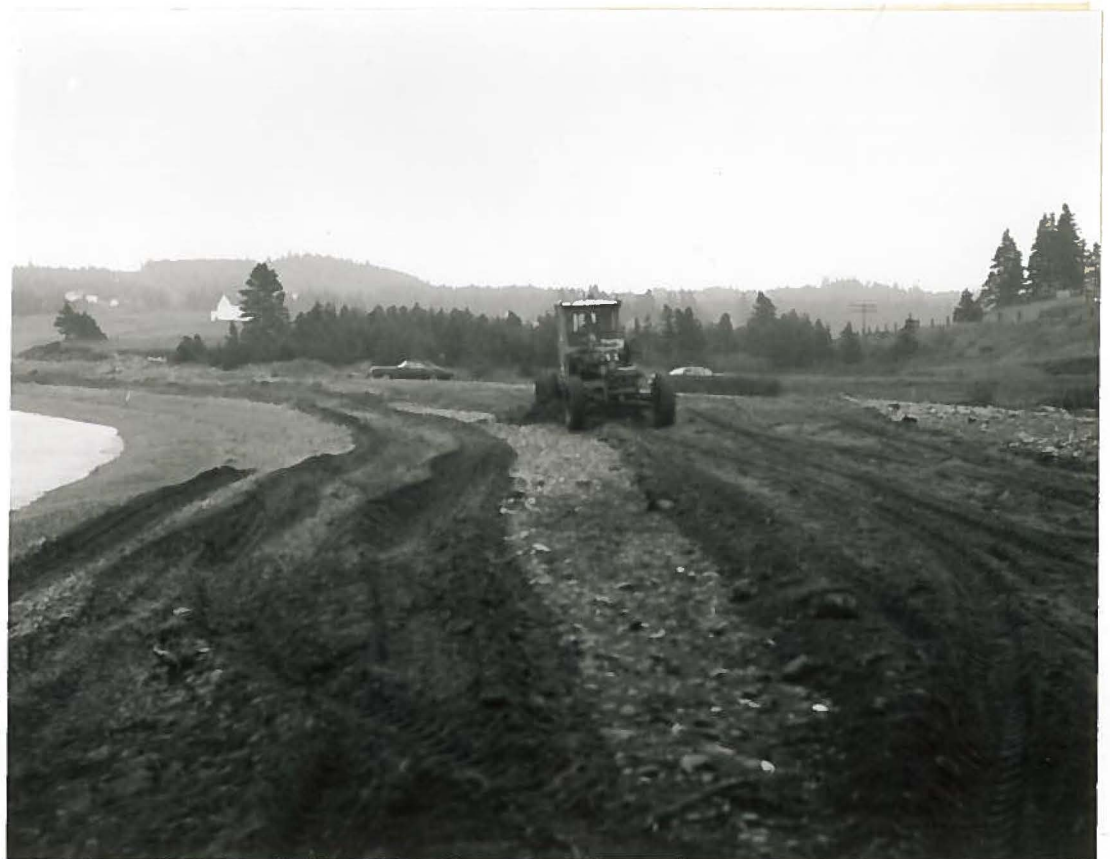
19

Effect of a decrease in traction and a non-level surface on the performance of the grader. The machine was almost stuck and churned up the beach to a depth of two feet.

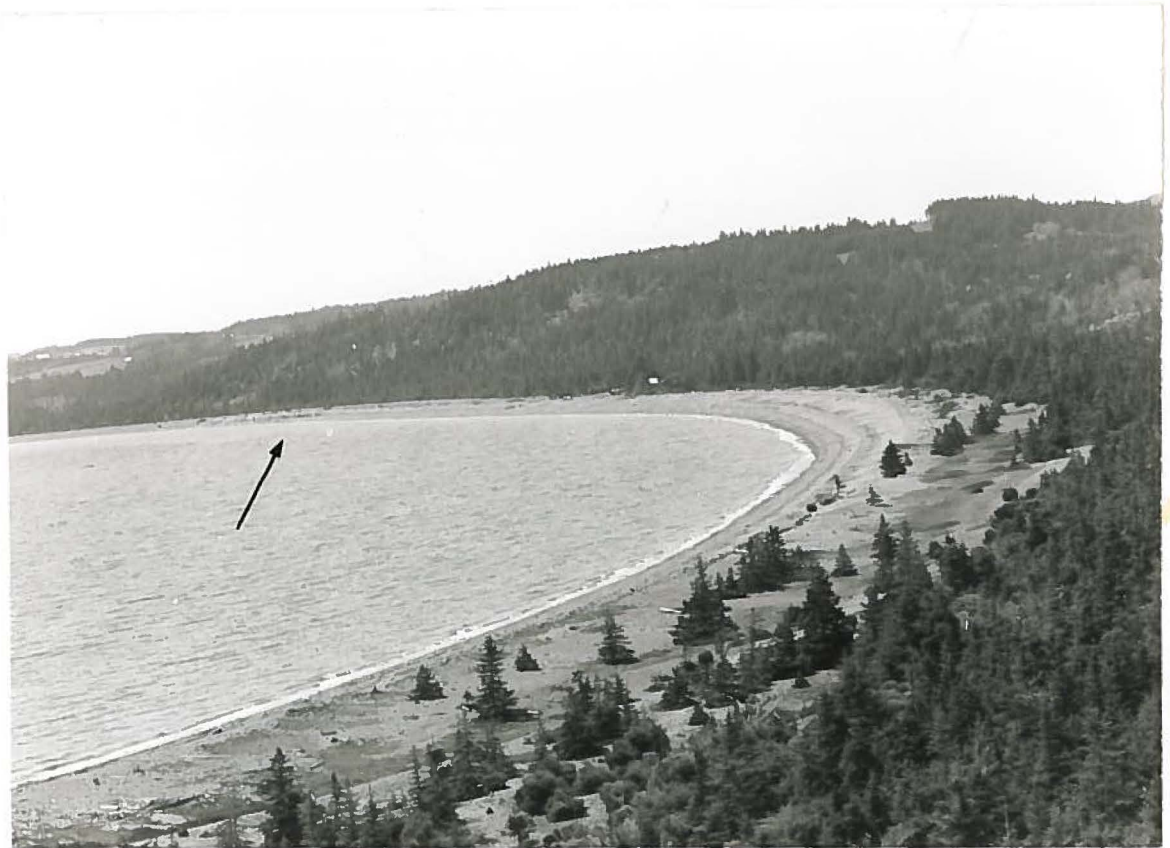
21

Air view of the main section of the beach at mid tide before restoration. The main storm ridge is backed by a vegetated swale which in turn is replaced by a higher vegetation sequence. A squad of "slick pickers" is removing contaminated material manually (see also photograph 41), these are located by an arrow. No sections of this beach were paralyzed, although originally heavily polluted most of the oil was buried or removed by normal wave action.

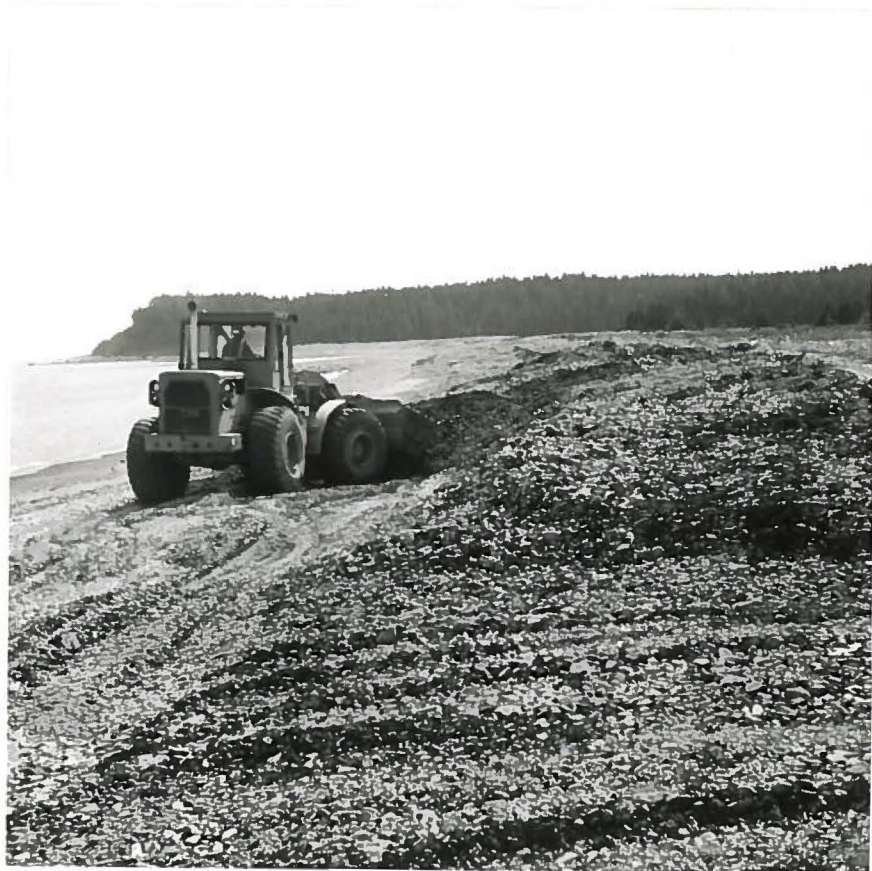
23

This is a similar area to Moose Bay though more heavily polluted, it is an active beach which had succeeded in cleaning itself well. Again contaminated material was reworked and this shows the loader attempting to remove a buried layer. This machine is quite efficient if operated well but there is a great deal of spillage from the bucket as it shoves into the beach.

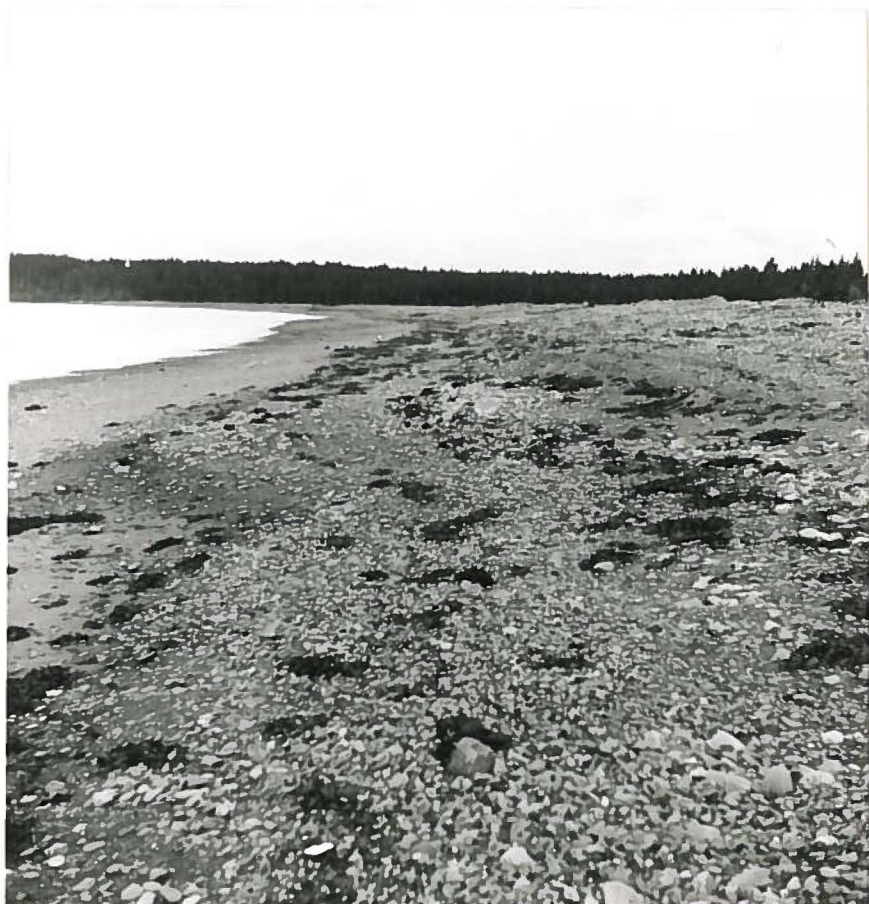
25

The west section after restoration at low tide. Much of the storm ridge has been removed and the beach has a much lower slope than previously. Dark patches are seaweed.

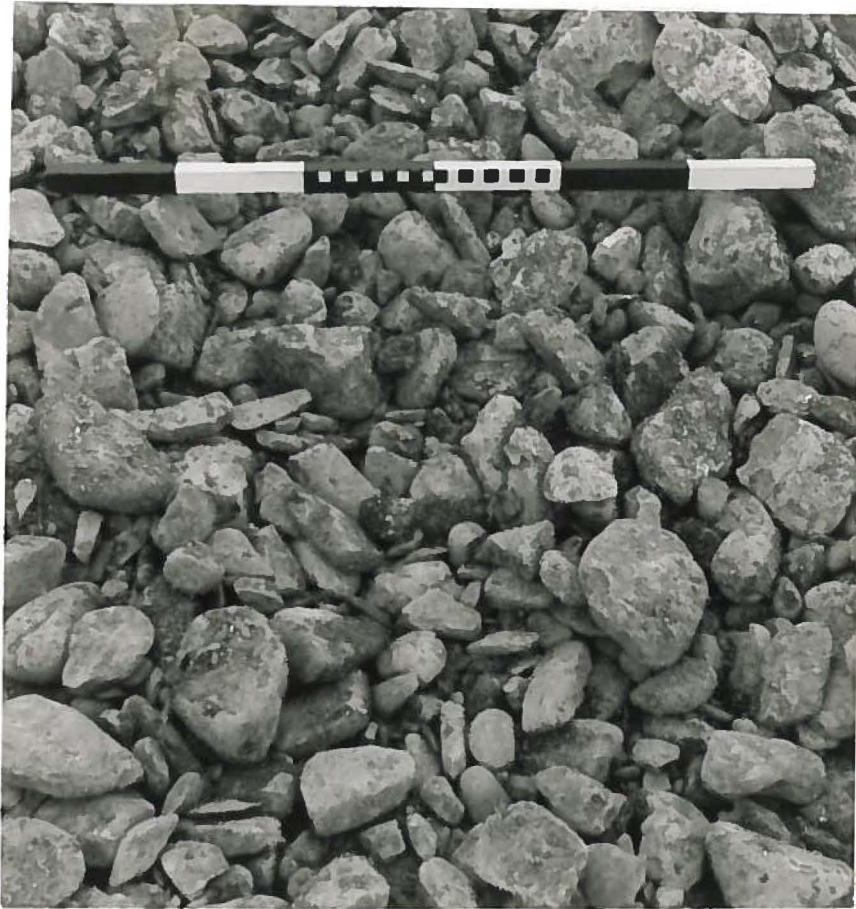
26

Close-up of beach material after restoration. Contaminated pebbles are still evident and the oil on the material has a surface coating of fines due to the mixing of the sediments by the heavy machinery. This surface coating of fines was easily removed by wave action. The scale is in centimeters and decimeters.

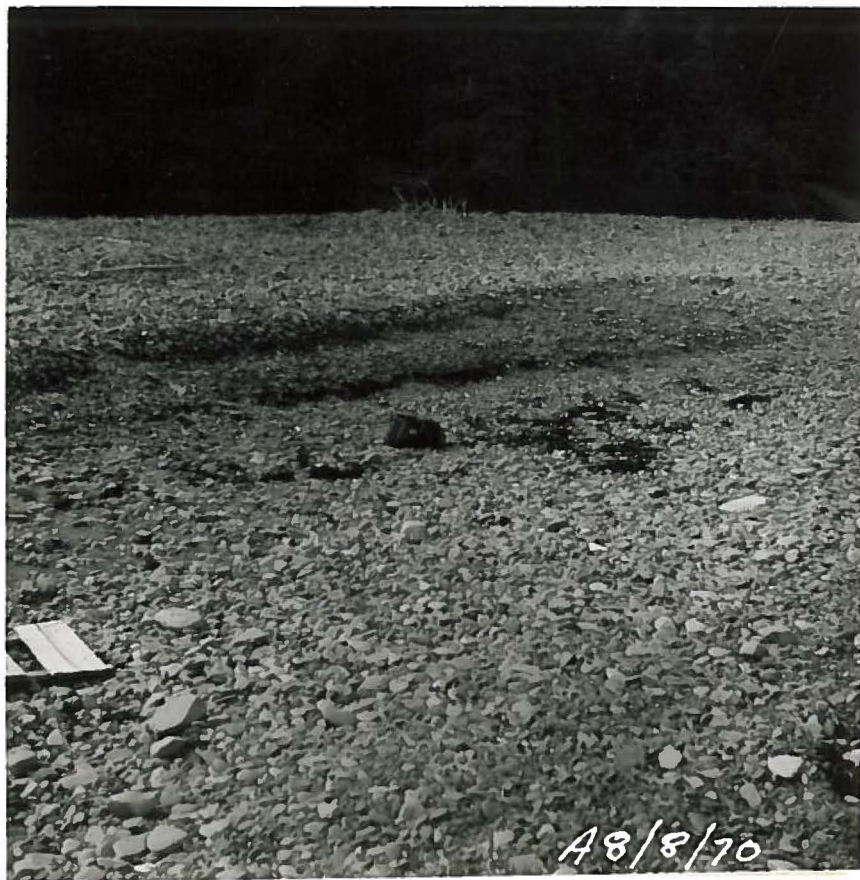
28

The layers of oil, when exposed by wave action, are more resistant to erosion but quickly collapse through sunlight and gravity.

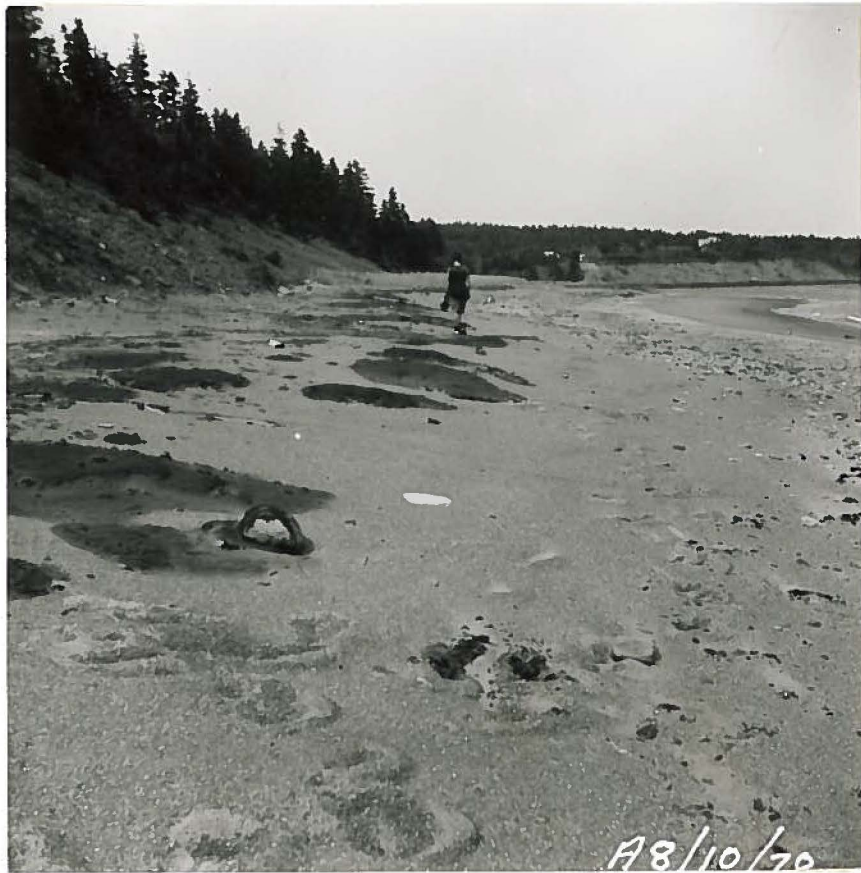
30

The east end of the beach was made up of coarse sand and the oil remained as large pans which had a surface layer of fines or was buried to a depth of several feet. No oil was visible in the intertidal zone.

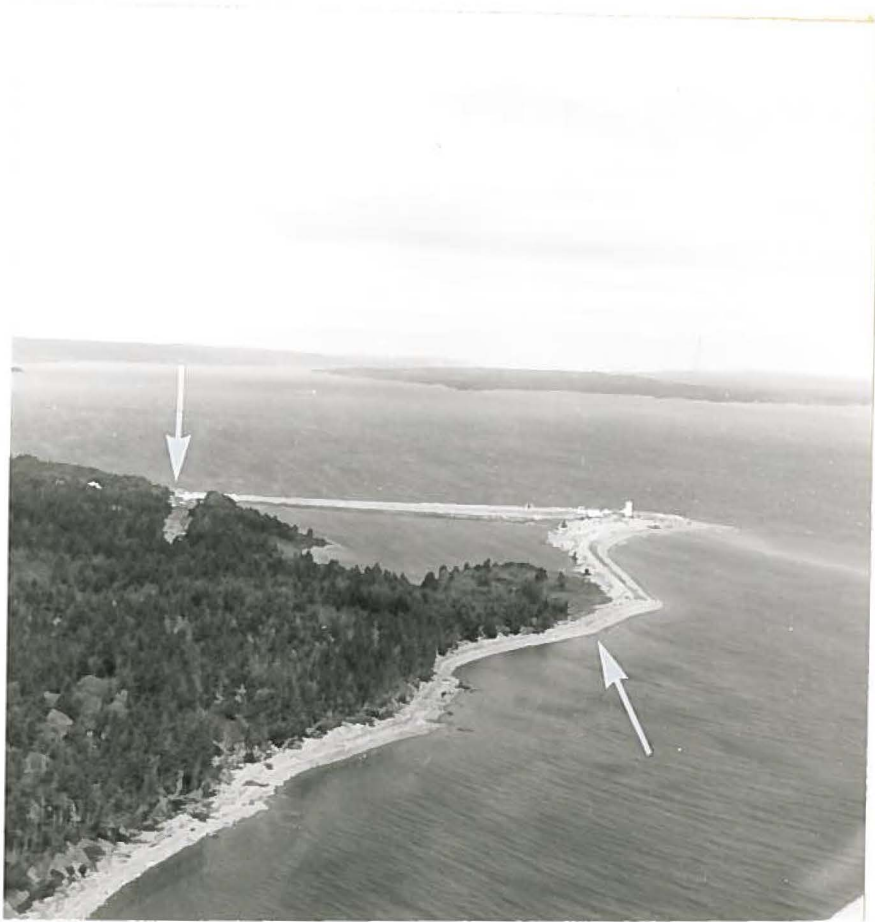
31

Air view looking north. The lagoon is fresh water and rarely breached by the sea. The contract limits are given by the arrows.

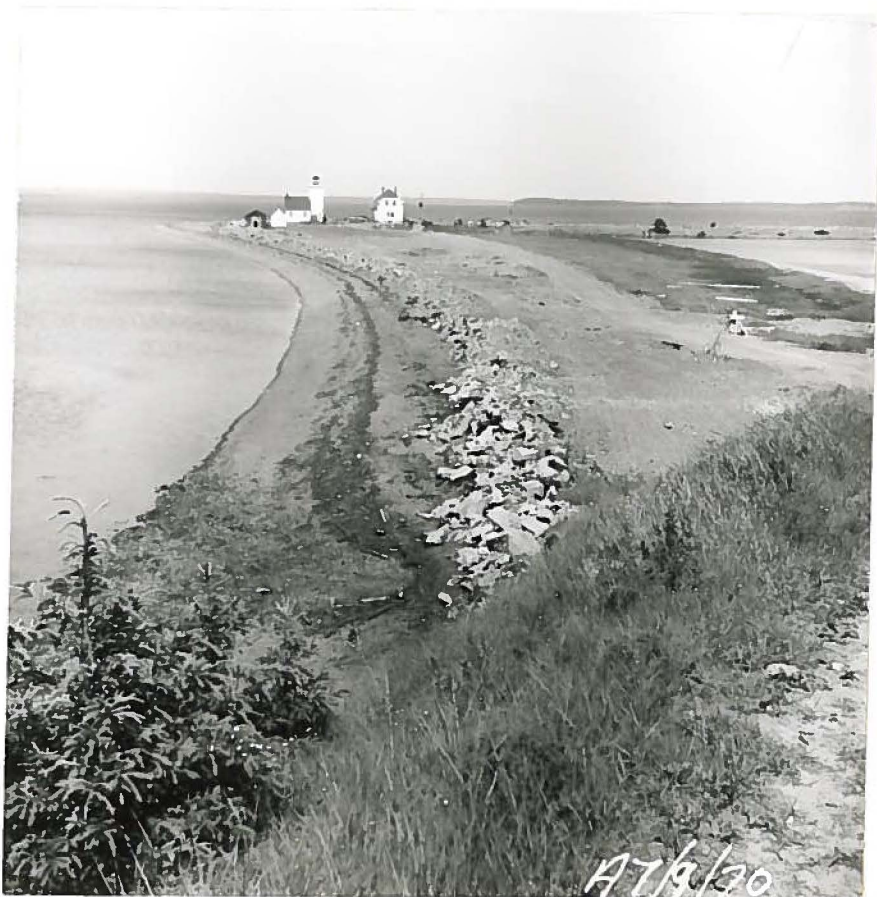
33

After restoration, at mid tide. Along this north shore clean material was brought in as replacement and deposited at the beach crest to prevent breaching of the bar.

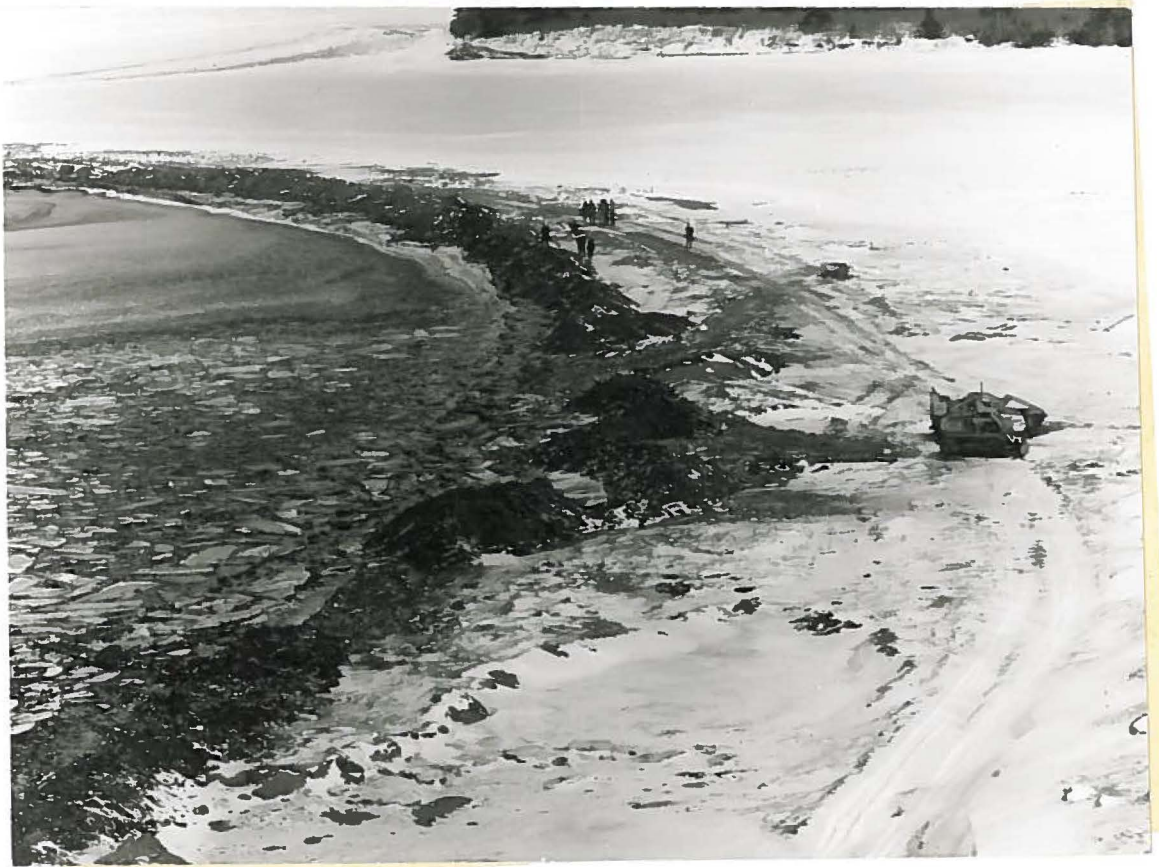
35

Air view of beach from the south at high tide. This beach was heavily contaminated on frequent occasions and at this time much of the sea ice was covered with oil. In the central section of the beach, near the group of people, the bar is only 100 feet wide, the far side is hidden by snow and ice cover.

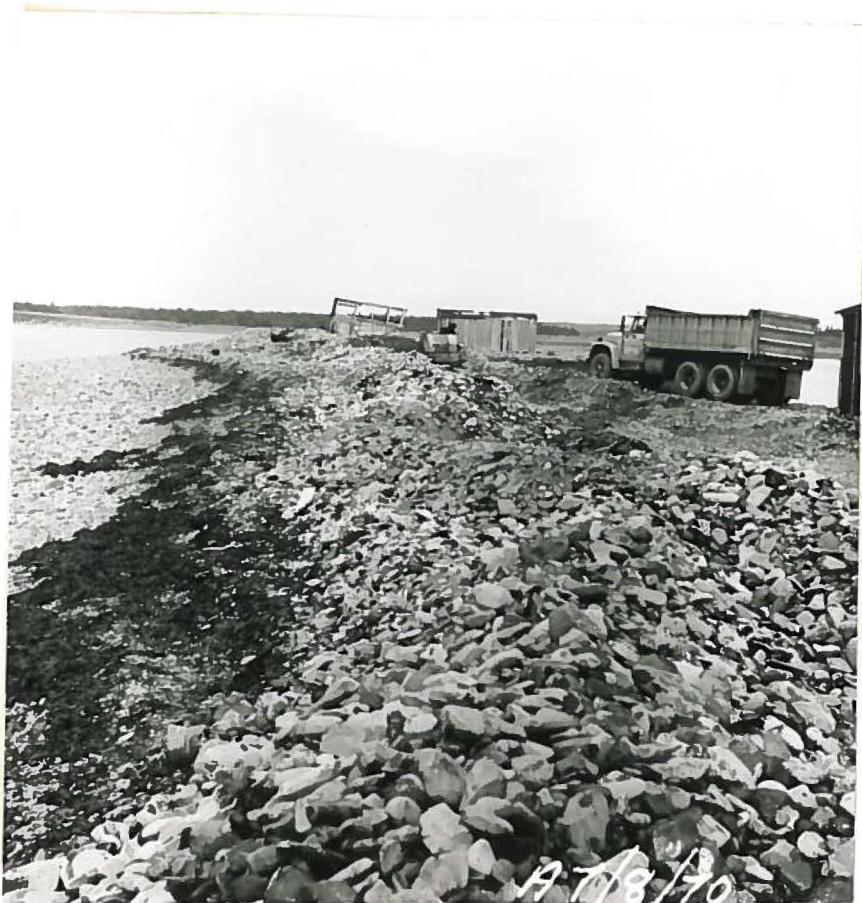
37

As replacement for material removed from the bar the spit was excavated in the centre to a depth of more than six feet. The location of the excavation is shown on photograph 36. The high water mark on the beach is indicated by a line of seaweed. This beach, on the exposed side of the spit, has been cleaned by wave action though it was heavily polluted on several occasions. The lee side is still paralyzed (see above).
