GEOLOGICAL ASPECTS OF THE BEACH RESTORATION
PROGRAMME IN CHEDABUCTO BAY,
NOVA SCOTIA, 1970.

E.H. Owens

Report to the
Scientific Coordination Team
Project Oil Task Force

September 1970.

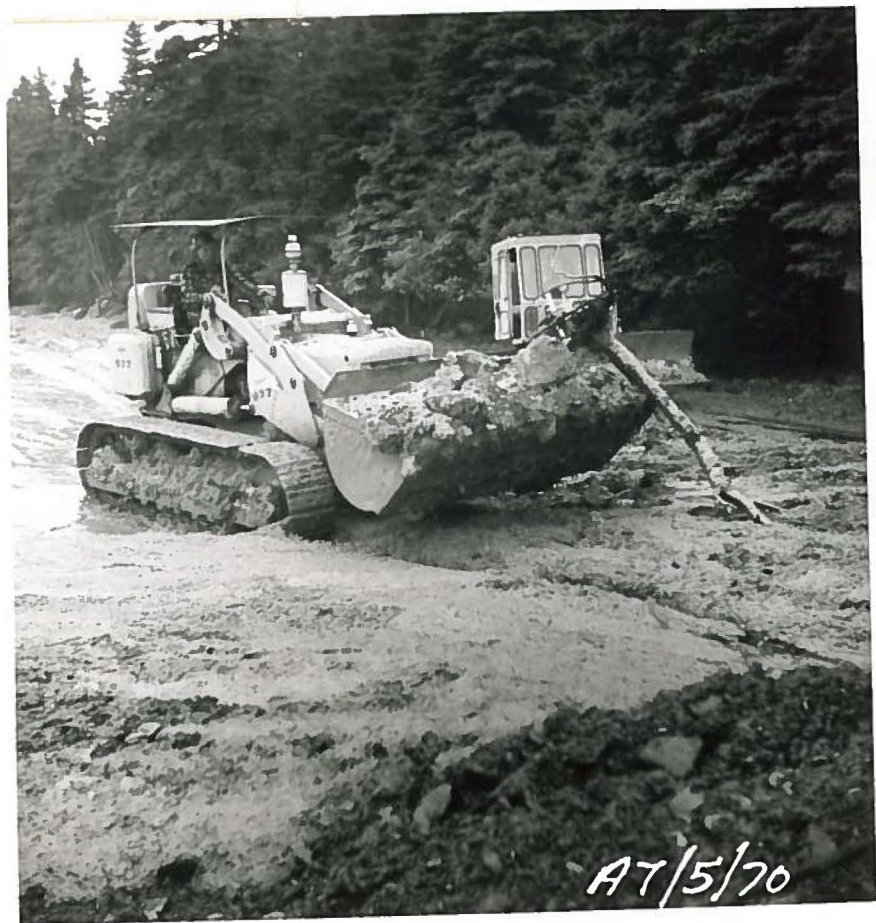
39

This beach on the sheltered north shore of Inhabitants Bay has had its thin surface layer of cobbles removed. This has exposed a wet layer of fines about three feet deep. These clean sediments have been thoroughly mixed with contaminated material by the tracked bulldozer and front-end loader.

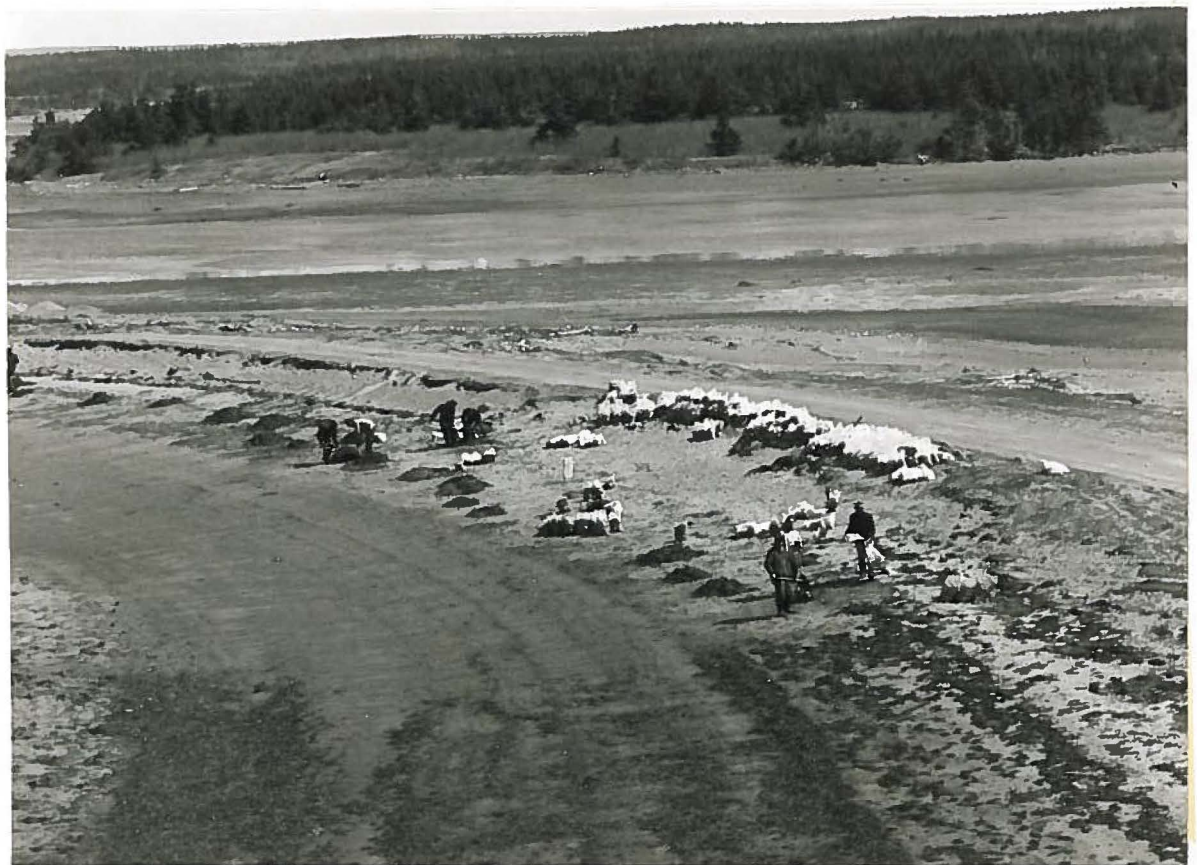
41

Air view of the restoration of a sand beach manually. Oil and oiled seaweed is shovelled into plastic bags which are collected for dumping. This method is very effective as spillage is negligible and only contaminated material is removed.
