EFFECTS AND CONTROL OF NICKEL AND IRON IMPURITIES IN CYANIDE ZINC PLATING BATHS

by WILFRED DINGLEY*

ABSTRACT

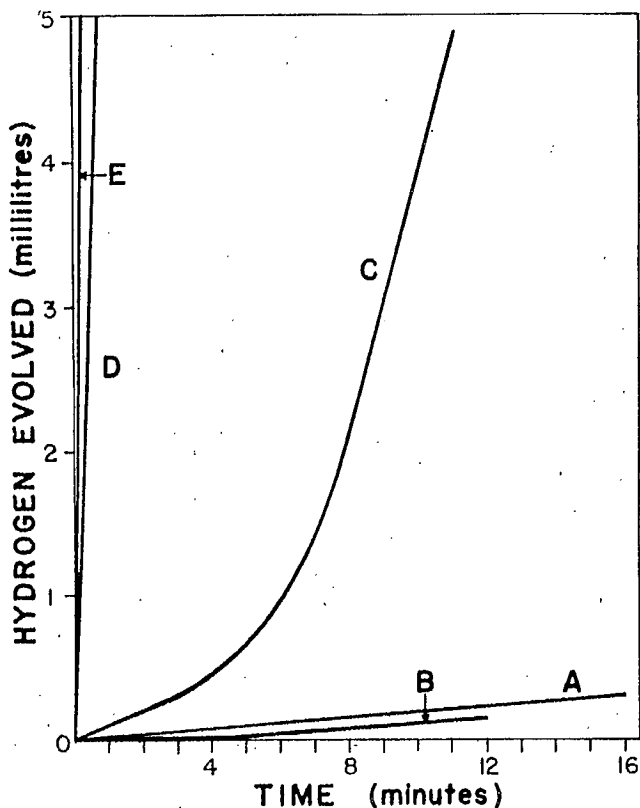
Fig. 1. Dissolution rates of laboratory-produced and plant-produced electroplated zinc coatings: A—laboratory-produced coatings on mild steel, from a purified cyanide plating bath; B—plant-produced coating on mild steel, from a commercial cyanide plating bath; C—plant-produced coating on mild steel, from an acid-sulphate plating bath; D—plant-produced coating on a Canadian 105 mm cartridge case, from a commercial cyanide plating bath; E—plant-produced coating on a non-Canadian cartridge case, from a commercial cyanide plating bath.

This procedure was first used for obtaining a measure of the metal contamination in various zinc coatings from laboratory experiments and plant production. Samples from other plants were also tested. In these tests the gas evolution rate varied from 0.05 to 17 ml/minute, and the time required to completely dissolve coatings of 0.6 mil thickness varied from 2 to 160 minutes. The dissolution rates shown in Fig. 1 illustrate graphically the great differences which were found in electroplated zinc coatings on steel. It is of interest to note that by far the greatest dissolution rates were obtained from zinc coatings on cartridge cases.

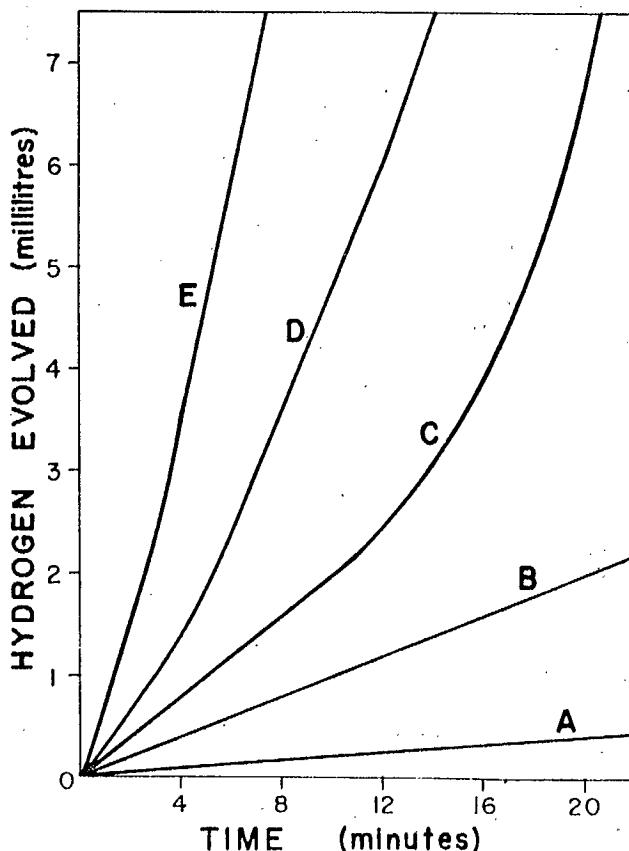
Fig. 2. Variation of dissolution rates of electroplated zinc coatings on cartridge cases with the number of cases plated: A—laboratory-produced coating on mild steel, from a purified cyanide plating bath (included for comparison); B—laboratory-produced coating on cartridge-case steel, from freshly-prepared commercial cyanide plating bath; C—plant-produced coating on the 5th cartridge case electroplated from a bath similar to that used in plating B; D—plant-produced coating on the 686th cartridge case plated from the same bath as C; E—plant-produced coating on the 1276th cartridge case plated from the same bath as C.

The next phase of this part of the investigation was to replace the contaminated bath at the plant by a new one produced from commercially pure chemicals, and to use the latter for plating cartridge cases. A piece of cartridge-case steel was plated in a sample of the new bath in the laboratory. The resulting coating was subjected to the hydrochloric acid test. Cartridge cases were plated continuously in the plant, starting with the same new bath: Plated cases No. 5, 686 and 1276 were removed and subjected to the hydrochloric acid test (1276 cases were approximately one and one-half days' production). For comparison, a piece of mild steel was zinc plated in a purified* bath in the laboratory and the resulting coating was subjected to the hydrochloric acid test. The results of the tests performed on the various coatings are shown in Fig. 2.

As shown in Fig. 2, none of the zinc coatings produced in the plant gave as low a rate of hydrogen evolution as did the one plated in the purified bath in the laboratory, i.e., under the most nearly ideal conditions. However, the rate of

hydrogen evolution increased considerably as the number of cases plated in the plant increased. The difference in rates between B (the first sample plated in the laboratory using commercial materials) and C (the fifth case plated in the plant using commercial materials) is particularly noteworthy. The result obtained with the coating on case No. 1276 approached that obtained with the coating on a case which had corroded in storage. These results strongly indicated that the original bath was comparatively free from contamination, but that the concentration of one or more contaminants increased as the plating proceeded.

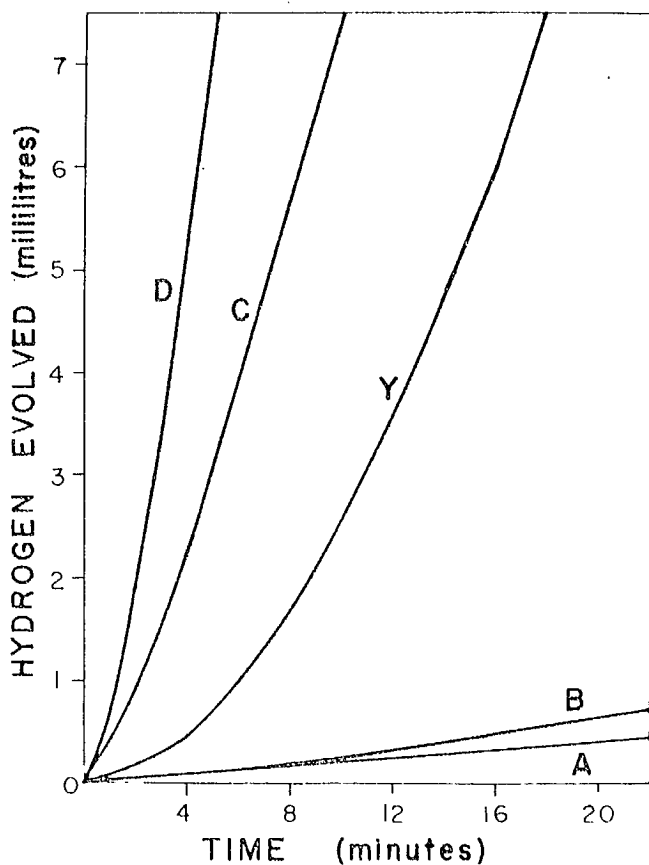
Fig. 3. Dissolution rates of laboratory-produced zinc coatings on mild steel, from purified zinc-plating baths containing ferrous iron or nickel as impurities: A—bath with no appreciable impurities; B—bath containing 0.05 g/l iron; C—bath containing 0.31 g/l iron; D—bath containing 1.25 g/l iron; Y—bath containing 0.09 mg/l nickel.

Since it was recalled that iron and nickel had been found in the original plating bath used at the plant, one or both of these was immediately suspected of being the contaminant which produced the great change in the rate of dissolution of the zinc in the acid test. To investigate this a series of laboratory experiments was performed. Zinc coatings were plated from solutions containing impurities as follows: (a) no appreciable impurities, (b) 0.05, 0.31 and 1.25 g/l iron in the ferrous state, (c) 0.09 mg/l nickel. The results of the hydrochloric acid tests on these coatings are shown in Fig. 3. It is quite evident that after iron or nickel is introduced into the plating bath, the hydrogen evolution rates of the resulting plated samples become greater (sometimes much greater) than they would be in the absence of these two contaminants; also

a much larger amount of iron than of nickel is required to produce the same effect. In view of the fact that copper and chromium were found in the zinc coatings and the plating bath it is possible that these elements also are undesirable contaminants. However, the effect of their presence was not studied during the present investigation.

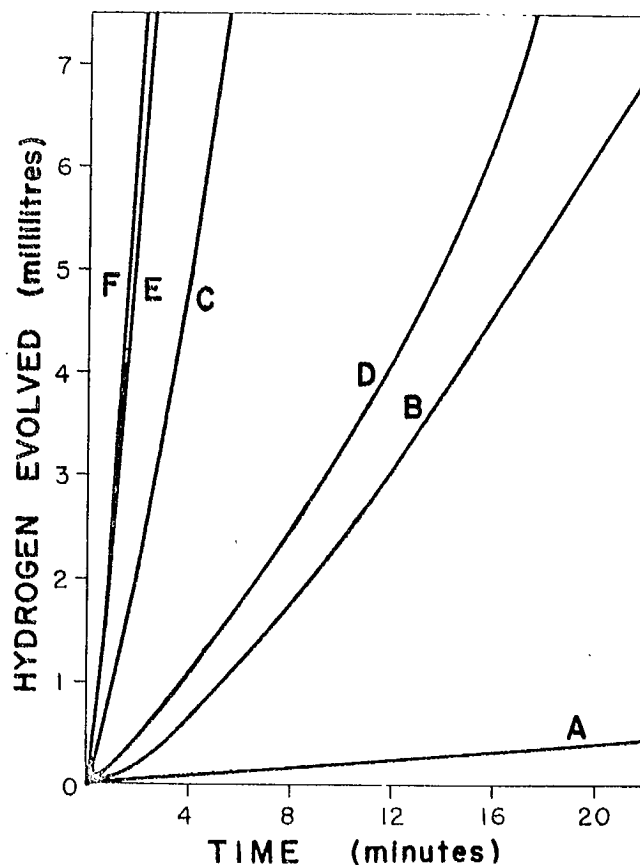
Fig. 4. Dissolution rates of laboratory-produced zinc coatings on mild steel, from purified zinc plating-baths in each of which an anode of zinc (99.99 per cent purity) and one of a different metal had been used. (Prior to plating each sample the non-zinc anode was removed from the bath): A—coating plated after bath had been used for 2 hr with 2 zinc anodes (for comparison); B—coating plated after bath had been used for 20 min with stainless steel (18-8) and zinc anodes; C—coating plated after bath had been used for 2 hr with stainless steel (18-8) and zinc anodes; D—coating plated after bath had been used for 2 hr with mild steel and zinc anodes; E—coating plated after bath had been used for 2 hr with nickel and zinc anodes; F—coating plated after bath had been used for 35 min with Inconel and zinc anodes.

The results of the hydrochloric acid tests on the plated samples are given in Fig. 4. It is believed that the increased dissolution rates shown by curves B, C, D, E and F, as compared to that of curve A, were due to nickel and/or iron dissolved from the anodes used in those baths. Here again it was shown that nickel is a much more serious contaminant than iron. Since the Inconel (76 per cent nickel) had an even greater effect than pure nickel it is possible that chromium also is a highly undesirable contaminant.

It has been shown in Figs. 3 and 4 that a very small amount of nickel is a serious contaminant when present in a zinc cyanide plating bath. This contamination can be avoided by using internal anodes of electrolytic iron, which are much cheaper than anodes of nickel or nickel alloys such as 18-8 stainless steel or Inconel. As shown above, this iron also dissolves slowly in the bath, but it can be removed quite rapidly by means of the zinc-dust electrolysis process described above.

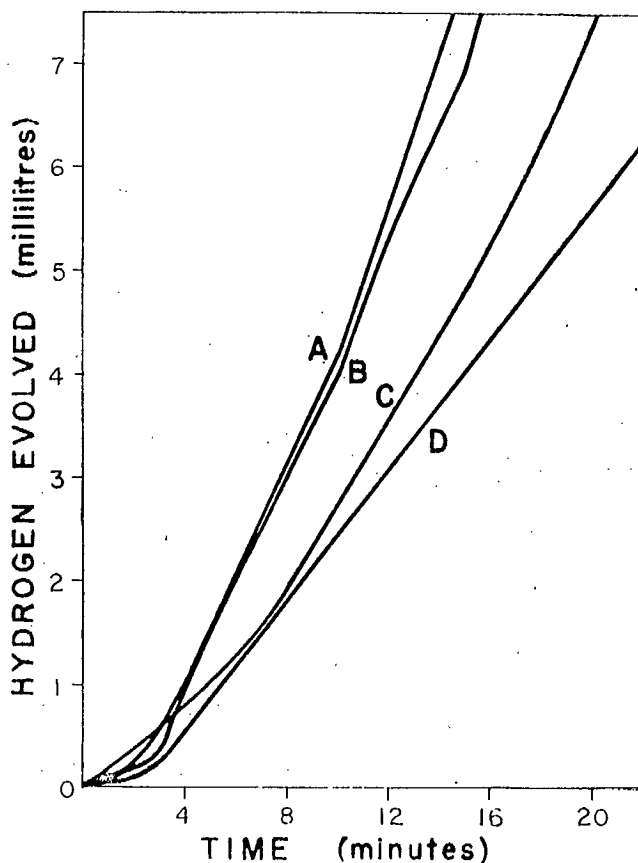
Fig. 5. Dissolution rates of laboratory-produced zinc coatings on mild steel, from commercial plating baths some of which had been purified by preliminary electrolysis using zinc anodes and mild steel cathodes (dummying): A—coating from commercial plating bath with no prelim. electrolysis, B—coating from commercial plating bath "dummyed" at a low current density for 16 hr, C—coating from commercial plating bath "dummyed" as in B. Anodes cleaned once in acid during "dummy" treatment, D—coating from commercial bath "dummyed" as in B. Anodes cleaned several times in acid during "dummy" treatment.

scale. Several procedures which had been proposed in the literature were first investigated, the first being the preliminary electrolysis of the plating bath using zinc anodes and mild steel cathodes at a low current density for 16 hours. Such a procedure is commonly called "dummying." In some of these experiments the anodes were cleaned in acid, which gave some improvement as shown by the hydrochloric acid test; however, none of the experiments involving the use of "dummying" were particularly successful, as shown in Fig. 5

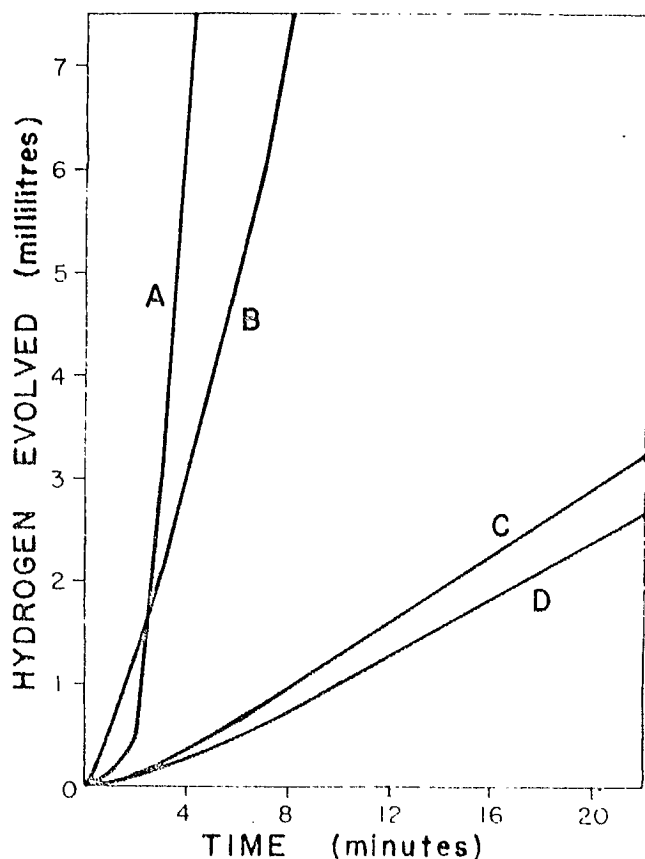
Fig. 6. Dissolution rates of laboratory-produced zinc coatings on mild steel, from plating baths purified by various zinc-dust treatments: A- Coating from severely contaminated bath (for comparison); B- coating from same bath as A after zinc-dust treatment at 70F; C- coating from same bath as A after zinc-dust treatment at 113F for 24 hr; D- coating from same bath as A after zinc-dust treatment at 70F accompanied by electrolysis, for one hr.

Much better results were obtained by a procedure called in this paper the zinc-dust electrolysis process, in which zinc dust was added to the plating bath either in the plating cell or in a purifying tank equipped with zinc anodes and a steel cathode. The solution, at room temperature, was vigorously agitated while being electrolyzed at a current density of 75 to 85 amp/sq ft. The quantity of zinc dust and the length of time required depended on how badly the bath was contaminated; however, 5 to 10 grams of zinc dust/litre of solution and one-half to two hours appeared to be adequate for most baths. The cathodes were scraped several times during treatment to remove the zinc sponge that formed on their

With this modification of the earlier zinc-dust process it is possible to purify the bath more thoroughly in considerably less time. When a purifying tank is used this process can proceed on a continuous basis without interruption in the plating. If it should be necessary to use the plating cell itself, a shut-down period of only two to three hours would be required for the whole procedure including the filtration. Although purification of baths with zinc dust has been proposed by a number of other investigators, it is believed that this particular modification has not been described in the literature. The results obtained in experiments with the different zinc dust treatments are shown in Fig. 6.

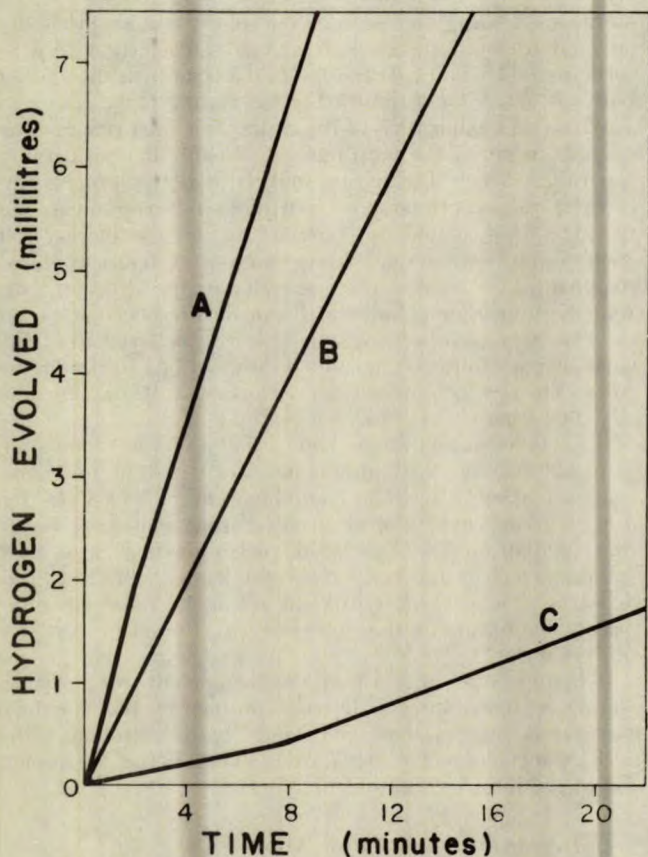
To produce zinc coatings that are satisfactory on the basis of the hydrochloric acid test it appears to be necessary to decontaminate both the plating bath and the anodes. On some occasions during the present investigation, it was observed that a plating bath purified by the zinc-dust electrolysis process produced zinc coatings having high dissolution rates. This appeared to happen when the zinc anodes had been used previously in a contaminated plating bath and had not been cleaned sufficiently afterward. Pickling the anodes in various strengths of hydrochloric, sulfuric or nitric acids failed to remove all of the contaminants from the zinc. It was found that anodes which had been used during the purification of a plating bath by the zinc-dust electrolysis treatment were quite free from contamination, and the resulting zinc coatings always gave a good hydrochloric acid test when produced in purified plating baths. Experimental data comparing the various methods of decontaminating anodes are given in Fig. 7.

Fig. 7. Dissolution rates of laboratory-produced zinc coatings on mild steel, from purified plating baths having zinc anodes which had been used in contaminated bath and then subjected to various cleaning treatments: A—from bath having anodes previously used in contaminated bath; B—from bath having anodes acid-cleaned after use in contaminated bath; C—from bath having anodes cleaned by zinc-dust electrolytic treatment after use in contaminated bath.
