*SLOPE STABILITY STUDIES
AT KNOB LAKE*

D.F. COATES, M. GYENGE AND J.B. STUBBINS
MINING RESEARCH CENTRE

Reprinted from the Proceedings of the Third Canadian
Symposium on Rock Mechanics, University of Toronto,
January 15-16, 1965

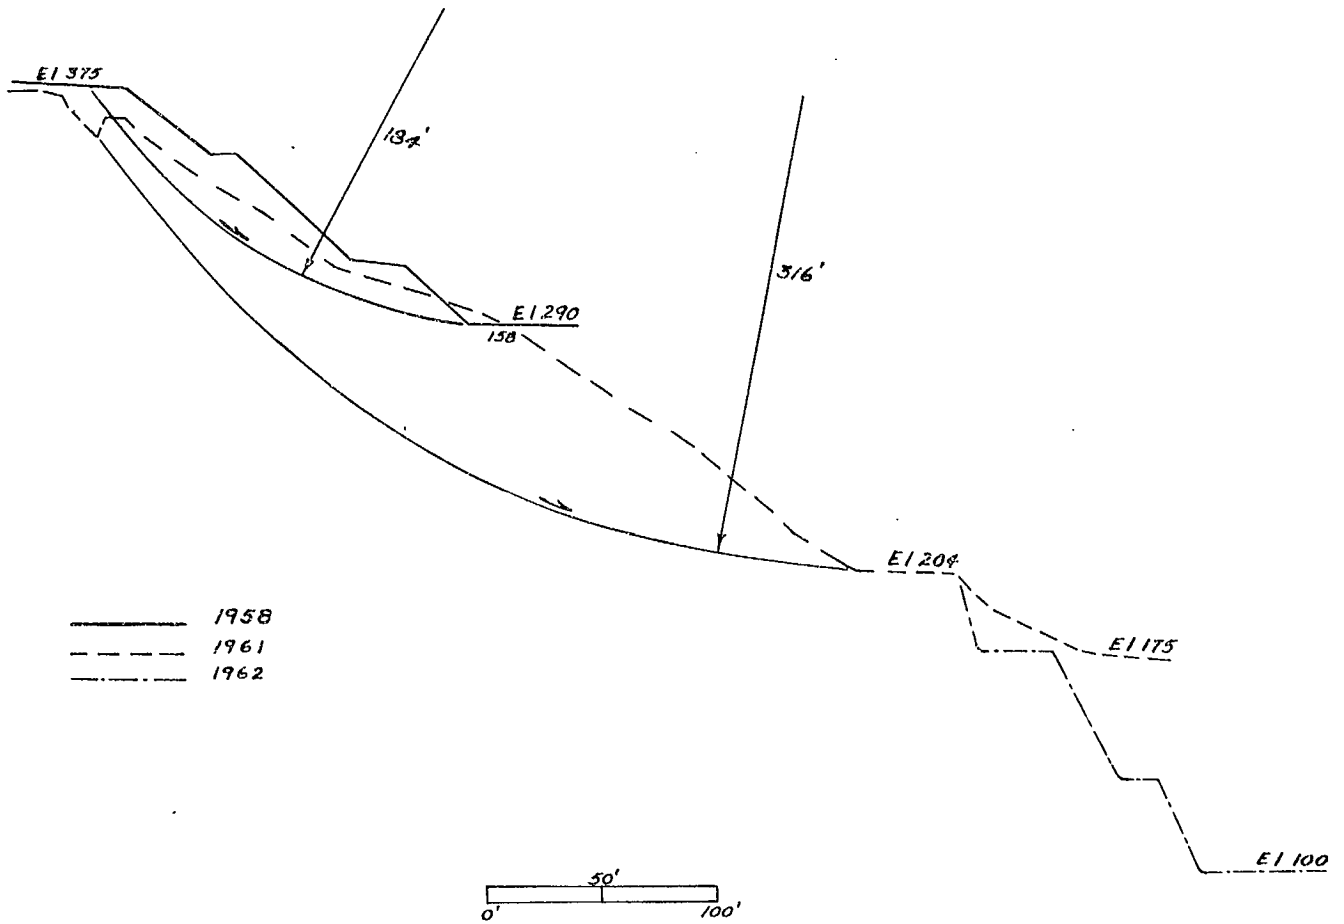
In Figure 1 the cross-section of a pit wall is shown in which several slides occurred during the mining of the ore. The ground consisted of the altered Ruth slate and Wishart quartzite, which in this area is relatively massive with dip angles between 40° and 75°.

In 1958 when the crest of the slope was at E1. 375 and the bottom of the pit was at E1. 290, a rotational shear slide occurred that caused the crest of the wall to move down some 9 ft and out 4 ft. The radius of the circle of failure was deduced to be about 184 ft. The toe of the slide was subsequently cleaned up when excavating for the ramp that was required for mining to proceed down to the lower levels.

In the spring of 1962 another rotational shear slide, connecting with one of the tension cracks in the crest, started. At this time the crest was at E1. 370, the toe at E1. 175 with the ramp at E1. 204. The movement of the wall was measured on several hubs placed on the surface of the ground. From this information it was deduced that the radius of the movement was about 316 ft as shown in Figure 1. The slide encroached on the ramp at E1. 204, but the waste material only had to be dug out twice to permit mining to proceed.

Figure 1. Cross-section of the pit wall for Case History A

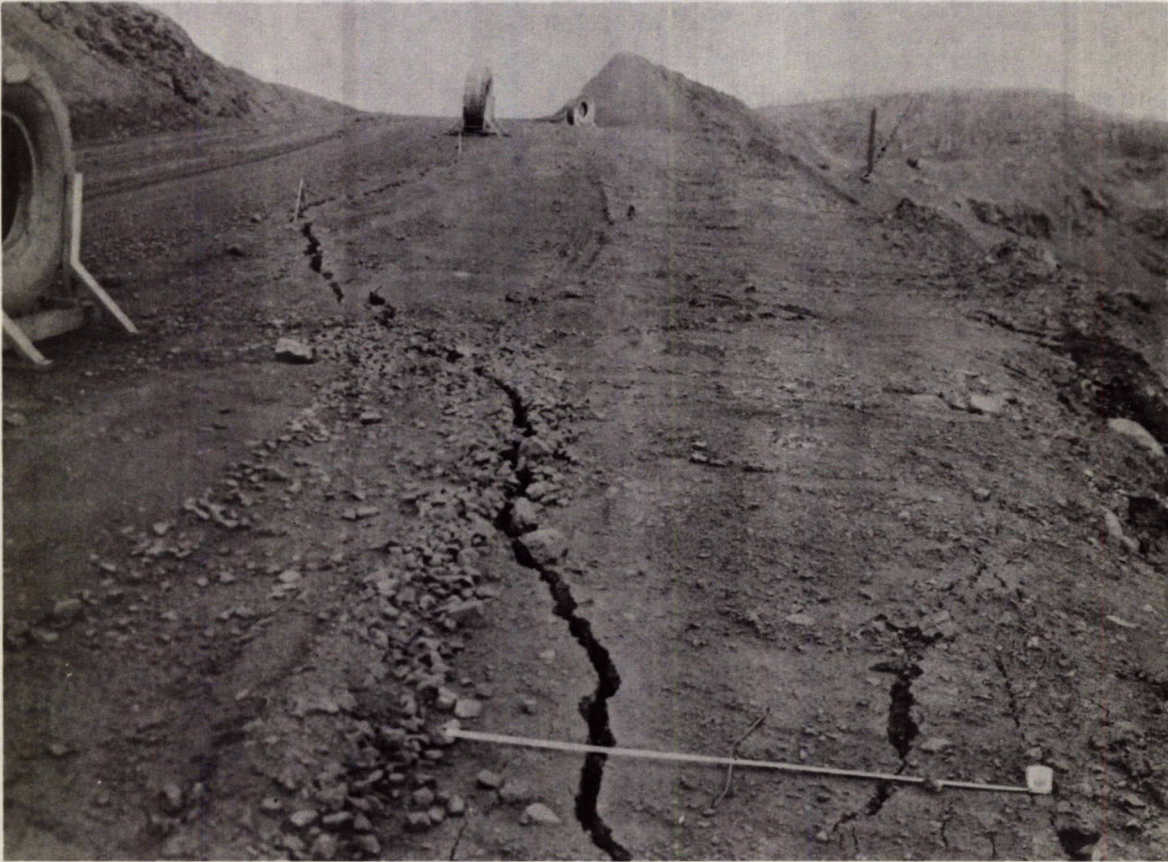
In July 1961 with the toe at E1. 204, new cracks opened up in the crest of the wall. For a period of about two months the cracks moved at the rate of about 5 in. per week outwards and 1 in. per week downwards. No actual slide occurred, nor was there any evidence of movement in the toe zone.

Figure 2. Tension cracks appearing in the crest of the wall
in Figure 1, July, 1961.

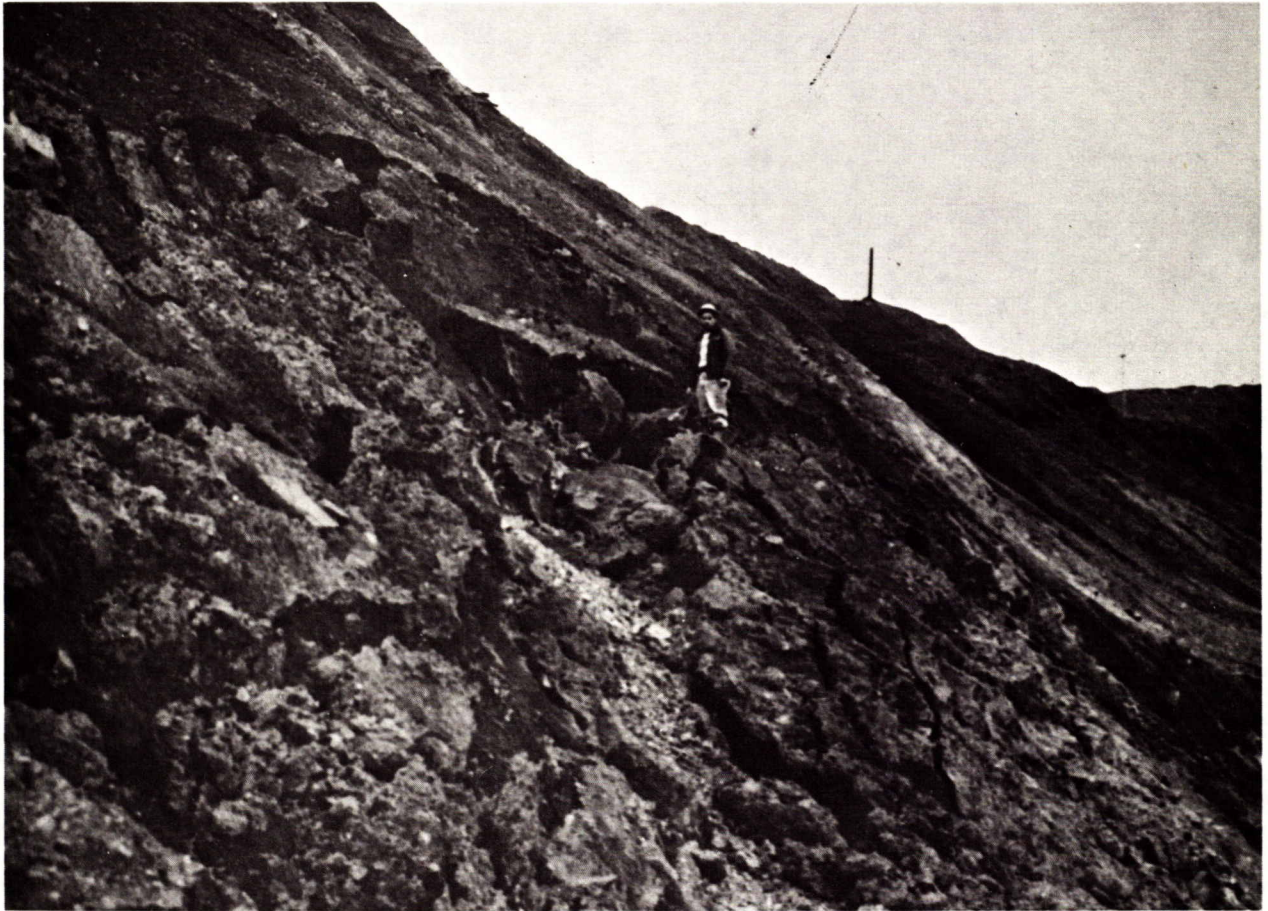
Figure 2 shows the appearance of some of the cracks in the crest during July 1961. Figure 3 shows the appearance of a small slide in the same wall just beside the main slide zone that occurred during July 1961. The total movement of this small slide during its active period, which was typical of slides in this material, was at the rate of about 5 ft per month.

Figure 3. A small slide in the same wall, adjacent to the main slide zone, July, 1961.

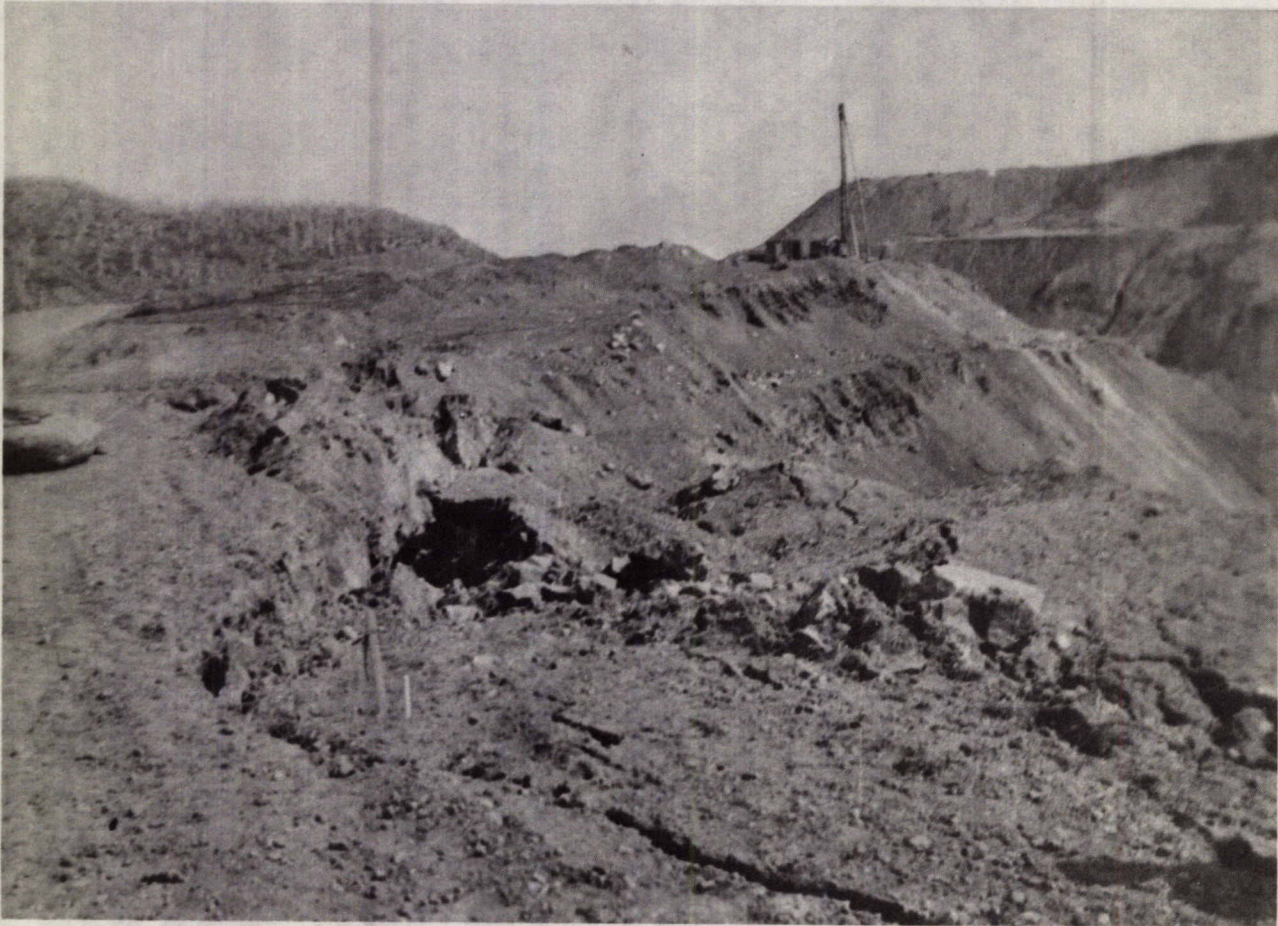
Figure 4 shows the deterioration of the ground at the crest of the slope during July 1962. Figure 5 shows the continuing cracking at the crest during September 1962.

Figure 4. The deterioration of the crest of the slope of Figure 1, July, 1962.

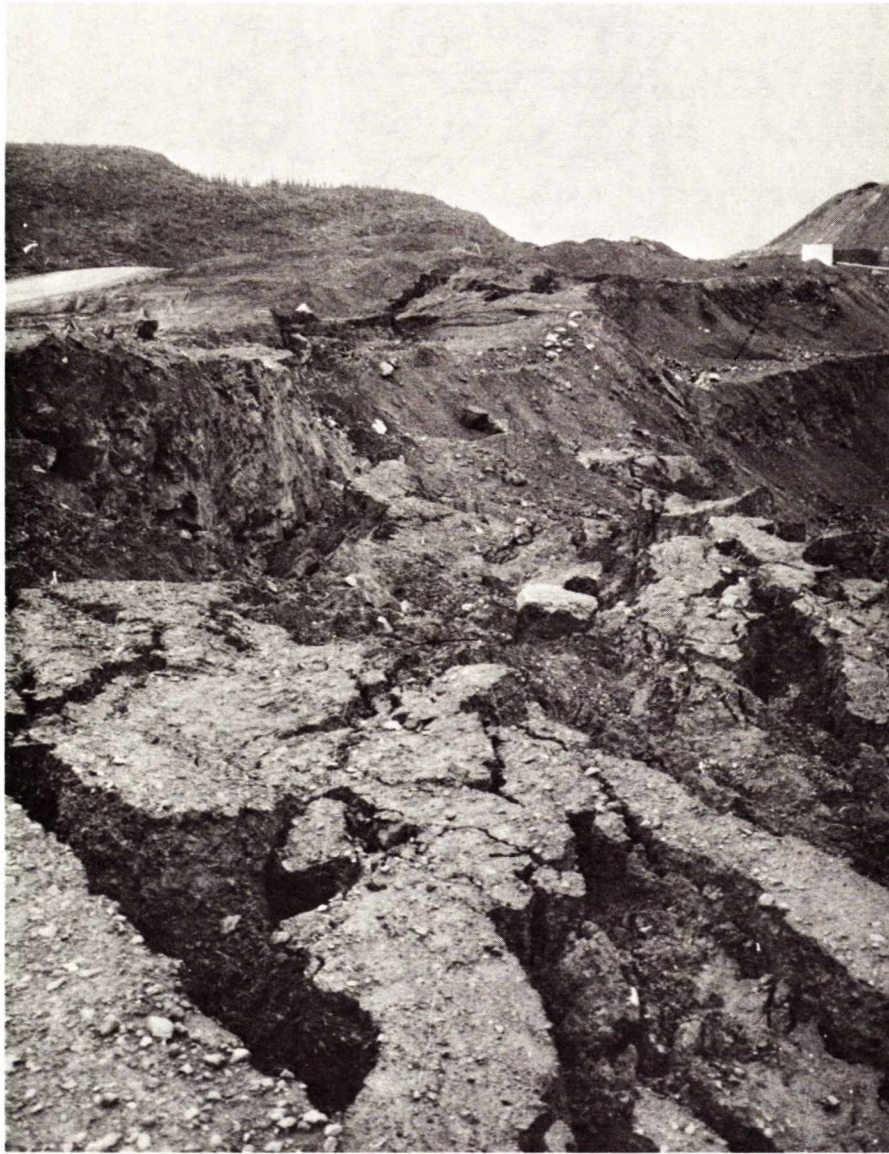
Figure 5. The continuing cracking in the same crest, September, 1962.

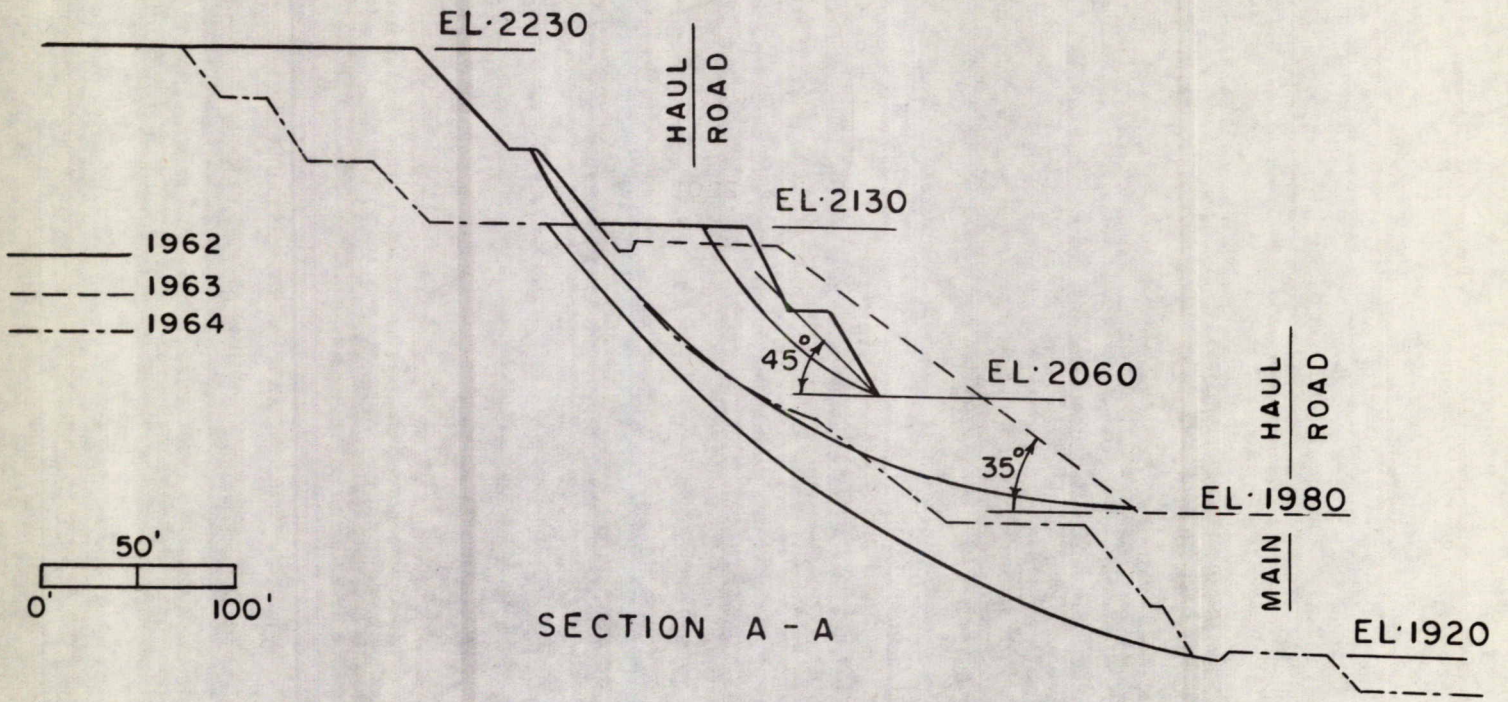
During the winter of 1961-62 stripping operations took the toe down to E1. 2060 with the crest at this section being at E1. 2230. Along the wall at E1. 2130, as shown in Figure 7, a haul road was located. The part of the wall between E1. 2130 and E1. 2060 had an average angle of 45°. Figure 8 shows the appearance of part of the face on May 14, 1962.

Figure 7. Cross-section of the pit wall for Case History B.

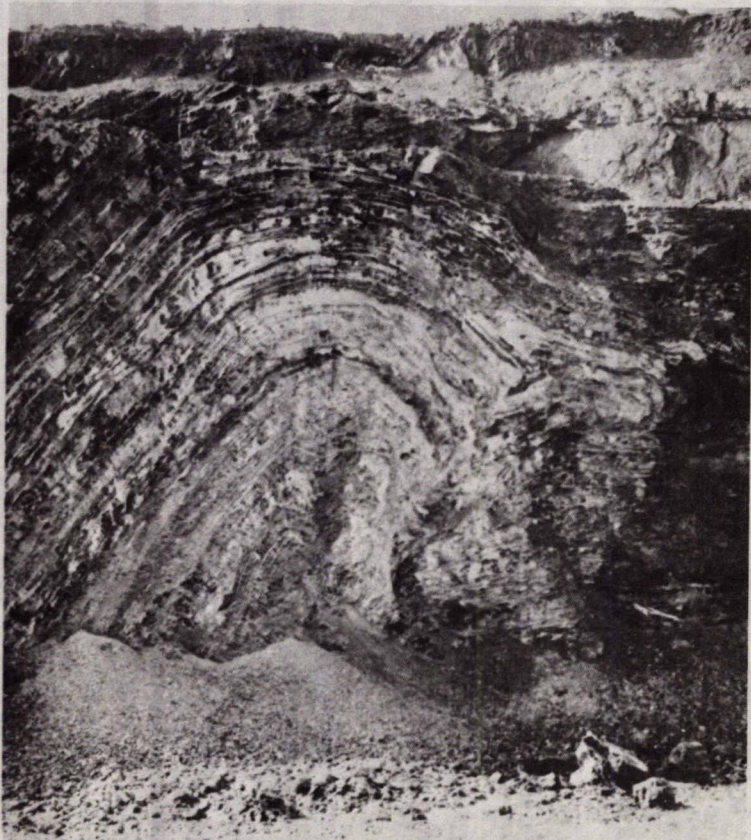
During May, 1962, mining operations in the next lower lift approached the toe of the wall in this area. On May 31 tension cracks opened up at the edge of the haul road at E1. 2130. During the night of May 31 the wall failed between section 36 and 37 and the edge of the road dropped 5 ft. The geological structure included a large synclinal fold which plunged toward the pit together with some smaller drag folds such as are shown in Figure 8.

Figure 8. Appearance of part of the face before the first slide occurred, May, 1962.

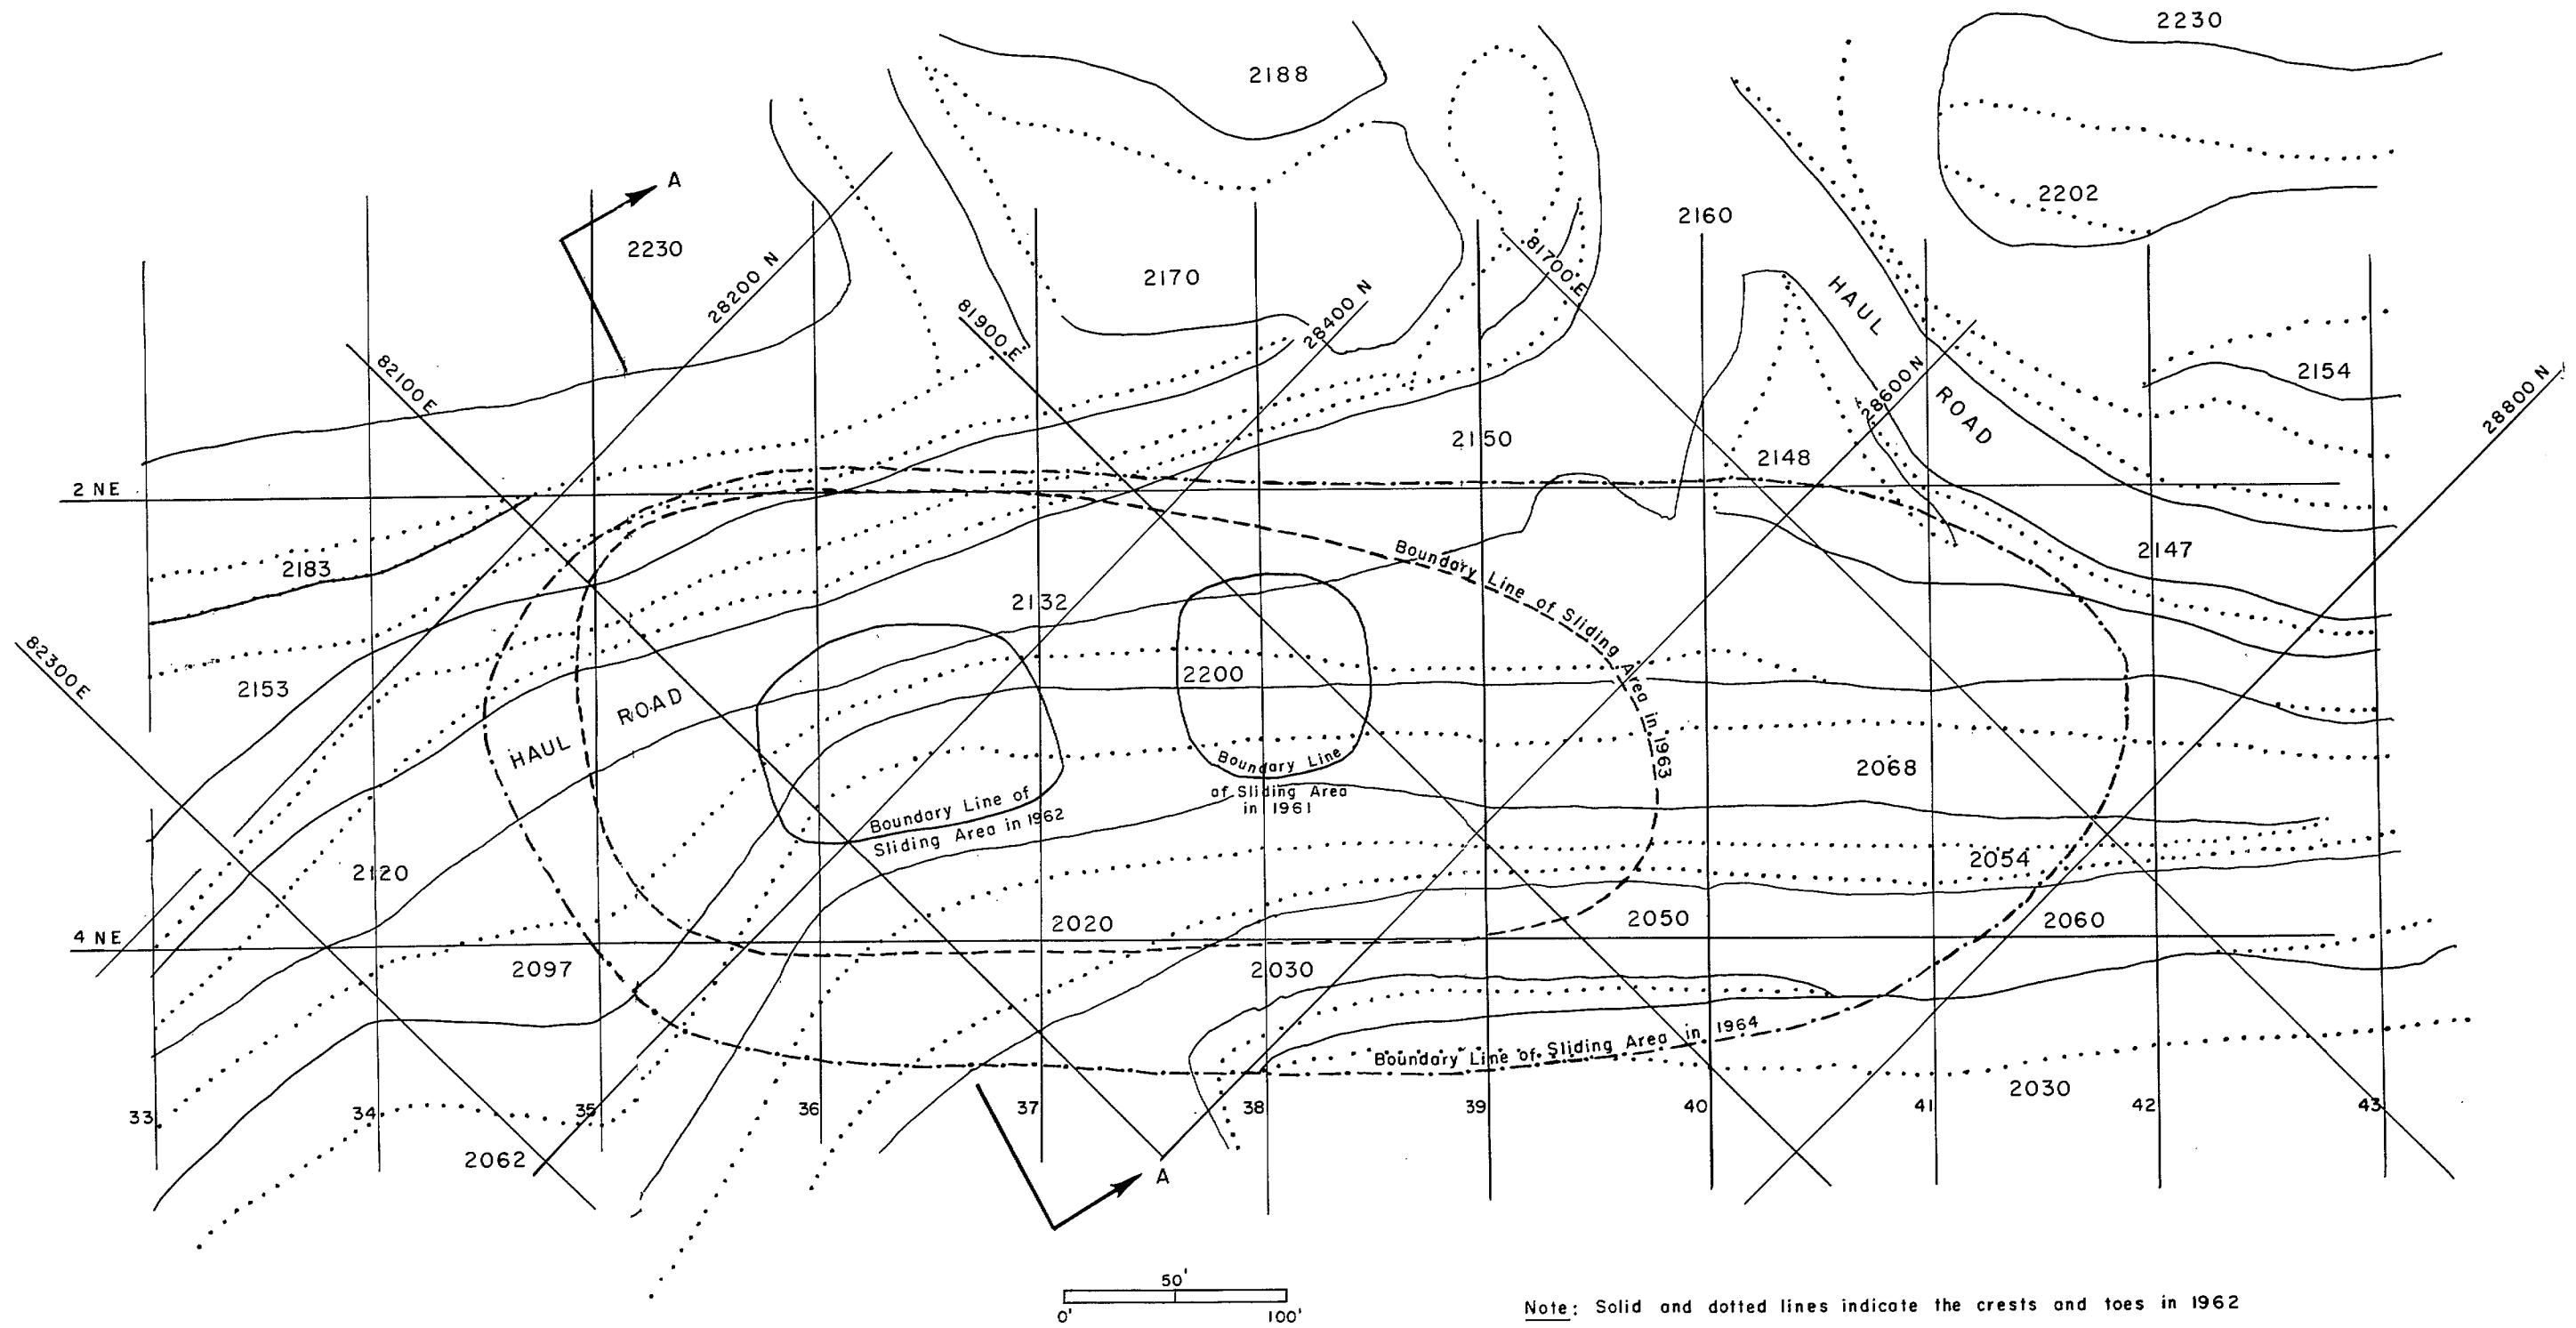
FIGURE 6

Figure 6 shows the plan and Figure 7 the cross-section of the pit wall in which several slides occurred over a period of years.

By the spring of 1964 the toe of the bank had been stripped down to E1. 1920. A new, larger slide outlined in Figure 6 then started to move down very quickly. The sliding surface in this case was in still slate.

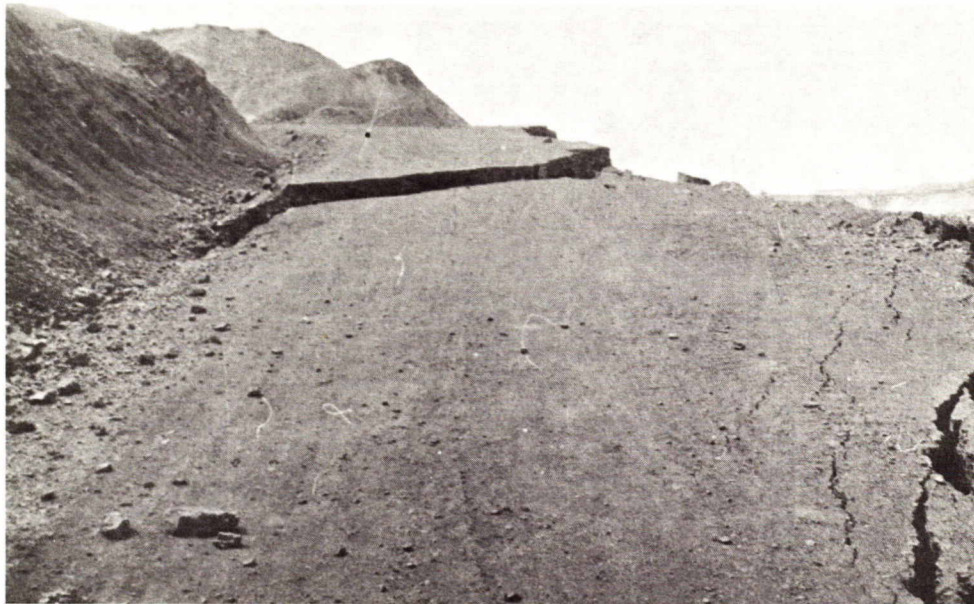
The movement of the wall was observed on several hubs placed on the surface of the ground and also on the new tension cracks which had formed across the haul road. By July this crack had opened up to a width of 2 ft with the edge of the road dropping about a foot as shown in Figure 9.

Figure 9. Two-foot-wide crack at the crest of the second slide, July, 1963.

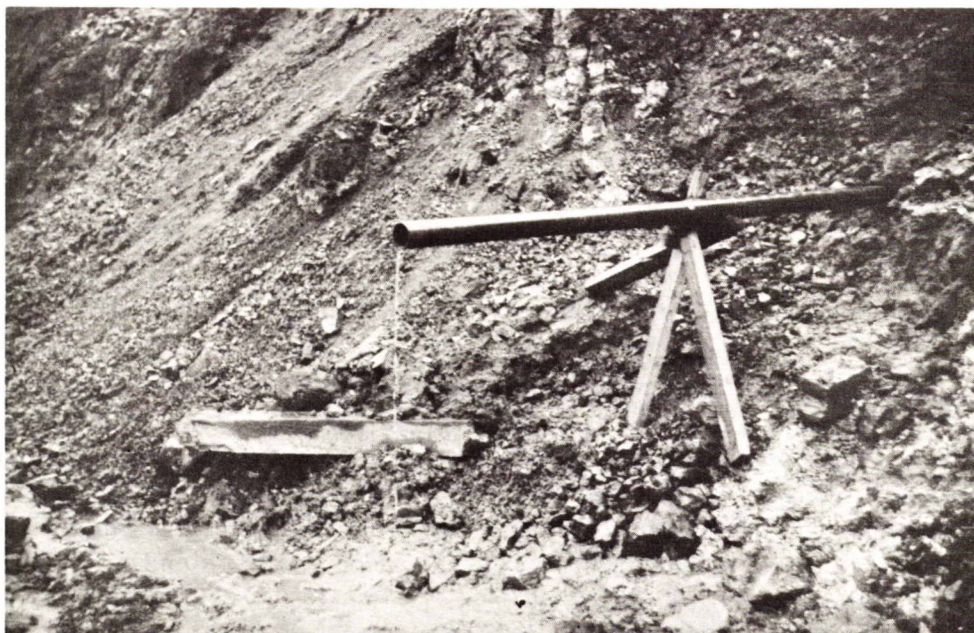
Figure 10. Horizontal drainpipe, July, 1963.

It is possible that failure was assisted by the effects of seepage water at this interface. During the summer of 1963 as part of the experimental remedial program, three horizontal drains were drilled through the slate into the more porous quartzite with the hope of decreasing the pore-water pressures and thus increasing the sliding resistance. A small flow was obtained, as shown in Figure 10, which increased during rainy periods; however, by the end of July the continued movement of the slide broke the pipes and the drainage action ceased.

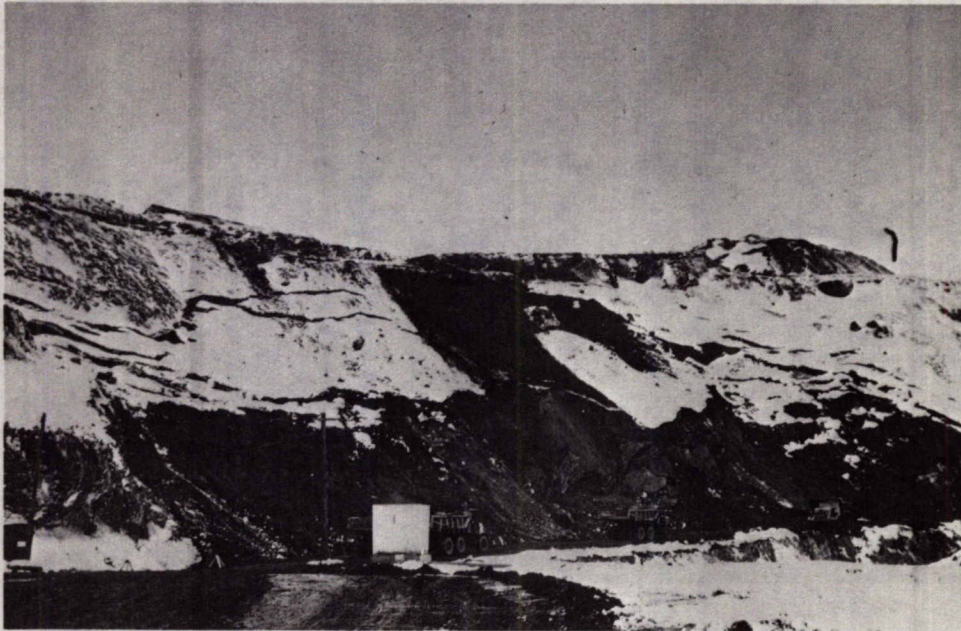
A main haul road was then required below the slide area at E1. 1920. To safeguard this road the average angle of the bank in this zone was decreased by moving back the wall above the old haul road. This work was done during the winter of 1963-64 with the removal of approximately 100,000 cu yards. When the ground at the crest of the slope was removed, the sloughed material at the toe of the slide was excavated with the material above the toe moving down under its own weight without any hangup. However, the removal of the slide material from the toe reactivated the old slide as shown by the cracks in Figure 11.

Figure 11. Shovel digging at the toe reactivates the slide, winter of 1963-64.
