IMPROVING THE PERFORMANCE OF FLUIDIZED BED BOILERS
AT CANADIAN FORCES BASE SUMMERSIDE

V.V. Razbin and F.D. Friedrich
Combustion and Carbonization Research Laboratory

APRIL 1986

ENERGY RESEARCH PROGRAM
ENERGY RESEARCH LABORATORIES
DIVISION REPORT ERP/ERL 86-21(OPJ)

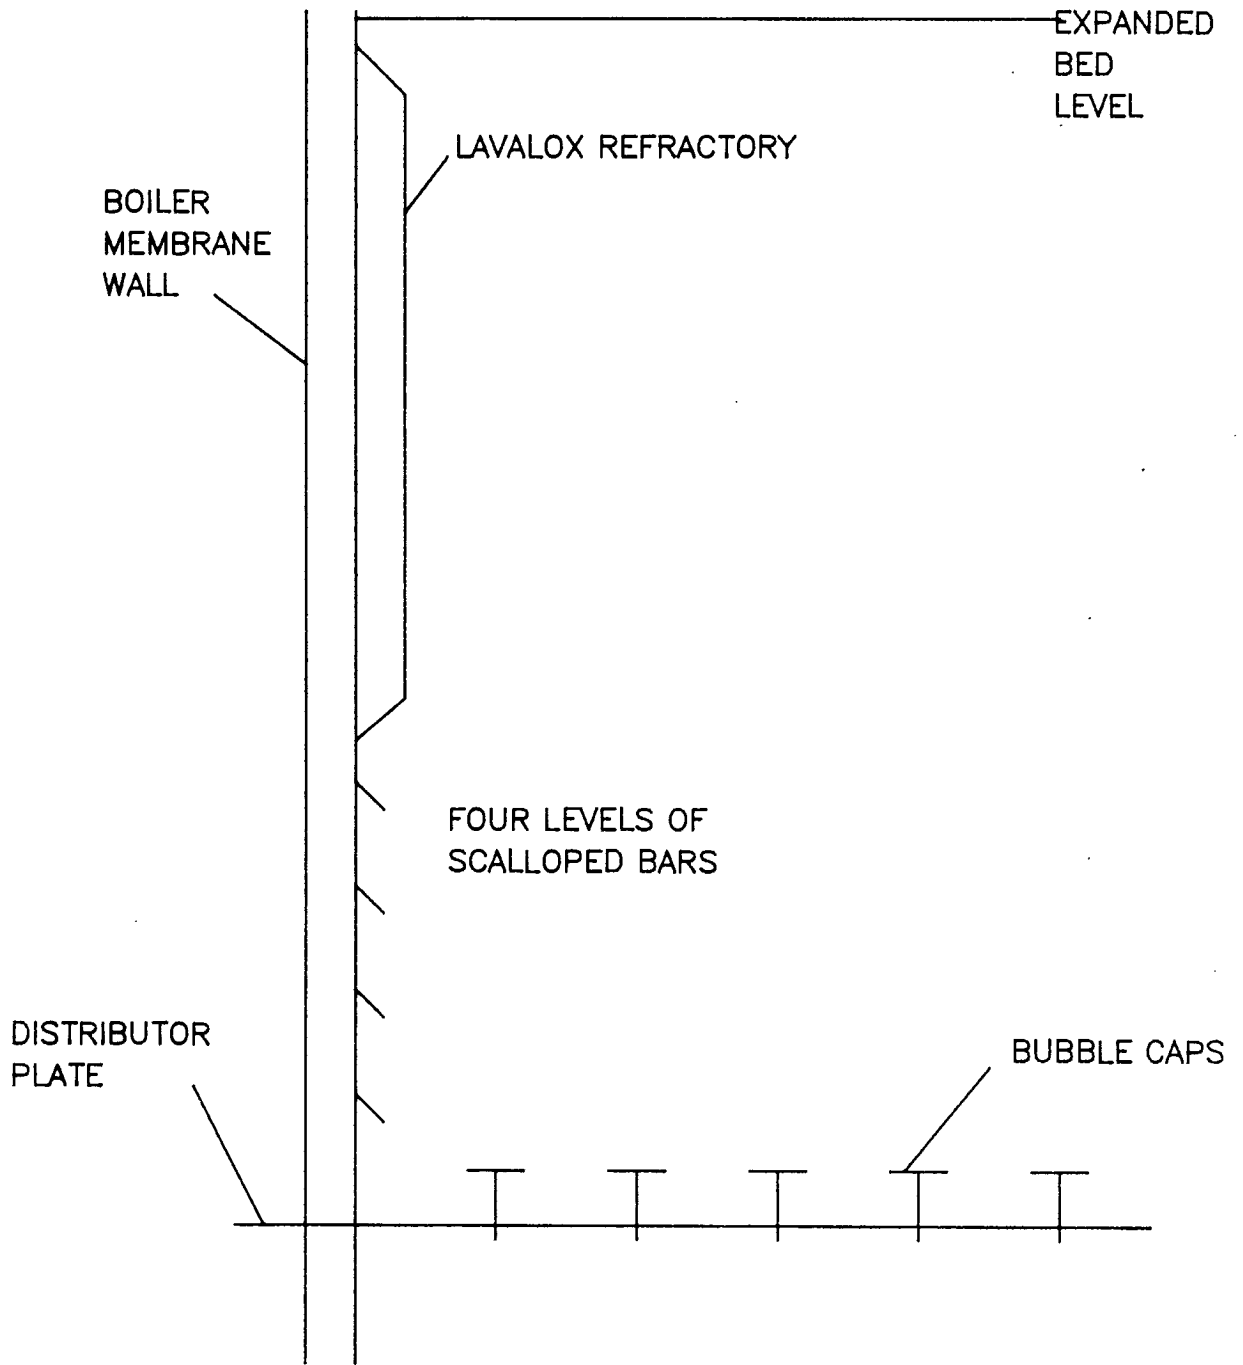
Fig.2- Schematic of refractory and scalloped bars applied to membrane walls

After a further 1000 h of operation, significant wastage of the membrane wall tubes below the refractory became evident. To counteract this, the contractor installed four rows of scalloped bars, which were welded to the fins between the tubes, angling downward at 45°, as shown in Fig. 2. Inspection after another 2000 h of operation revealed that:

- there was further polishing of the membrane wall tubes between the scalloped bars,
- a few sections of the scalloped bars had broken away,
- most of the protective alonized layer on the in-bed tubes in Bed B had spalled off, and
- there was some metal wastage of the in-bed tubes, particularly on the underside of the lower bend.

- all of the scalloped bars were removed,
- the protective refractory was removed from Bed A, but not from Bed B, because of inadequate access,
- pin studs were spot-welded to all exposed membrane wall tubes from the level of the distributor plate to a height of 1525 mm (60 in) The studs, 9.5 mm (0.375 in.) in diameter and 19 mm (0.75 in.) long were closely spaced, vertically oriented alternatively at 10, 12 and 2 o'clock or 11 and 1 o'clock, as shown in Fig. 3.
- to protect the in-bed tubes, carbon steel rods, 9.5 mm (0.375 in.) in diameter were welded to them longitudinally at the 1,4,6,8 and 11 o'clock positions, as shown in Fig. 4. The rods were welded continuously on both sides to ensure good heat transfer. At a few locations, the tubes were so thinned by erosion that they burned through during welding, and localized repairs were required.

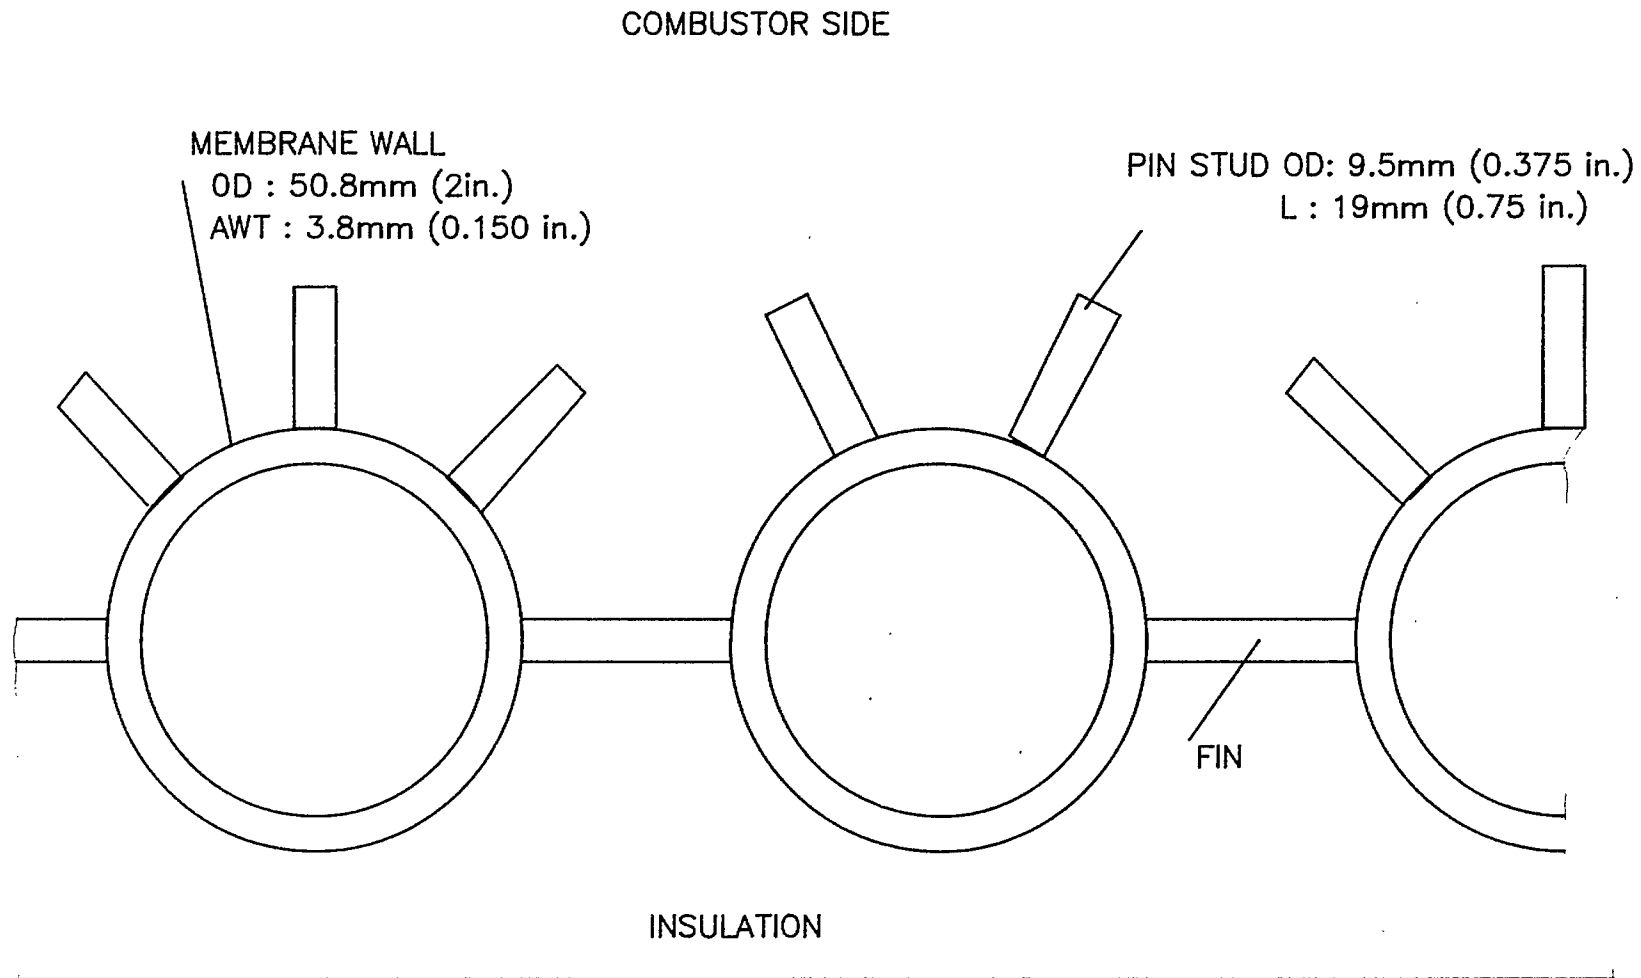
Fig.3 – Orientation of the pin studs on the membrane wall tubes

In February 1985, when Boiler No. 2 had logged 5600 h of operation, one membrane wall tube in Bed A ruptured at an exposed bend below the ignitor. Detailed inspection revealed that there were several other areas on the membrane walls, above and below the refractory, where tube thickness was less than 2.28 mm (0.090 in.) compared with the original thickness of 4.45 mm (0.176 in.). The in-bed tubes in Bed B also showed

Boiler No. 2 resumed service in September 1985. It was found that replacement of the refractory with the pin studs substantially improved heat transfer, as evidenced by an increase of almost 50% in boiler capacity, and a reduction in excess air to the 50-60% range. An inspection after 2500 h of operation revealed that none of the tube surfaces showed any signs of polishing; instead they were covered with a thin, black carbonaceous deposit. Some of the studs had rounded tips whereas others were capped with a partially sintered deposit of ash. Substantial quantities of gravel-sized shale particles were trapped between the studs in a band 380 to 890 mm (15

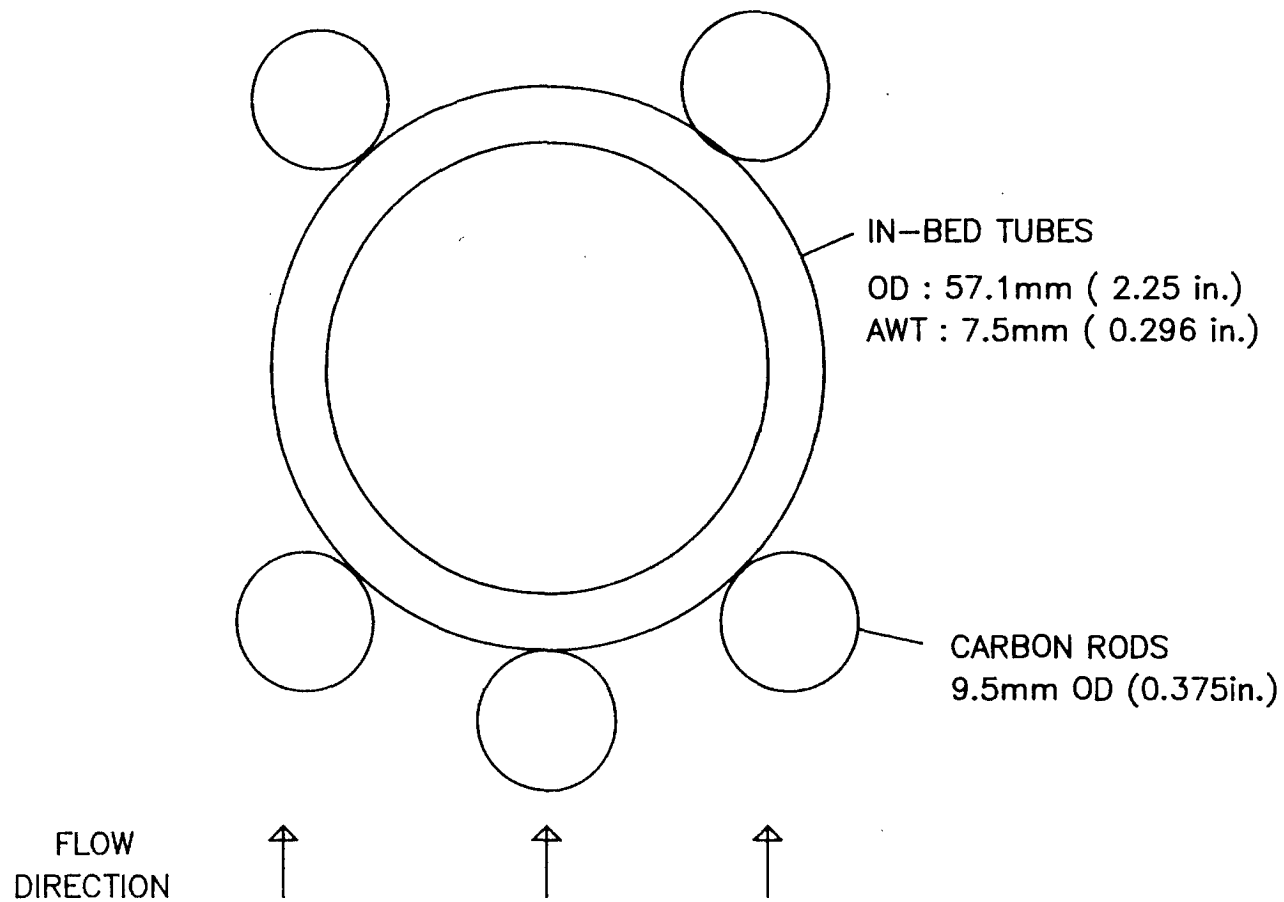
Fig.4 – Orientation of the carbon steel rods applied to the in-bed tubes

significant wastage; in localized areas wall thickness was reduced to 1.5 mm (0.060 in.) from the original 7.5 mm (0.30 in.). Undoubtedly a contributing factor to the high wastage rate was the high excess air level, which not only increased fluidizing velocities, but elutriation rate and therefore fly ash reinjection rate.

to 35 in.) above the distributor plate. The in-bed tubes likewise revealed no wastage beyond some polishing of the protective rods.

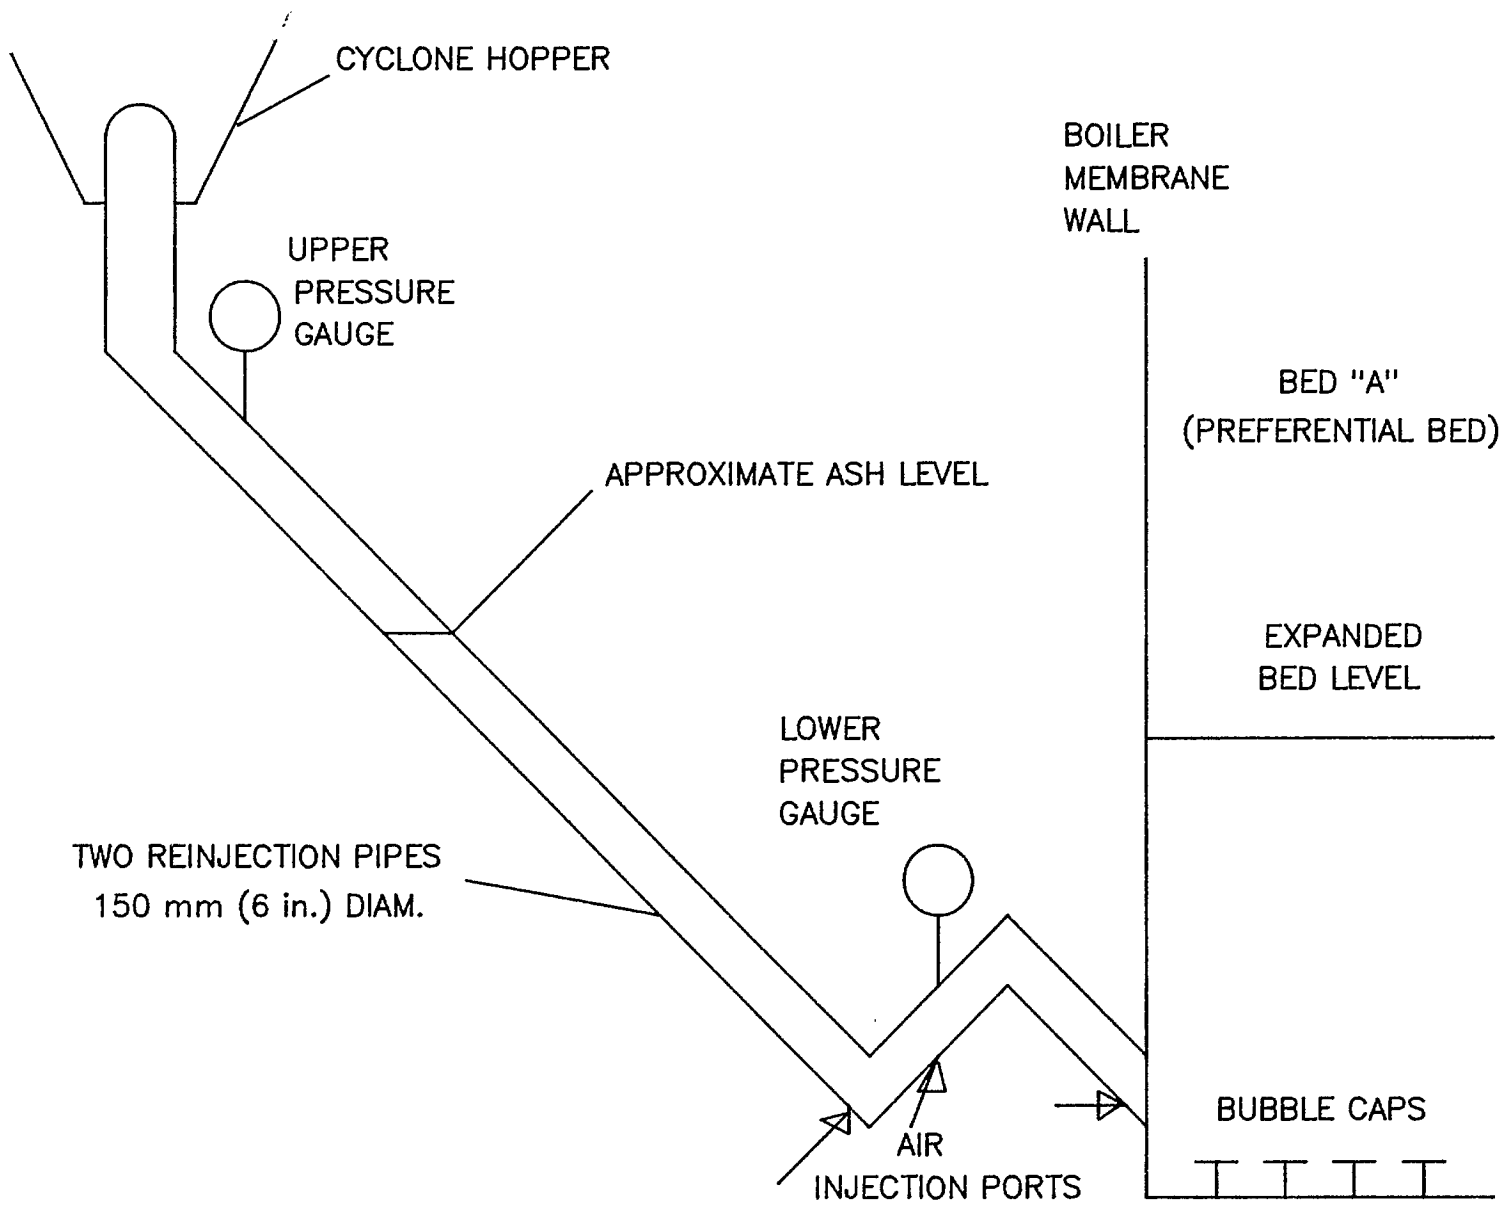
Fig.5 – Schematic of the new fly ash reinjection system

The two fly ash reinjection systems with which each boiler was originally equipped have already been described. Of these, the double lock hopper system serving the multiclone collector has required excessive maintenance, in that the lock hopper gates and their drive mechanisms had to be replaced or repaired several times because of erosion.

Furthermore, in Boiler No. 1, during the 1984/85 heating season, a solenoid valve in the vent line from one of the lock hoppers failed due to erosion, with the result that the vent line was subjected to a high-velocity flow of fly ash whenever that lock hopper was being discharged. The vent line terminated in the flue gas breeching upstream of the baghouse. Since several bags were broken, coarse fly ash penetrated to the induced draft fan, and caused sufficient erosion damage to the fan casing and impeller that both had to be replaced in the summer of 1985.

In the summer of 1985, the fly ash reinjection system serving the multiclone collector on Boiler No. 2 was replaced with a much simpler system employing a modified L-valve such as is commonly applied to a circulating fluidized bed combustor. The new system consists of two pipes 150 mm (6 in.) in diameter, each connecting one of the multiclone hoppers to one of the reinjection ports in the furnace wall. The pipes have a "Z" section at the lower end, as shown in Fig. 5, to form a seal against the static pressure of the fluidized bed. Fly ash flows by gravity from the multiclone hopper down the inclined pipe, is lifted over the "Z" section by small amounts of air injected at the lower elbow, and is then injected into the bed by an air

nozzle located in the reinjection port. Thus, except for the reinjection nozzles the entire system operates at low velocity, with minimal potential for erosion.

At the onset of the 1985/86 heating season, it was quickly demonstrated that the new system performs well in every respect. Upon failure of the air supply it is self-sealing, and subsequently can be restarted without difficulty. Similarly, on a few occasions the boiler was operated on Bed B only, which meant that fly ash recycle had to be interrupted until Bed A was put back in service. That situation, too, was handled without difficulty. The reinjection nozzles were inspected after 2500 h and 4500 h of operation, and showed no signs of erosion.

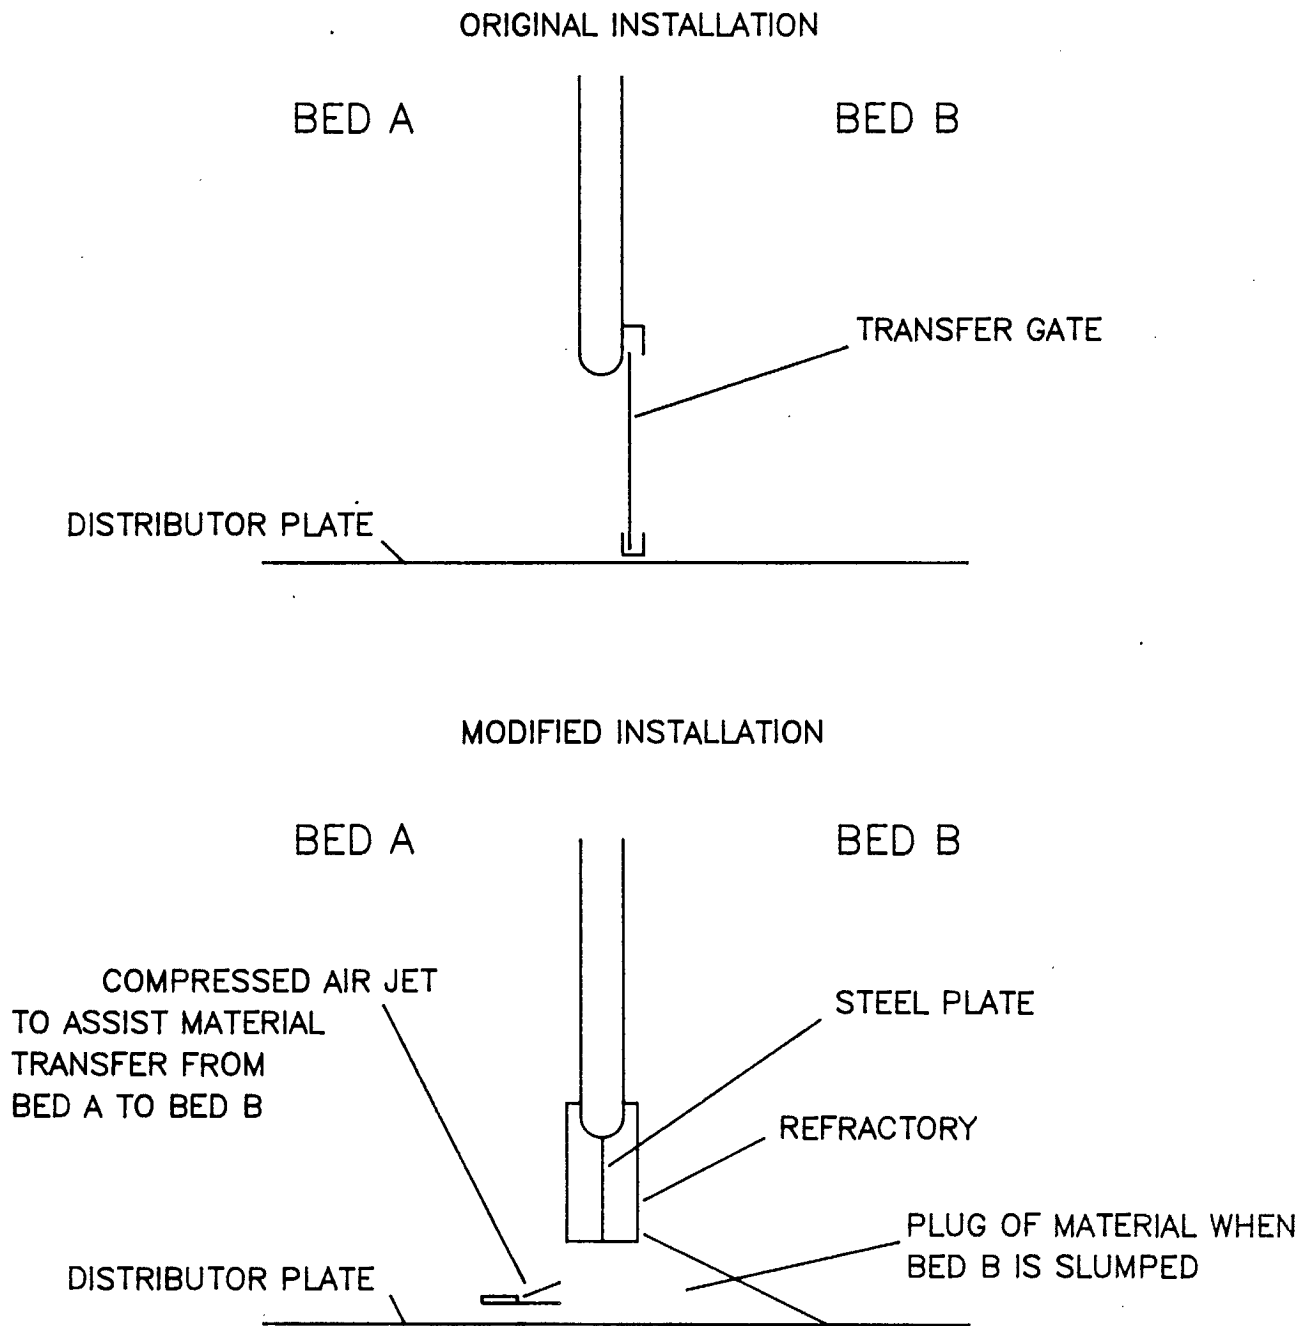
Fig.6 – Schematic of the inter-bed transfer gate as originally installed and as modified

As already explained, the boilers were originally equipped with an inter-bed transfer gate in the membrane wall separating Beds A and B. As shown in Fig. 6, it consisted of a steel plate sliding in a simple track, operated by means of a shaft extending through the stoker end of the combustor wall. Its function was to accomplish light up of Bed B by permitting a flow of hot material from Bed A, and it was intended to be closed when either or both beds were in normal operation.

Since the gate and shaft were uncooled, substantial warping occurred, with the result that the gate was often inoperable, and Bed B could not always be brought into service when required. Furthermore, the membrane wall tubes along its path of travel could not be protected against erosion.

At times when the gate could not be closed, it was observed that with Bed A in operation and Bed B slumped, the opening sealed itself with a buildup of slumped material in Bed B. It was therefore decided to remove the gate and leave a smaller, permanent opening. This was accomplished by welding in a steel plate and protecting it with refractory on both sides, as shown in Fig. 6. Also, studs were applied to the previously unprotected membrane wall tubes.

Some experimentation was required to establish an optimum size for the opening. Occasionally crusting of the slumped material occurred, and prevented a free transfer of material when Bed B was subsequently fluidized. This was overcome by installing two compressed air jets in the opening, pointing from Bed A to Bed B.

The permanent opening has permitted trouble-free operation throughout the 1985/86 heating season. Bed B can be slumped at a low level while Bed A is operating at normal level. Ignition of Bed B is accomplished quickly and reliably when it is fluidized. The air jets were used only on a few occasions when the difference in height between the two beds was insufficient to cause the desired flow from Bed A to Bed B.

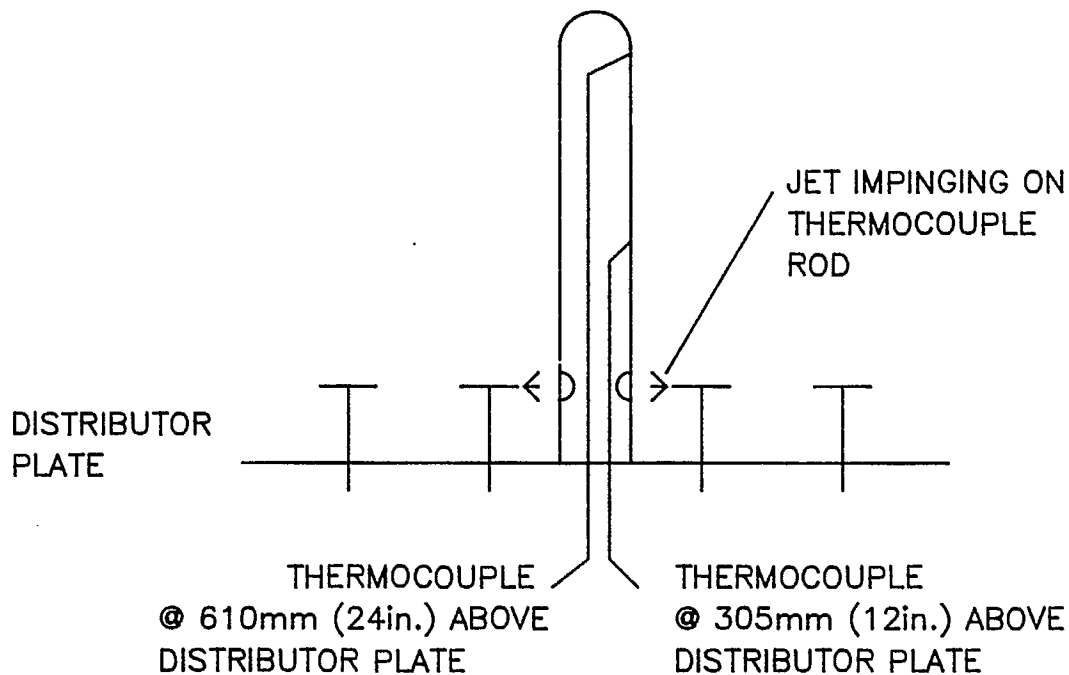
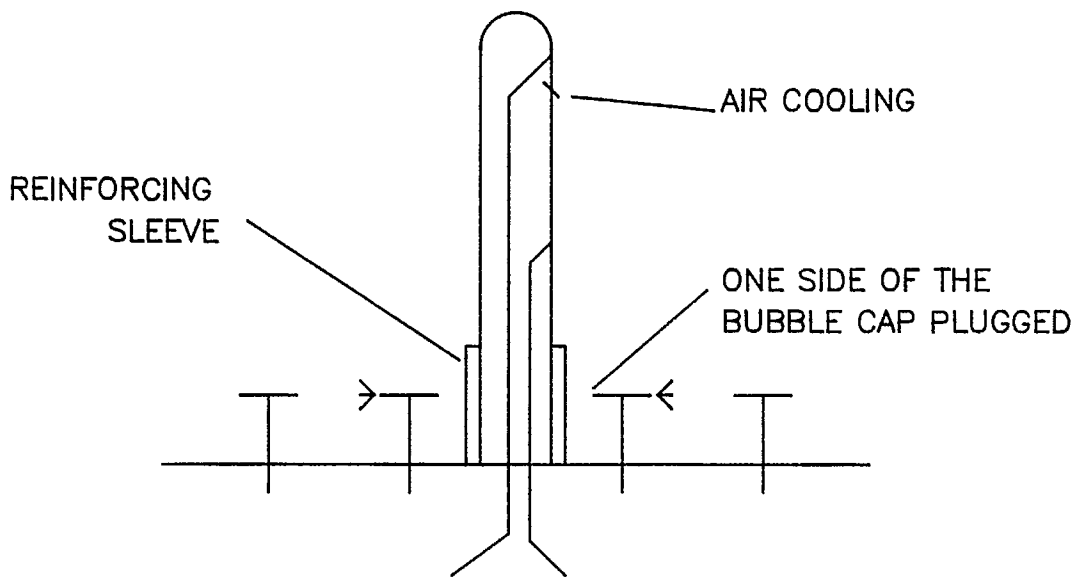
Fig.7 - Bed thermocouple installation as originally provided and as modified

A consequence of the low bed level during the light-up procedure was that the bed thermocouples were exposed to the high temperatures generated by the ignition burner and the surface fire, and therefore failed frequently. Often there were one or two thermocouple failures during the light-up process. Thermocouple failure was also common due to erosion caused by impingement of air jets from the bubble caps on the base of the thermocouple well, as shown in Fig. 7.

During the 1985 summer shutdown, 75% more bubble caps were installed in Bed A of each boiler. Furthermore, in all beds, those bubble caps pointed at the thermocouple wells were plugged. Similarly, bubble caps around the periphery of each bed were rotated to ensure that no jets impinged on the membrane wall tubes. Finally the thermocouple wells were modified as shown in Fig. 7, by making them of heavier material, putting a protective sleeve around the base, and drilling a small hole below the upper thermocouple junction, which permits a small flow of cooling air from the plenum.
