Research Report No. 49, "Experimental Zinc Die C	asting	ſ						
Equipment.								
(Preliminary Work on Project Zn-4)"								
ł								
			······	المراجع				
				TENT	5			
	BLE C	JF CO	NTEN	15				
						Page		
Introduction		••		••	• •	1		
Die Casting Machine				• •		2

RESEARCH REPORT NO. 49.

Experimental Zinc Die Casting Equipment

(Preliminary Work on Project Zn-4)

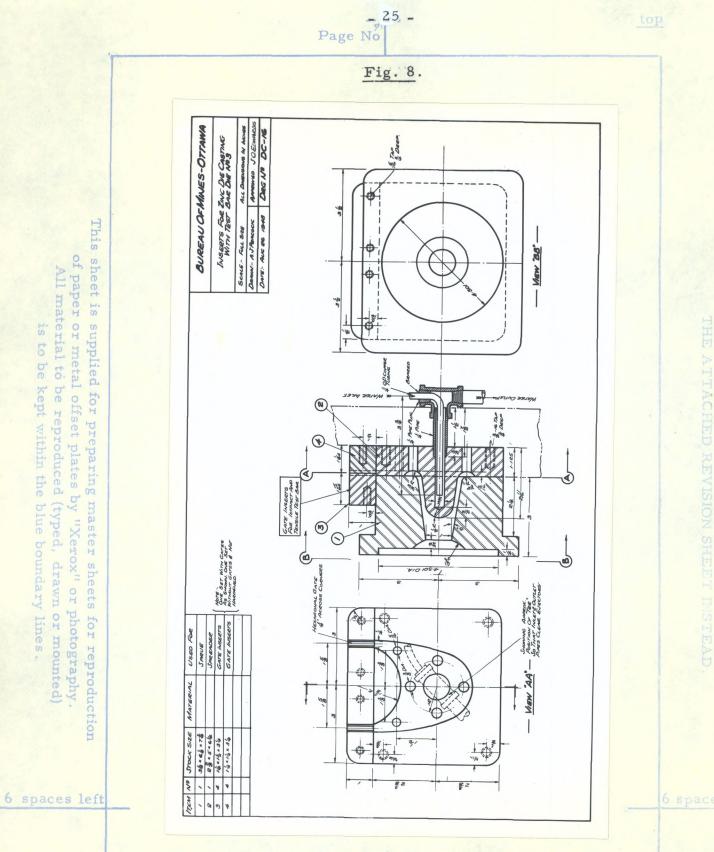
This die was based on a design submitted by the Precision Castings Company Inc., Syracuse, N. Y., to ASTM Committee B-6. The die is illustrated in Figs. 7 and 8. Initially, half of the full hexagon gate was inserted, and sound castings were produced. The full hexagon gates gave less satisfactory results, and since neither of these gates was of conventional design it was decided to replace them with gates similar to those shown in Fig. 4.

Drawing showing details of sprue and gate inserts for two-cavity test bar die.
