A CASE HISTORY OF SUPPORT AT NACIMIENTO MINE

Ben L. Seegmiller

DECEMBER 1976

MINERALS RESEARCH PROGRAM
MINING RESEARCH LABORATORIES
CANMET REPORT 76-27

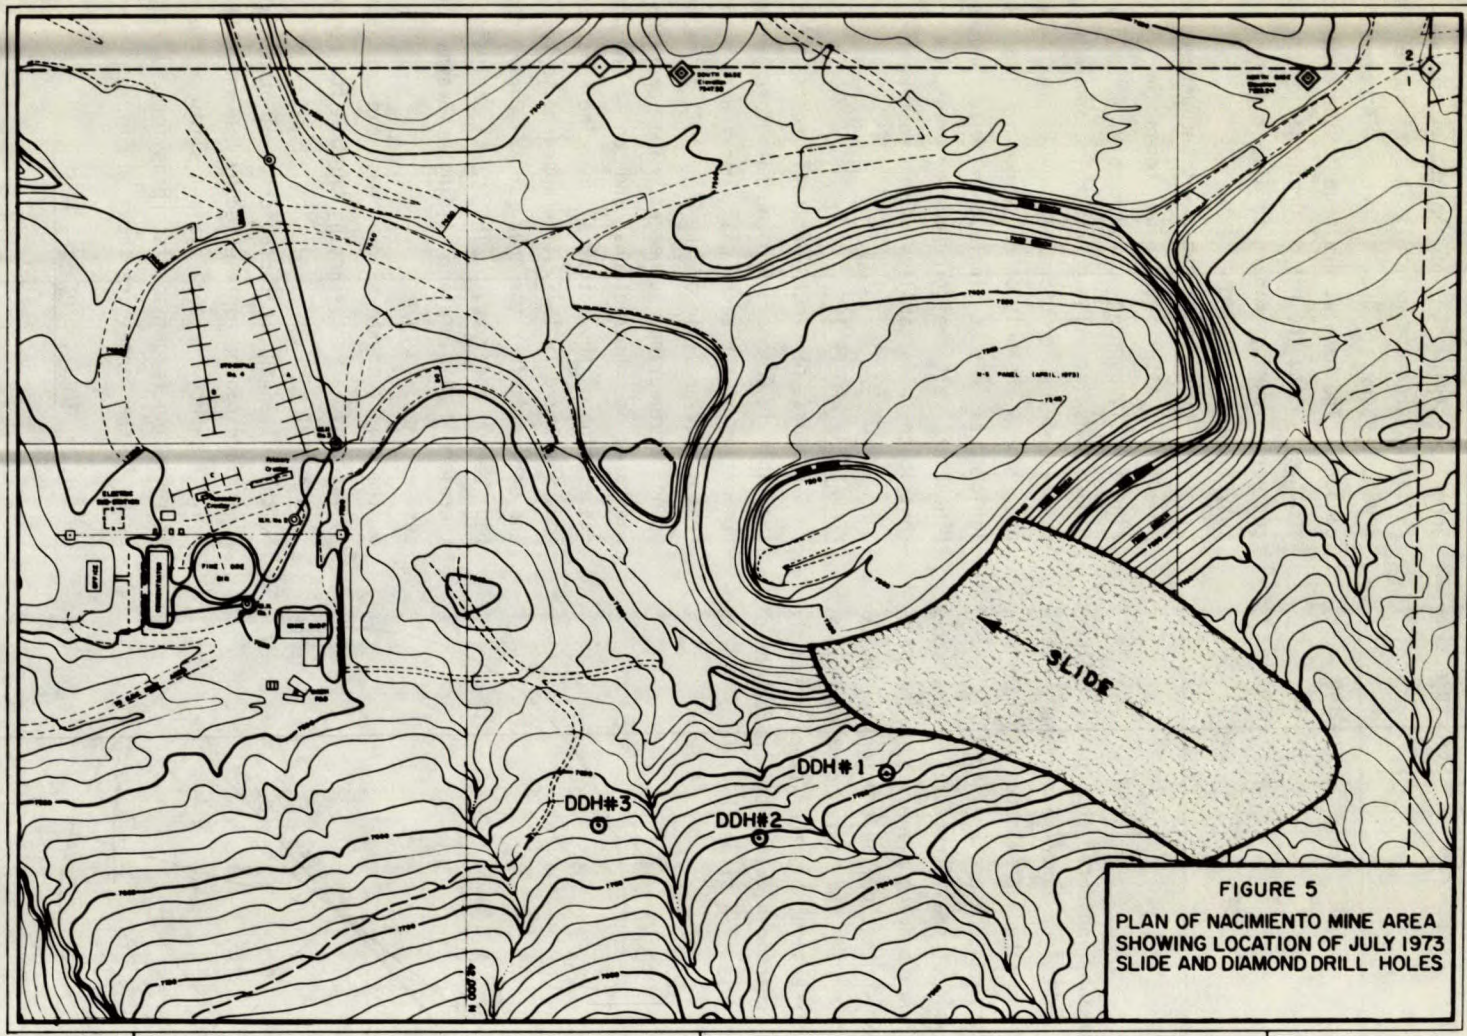
Fig. 5 - Plan of Nacimiento Mine area showing location of July 1973 slide and diamond drill holes.

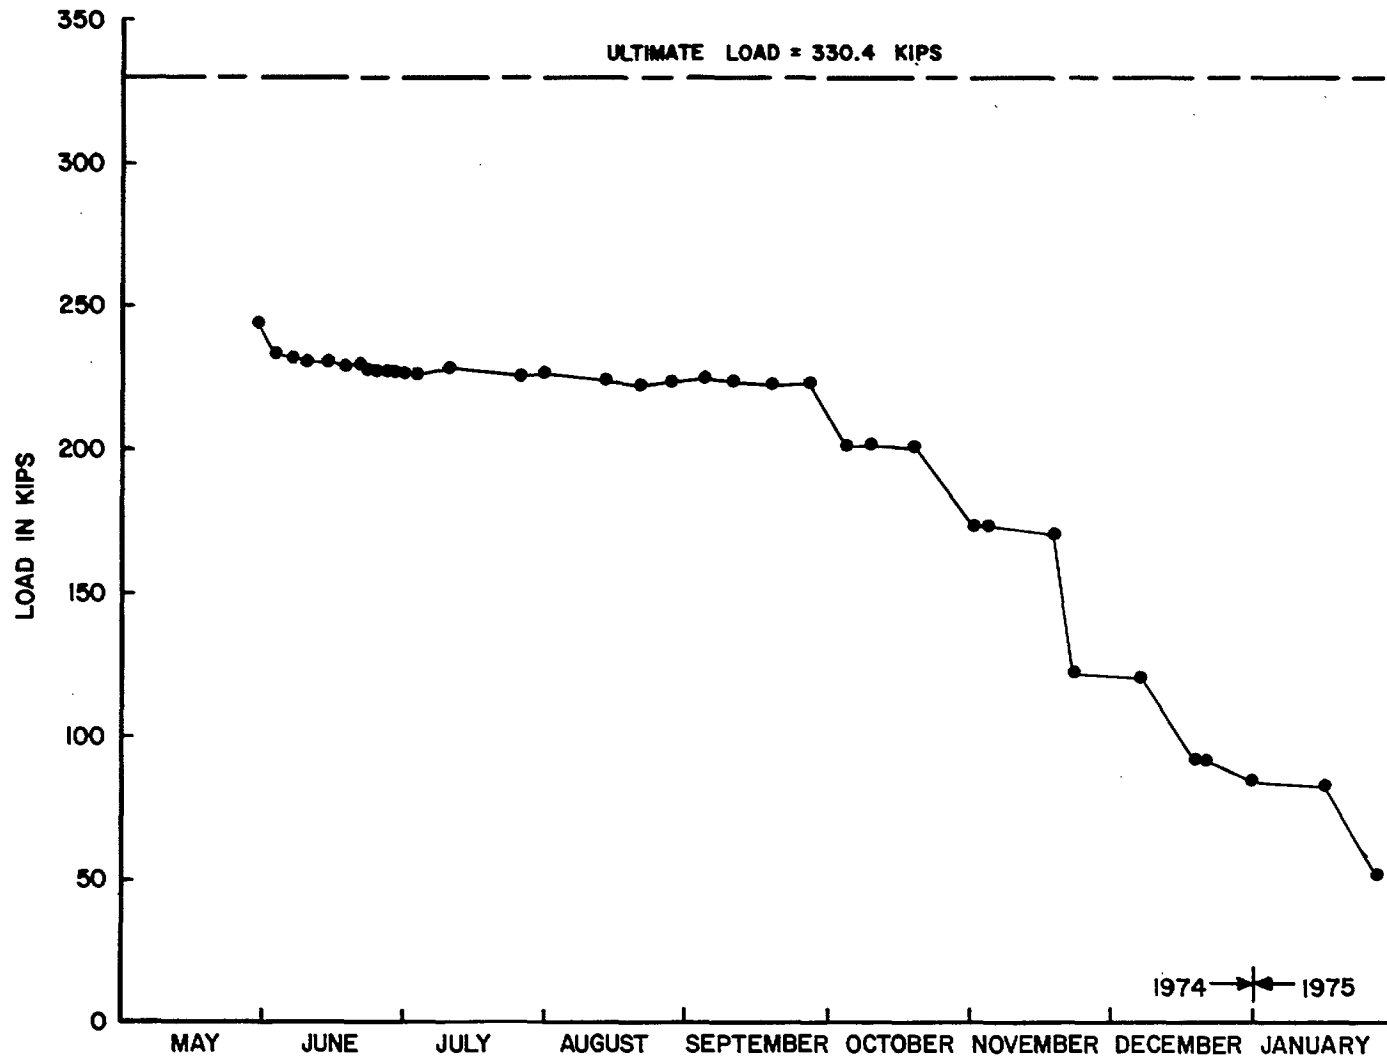
Fig. 30 - Load cell plot showing typical load loss

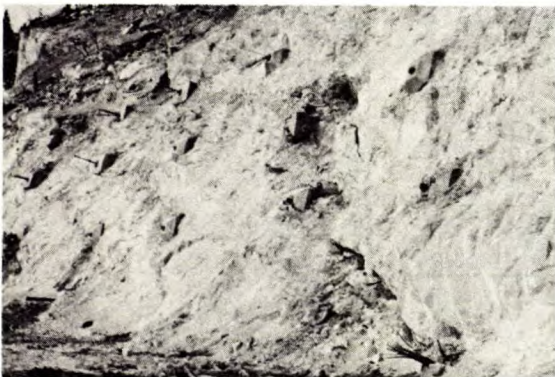
When the Agua Zarca - Cutler contact was undercut at the north end of the 7470 Bench water flowed out along the contact at approximately 50 gpm and persisted for several days. As each successive level was stripped and more of the contact exposed, water continued to drain. The undercut contact on the north end of the anchor installation is shown in Fig. 31. Two additional drain holes were drilled on the south end of the 7470 Bench, but these were also dry. When the 7460 Bench was drilled, water flowed from several of the anchor holes and continued for several days. It was concluded that large adverse groundwater pressures had not been present, but that isolated zones of groundwater did exist with localized effect only.

Fig. 31 - Undercut Agua Zarca-Cutler formation showing draining water

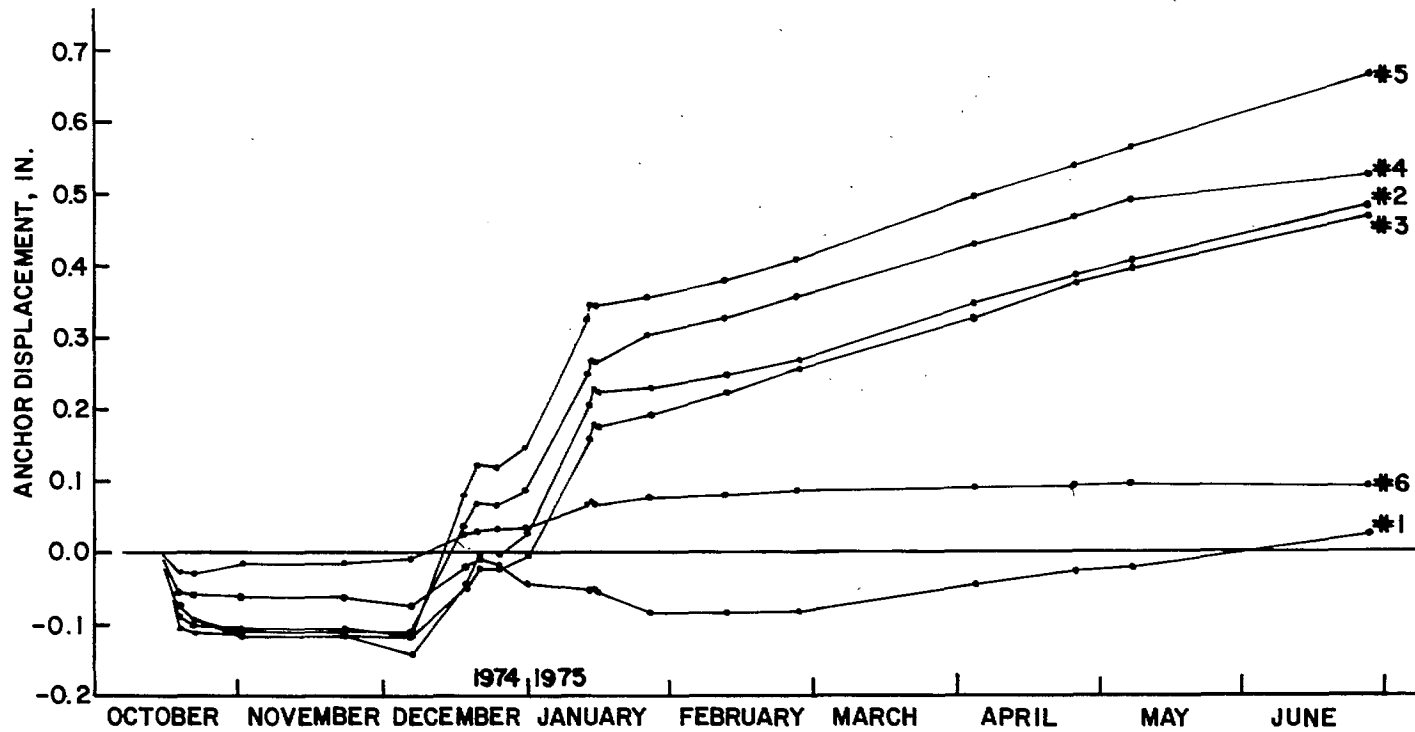
Fig. 32 - Displacement plots for extensometer anchors

Table 12. As shown in Fig. 32, anchors 1 and 6 had moved only slightly. Anchors 2 to 5 showed movement greater than 0.5 in. Any actual movement should have been shown by the deepest anchor, no. 1. It appears therefore that anchor 1 was no longer functioning and should have been disregarded. In this case, Fig. 32 indicates that a movement of approximately 0.5 in. had occurred between anchors 5 and 6 and appeared to be continuing at a slow but steady rate. This possible movement is relatively shallow and occurred between 30 and 100 ft from the collar. The Agua Zarca - Cutler contact in the extensometer hole was located at a depth of 214 ft from the collar.
