PIT SLOPE MANUAL

supplement 2-5

STRUCTURAL GEOLOGY CASE HISTORY

MINERALS RESEARCH PROGRAM
MINING RESEARCH LABORATORIES
CANMET REPORT 77-24

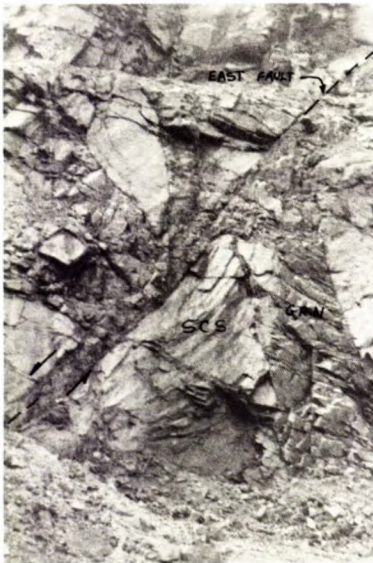
22. Faults have offset the granite and granodiorite, indicating that faulting is more recent than the youngest rocks. In most cases, the amount of offset is impossible to determine, but in some places appear to be several tens of feet. Offset ranges from 2 ft (0.6 m) on small faults to approximately 200 ft (60 m) on large faults. The East fault, no. 41 in Fig 1, for example, has a normal displacement of 20 ft (6 m) as indicated in Fig 5, whereas the Southwest fault, no. 13 in

Fig 5 - East fault with a displacement of 20 ft (6 m).

Fig 1, has displaced the orebody approximately 200 ft (60 m). The twisted and drag folded nature of the material adjacent to this fault is evident through the Central Fault Zone between fault no. 13 and fault no. 14.

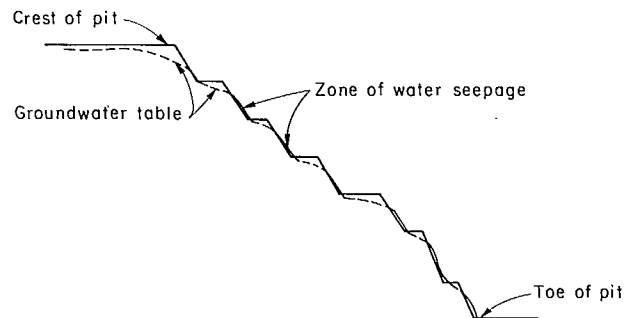
Fig 14 - Groundwater level in the hanging wall, with a visual classification of seepage.

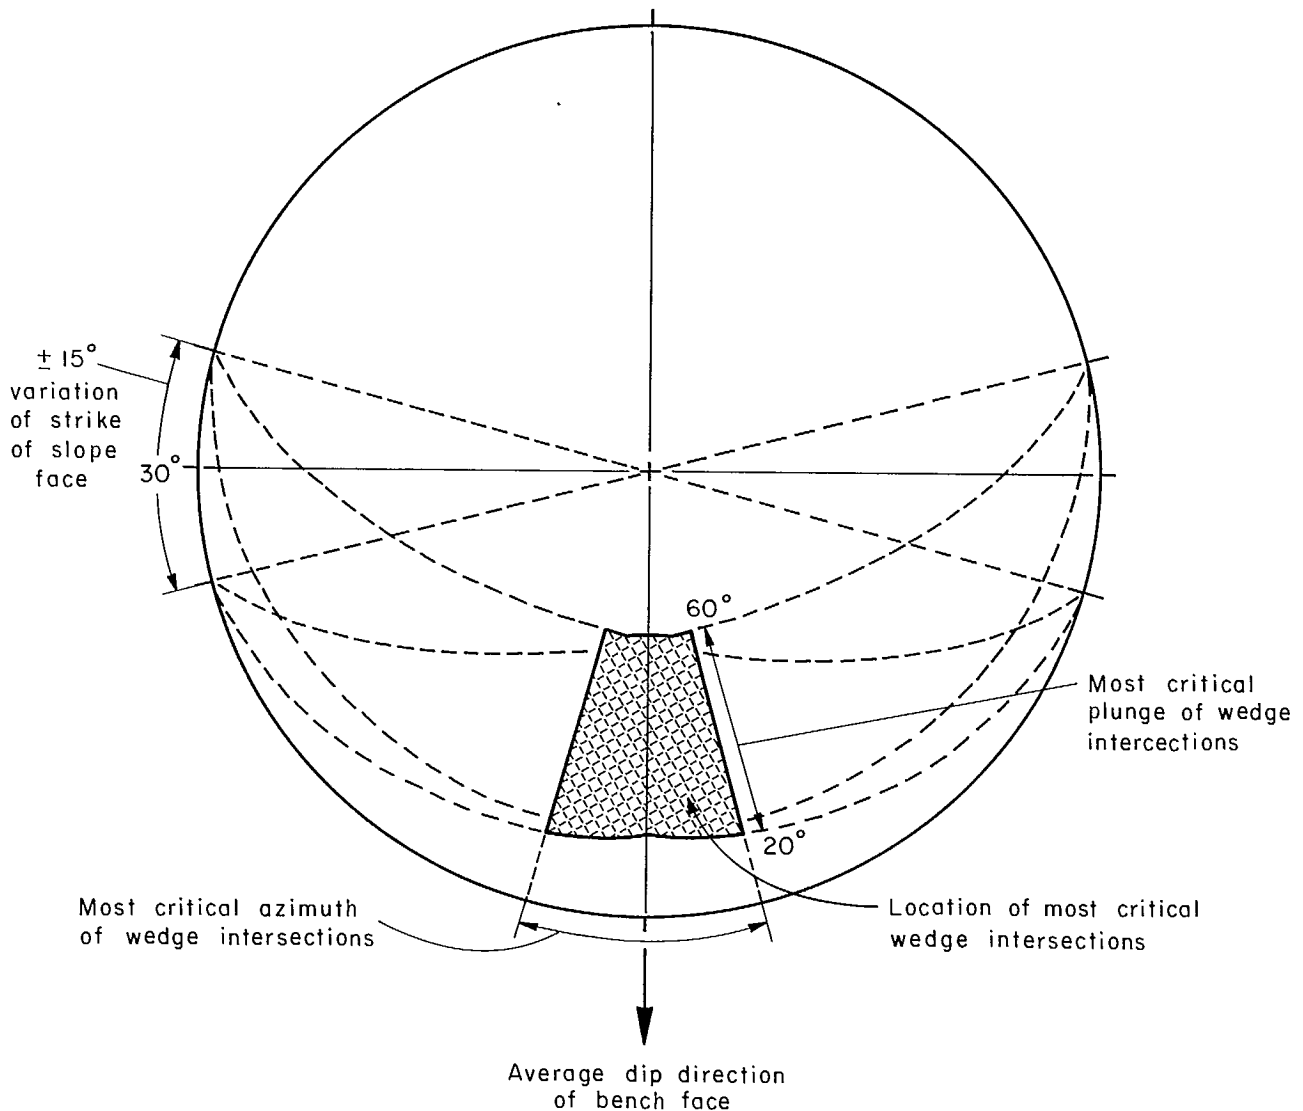
68. The major structures were grouped in areas in which the trend of the bench faces are approximately similar and plotted on equal area nets. Each plot was examined individually and in combination with adjacent equal area nets to define the lines of intersection of all possible unstable wedges using the criteria described above. All intersections falling within the shaded area marked by heavy lines on Fig 15 were

Fig 15 - Critical wedge intersections.

considered unstable wedges.

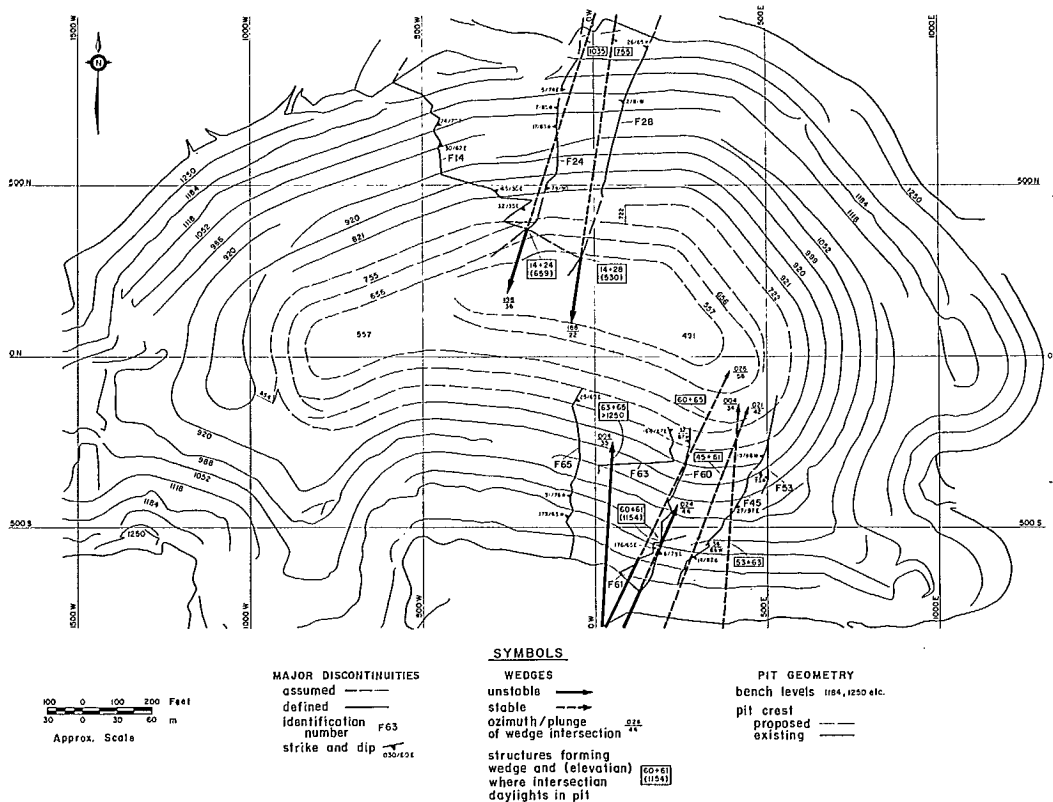
Fig 16 - Critical wedges from fault intersections in proposed slopes of Hilton Mine pit.

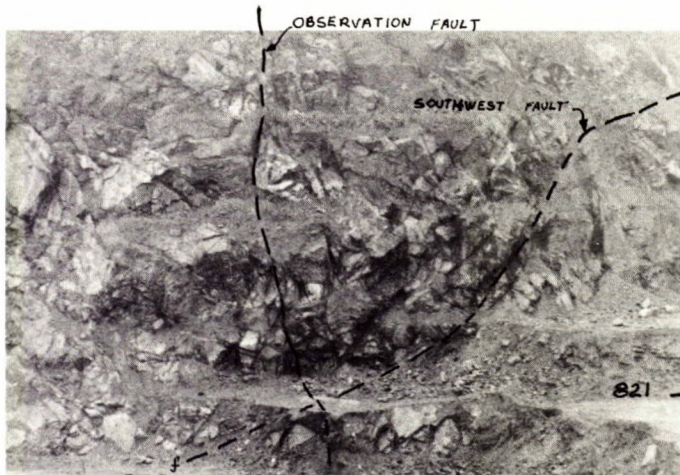
98. A recent failure on bench 920S involved the Southwest fault and several major joints and shears which form a zone of large loose blocks in the slope (Fig 20). Material fell from this zone twice during the summer of 1973 and loose material still exists. Groundwater along the Southwest

fault appears to have contributed to the failures.

99. The Southwest fault has a well brecciated zone on the lower part of the footwall and flattens considerably with depth. The intersection of the Southwest fault and the Observation fault is visible on bench 799S (Fig 20) but dips into the face and does not present any potential stability problem. However, several other faults on the Southwest nose could be involved in possible instability.

Fig 20 - Unstable southwest nose area due to intersection of observation fault and southwest fault (F 13).

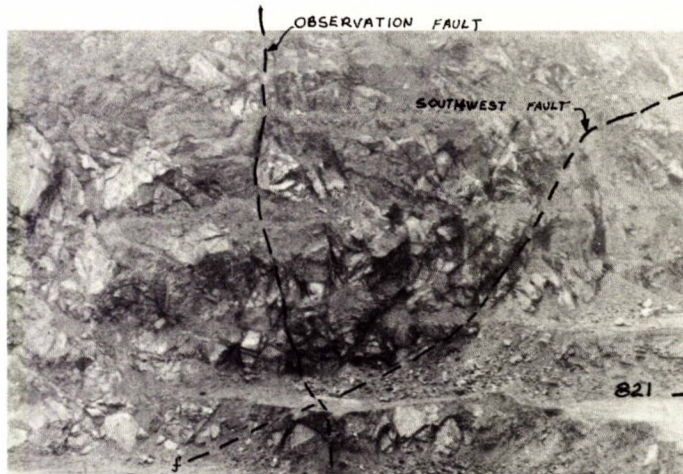
fault appears to have contributed to the failures.

99. The Southwest fault has a well brecciated zone on the lower part of the footwall and flattens considerably with depth. The intersection of the Southwest fault and the Observation fault is visible on bench 799S (Fig 20) but dips into the face and does not present any potential stability problem. However, several other faults on the Southwest nose could be involved in possible instability.

Fig 20 - Unstable southwest nose area due to intersection of observation fault and southwest fault (F 13).
