BRIEF REPORT ON VISIT TO THE EPICENTRE OF THE
2 MARCH 1987 EDGE CUMBE, NEW ZEALAND, EARTHQUAKE

John Adams

Internal Report #87-6

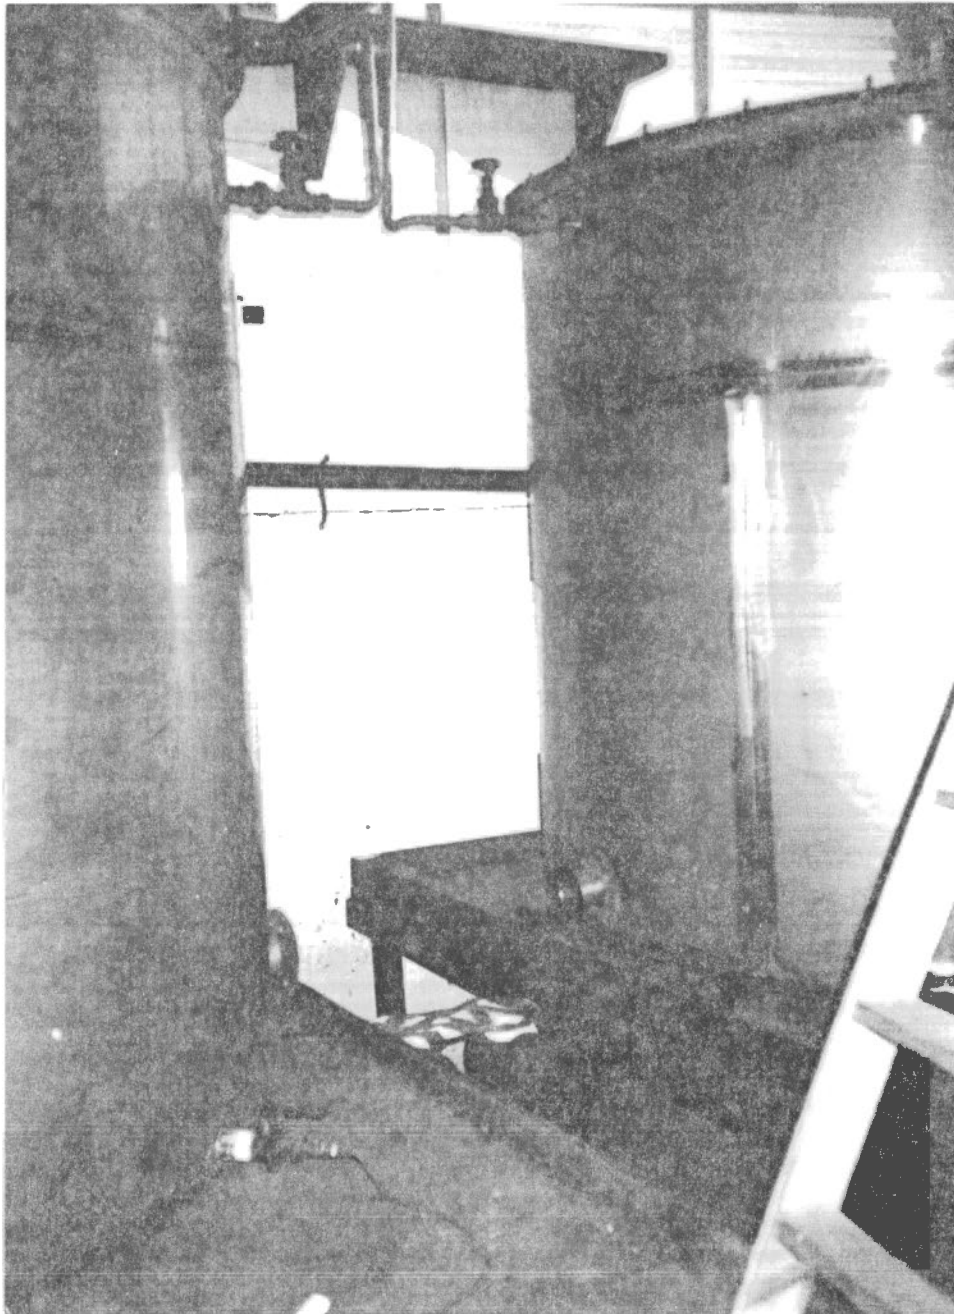
Figure 4. Failure of water supply pipe, mechanical room, top floor Whakatane Hospital.

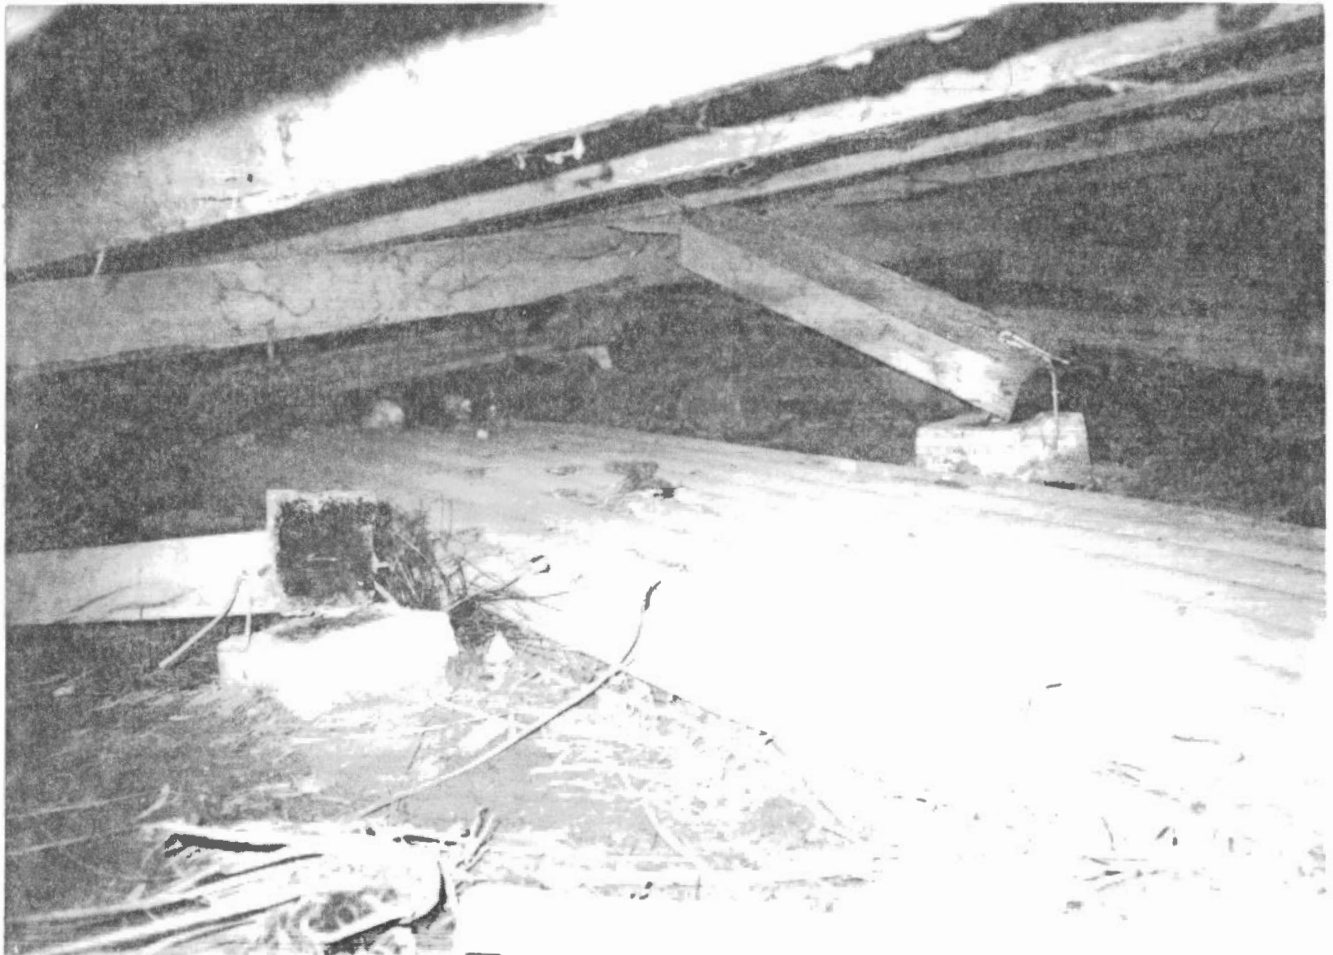
Figure 5. Failure of timber piles, house at Edgcumbe.
