ORE DRESSING AND METALLURGICAL LABORATORIES.

Investigation No. 890.

An Examination of a Broken Front Axle Housing.

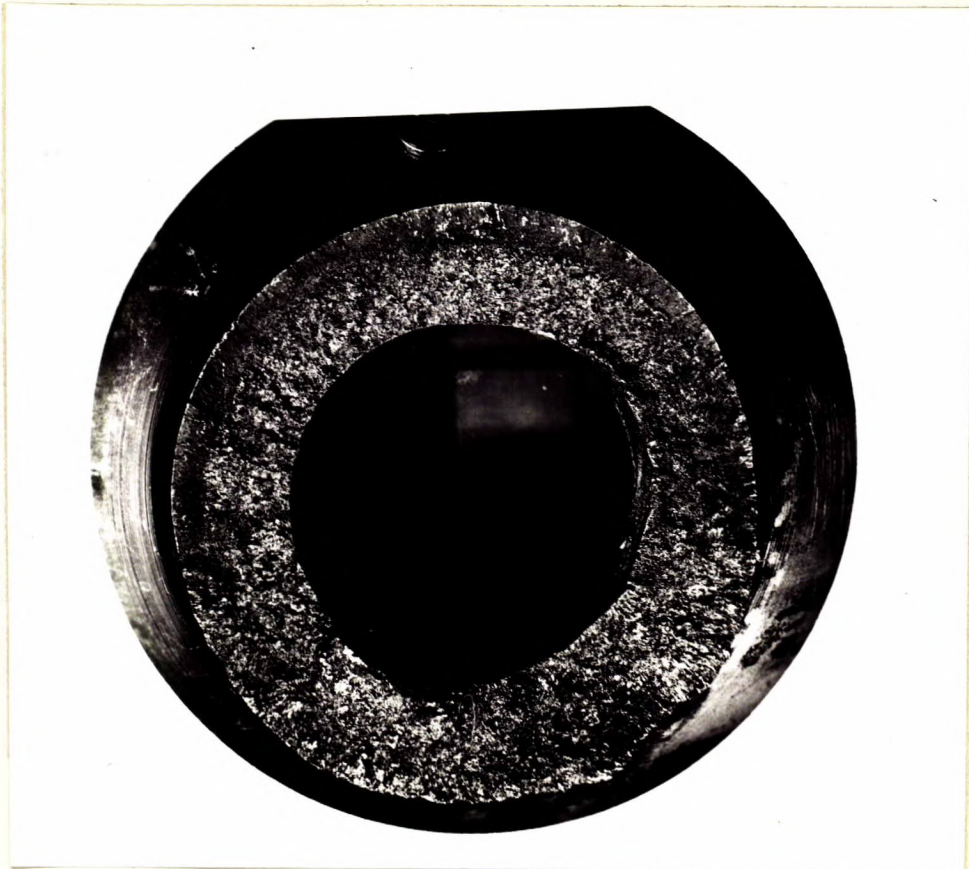
Figure 1.

The housing failed just before it expanded into the ball joint portion through which the king-pin runs. Figure 1 shows the fracture on the ball joint section, while Figure 2 shows the fracture as viewed along the housing in the direction of the differential. Both photographs are approximately to size. It may be seen that the fracture is of the duplex type, all but a small smooth area being coarse-grained. The location of the greasing connection in the ball joint and the position of the king-pin bearings indicate that the centre of the smooth area was at the top of the housing.

The duplex type of fracture exhibited by the broken casting is the type usually associated with failures produced by the action of changing bending stresses, the smooth surface showing where the gradual failure occurred, as the two faces in this zone had a chance to wear smooth on each other. The coarse-grained portion of the fracture reveals the portion of the housing that failed at the time of accident. Fatigue cracks usually start at points that are locally more highly stressed as a result of changes in section or because of the presence of surface imperfections. It is significant that there appears to be a heavy tool mark on the outer surface of the housing at the point where the fine-grained portion of the casting starts.

To size.  
Fracture, showing ball joint portion of housing in background.

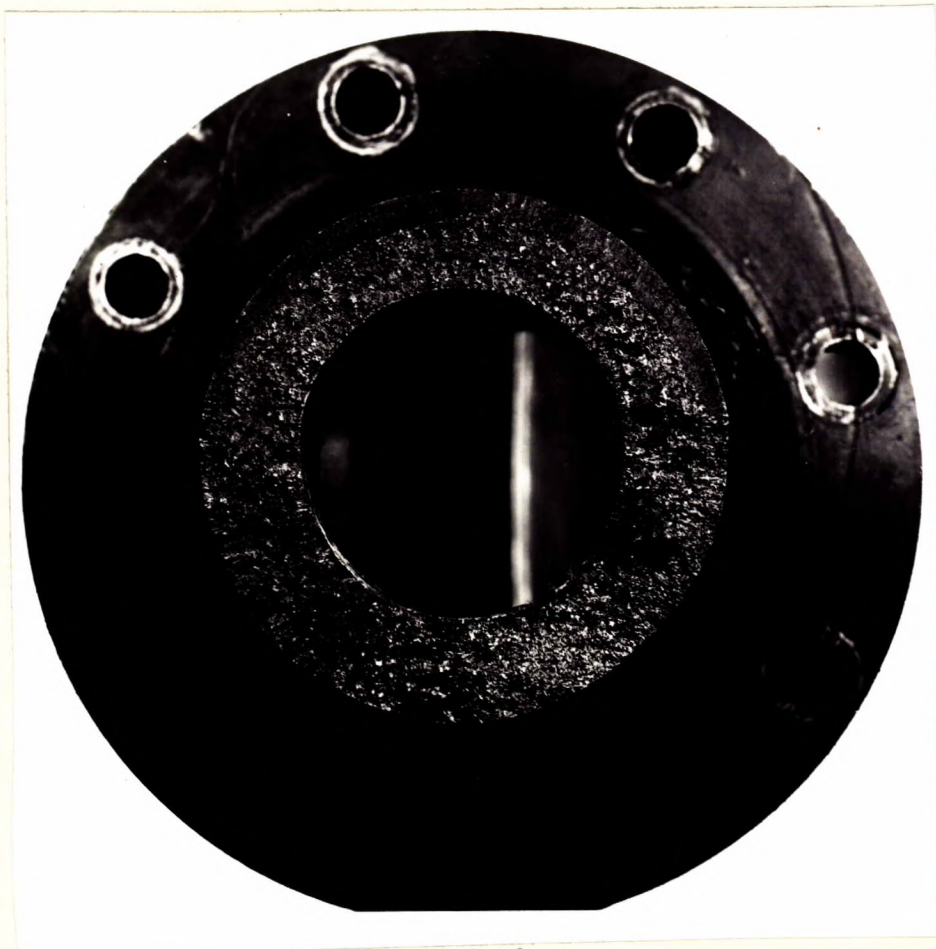
Figure 2.

To size.  
Fracture, showing flange portion of housing in background.

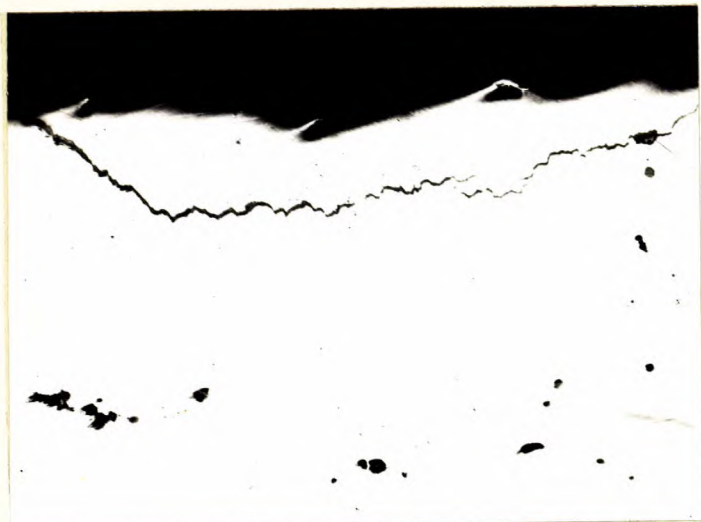
Figure 3.

Samples of the steel, both in the "as received" and heat treated conditions, were polished and examined under the microscope. The steel was found to contain a fair number of inclusions, which appeared to be manganese silicate. A wavy crack was also found near the smooth portion of the fracture. This crack and a few of the inclusions are shown in Figure 3 (X200 magnification). A fairly large number of internal shrinkage cavities were also noted. An area close to the fracture, containing a number of these cavities, is shown in Figure 4 (X100 magnification).

The dirtiness of the steel and the number of shrinkage cracks present indicate poor foundry practice. The jagged crack shown in Figure 3 is the type usually produced by the action of changing stresses and indicates that the housing fatigued at this point. The major fracture also was undoubtedly produced by a similar mechanism.

Showing inclusions and fatigue crack. Unetched.

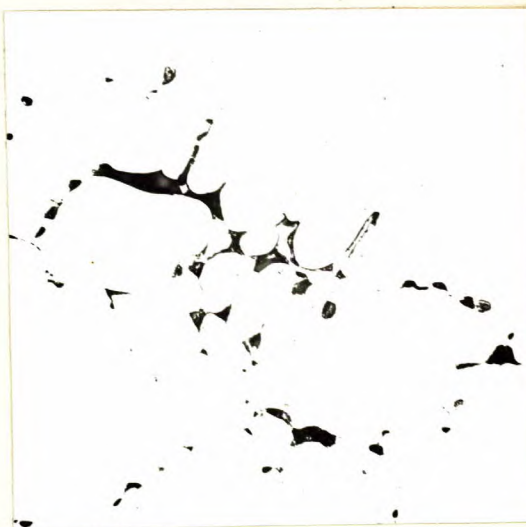
Figure 4.

Showing internal shrinkage cavities. Unetched.

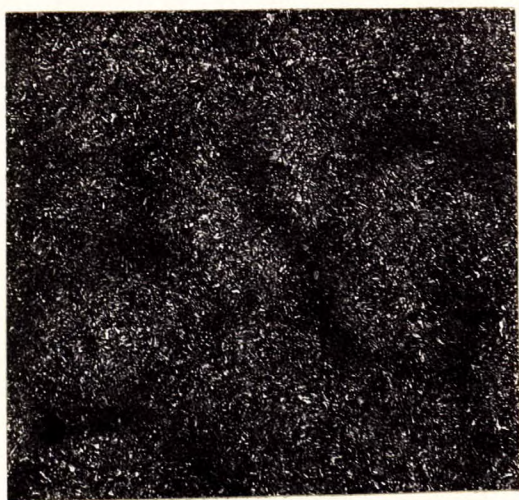
Figure 5.

The samples were then etched in a 2 per cent solution of nitric acid in alcohol and re-examined. Figure 5 (X200) and Figure 6 (X1000) show the structure of the steel in the broken housing. The structure shown in Figure 6 is finely spheroidized, the small particles being iron carbides and the background being ferrite, the iron constituent. The vague dark lines shown in Figure 5 have the same structure as the lighter portions of the

sample. It is thought that they indicate the location of former austenite grain boundaries. The sample that had been furnace-cooled was made up of free ferrite and lamellar pearlite, while the air-cooled sample had a troostite-martensitic structure. The structure of the "as received" sample was duplicated in the specimen that had been normalized and then drawn at 1100° F.

Structure of housing steel near point of failure. Etched in 2 per cent Nital.

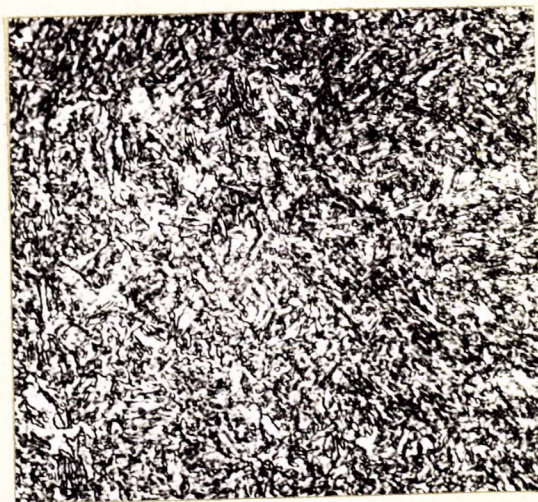
Figure 6.

The absence of free ferrite from the housing steel shows that it was cooled fairly rapidly, as the furnace-cooled specimen contained this constituent. The steel may have been quenched in oil but as it is air-hardening it was more likely normalized. The finely spheroidized structure of the steel indicates that it was drawn at around 1100° F. after this normalizing treatment. The microscopic examination, then, confirms the findings of the hardness tests.

Structure of housing steel near point of failure. Etched in 2 per cent Nital.
