ORE DRESSING AND METALLURGICAL LABORATORIES.

Investigation No. 894.

Report on Comparison of Tools Submitted for
Examination by the Department of National
Defence, Ottawa, Ontario, on August 19th, 1940.

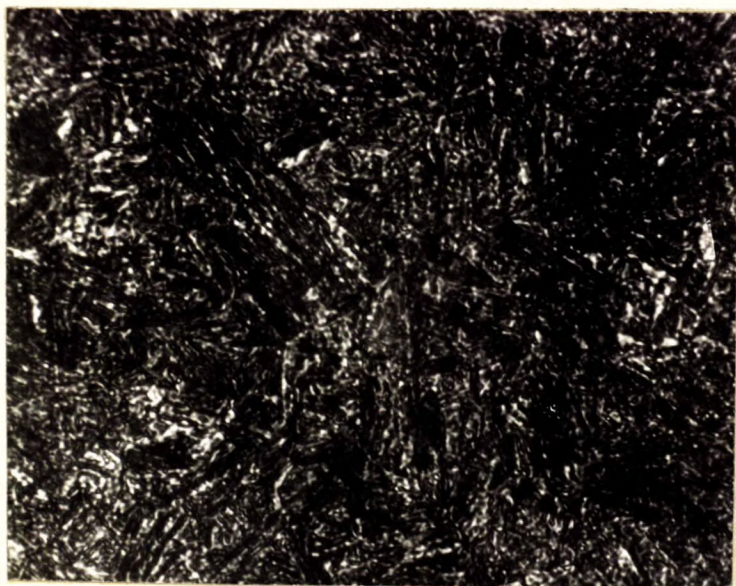
Figure 3.

- (1) The socket adaptor had a forging "lap" or cavity.
- (2) The MASTER ALLOY flat spanner had one end ground out to a larger size. This grinding had been done by hand.

1000X.
(Nital etched)
MASTER ALLOY adaptor.

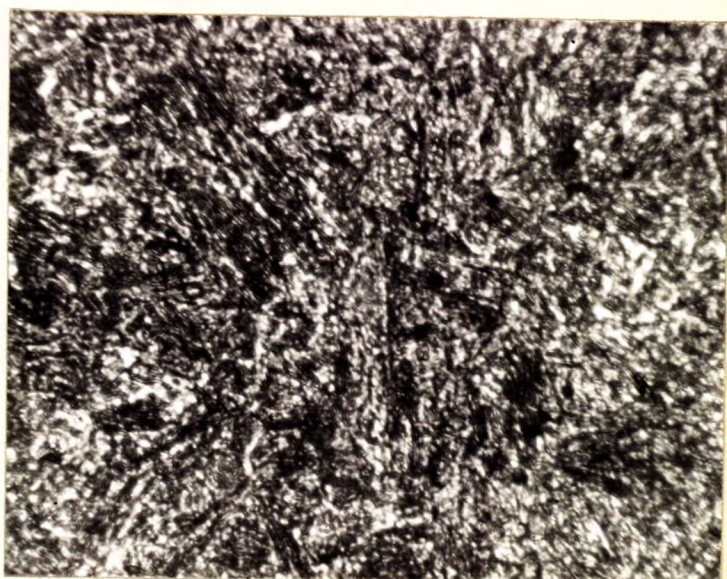
Figure 4.

2000X.
(Nital etched)
SNAP-ON adaptor.

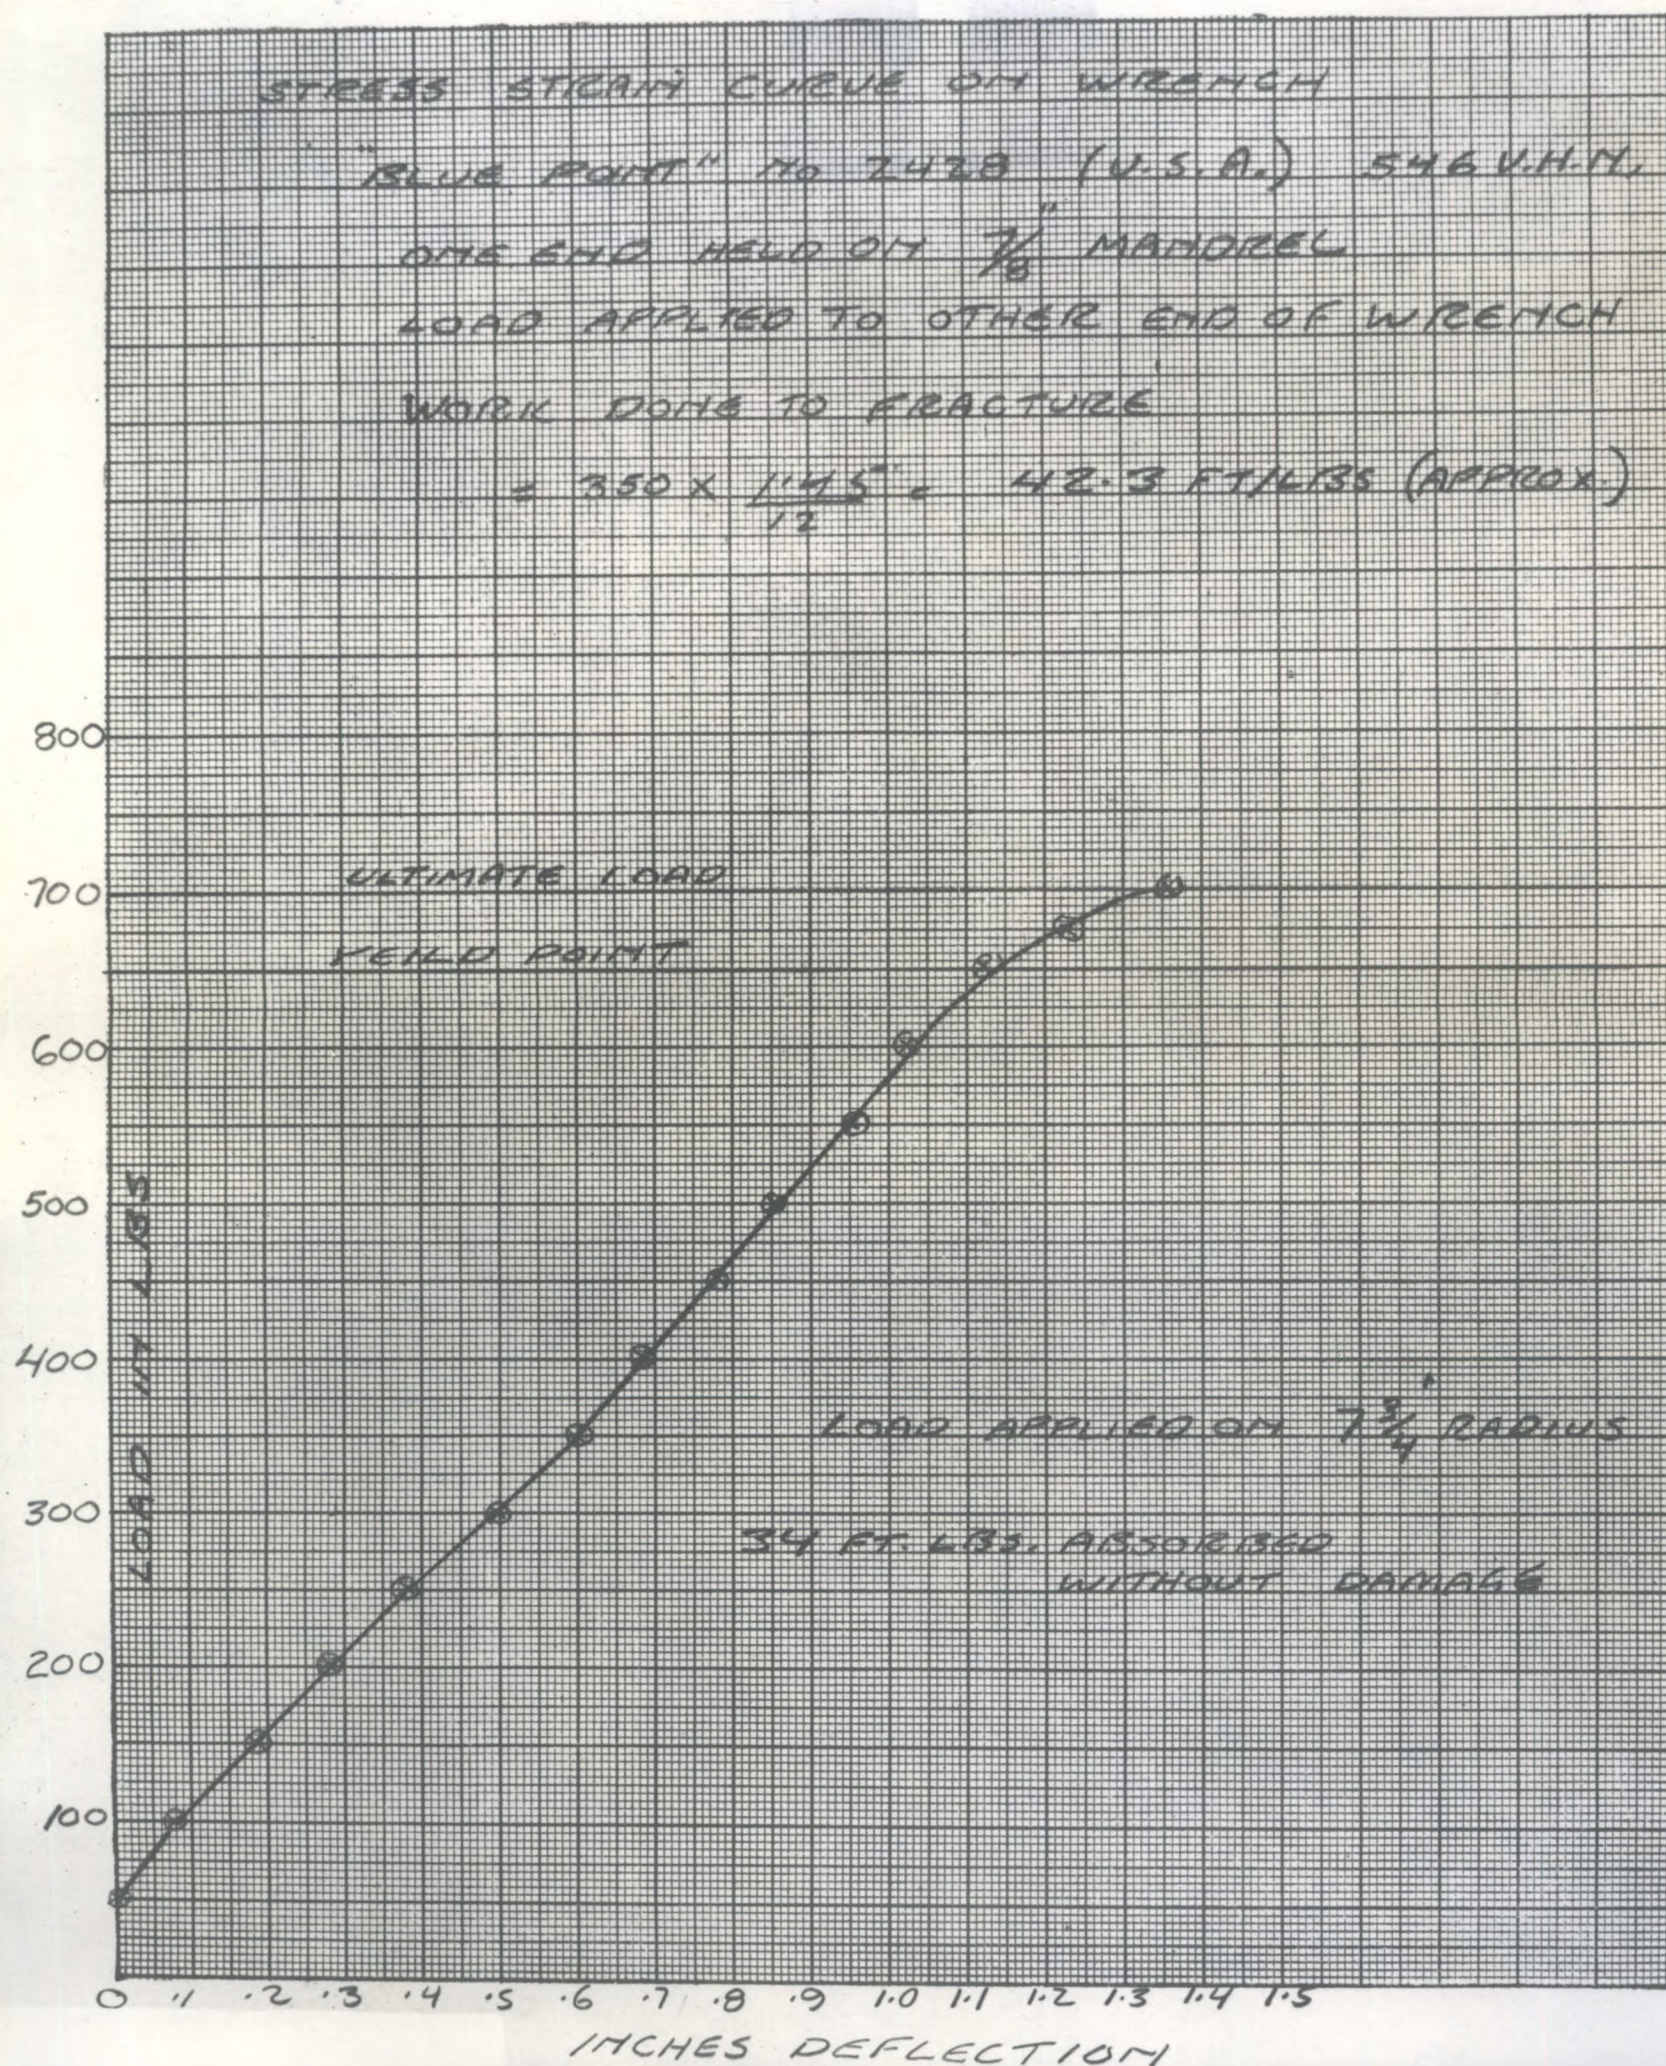
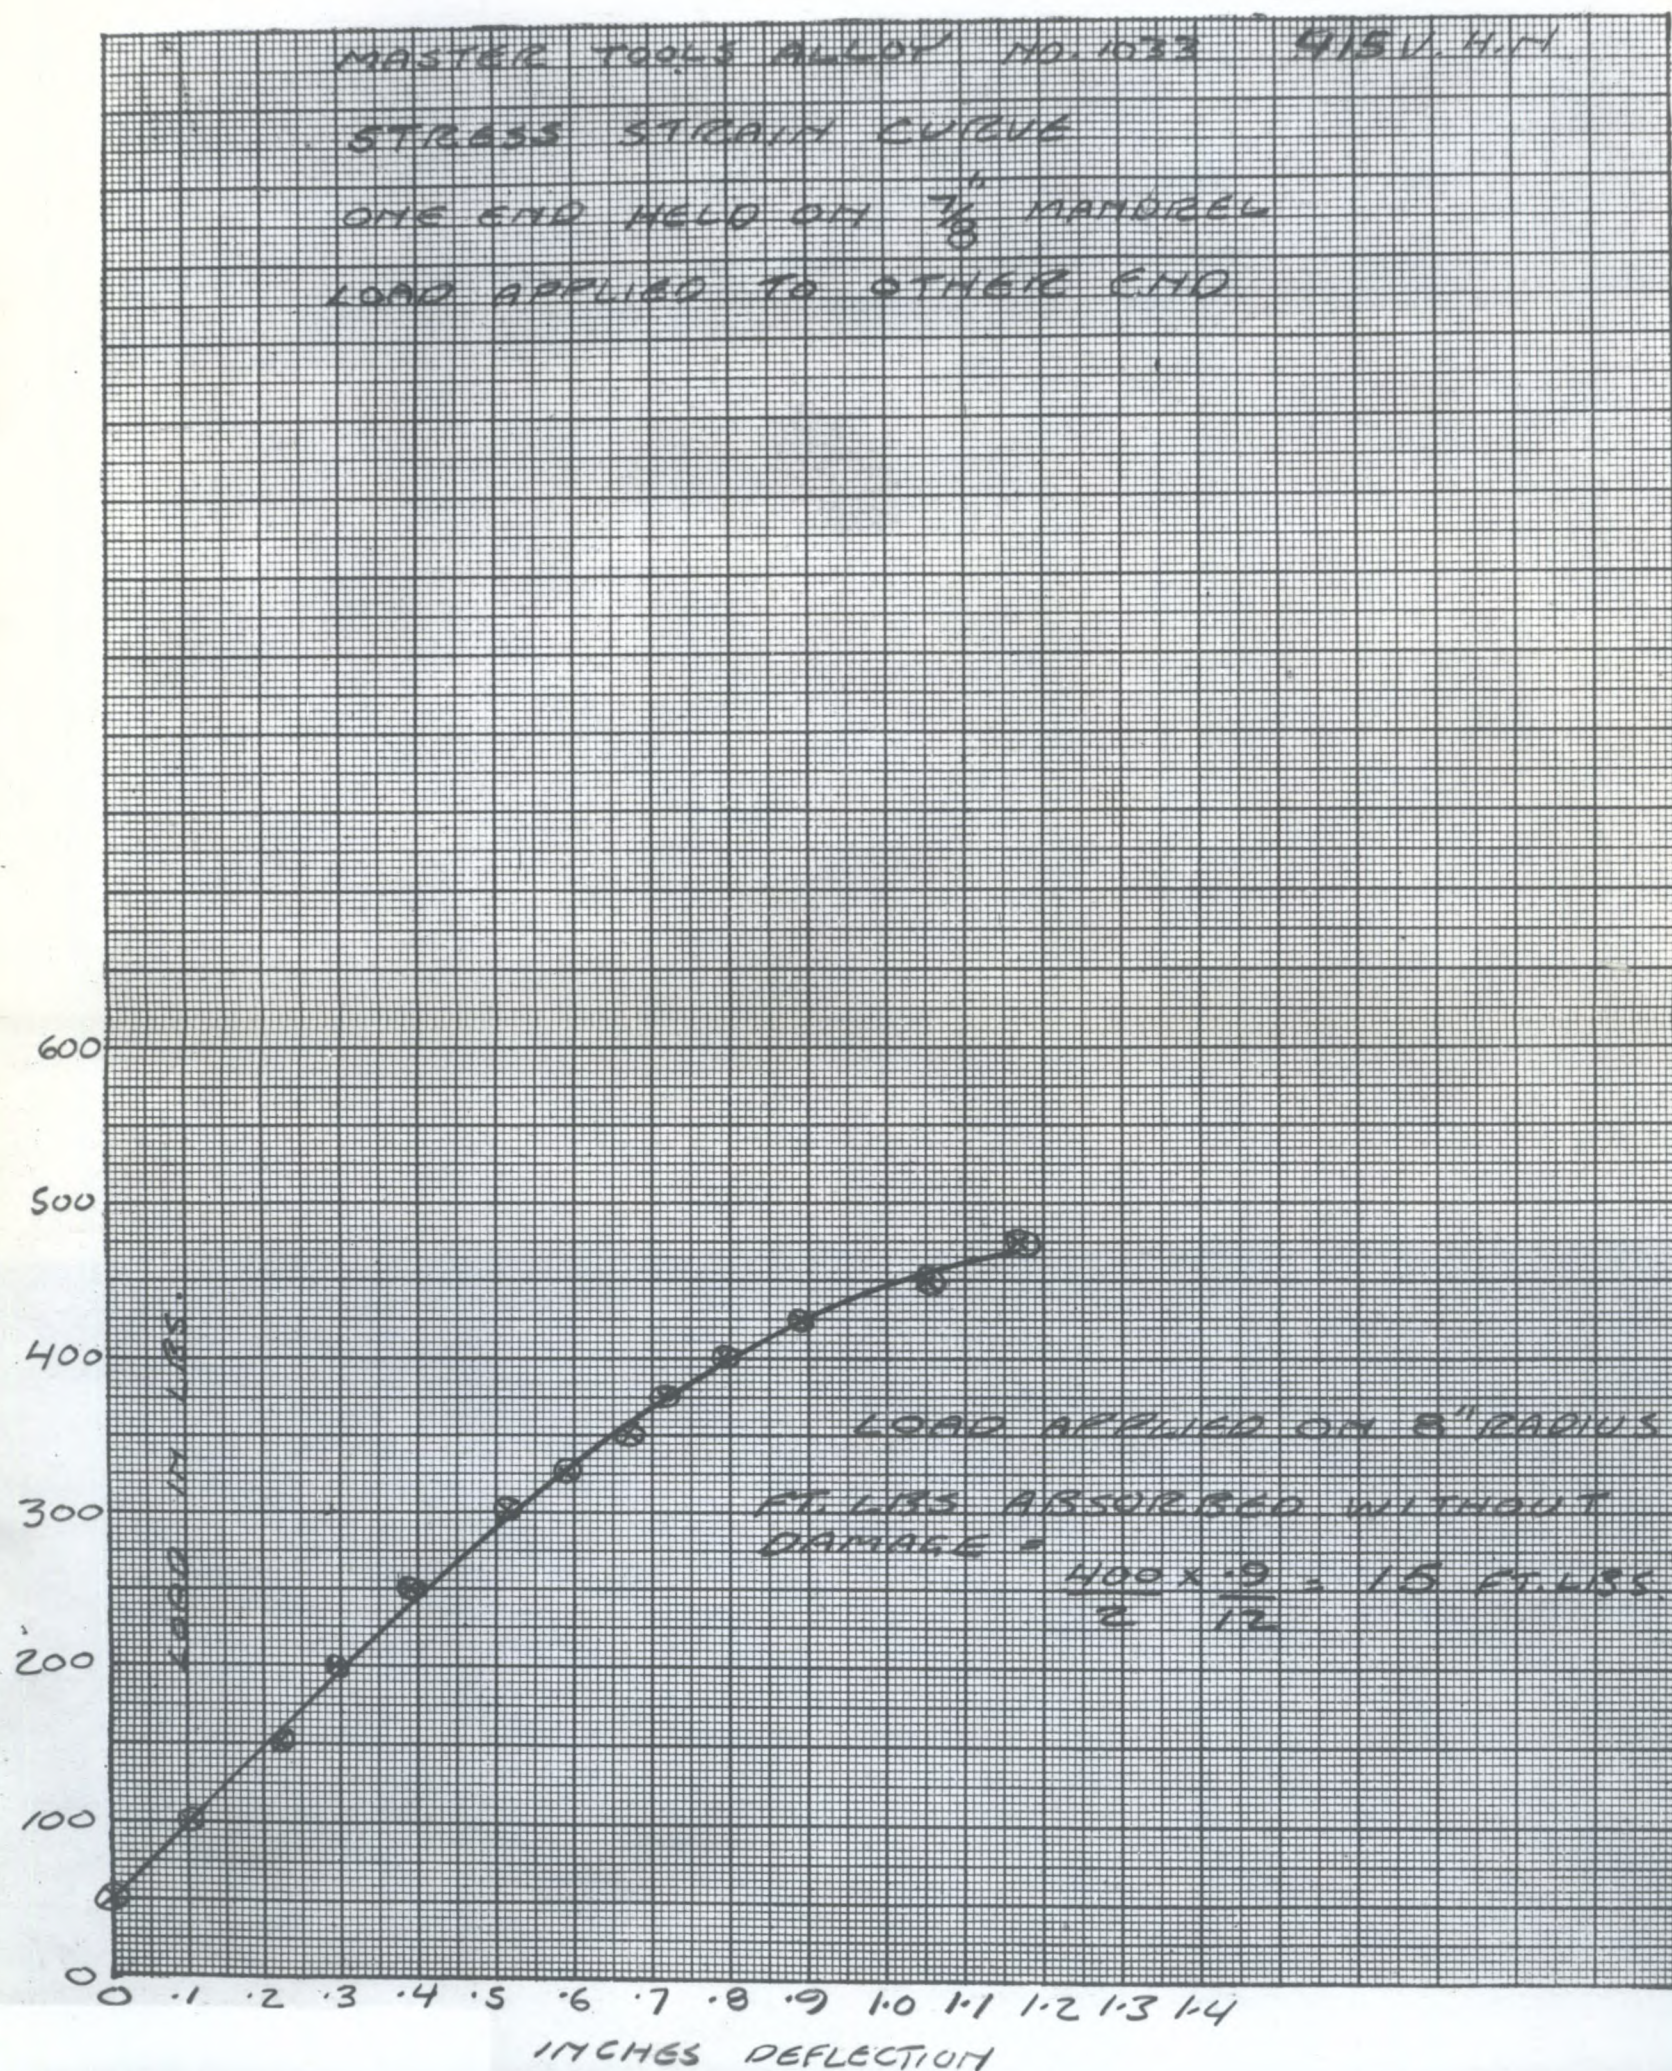
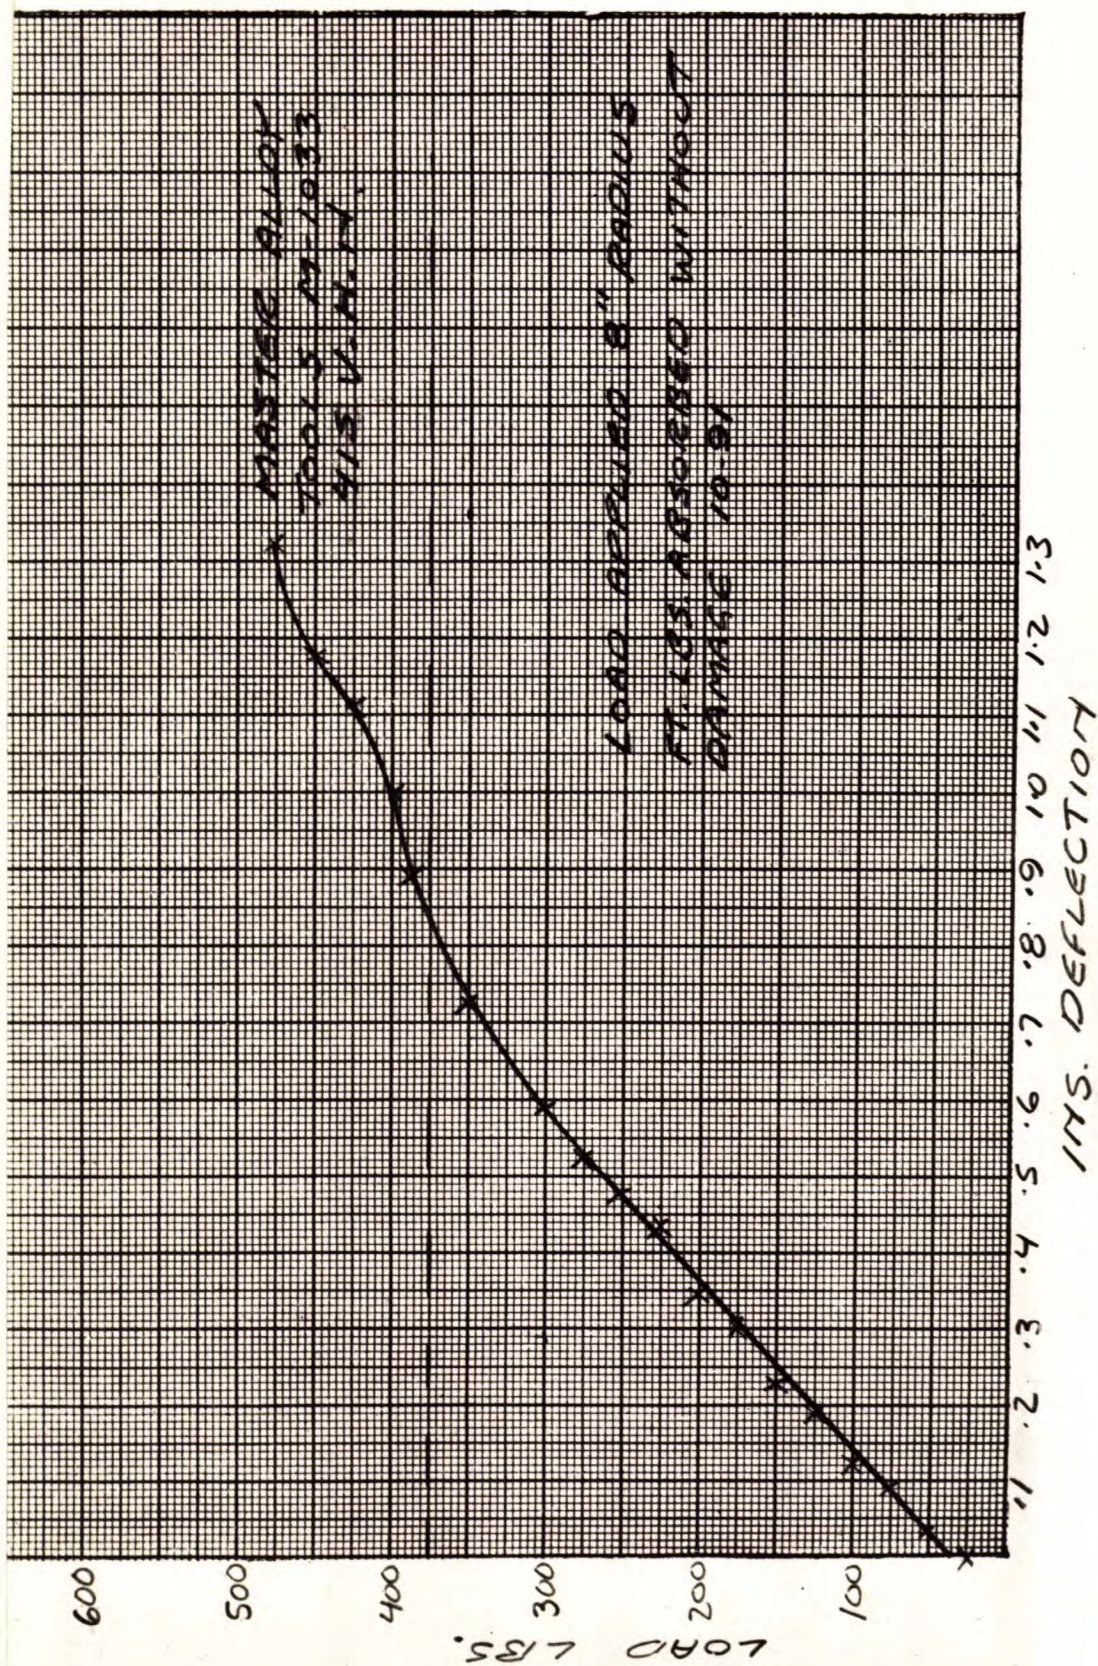
<u>Tool.</u>		Maximum foot pounds absorbed without any damage to wrench.		<u>Type of failure.</u>
BLUE-POINT	--	34 foot pounds.		Fracture at base of jaw.
MASTER ALLOY, No. 1	--	15 " "		Deformed jaw.
MASTER ALLOY, No. 2	--	11 " "		" "
GRAY DREADNAUGHT	--	7 " "		" "

(Note: Load and deflection curves
for these wrenches are shown in
Figures 6, 7, 8, and 9.)

The BLUE-POINT wrench will absorb twice as much punishment as the MASTER ALLOY wrench and three times as much as the GRAY wrench before damage occurs.
