ORE DRESSING AND METALLURGICAL LABORATORIES.

Investigation No. 927.

An Examination of a Cracked Military  
Vehicle Universal Joint Part.

November 28th, 1940.

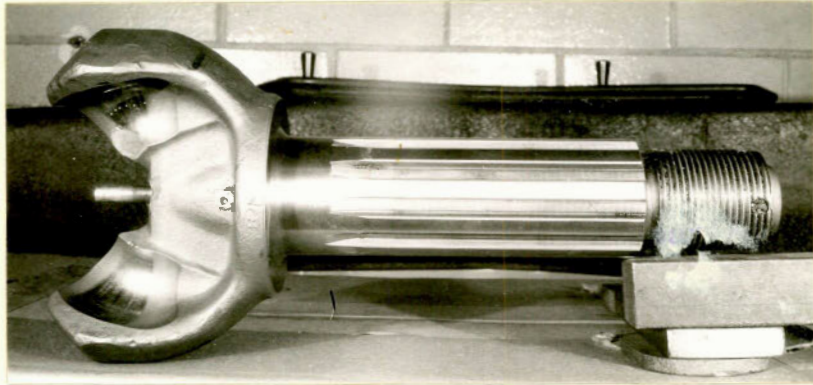
Figure 1.

Photographs of the cracked part are shown at about four-tenths size in Figure 1 and to size in Figure 2. The crack may be seen at A. A small piece of the steel has also chipped off at this point. The pin shown at B holds a spacing ball in place. This ball serves to keep apart two larger balls which work against the shiny surfaces C and D. The pin is at the centre of a crater-like depression, the crack apparently starting at the edge of the "crater". With the exception of the surfaces C and D and the splined portion of the part, the surface is in the "as forged" condition. There are, however, no major surface imperfections at the point where failure occurred.

The material in which the crack started would undoubtedly be high in carbon, because its wedge shape allows for a carburizing from two sides. As a result of this, there would probably be little core material to support the case on the wedge. The crack appears to have been formed by the action of alternating stresses. It is not surprising that a fatigue failure would occur at such a place, for hardened high carbon material is liable to such failures in the absence of perfection in surface finish. Even if the surface were perfectly finished, the shape of the part

would probably allow for sufficient stress concentration to cause failure.

Cracked Part.

Apart, then, from the high carbon areas in the case, the part is in good condition. Even if the case were free from excess carbide, however, the part would be likely to fail as the case is supported by very little core material at the point where the crack occurred. The shape of the part would also allow for a certain stress concentration at this point. Under these conditions it would be much better if this portion of the part were not case-hardened, as the softer core material, being more subject to plastic flow and consequently less notch-sensitive, would be much less liable to crack. Certainly, if the shine on the part is any indication, only the areas marked C and D on Figures 1 and 2 need a wear-resistant case-hardened surface. It is thought, then, that if the part had been

selectively carburized by copper plating before carburizing all areas but those requiring wear resistance, it would probably have given satisfactory service.

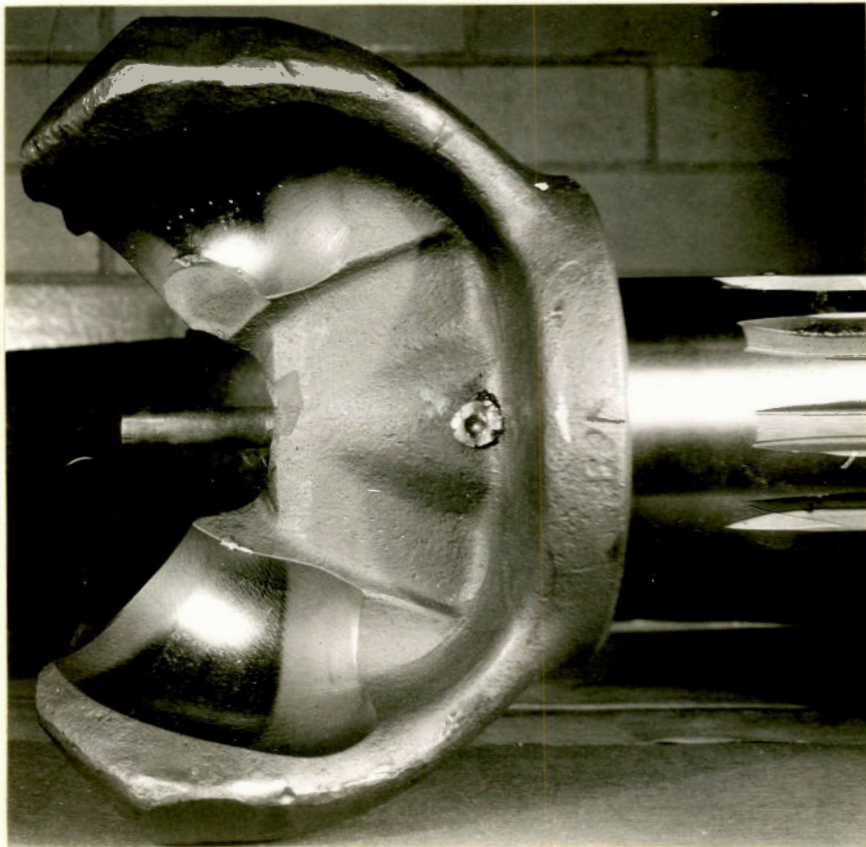
Hardness tests were made at various points on the surface shown in Figure 2. In addition, hardness tests were also made across the section of the part. The Rockwell method was used for the first test work and the Vickers method for the second. The part was found to have been case-hardened, with the case having an average Rockwell "C" hardness of 60 (627 Brinell) and the core a Vickers

Cracked Part.

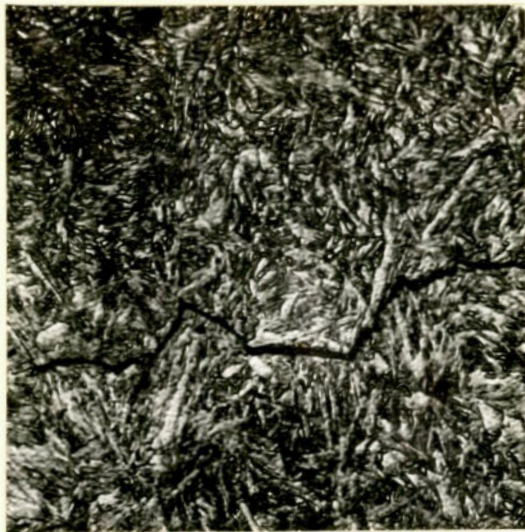
Figure 3.

A sample cut from the part so as to include the crack was polished on a section at right angles to the surface and examined under the microscope. The steel was found to be quite clean, only a very few inclusions being located. The sample was then etched in a 2 per cent solution of nitric acid in alcohol. The etch revealed clearly the core and case material. The case depth as measured under the microscope was found to be 0.063 inch. Figure 3, a photomicrograph at X1000 magnification, shows the structure of the greater part of the case. A crack may be seen running through the centre of the field. This crack parallels the main crack. It may be seen that the material surrounding this crack has the same structure as the remainder of the case. The same is true for the material around the main crack. Figure 4, a photomicrograph at X1000 magnification, shows the structure of the core. The dark

The low inclusion content of the metal shows that the steel making operations were carefully conducted. The case is quite thick, but no doubt the designers considered such thickness necessary for the service. The crack shown on Figure 3 is probably of the fatigue type. The similarity in the structures of the case material surrounding the crack and the remainder of the case indicates that the cracks were formed in service rather than in the manufacturing operation, although if heat treating operations were carried out under perfect atmosphere control a case cracked in manufacture would have a similar appearance. The amount of ferrite present in the core and the result of the heat treatment experiment definitely show that the final heat treatment given this steel was an oil quench from around 1500° F. This is a recommended heat treatment for this steel when high core strength is desired. Apart from the extreme outer edge the case structure is satisfactory. The material at the edge, however, is too high in carbon, as material which has carbide present in practically continuous envelopes is very liable to crack. The presence of such a large amount of free carbide indicates that too active a carburizing medium was used, although it is difficult to avoid the presence of some free carbide when such a thick case is applied.

X1000.  
Case Structure, Showing Crack.

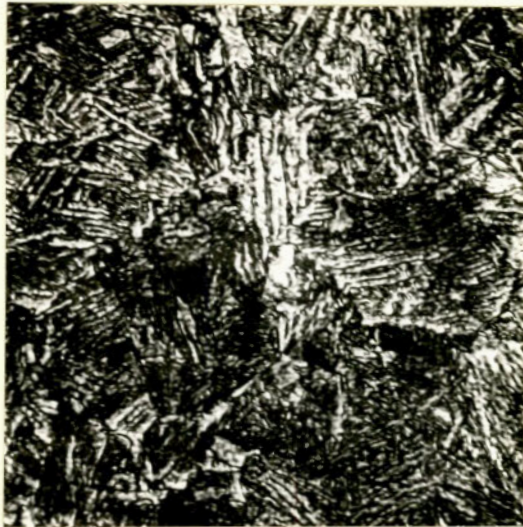
Figure 4.

etching material is a low-carbon pseudo-martensite; the white etching material is ferrite, the iron constituent. In order to check on the method of heat treatment a portion of the part was quenched in oil from 1500° F. This specimen was found to be identical in structure and hardness with the "as received" material. All of the case did not have the structure shown in Figure 3, as the extreme outer edges were higher in carbon. Figure 5 shows the structure of this outer zone at X1000 magnification, the print shown being over-developed in order to bring out more clearly the white carbide particles. It may be seen that these carbide stringers are practically continuous in places. The background area if developed less fully would show a structure similar but somewhat darker than that shown in Figure 3.

X1000.  
Core Structure.

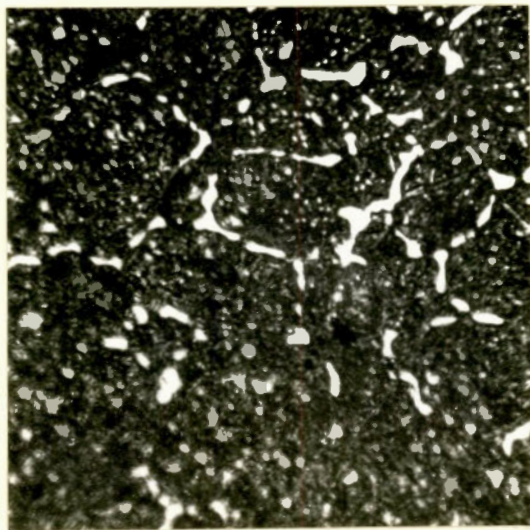
Figure 5.

The crack, apparently of the fatigue type, started at the edge of the spacing ball cavity. The part was case-hardened so as to give good resistance to wear and good resistance to a brinelling action of the ball parts, the case being quite thick and hard and the core hardness relatively high. The core was found to have a satisfactory structure and good physical properties. The case structure, apart from the very high carbon outer edge in which free carbides were present in practically continuous envelopes, was satisfactory. It was pointed out that high carbon material, such as was present at the outer surfaces, cracks easily and that the condition probably could be remedied if a less active carburizing medium were employed or if the case thickness were reduced.

X1000.  
High Carbon Area at Outer Edge of Case.
