ORE DRESSING AND METALLURGICAL LABORATORIES.

Investigation No. 928.

Report on a Stub-Axle from  
a 2-Pounder Gun.

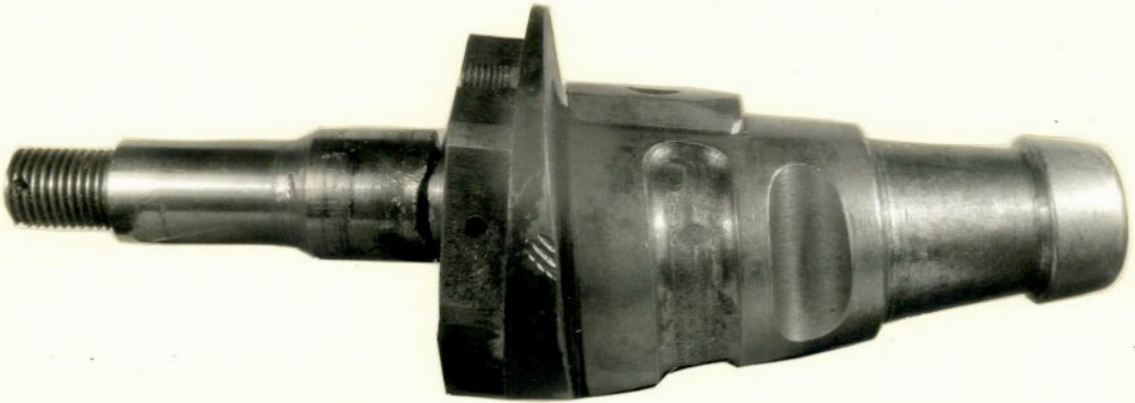
Figure 1.

Axle as received.

The axle was machined out of a piece of bar stock. Fracture occurred at the base of the axle.

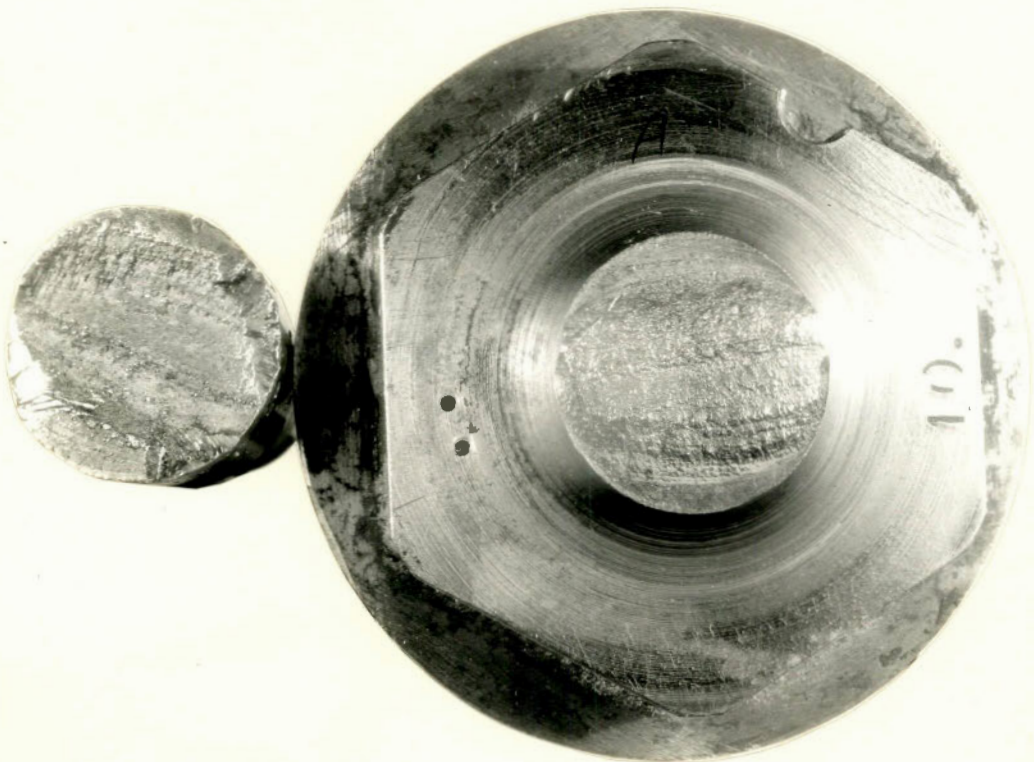
Figure 2.

Fractured surface.

Figure 2 shows the nature of the fracture. Smooth crescent-shaped fatigue cracks can be seen on opposite sides of the shaft, reducing the effective cross-section to about 70 per cent of its original area.

The rough machined surface on this axle lowers its bending fatigue strength. According to Sachs (Iron Age, Sept. 5, 1940), a ground finish would probably have 20 per cent greater bending fatigue strength.

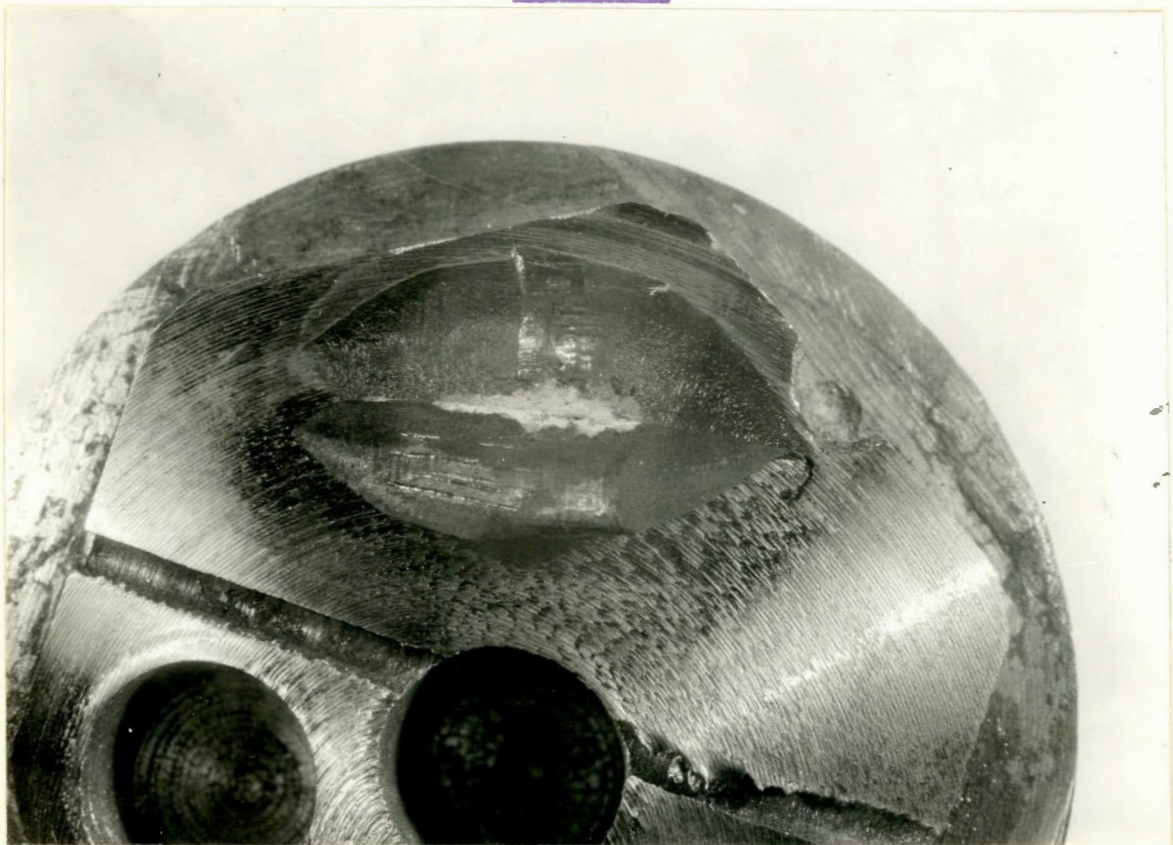
Flaw uncovered in machining for impact test. x2.

In preparing samples for impact and micro-examination, a flaw was uncovered. This is shown in Figure 3. As the surface shown at (A) in Figure 2 was machined down, a crack appeared. A cold chisel was used to pry open the crack and expose the flaw. The defect as shown in Figure 3 is about 1-3/8 inches long and 3/8 inch wide, running perpendicular to the surface of the bar stock.

It is apparent that a slag-and-oxide seam existed in the billet. This was not discovered after rolling although its decarburized surface indicates that the flaw extended to the outside of the bar.

The slag seam shown in Figure 3 is not in a part of the axle which is under stress. However, it is possible that the lot of steel from which this axle was made may have more flaws in it. The metal may be classed as "unsound".

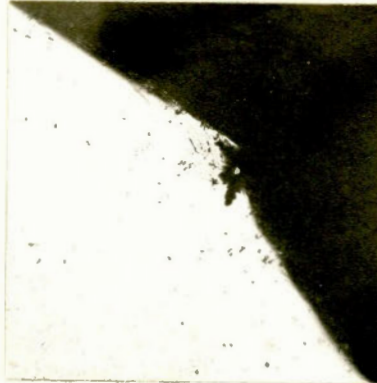
Figure 4.

Edge of fracture.  
x100, unetched.

Figure 4 shows the fractured surface passing through a dirt cavity.

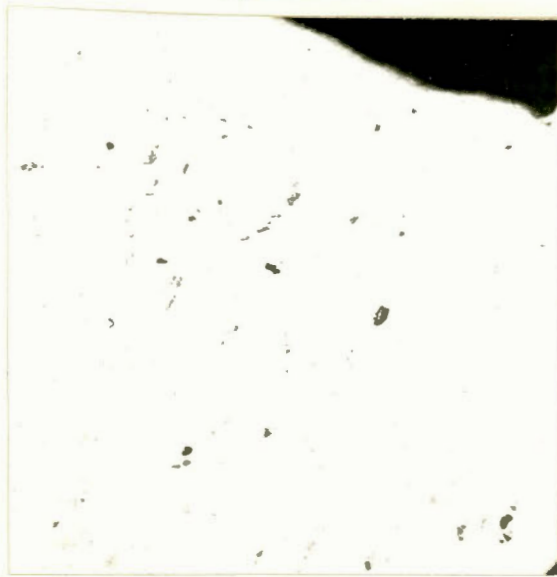
Dirt inclusions in steel.  
x100, unetched.

The metal contained a considerable quantity of dirt, as is shown in Figure 5. The inclusions tended to be grouped in areas. The fracture ran through quite a few foreign inclusions.

Foreign inclusions, or "dirt", affect the physical properties of metal, especially its resistance to alternating stresses. Without having had the opportunity to run fatigue tests on this lot of steel we cannot state the exact effect of these inclusions. However, it is significant that the fracture passed through a group of inclusions. Most of the "dirt" is in the form of oxides.

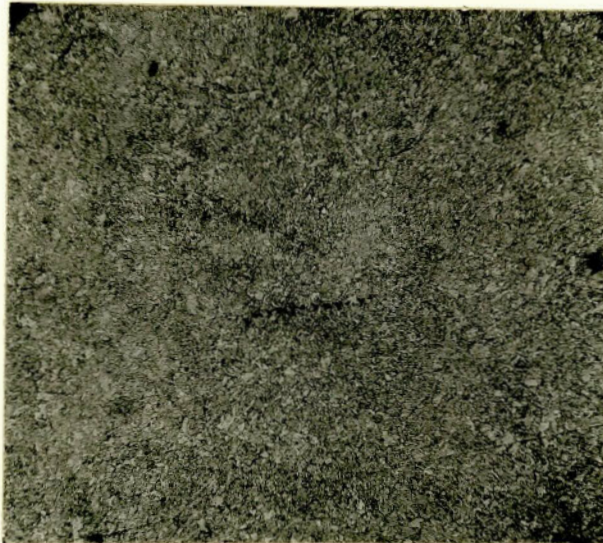
Figure 6.

Stub-Axle. x100.  
(Nital etch).

The structure shown in Figure 6 is that of a fine-grained alloy steel.

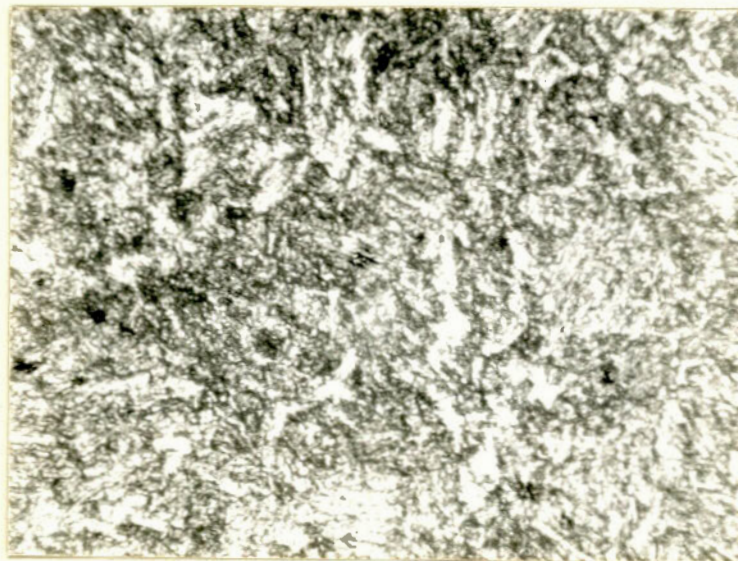
Stub-Axle. x1000.  
(Nital etch).

The distribution of the carbides is shown in Figure 7. This is typical of a good quality nickel steel.

The structure of the metal shows finely dispersed carbides indicative of a satisfactorily quenched and drawn alloy steel.

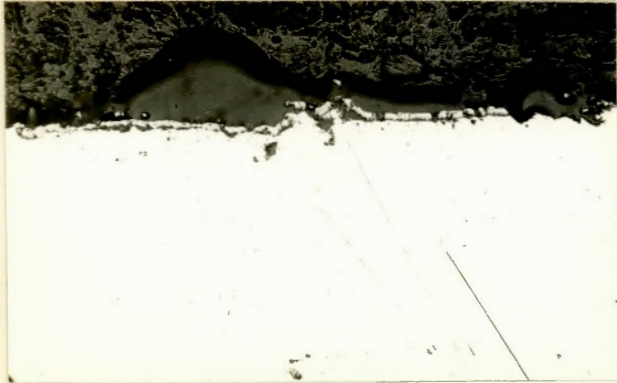
Figure 8.

Edge of flaw.  
x100, unetched.

Examination of the flaw shown in Figure 3 shows a layer of slag on the surface of the flaw. This slag is composed of oxides and silicates. The metal is decarburized at the surface of the flaw.

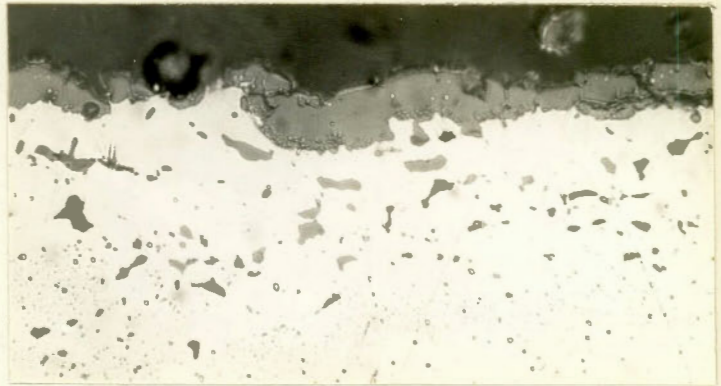
Figure 9.

Edge of flaw.  
x500, unetched.
