R E P O R T  
of the  
ORE DRESSING AND METALLURGICAL LABORATORIES.

Investigation No. 939.

Report on Failure of Leaf Spring  
on Military Vehicle.

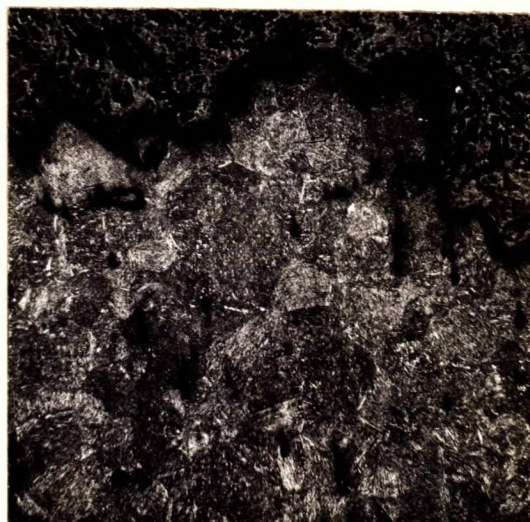
Dirt inclusions in the steel are shown in Figure 1. Metal structure is shown at 100X in Figure 2. Note that the irregular indentations at the fractured surface are of approximately the same size as the grains in the steel.

100X, nital etch.  
At edge of fracture.

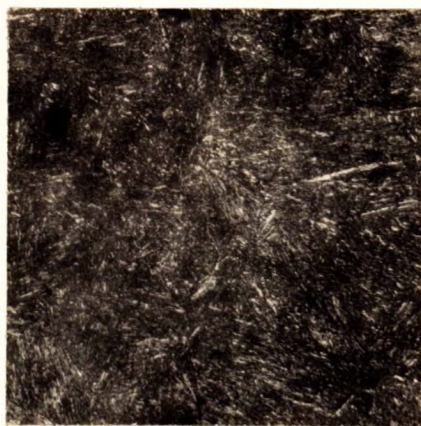
Figure 3.

1000X, nital etch.  
Tempered martensite and ferrite.

Figure 3 shows the nature of the metal structure.

It is tempered martensite with ferrite included.

Springs are made of a high strength steel. The desired structure is tempered martensite. The presence of free ferrite either in the martensite or in a decarburized skin will weaken the spring. Free ferrite has been allowed

to form in the heat treatment of this spring. (See Figure 3).

It is recommended that,

- (1) Quench should be drastic enough to form martensite with no traces of free ferrite; and
- (2) Heat treating should be done in a protective atmosphere so that there is no decarburization, i.e., no free ferrite produced at the surface.
