Investigation No. 1055.

Examination of a Rudder Pedal Leg.

In a letter dated June 30th, 1941, Group Captain A. L. Johnson, Air Service Branch, Department of National Defence, Ottawa, Ontario, requested the examination of a broken piece of a rudder pedal leg, Dwg. 82320 (Federal Aircraft Limited, Montreal).

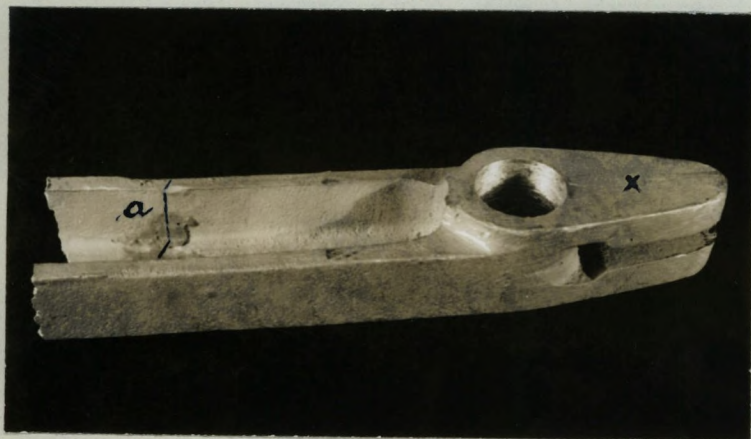
Figure 1.

Figure 1 shows the broken piece of the casting as received. Figure 2 shows the character of the fractured surface. There were numerous yellowish particles scattered across the complete surface.

Sample as received.
Approximately $\frac{1}{2}$ size.

- (1) In Figure 1, location marked "X":

V.H.N. = 70 to 85.

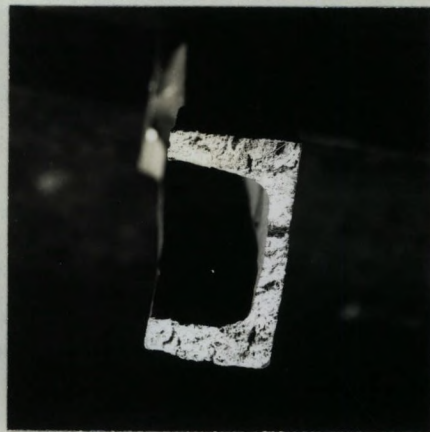
Figure 2.

Fracture.
(As received)
Approximately $\frac{5}{4}$ size.

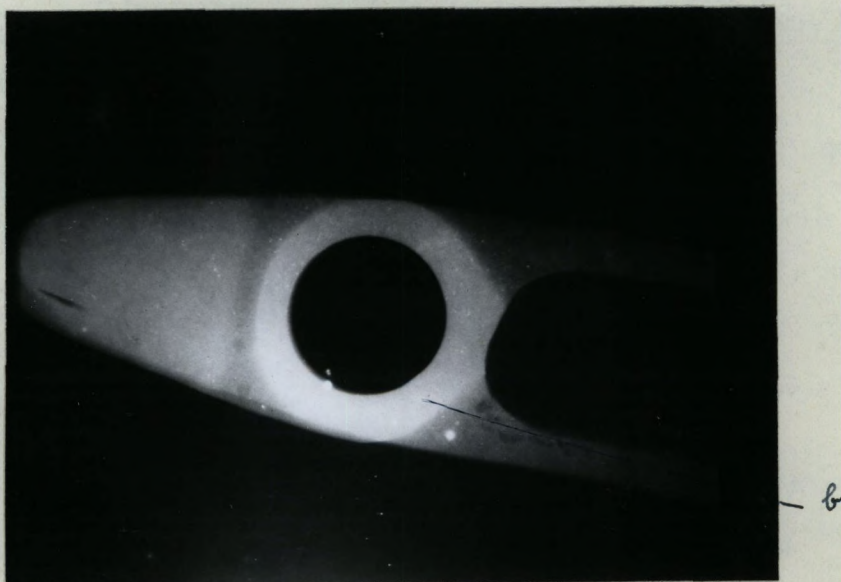
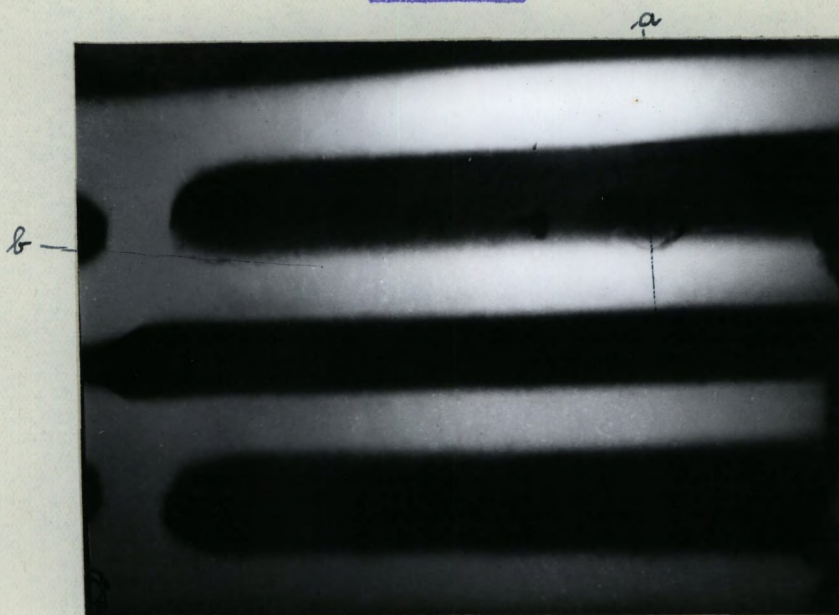
Radiographs.

The X-ray examination carried out by L. W. Ball (on loan from the National Research Council, Ottawa) showed cavities in two places. The location of these cavities is shown in Figures 3 and 4 by marks "a" and "b".

The X-ray examination shows many cavities and the porosity of the whole part. Microradiographs show also the segregation of the $CuAl_2$.

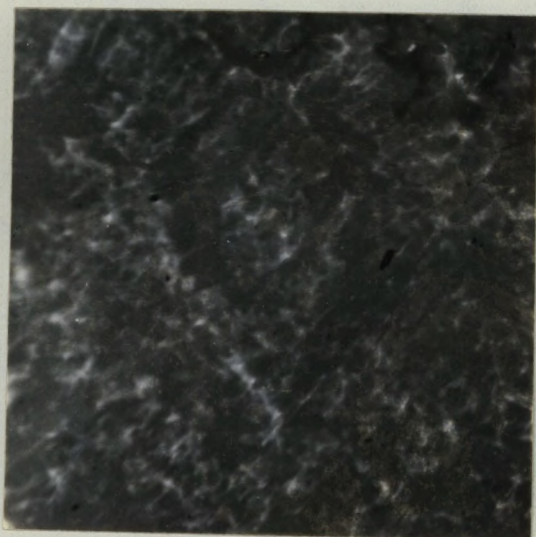
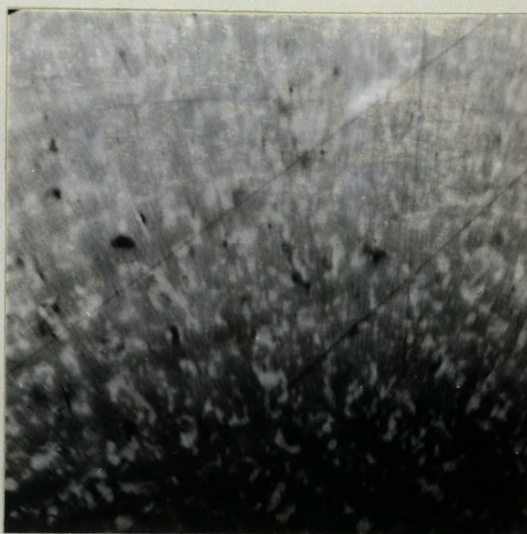
Microradiographs.

Thin sections of the metal near the break were examined by the new method of microradiography. Segregation of CuAl_2 and very small cavities similar to those seen by

the microscope were shown. Figures 5 and 6 are reproductions of microradiographs made by L. W. Ball.

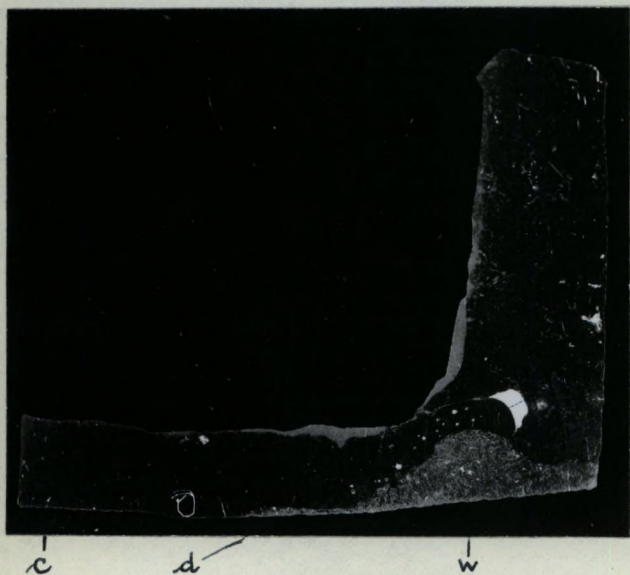
Figure 7.

Hardness taken on cross-section of this part shown in Figure 1 at "a", with locations shown in Figure 7 by marks "c", "d", and "w".

- (2) Location "c":

V.H.N. = 60.

- (3) Location "d" (near the welded area):

V.H.N. = 70 to 85.

- (4) Location "w" (on welded area):

V.H.N. = 100.

Figure 7 shows that this part was welded on both sides. Probably due to the porosity of this casting, welding was done in order to salvage this particular part.

The variations of the hardness shows that the metal has been affected by the heating during the welding operation and the different rate of cooling afterward.

Heat-treated aluminium-alloy castings intended for use in aircraft construction should not be repaired by welding. In cases where this might be necessary, extreme care should be taken to prevent any change in the structure.

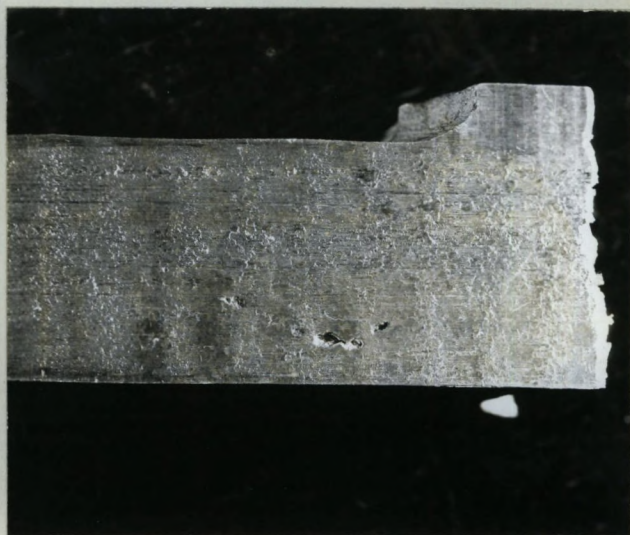
Figure 8.

The characters of the cavities as located by the X-ray are shown in Figure 7 (section shown in Figure 4, marked "a") and Figure 8 (section shown in Figures 3 and 4, marked "b").

Figure 8 shows shrinkage cavities.

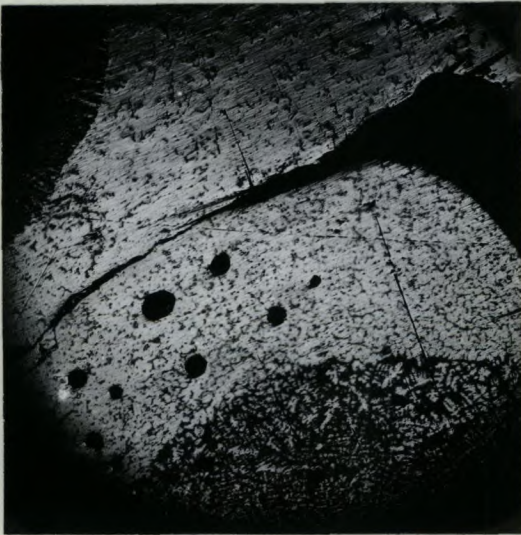
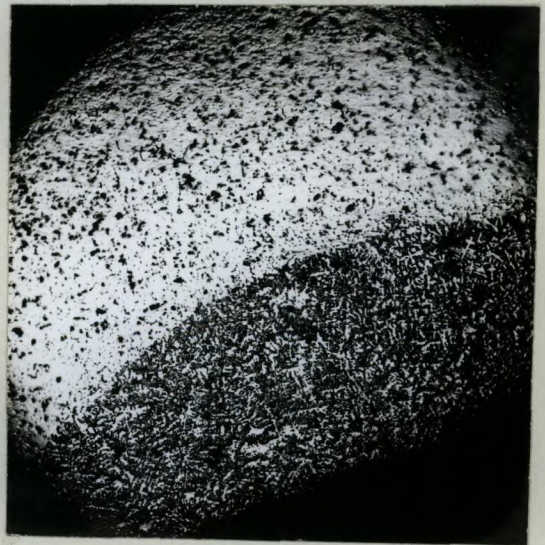
Figures 9 and 10 show the nature of the welded part. The material used for the welding includes silicon. This was determined by a chemical spot test (as given in "Light Metals" - Vol. 1, 1938, page 355) as well as by the difference in microstructure.

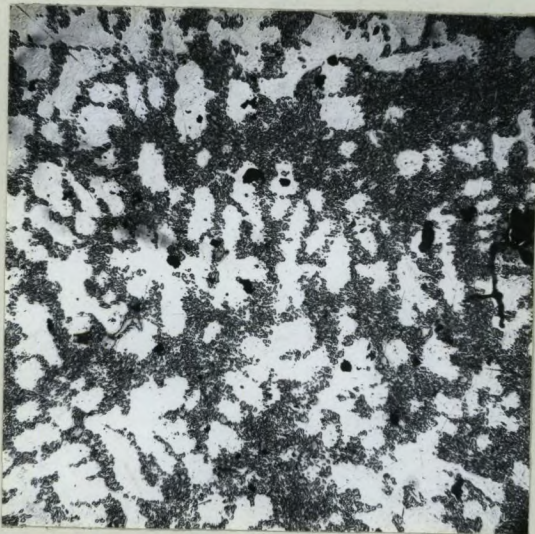
Figure 11.

Section in weld area.

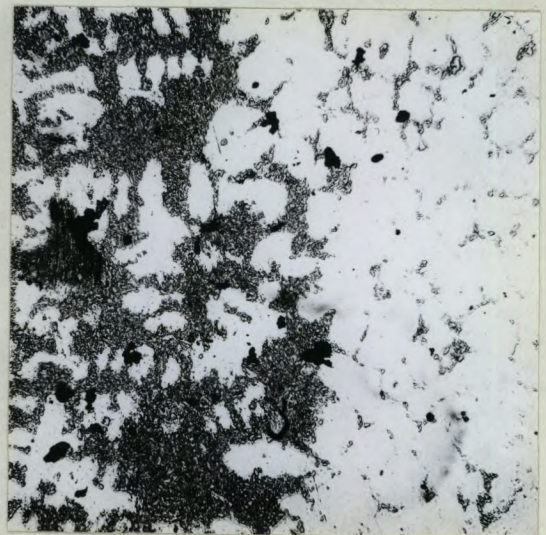
Figure 12.

Welding boundary.

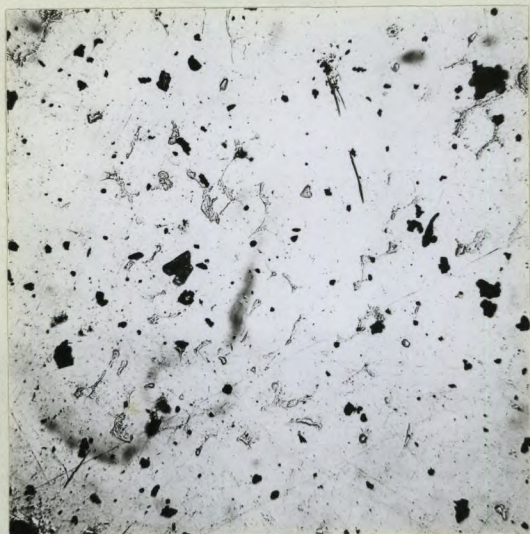
Figure 13.

Material as cast, near
the welded area.

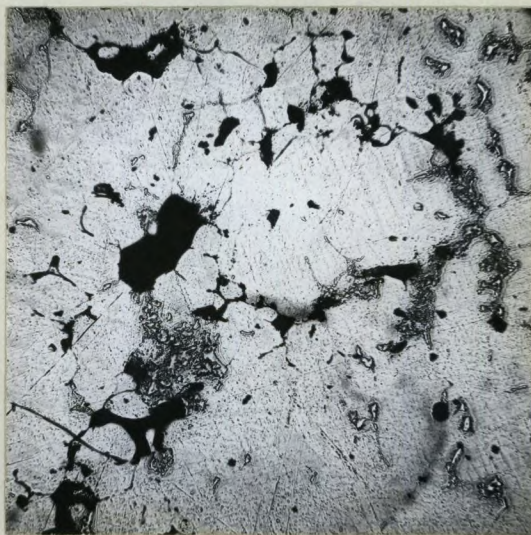
Figure 14.

Material as cast,
remote from welded area.

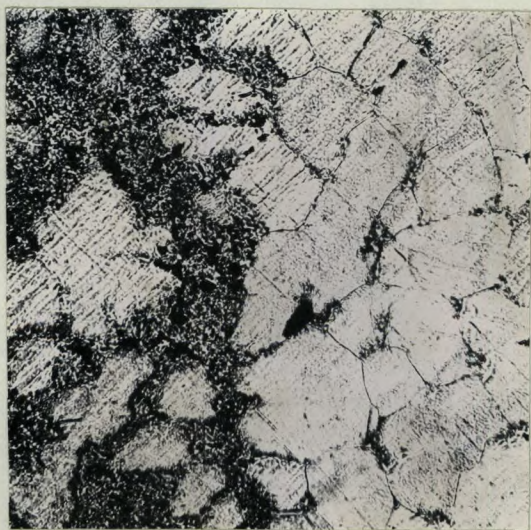
Figure 15.

Welding boundary.

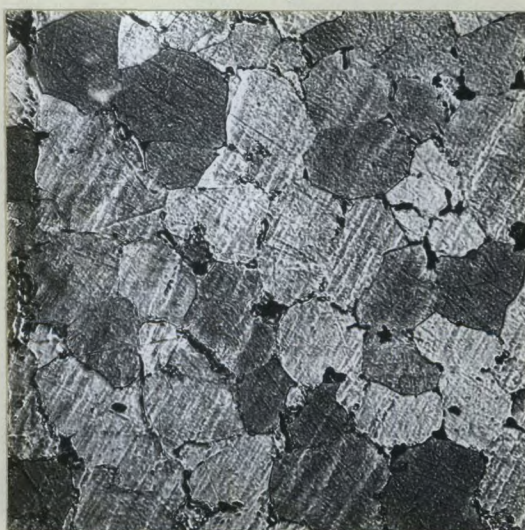
Figure 16.

Material as cast, near
the welded area.

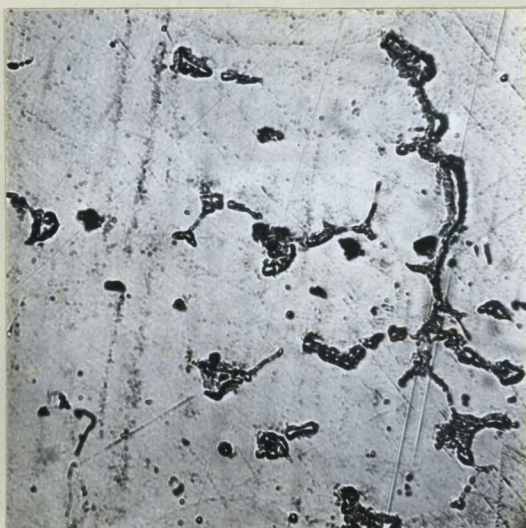
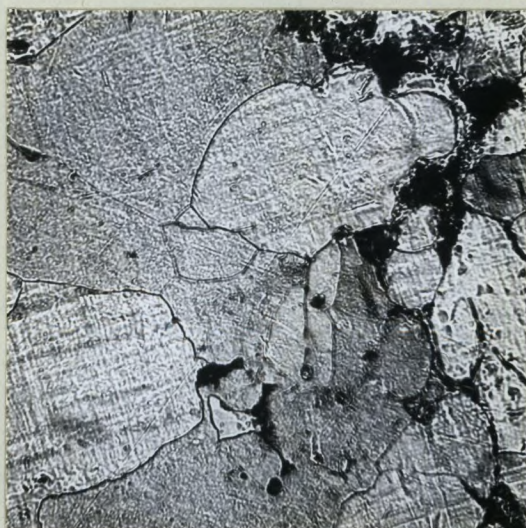
Section adjacent to the fractured
surface, as received.

porosity existed in the casting and also shows the character of the welding. The welding material included silicon (determined by chemical spot test) and copper (indicated by hardness tests). The microstructure adjacent to the fractured surface shows pronounced segregation of CuAl_2 .
