August 15th, 1941.

ORE DRESSING AND METALLURGICAL LABORATORIES.

Investigation No. 1069.

Examination of a Section of a Broken Liner.

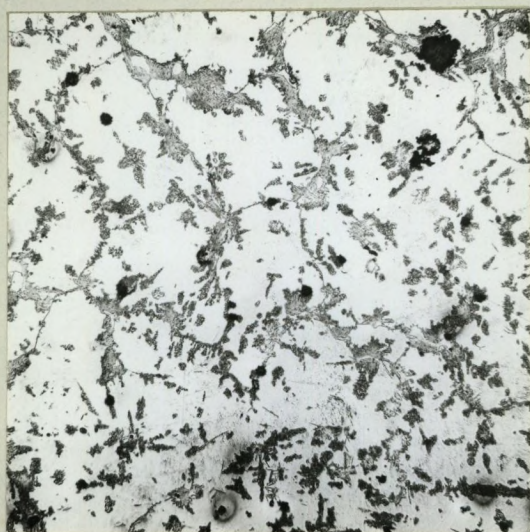
Figure 1.

X100, nital etch.  
Steel as Received.  
B.H.N. 269.

Since Figures 1 and 2 showed the presence of large amounts of carbide out of solution, it was decided to heat-treat another piece of the sample. The specimen (2" x 2") was held at 1900° F. for 45 minutes and then quenched in water. Figure 3 shows the resulting austenitic structure, free from undissolved carbides.

The brittleness of the metal was due to the presence of large amounts of carbides out of solution (Figures 1 and 2).

A regular heat treatment is all that is required to give this metal the usual properties of austenitic manganese steel.

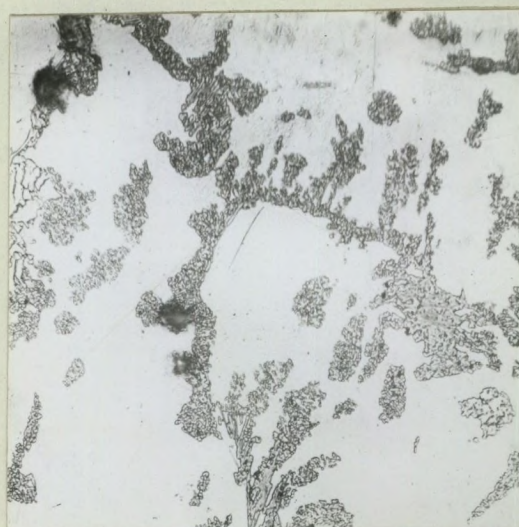
Figure 2.

X1000, nital etch.  
Steel as Received.  
B.H.N. 269.

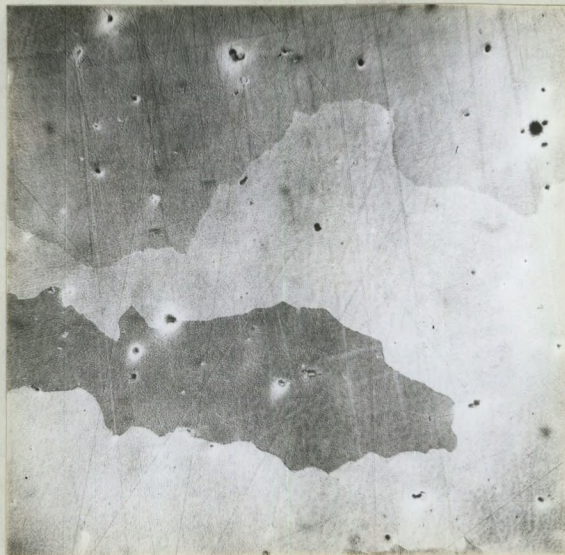
Figure 3.

X100, nital etch.

After Heat Treatment.

B.H.N. 173.
