August 21st, 1941.

ORE DRESSING AND METALLURGICAL LABORATORIES.

Investigation No. 1070.

Season Cracking in Brass Primer Bodies.

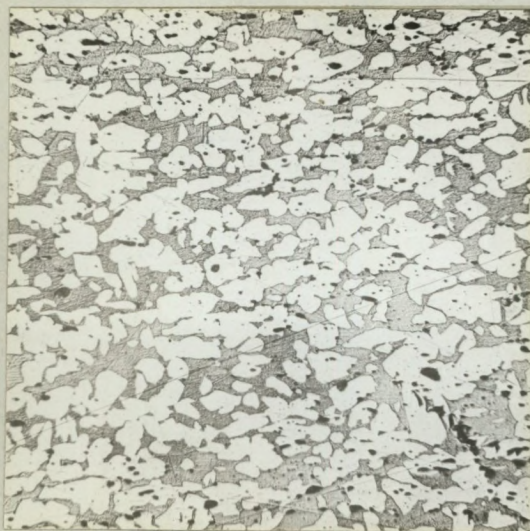
Figure 2.

X100, NH<sub>4</sub>OH Etch.

LONGITUDINAL SECTION.

Figure 2 shows that the material was free-cutting leaded yellow brass. It is in the alpha + beta form with a fairly fine grain size. Figure 3 shows the intercrystalline crack passing through the beta phase.

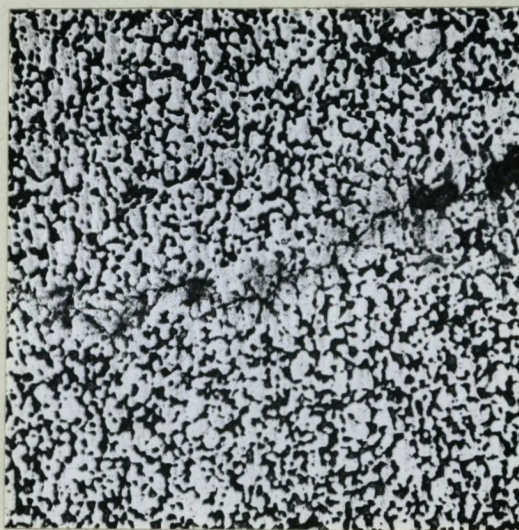
Figure 3.

TRANSVERSE SECTION.

Through Cracking.

The parts examined were turned from free-cutting leaded yellow brass bar stock. Intercrystalline failure through the beta phase identifies the failure as the "season cracking" type. This phenomenon is generally attributed to selective corrosion attack on the metal while it is internally stressed. Both hardness and "ring" tests indicate that a layer of metal at the surface of the bar was under tension. Corrosion from the atmosphere or from cutting coolants attacked the metal and produced the crack.

Had the above test been carried out on the bar stock, it is probable that the cracking condition would not have occurred. Season cracking will not occur without some corrosive agent present. The cutting coolant and other liquids and gases which come into contact with this part should be examined carefully. Internal strains can also be set up by threading one part on another too tightly, i.e., in gauging or assembly. Strains are easily removed from brass by a low-temperature anneal. Certain mechanical treatments of bar stock have been found to remove internal strain.

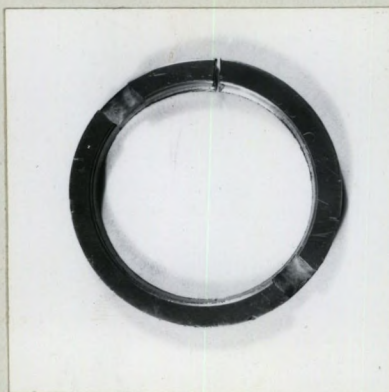
Figure 4.

It was decided to test the metal in the primer body for internal strain. This was done by machining a ring from the base (see Figure 4). The ring was then clamped in a vise and a saw-cut made through it. After measuring the gap, the ring was removed from the vise. The gap was measured again.

It was found to have decreased from 0.029 in. in width to 0.014 in. This was taken as proof that strain existed in the metal.

Ring Test for Strain.
