ORE DRESSING AND METALLURGICAL LABORATORIES.

August 21st, 1941.

Investigation No. 1074.

Examination of Defective Wheel Clamping Bolt.

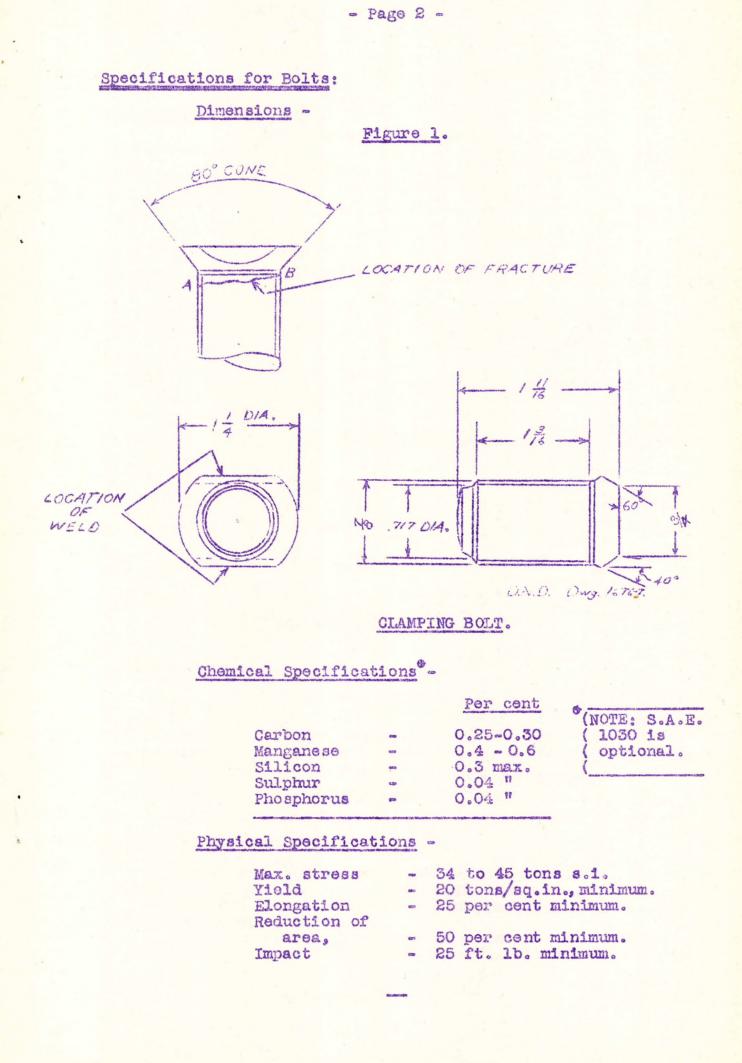
A broken bolt, fractured at AB (see Figure 1), and a new bolt were received for comparison.

Unfortunately the welded head was not available for examination, but hardness tests showed that the metal was 35 V. H. N. softer at the fracture than in the body of the bolt.
