ORE DRESSING AND METALLURGICAL LABORATORIES.

Investigation No. 1078.

Four-Wheel-Drive Transmission  
Jack Shaft Failures.

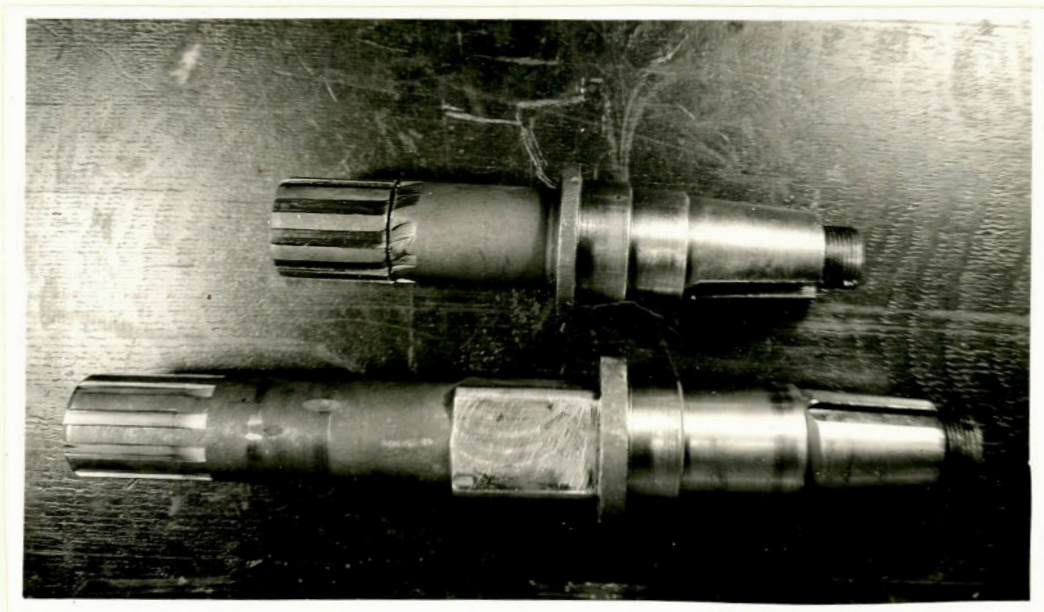
Figure 1.

SHAFTS AS RECEIVED.

Broken shaft (rear).  
Long shaft (front).

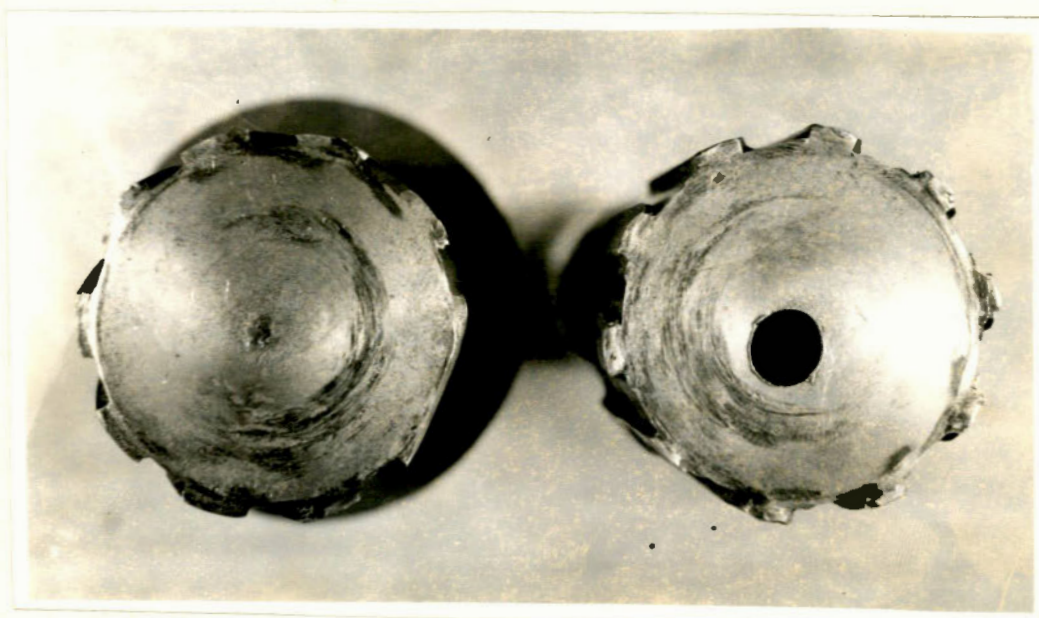
Figure 2.

Appearance of Fracture.

Distortion of the splines at the point of failure indicated:

1. The shaft is soft.
2. Forces exceeding the elastic limit or yield point of the material have been exerted.
3. Fatigue failure must have started from the centre of the shaft.

The smooth fatigue fracture extends from the centre of the shaft to within 1/8 inch of the outside surface. Apparently the starting point for the fatigue crack was the bottom of an eccentric hole in the shaft.

1. The transmission shaft failed due to fatigue.
2. Fatigue failure was accelerated by:
  - (a) Strains exerted on the shaft which sometimes exceeded its elastic limit.
  - (b) Low elastic limit in the shaft due to its low Brinell hardness.
  - (c) An eccentric hole, ending at a highly stressed part of the shaft, served as a focal point for the start of fatigue cracking.
3. The shaft should be made harder and should be solid at the point of maximum stress.

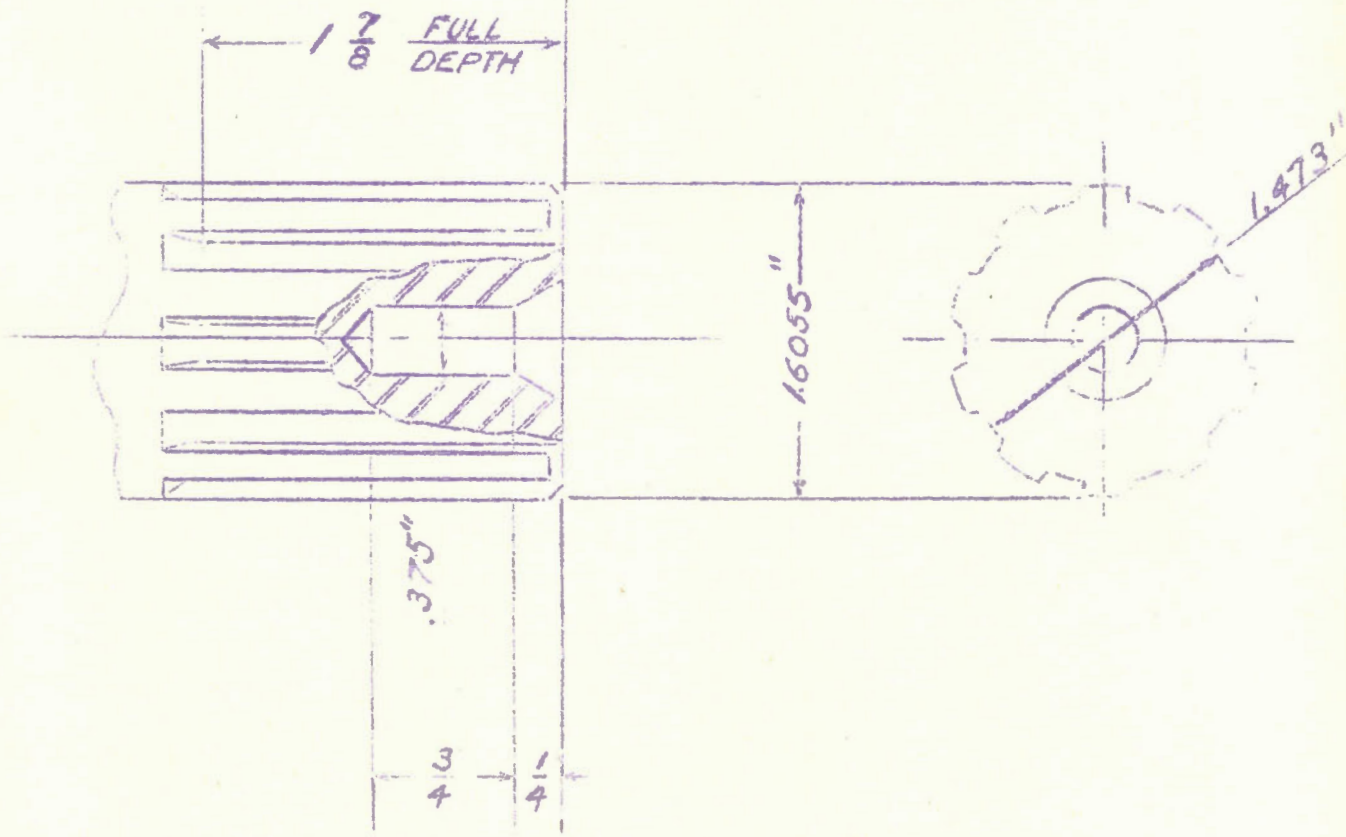
Figure 3.

Dimensions of Splined End.

The hole in the end of the shaft (Figure 3) was not to specification. In the broken shaft an eccentric hole over 2 inches in depth had been bored. In the long shaft a hole about  $1\text{-}\frac{7}{8}$  inches deep was found.
