R E P O R T
of the
ORE DRESSING AND METALLURGICAL LABORATORIES.

Investigation No. 1080.

Examination of a Mark III Tank Manganese
Steel Track Link.

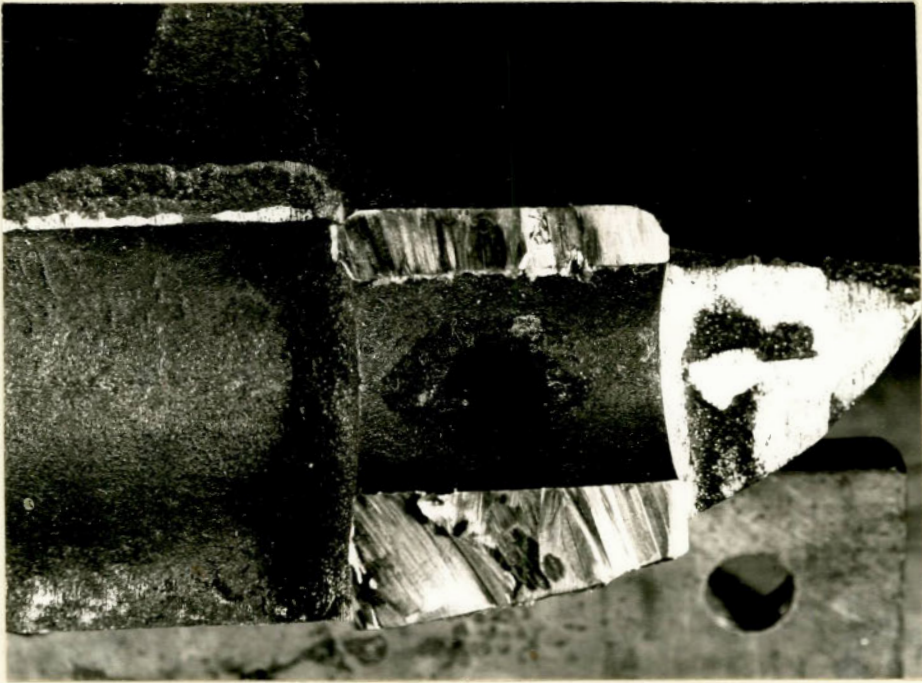
The link appeared sound on the surface but a close examination revealed flaws,

- 1st, on the inside part of one of the end bearing holes, and
- 2nd, on one end of the central bearing portion, as shown in Figure 1.

Flaw on End of Bearing Hole.
(Approximately to size)

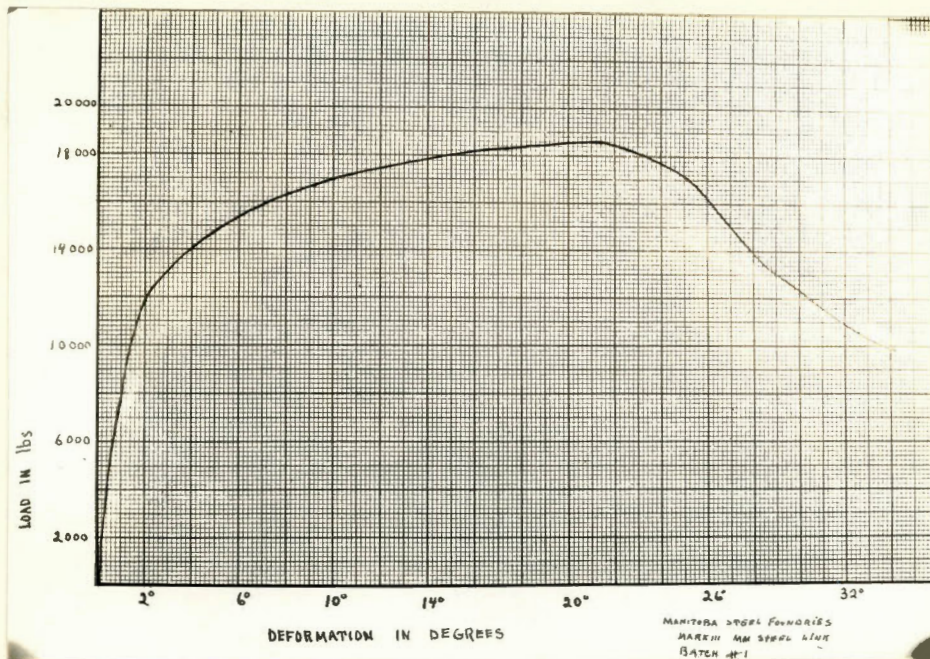
The deformation of the link under a given load is given in Figure 4. The break occurred on the point of the bearing where the presence of a shrinkage cavity has been revealed by X-ray. Figure 5 shows the extent of the shrinkage defect, which occupies the larger part of the fractured surface on this particular side of the link.

Deformation, Under a Given Load,
of Link Between 12-inch Centres.

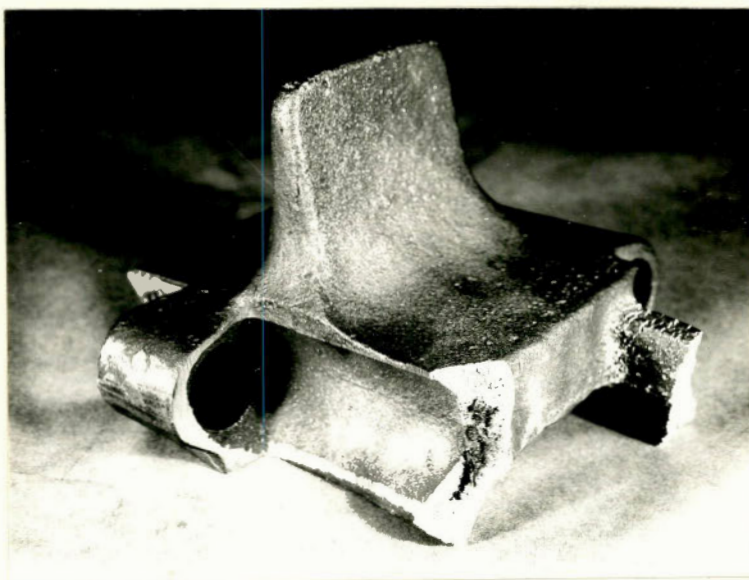
Figure 5.

The flaw extending more than two-thirds of the section on one side of the middle bearing portion would obviously reduce the strength of the link and would explain the low maximum load observed.

Shrinkage Cavity at Fracture.
(Approximately $\frac{1}{2}$ size)

(a) by increasing the pressure of the hot metal in the mould by the use of a proper gate and riser;

(b) by using metal chills (fillets) in the mould so as to displace the shrinkage cavities to a point where the hot metal would flow more easily (i.e., approximately $\frac{1}{8}$ inch from present shrinkage cavity on each end of the central bearing portion).

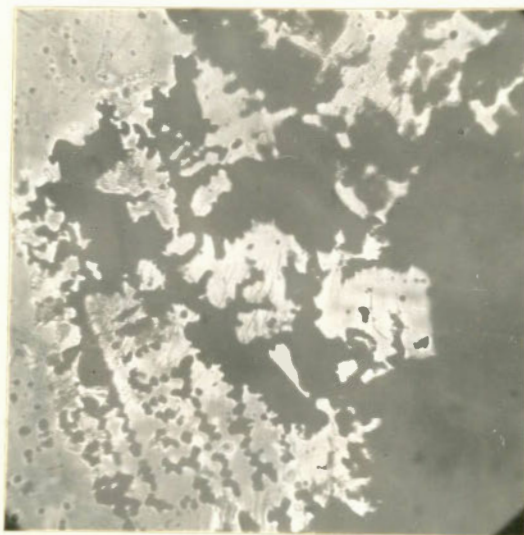
Figure 6.

Figure 6 (magnification, X40) shows the dendritic formation of the flaw in the central bearing portion at the point of fracture. A sample was also cut on one of the bearings, given a metallographic polish, and etched in a solution of 2 per cent nitric acid in alcohol. Figure 7 (magnification, X100) shows the steel structure. It consists of grains of austenite (a solid solution of iron and carbon). There is no indication in that section of the presence of iron carbide, which would appear as white particles. The small dark particles within the grain boundaries are inclusions.

X40.

Portion of Shrinkage Cavity,
Showing Dendritic Formation.

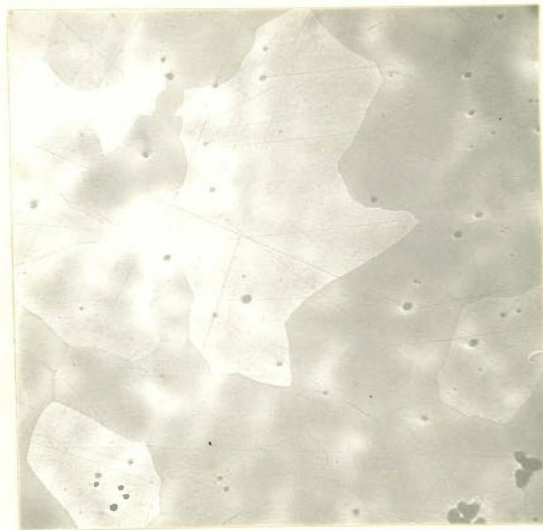
Figure 7.

The microphotograph in Figure 7 reveals a structure practically free from iron carbide as a consequence of an adequate solution heat-treatment. The moderately small grains of austenite indicate that the pouring temperature was properly controlled. The steel contains a fair amount of inclusions and microshrinkage cavities.

X100, nitral etch.
Steel Structure of Link.
