R E P O R T
of the
ORE DRESSING AND METALLURGICAL LABORATORIES.

Investigation No. 1104.

Examination of Surface Defects
on Brass Primer Bodies.

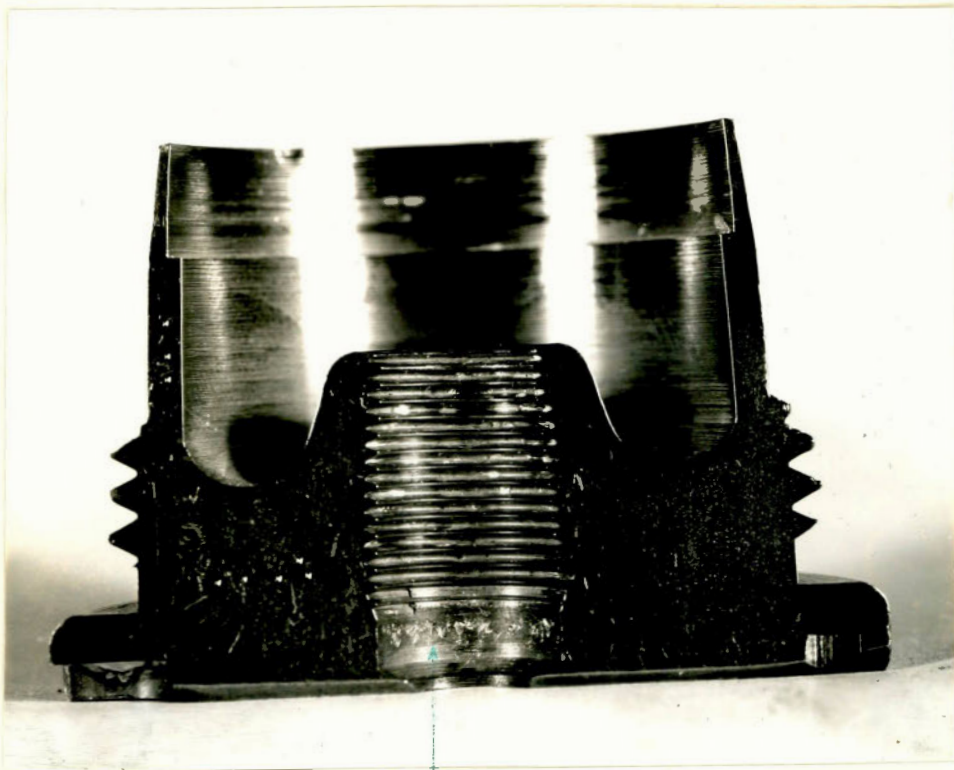
Figure 1.

Figure 1 shows the section of Primer Body No. 2 with the surface defects as marked. All of the other primer bodies received show the same defects at the same place.

SECTION OF PRIMER BODY
NO. 2, showing the
surface defects.

Since the metal has a normal microstructure and is relatively free from foreign inclusions, it would seem that the surface defects had little connection with metal structure. It is significant, however, that the only surface defect occurs at the same spot in every primer body. Micro-examination and hardness tests reveal that the metal has been "scuffed" or dragged, probably by the cutting tool. This might have resulted when the tool became dull or when the tool angles were not properly designed. Application of cutting lubricant or of changes in speeds and feeds might eliminate this defect.

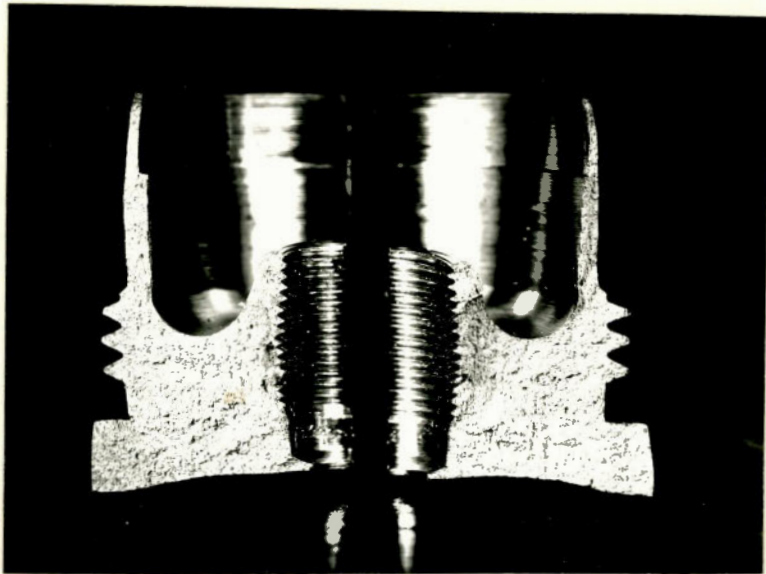
Figure 2.

Fractured surface of
Primer Body No. 1.

The fracture shows no inclusions or other
defects in the brass rod used for manufacturing the primer
bodies.

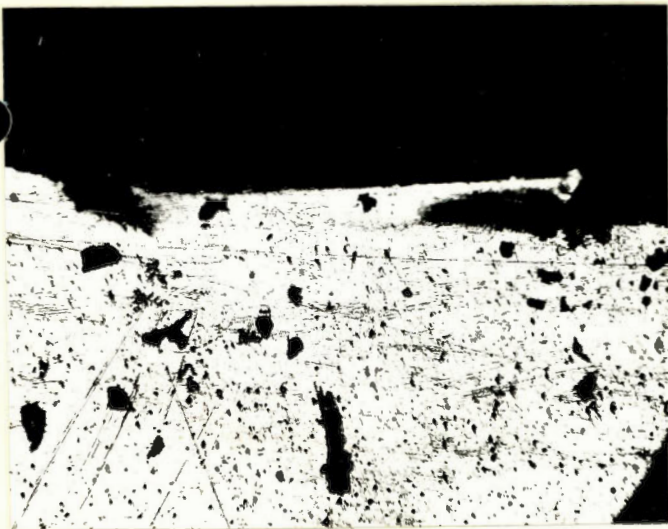
Figure 3.

X100, unetched.
TRANSVERSE SECTION,
PRIMER BODY NO. 3.

The micro-examination shows that the structure is typical of alpha + beta brass, with a fairly fine grain size. Some inclusions which might be connected with the extrusion have been observed (see Figures 3, 4, and 5). Their presence, however, does not seem to be in any way related to the surface defects shown in Figure 1.

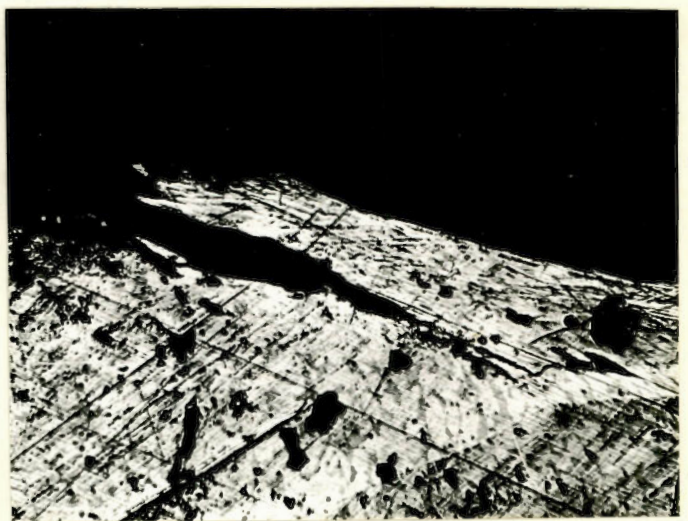
Figure 4.

X250, unetched.
TRANSVERSE SECTION,
PRIMER BODY NO. 3.

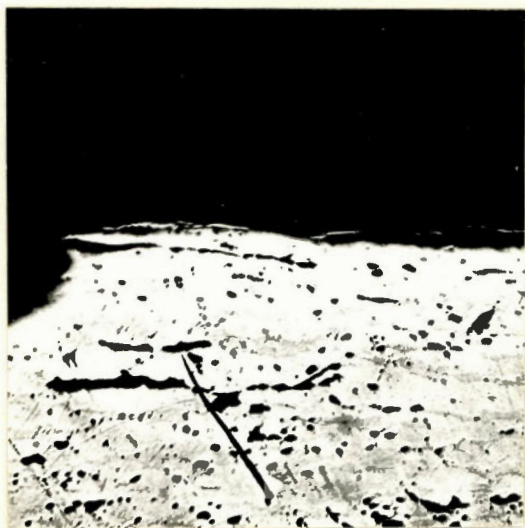
Figure 5.

LONGITUDINAL SECTION,
PRIMER BODY NO. 1.

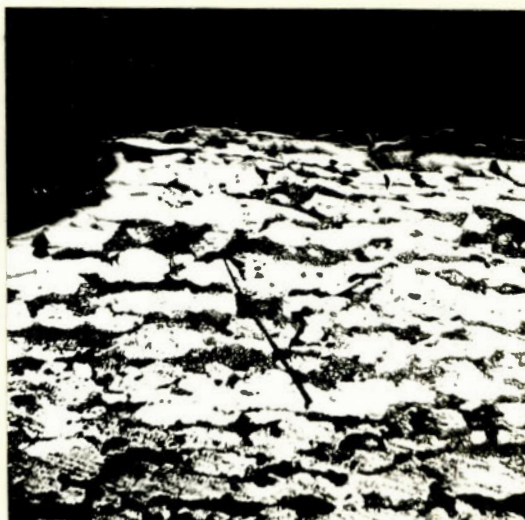
Figure 6.

LONGITUDINAL SECTION,
PRIMER BODY NO. 1.

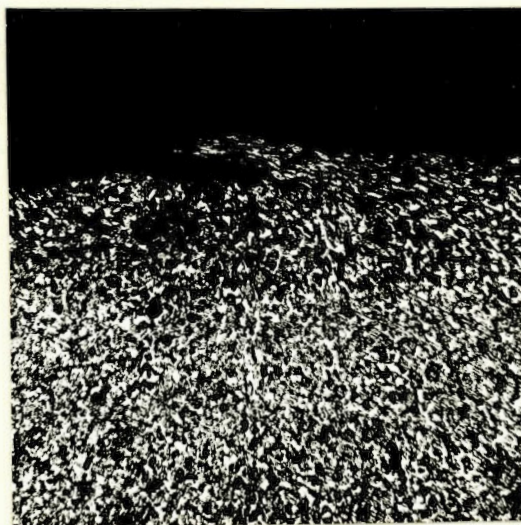
Figure 7.

TRANSVERSE SECTION,
PRIMER BODY NO. 3.
