October 9th, 1941.

ORE DRESSING AND METALLURGICAL LABORATORIES.

Investigation No. 1106.

Examination of a Fractured 4130X Steel  
Aircraft Tube.

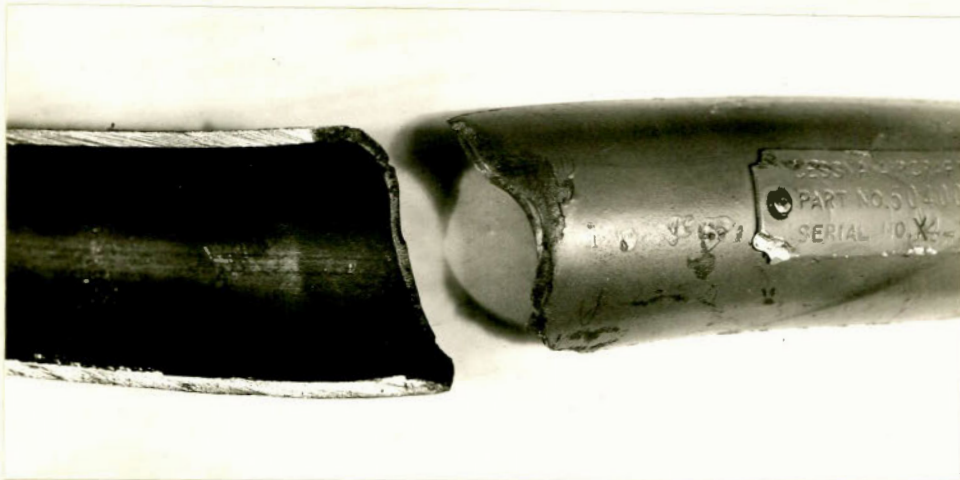
Figure 1.

The distortion at the point of fracture is of the type usually associated with failure due to tension or torsion. However, the fracture has been somewhat damaged and the appearance may be misleading. Distortion at the fracture may have been caused in the accident, so there is a possibility that the part failed in fatigue. One would expect, however, that any fatigue failure in this tube would have started in the tapped thread holes holding the name-plate screws.

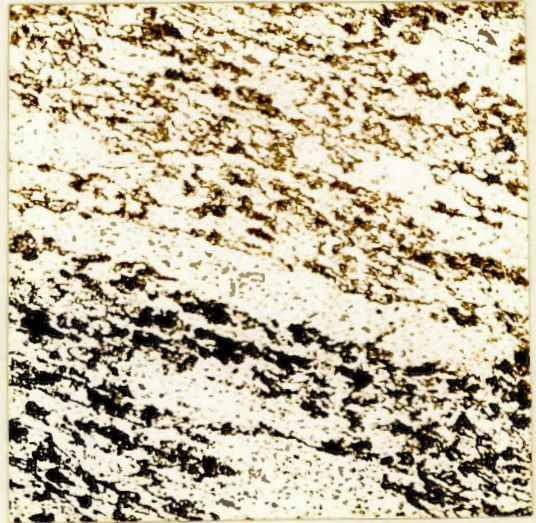
Figure 4.

The photomicrographs shown below, Figures 3 and 4, indicate that this tubing had a structure normal for S.A.E. 4130X steel.

X500, nital etch.

The microstructure is normal for an S.A.E. 4130X steel.
