Investigation No. 1117.

Examination of a Welded Wing Strut.

R E P O R T
of the
ORE DRESSING AND METALLURGICAL LABORATORIES.

On November 1st, 1941, a welded wing strut was received from G. E. Wallingford, for Chief Aeronautical Engineer, Air Services, Civil Aviation Division, Department of Transport, Ottawa, Ontario. The steel strut, described as "a starboard inner interplane diagonal bracing strut, taken from Fleet Aircraft CF-ANG," had failed in the air, causing collapse of the wing.

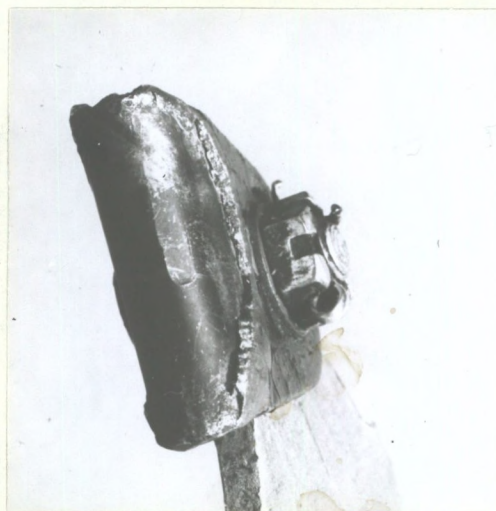
Figure 3.

U-terminal, showing failure at weld.
(Approximately to size).

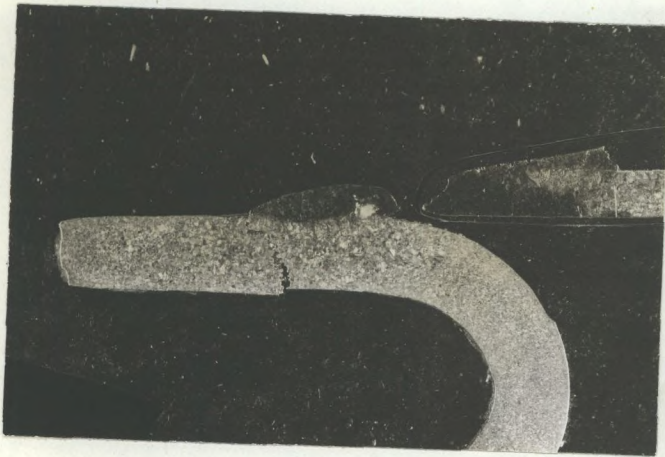
Figure 4.

The entire strut assembly is shown in Figure 1. It consists of an S.A.E. X4130 steel streamlined tube, 0.049 x 0.709 x 1.702 in., as depicted in Figure 2. A U-terminal 0.095 inch thick is welded at each end of the tube and forms an anchorage for a bolt. One of these U-terminals, described as attached to the front starboard mainplane spar fitting, was broken at the weld, as shown in Figure 3. Close examination of this part revealed a crack approximately $\frac{1}{4}$ inch long extending from the side of the terminal into the intermediate zone, i.e., the zone adjacent to the weld seam (see location on Figure 4, magnification x5).

Macroscopic examination indicates that a crack was starting in the intermediate zone adjacent to the weld seam of the U-terminal. Such a condition is often observed in the metal adjacent to a weld and is recognized as very harmful, since it is sufficient to determine a fatigue failure under high vibratory stress. However, in the present case, failure actually took place in the weld and not in the intermediate zone.

X5 magnification,
nital etch.
Section of the welded parts.

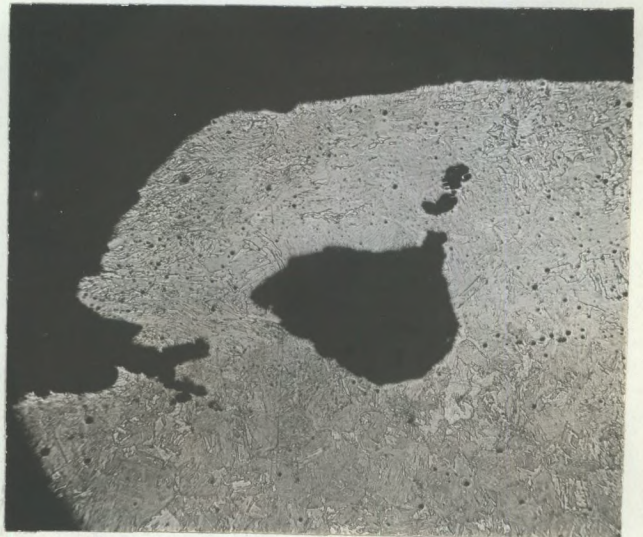
Figure 5.

contrast with the rest of the base material. The minimum thickness of the material at the weld measures approximately 0.03 inch. A large bright spot and several small ones are visible on the weld of the U-terminal and seem to form a chain extending up to the point where the weld has failed. These spots are blowholes, as is evidenced in Figure 5 (magnification, X40) and Figure 6 (magnification, X100), which give enlarged pictures of these blowholes.

Such blowholes as shown in Figures 5 and 6 are sufficient to considerably reduce the endurance limit of the weld and to contribute in bringing fatigue failure under high repeated stress. The lack of homogeneity in the welded material may come from some of the following: unsuitable fluxing, moisture on the weld, or improper welding technique such as hesitating before breaking the arc, backing up over the previously deposited metal, etc. These flaws can be detected by X-ray examination.

In the present case, the internal stress concentration due to blowholes in the weld has contributed to the failure of the parts under examination.

X40, nital etch.
Blowholes in U-terminal weld.

1. Welding with a crater eliminator. (®)
2. X-ray examination of the weld seam, to detect flaws after welding.
3. Periodic magnafluxing of the welded areas to detect fatigue cracks.

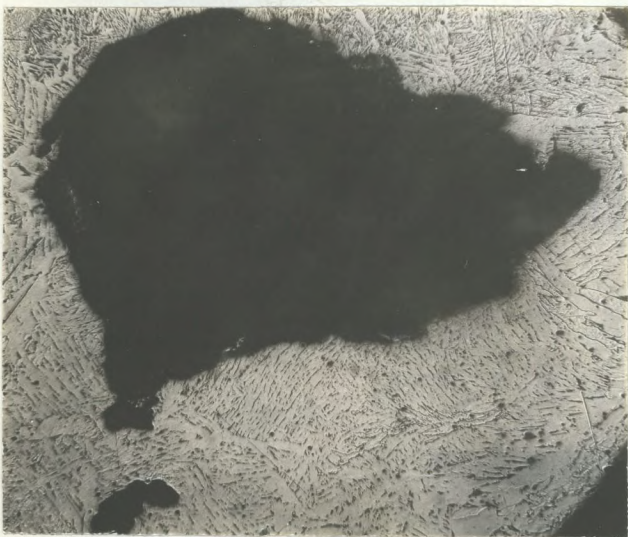
Figure 6.

X100, nital etch.
Large blowhole in U-terminal.

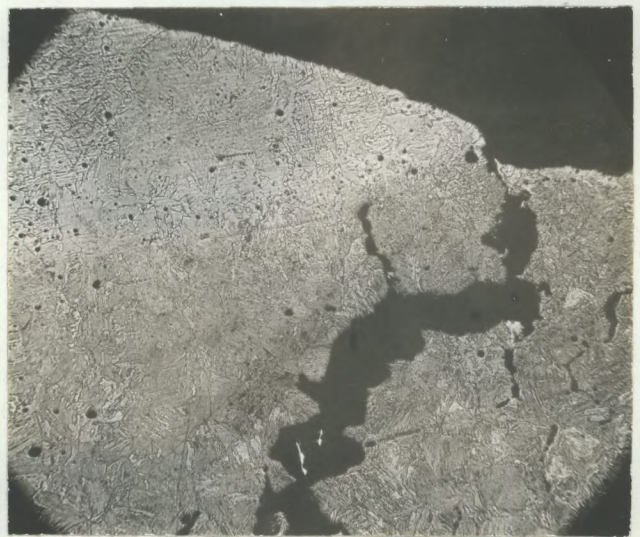
Figure 7.

Figure 7, magnification X100, shows the crack at the base of the weld, in the intermediate zone, while Figure 8, magnification X100, shows a portion of the same crack at higher magnification. As is seen in this last photomicrograph, the crack follows the grain boundaries and is therefore very irregular in appearance. The grain structure appears coarser at this intermediate zone of the U-terminal and the pearlite appears to be finer in some areas. Figure 9 (magnification X250) was taken from the U-terminal at the zone where the weld and base metal are in contact. The white constituent present in much larger amount in the weld portion is ferrite and the darker constituent is pearlite, the eutectoid of iron and iron carbide. Figure 10 (magnification X250) also shows the zone of fusion between the weld and base metal on a section of the weld on the strut tube. The two large dark areas are blowholes.

X40, nital etch.
Crack in the intermediate
zone.

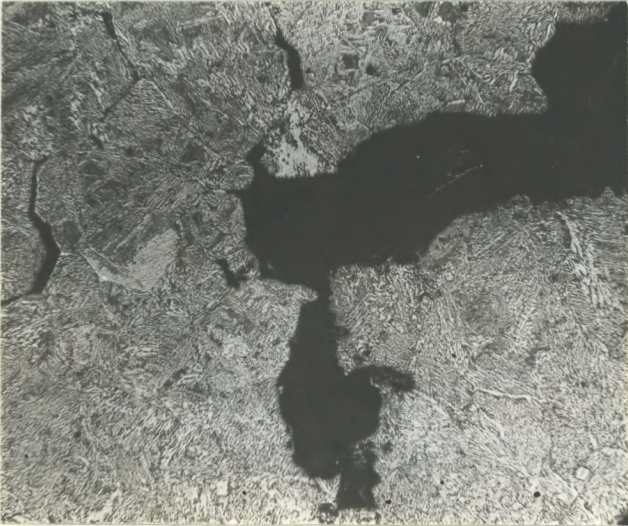
Figure 8.

X100, nital etch.

Portion of crack in
intermediate zone.

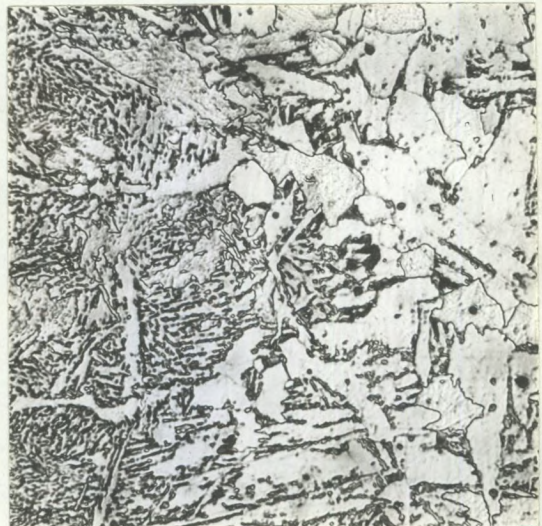
Figure 9.

Fusion is fairly good between the weld and the base material (Figures 9 and 10). The weld metal contains

less carbon than the base metal, as can be seen by the lower amount of pearlite (grey constituent) present in the weld. (Figures 9 and 10).

X250, nital etch.

Zone of fusion between
weld and base metal
on U-terminal.

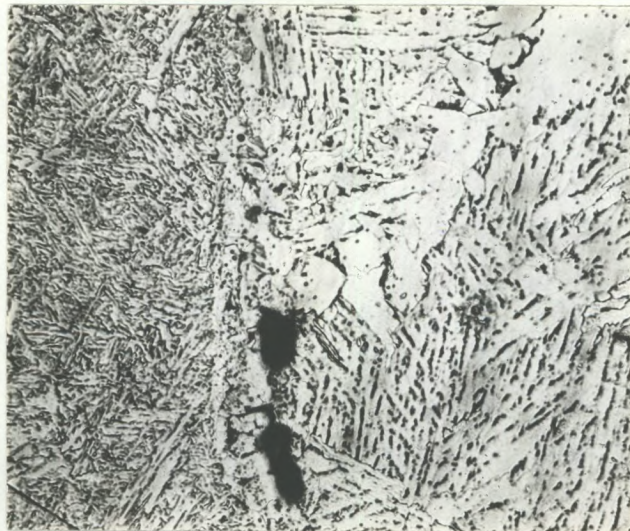
Figure 10.

X250, nital etch.

Zone of fusion between weld and
base metal on strut tube.
