ORE DRESSING AND METALLURGICAL LABORATORIES.

Investigation No. 1125.

Examination of Surface Defects
on Brass Primer Bodies.

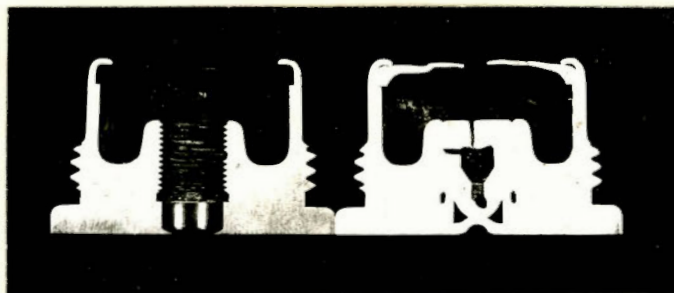
Figure 1.

Cross-sections of Primer Bodies
Nos. 1 and 3, showing the turnover contour.

Left - Primer Body No. 1,
(Lot No. 1, marked violet).

Right - Primer Body No. 3,
(Lot No. 2, marked blue).

3. Figure 1 shows the turnover contour of primers from both lots. There is no appreciable difference in contour shape.

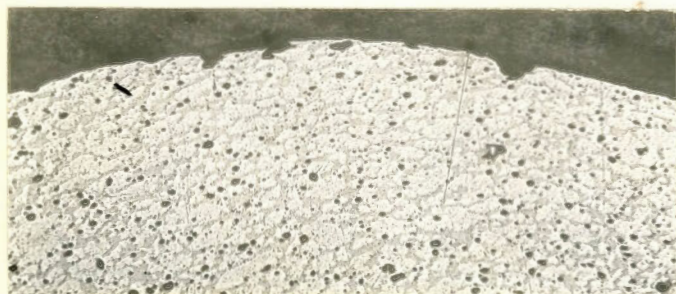
Figure 2.

X100.
PRIMER NO. 1.
Outside contour of
the turnover.

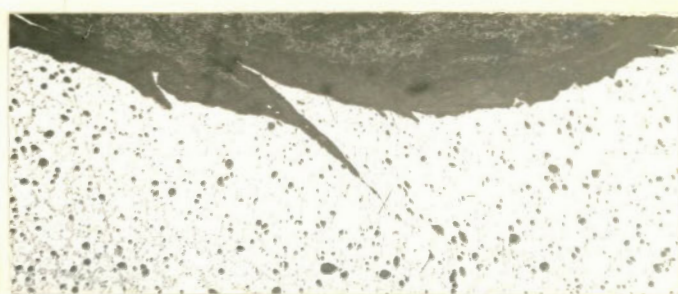
Figure 3.

X100.
PRIMER NO. 1.
Inside contour of
the turnover.

The insides of the turnover contours show worse surface condition than the outer sides. Figure 3 shows an especially bad flaw. This would seem to have been caused by the machining, as in only one instance is any corrosion effect shown (Figure 5) which might possibly have been caused by the explosive material.

2. These defects are not due to any characteristics of the materials but are believed to be caused mechanically. The elimination of these defects might probably be obtained by improving the machining conditions or by modifying the turnover method (e.g., by rolling).

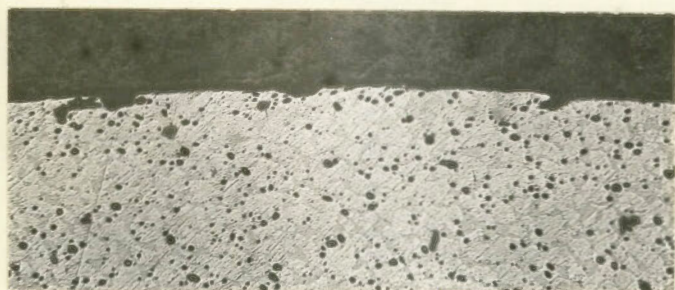
Figure 4.

X100.
PRIMER NO. 2.
Outside contour.

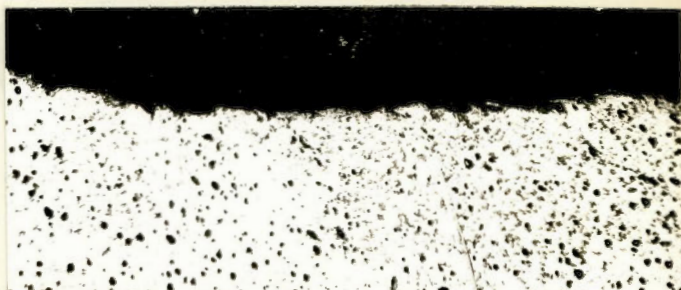
Figure 5.

X100.
PRIMER NO. 2.
Inside contour.

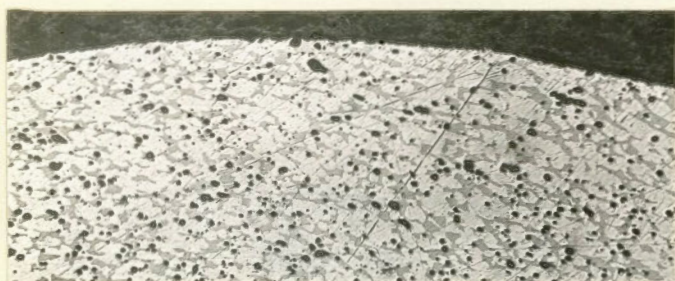
Figure 6.

X100.
PRIMER NO. 3.
Outside contour.

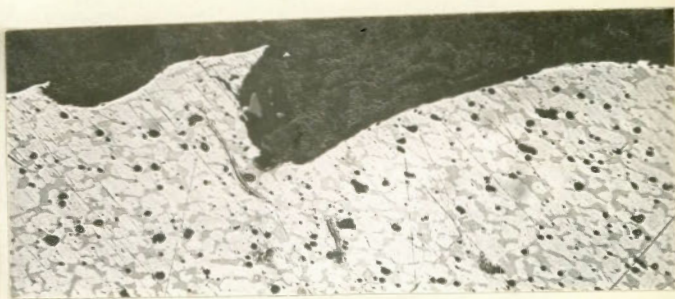
Figure 7.

X100.
PRIMER NO. 3.
Outside contour.

The micro-examination shows that the circumferential lines around the outside of the curved turnover are very shallow (close to the surface) and the shape of these defects is not of the "v" type notch but rather of the "u" type. The only specimen which exhibited a variation of this defect is shown in Figure 7 (Primer No. 3, Lot No. 2, marked blue) and this also is not a true "v" type, only slightly deeper.

a defect, but this is the worst shown in the examination (Figure 7).

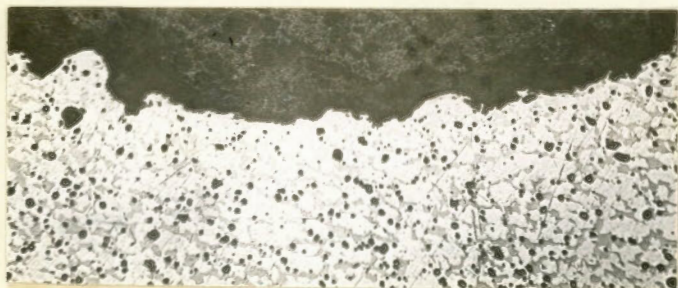
Figure 8.

X100.
PRIMER NO. 3.
Inside contour.

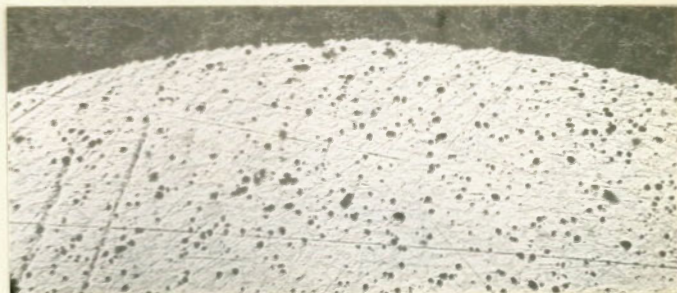
Figure 9.

X100.
PRIMER NO. 4.
Outside contour.
