CANADA
DEPARTMENT
OF
MINES AND RESOURCES
MINES AND GEOLOGY BRANCH

Investigation No. 1126.

Examination of a Defective Valentine Tank
Manganese Steel Track Link.

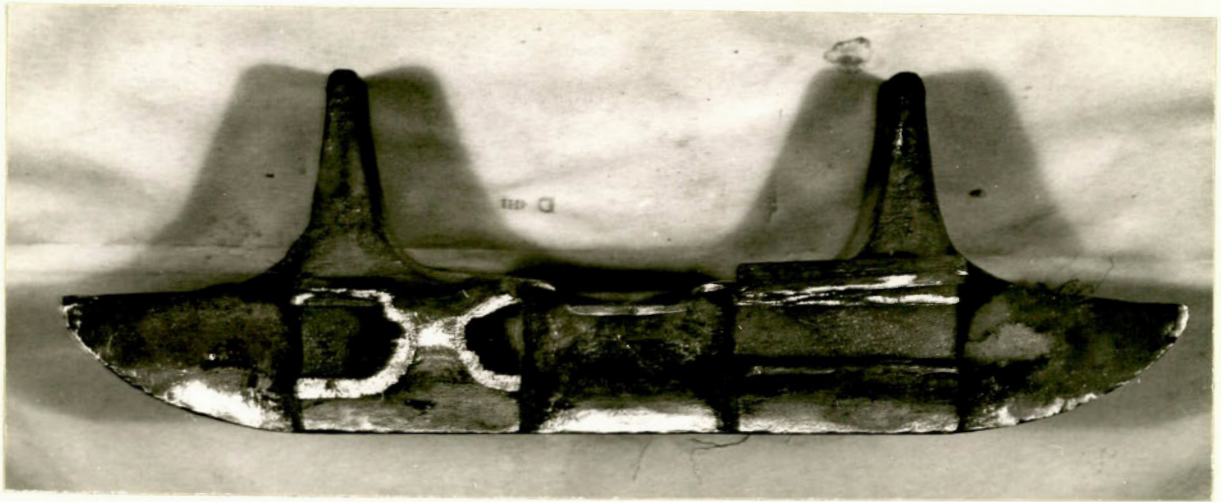
Figure 1.

Two identification marks appeared on the link: the letter H and the pattern number 2(?)2646T. Figure 1 shows the link as received. One of the end bearing holes is torn open while the other is partially broken. As seen in Figure 2 (natural size), failure has started on this latter bearing. A longitudinal flaw extending along the entire length of the bearing reveals two surfaces (one curved outside, the other inside) which were adhering only at one spot. A similar discontinuity in the material is also found extending approximately one inch from the inner portion of the other bearing (Figure 3, natural size). The surface of the track link appeared bright and polished, indicating that the casting had been in service for some time.

Track Link As Received.
(Approximately 1/6 size)

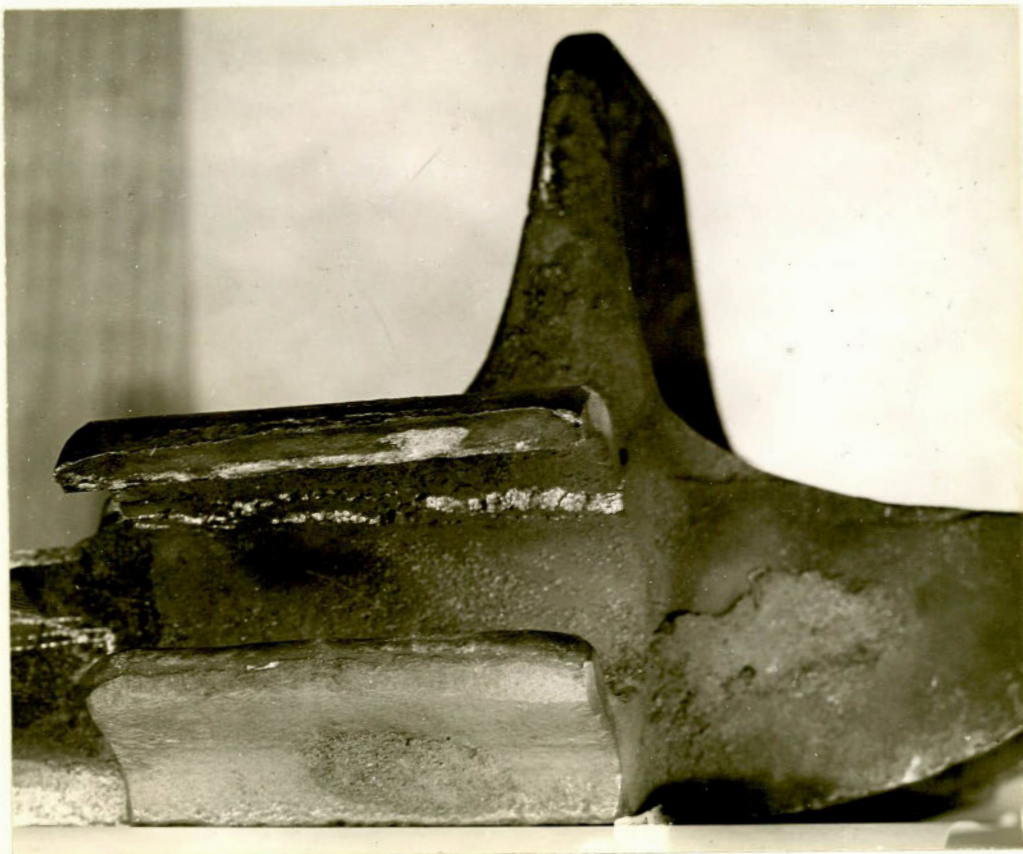
Figure 2.

Macro-examination of the casting reveals the presence of "cold shut". This flaw would originate while pouring and would be due to the freezing of one surface before the other metal flows over it, thus causing a lack of continuity in the structure of the material.

2. The casting under examination reveals a defect, known as "cold shut", which caused its failure in service. Such a defect is due to a lack of fluidity, most likely resulting from pouring the metal too cold.

Bearing Hole Torn Open Due to Cold Shut.
(Natural size)

It is recommended that a test such as the stethoscopic test be developed in order to readily identify by the sound the defective castings before use. In doubtful cases more expensive tests, such as X-ray or gamma ray examination, might also be used.

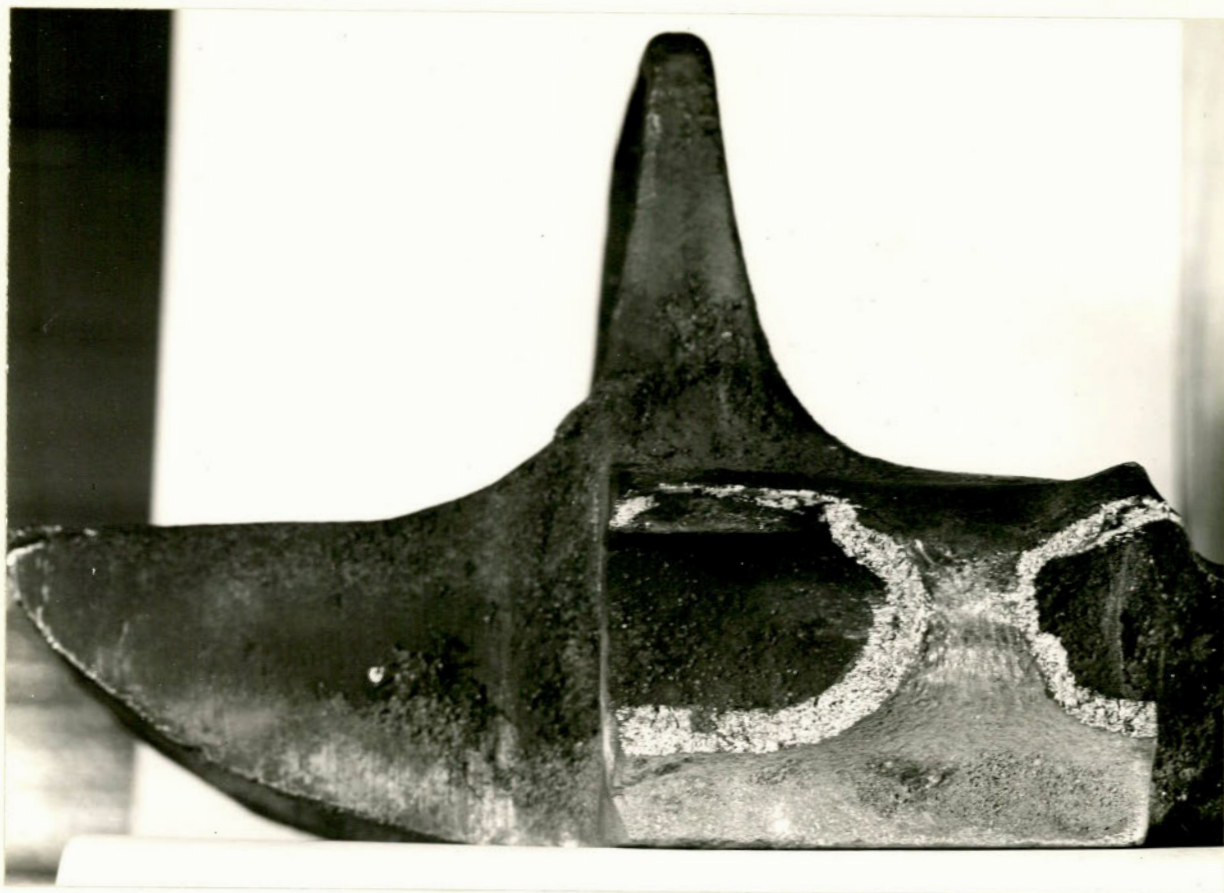
Figure 3.

Bearing Hole Partially Broken Due to Cold Shut.
(Natural size)
