R E P O R T

Investigation No. 1129.

Examination of a Welded Aluminium  
Alloy Casting.

R E P O R T  
of the  
ORE DRESSING AND METALLURGICAL LABORATORIES.

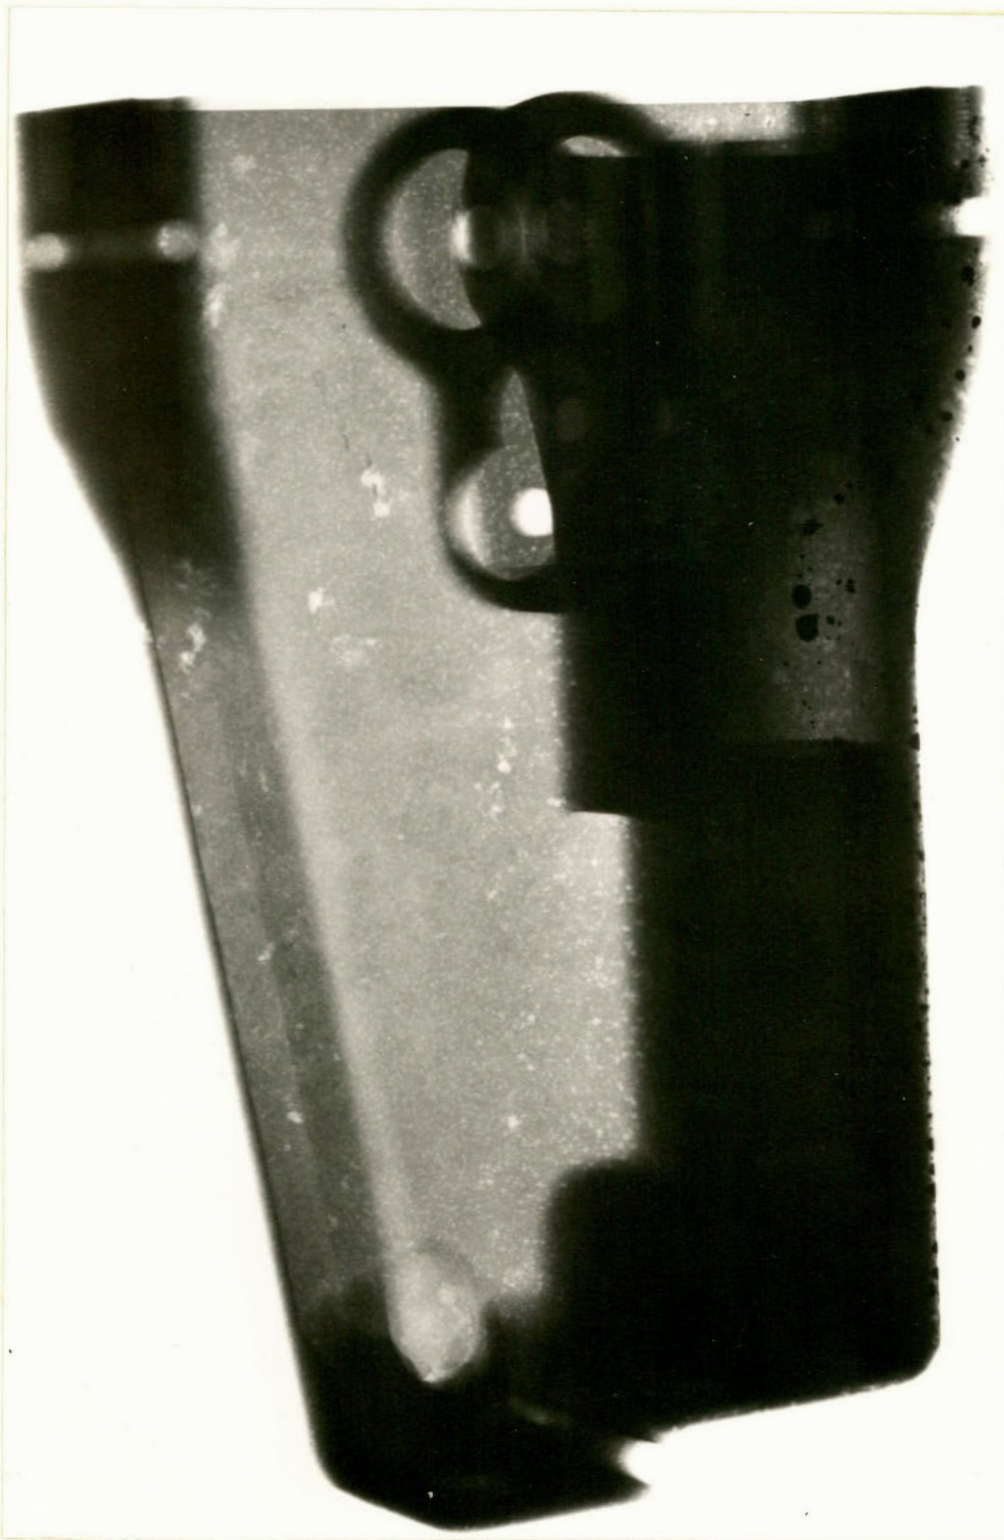
Figure 1.

showed in the original casting many gas cavities, a considerable pinhole porosity, and also, on one side, many inclusions of heavy metals. The section of the casting which was rectified by welding appeared to be satisfactory for the purpose. The joining of the casting and the welded part showed uniformly homogeneous structure. The welded portion is almost completely free from porosity, but there is one area where the metal is thinner than is desirable.

RADIOGRAPH OF THE CASTING.

(Note: This is a print of radiograph; consequently, cavities appear as white spots and heavy density areas (such as solder) appear as black spots.)

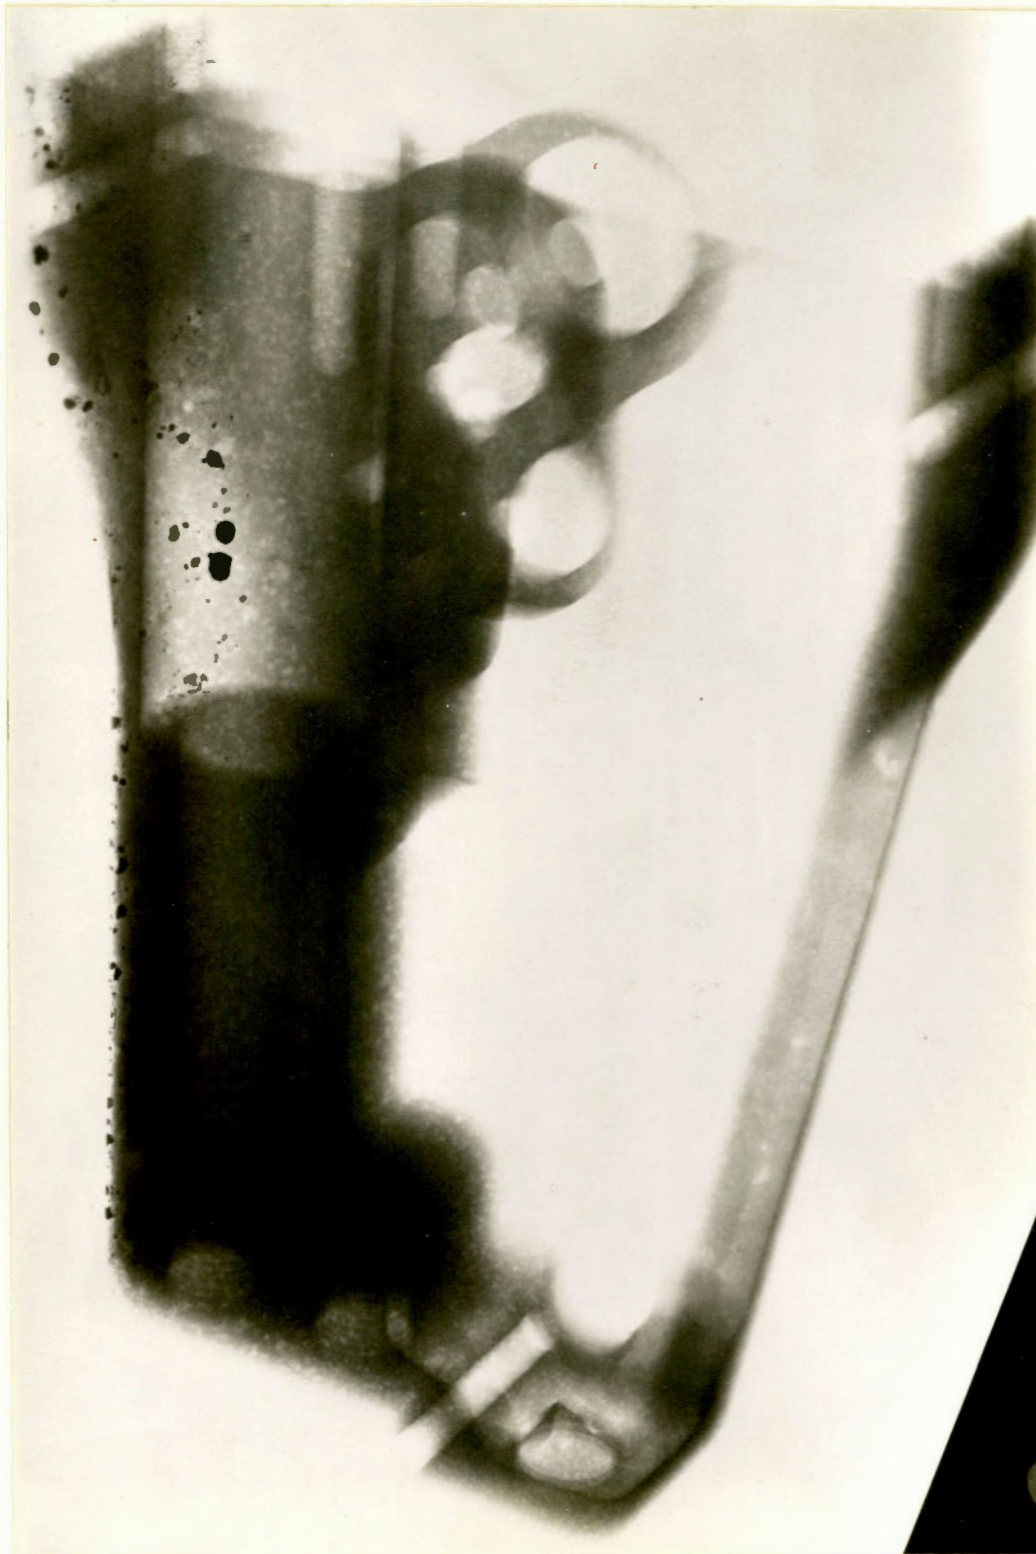
Figure 2.

RADIOGRAPH OF THE CASTING.

Dark spots - heavy metal inclusions.  
White spots - porosity and gas cavities.

X-ray examination made to examine the serviceability of the weld shows that the casting itself would not be considered to be of satisfactory quality, due to porosity, and had been repaired by soldering. This was confirmed by qualitative spectrographic analysis, which demonstrated that the inclusions of heavy metals shown in the radiographs were essentially an alloy of zinc and tin.

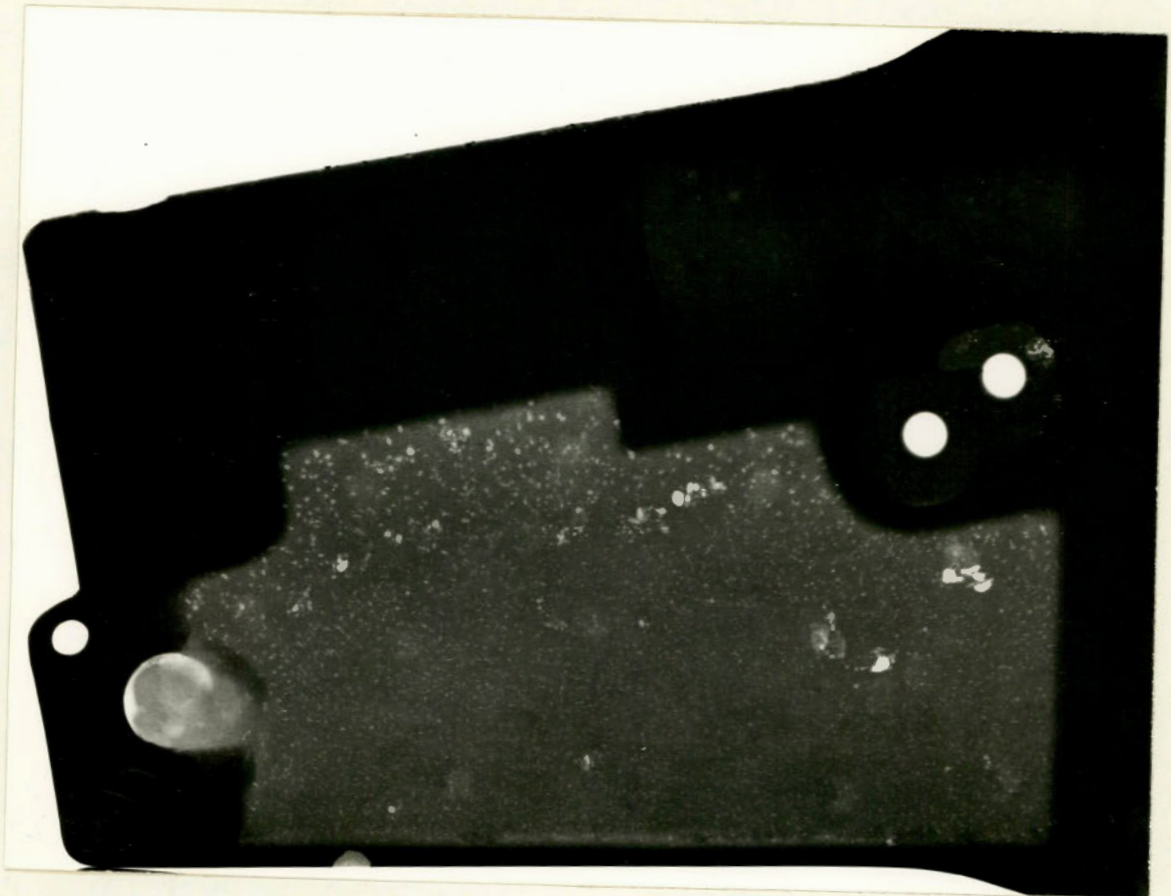
Figure 3.

RADIOGRAPH OF THE CROSS-SECTIONED CASTING.

White spots - cavities and porous areas.  
Dark spots - heavy density areas.

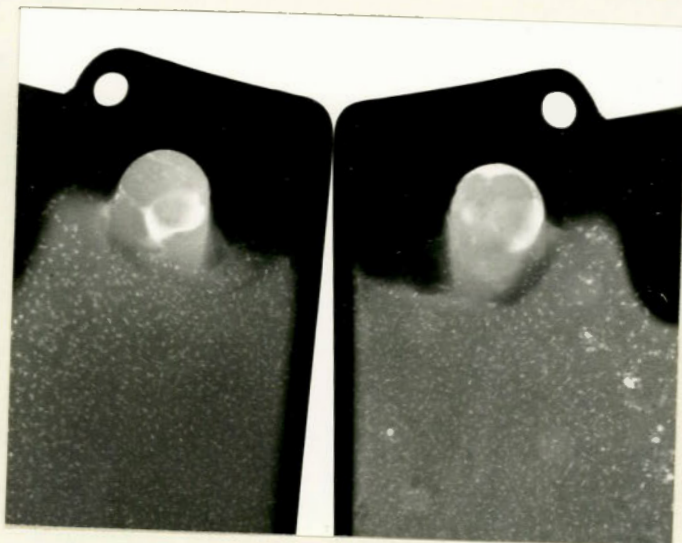
Figure 4.

RADIOGRAPH OF THE WELDED AREA.  
This shows the non-uniformity of the welded  
metal.

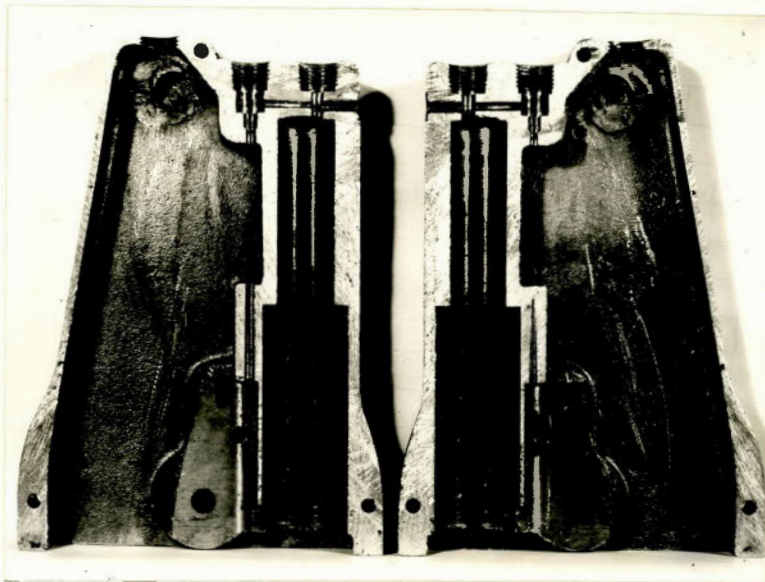
Figure 5.

CROSS-SECTION OF THE CASTING.

Upon visual examination of the casting after cross-sectioning, the gas cavities were very clearly shown on the machined surfaces and in the sawed section surface.

Considering the conditions under which the welding had to be done, it is reasonably satisfactory.

Some very loosely attached flux was knocked off during the sawing operation.

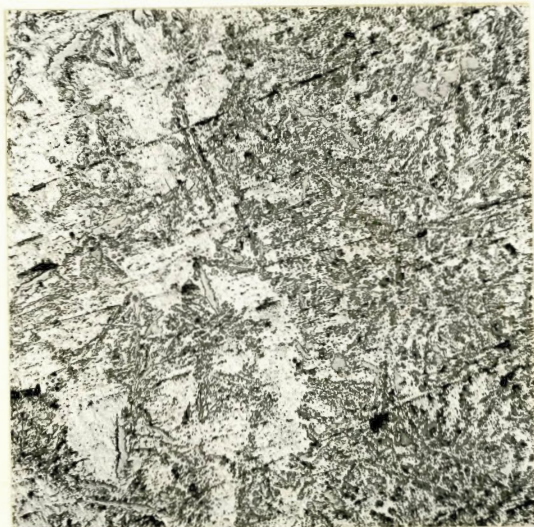
Figure 6.

X100, unetched.  
Welding boundary.

Figure 6 shows that the welding joint is satisfactory. Figure 7 shows some porosity in the welded section and the microstructure indicates that a high-silicon aluminium alloy welding rod was used.

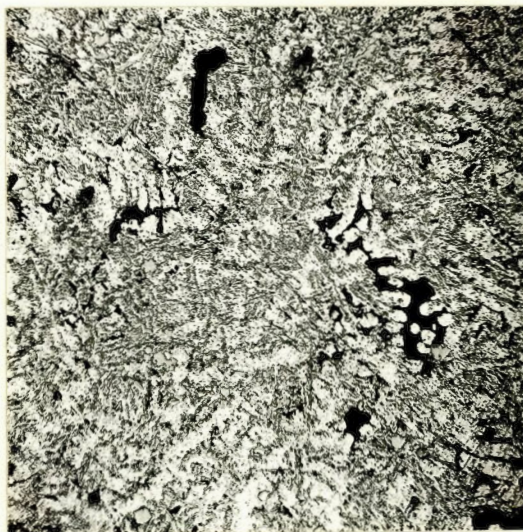
Figure 7.

X100, unetched.  
Section in weld area.

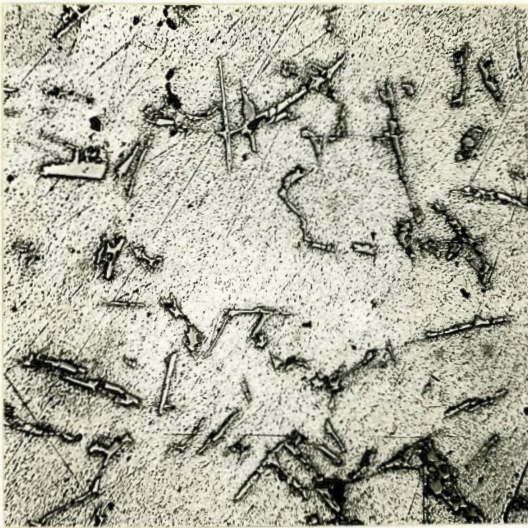
Figure 8.

Section of the original casting  
(remote from the welded area).

Figures 8 and 9 show the microstructure normal for a low-silicon aluminium alloy with copper content. Figure 9 shows considerable porosity and gas cavities, similar to those repaired by soldering.

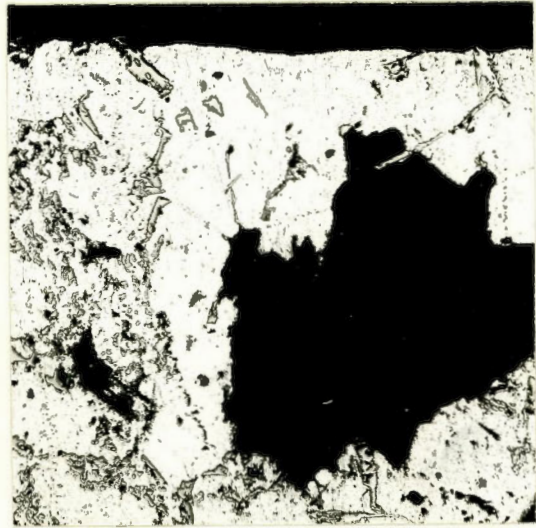
Figure 9.

Material as cast, near  
the soldered locations.

The micro-examination shows that the welded area and the joining possess satisfactory structures. The microstructure of the casting (Figure 9) shows porosity cavities and larger gas cavities.

1. The considerable pinhole porosity and many gas cavities in a casting intended for a part the failure of which would cause loss of control of the engine should be sufficient reason for its rejection.
