December 23rd, 1941.

Investigation No. 1136.

Examination of Aluminium Alloy Forgings.

Canadian Jacobs Anson Part No. R.81414, Material 17ST

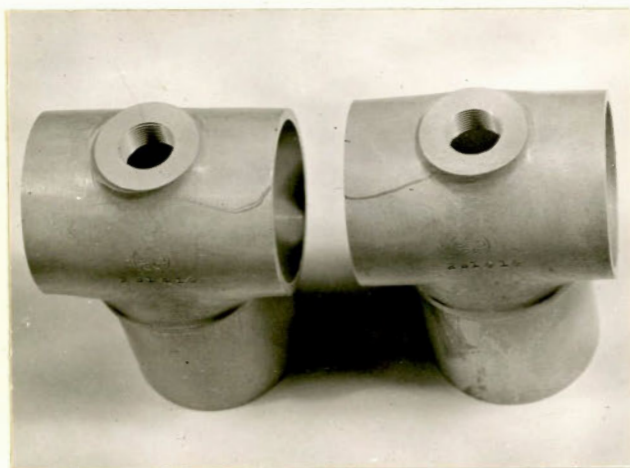
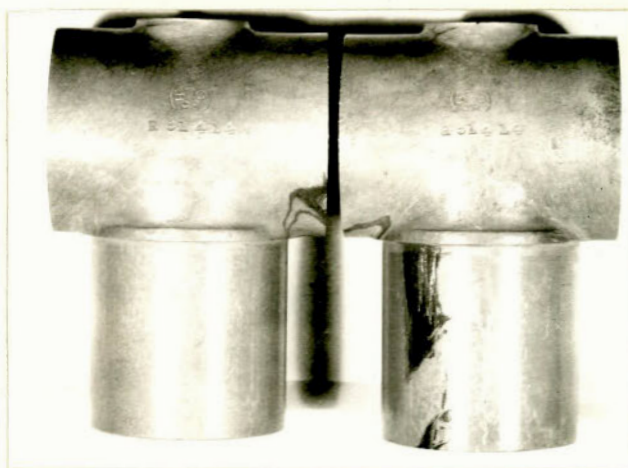
PARTS AS RECEIVED.

The nature of the defect is shown in Figures 1 and 2 below:

The micro-examination shows that the stain visible on the surface after anodizing was due to pronounced segregation of heavy compounds (Cu, Mn, Fe) in the aluminium alloy.

The stain on the surface of the examined forgings was caused by segregations in the alloy.

This type of defect seriously impairs the uniformity (strength and ductility) of the metal.

Parts with such defects are not recommended for use in aircraft construction.

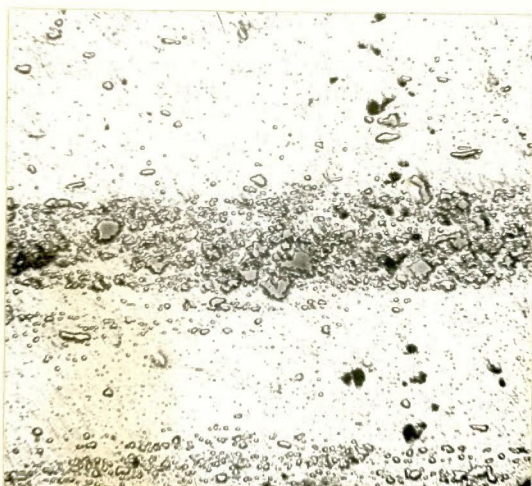
Figure 3.

Figures 3 to 6 show strings of pronounced segregation of heavy compounds (Cu, Mn, Fe) in the base alloy.

X100, unetched.

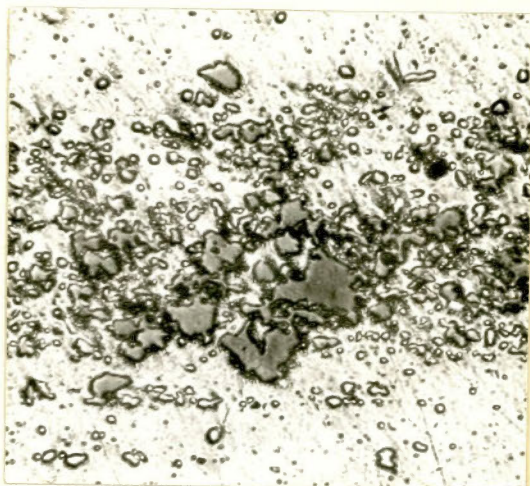
Figure 4.

X250, unetched.

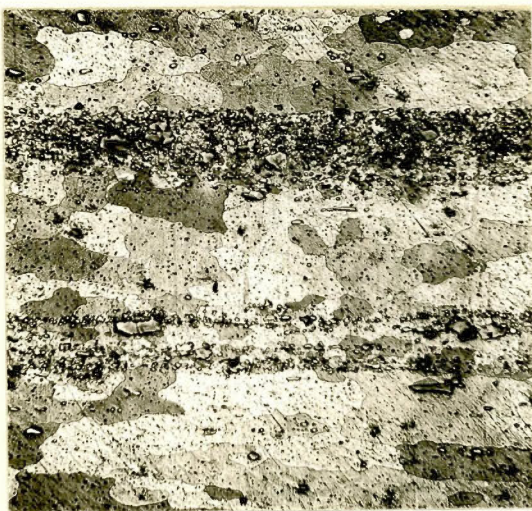
Figure 5.

X100, etched with Keller's reagent.®

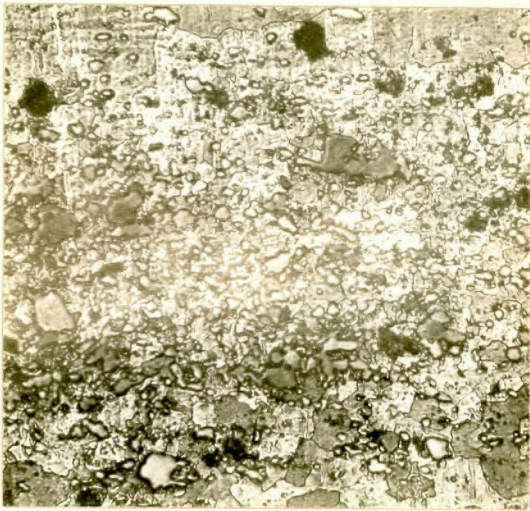
Figure 6.

X250, etched with Keller's reagent.®

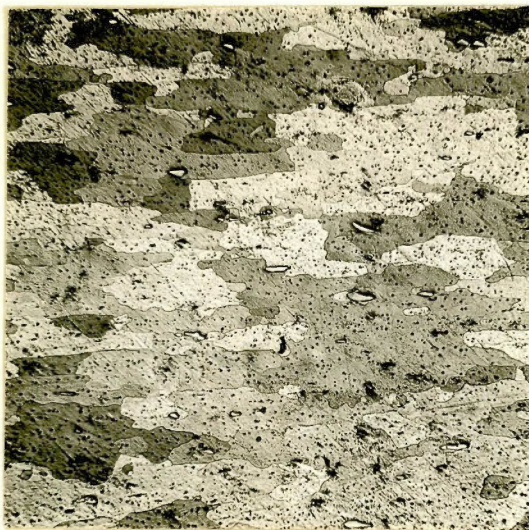
Figure 7.

Figure 7 shows the structure of the "sound" material, normal for this type of alloy.

X100, etched with  
Keller's reagent.⊕
