December 29th, 1941.

ORE DRESSING AND METALLURGICAL LABORATORIES.

Investigation No. 1141.

An Examination of Two Towing
Hooks.

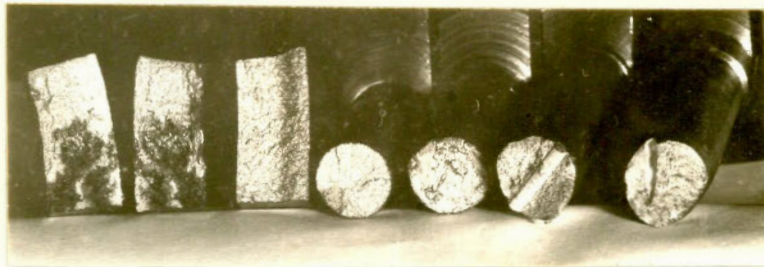
Figure 1.

The use of internal chills has been mentioned in a previous report on towing hooks issued by this Department. [⊕] Since X-ray inspection has come into use as a tool for measuring internal soundness, soft wire coils have been used in the mould to chill the metal and reduce shrinkage. Figure 1 shows that these wires are not always bonded to

the metal of the casting.

↑ ↑ ↑ ↑ ↑ ↑
E F D C B A

- | | | |

| A |) | |
| B |) | - Test bar fractures of No. 6. |
| C |) | |
| D | - | " " fracture " No. 7. |
| E | - | Bend test fracture of No. 6. |
| F | - | " " " " No. 7. |

The physical tests are not truly representative of the quality of the metal, since the fractures occurred at internal chills, shrinkage, etc.

The shrinkage and internal chills appear to be confined mainly to the base of the casting.

Regular X-ray inspection should be used to detect occurrence of shrinkage defects.

A proof test would afford much more satisfactory indication of the quality of the casting than is obtained by test pieces cut out of the base.
