January 10th, 1942.

ORE DRESSING AND METALLURGICAL LABORATORIES.

Investigation No. 1145.

Examination of Material in Spar Member
and Elevator Hinge from Cessna-Crane
Aircraft 7664.

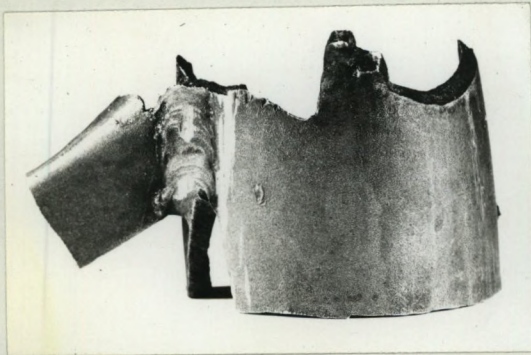
Figure 1.

Spar fracture.

In so far as the steel is concerned the failure does not appear to have been caused by alternating stresses, as there was a fair amount of plastic deformation at the point of failure. This also was true of the steel specimen that had been taken from the spar of the other wrecked Cessna-Crane aircraft. The lack of distortion in the magnesium-alloy hinge failure is consistent with the assumption that it failed in fatigue. One would, however, expect that a fracture produced by alternating stresses

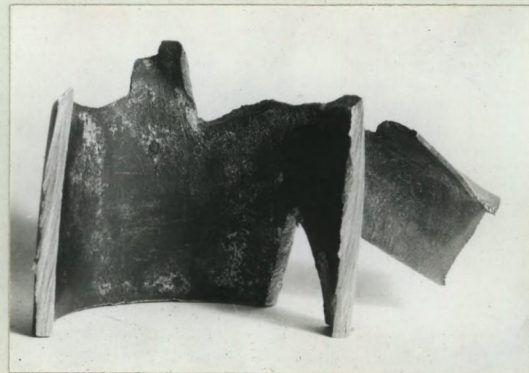
Figure 2.

Spar fracture.

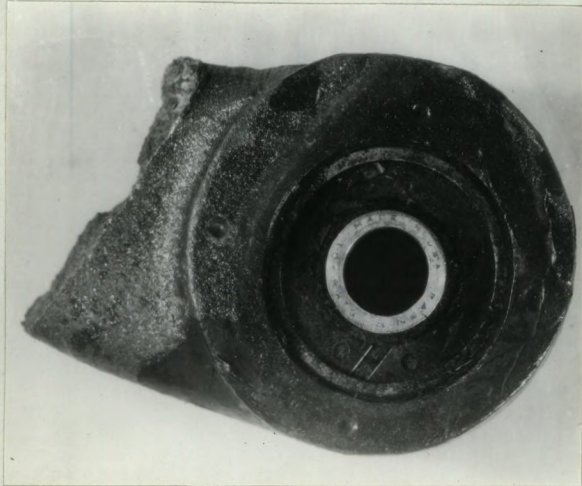
Figure 3.

Hinge fracture.

Figure 3 shows the location of the break, while Figure 4 shows that the fracture, apart from a small bruise at one end, has a uniform appearance.

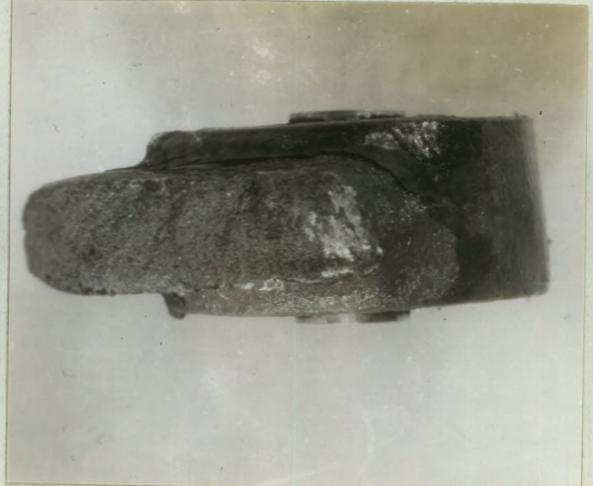
Figure 4.

Hinge fracture.

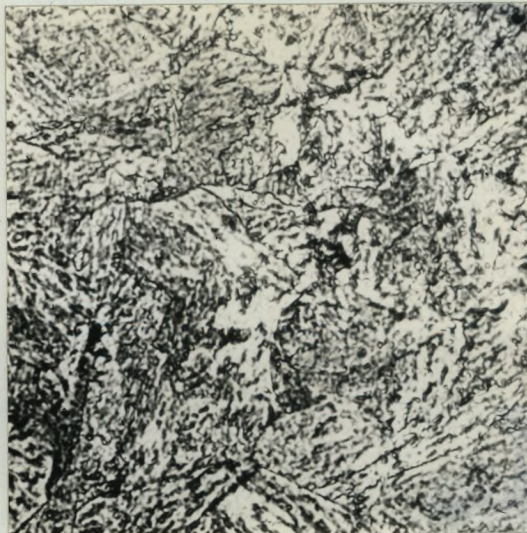
Figure 5.

In Figure 5 the steel structure is shown at X1000 magnification. The structure is finely pearlitic and contains some ferrite.

The structure of the steel is normal for X4130 steel. This also applied to the welded areas examined. The magnesium-alloy structure is that produced by a solution heat-treatment. Inasmuch as this treatment confers better ductility than the solution-and-ageing treatment without lowering the fatigue strength perceptibly, it would seem that the hinge material has received the best possible heat treatment. The single-phase material would also be expected to have a better corrosion resistance.

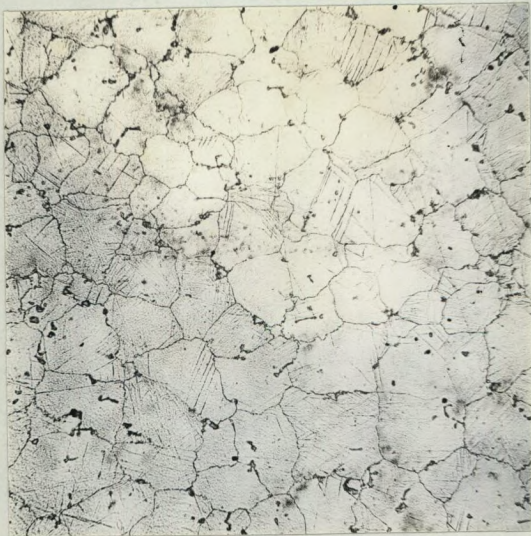
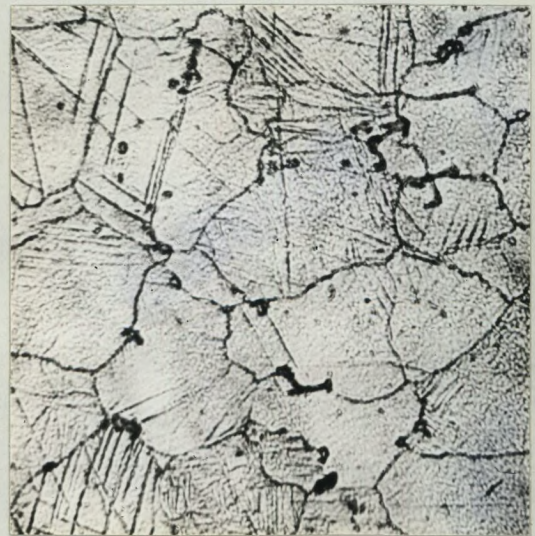
Figures 6 and 7, at X100 and X250 magnification respectively, show the structure of the magnesium alloy.

MAGNESIUM ALLOY.

These figures show that the alloy is a single phase,

all constituents being in solution.
