January 21st, 1942.

ORE DRESSING AND METALLURGICAL LABORATORIES.

Investigation No. 1150.

Examination of a Universal Carrier
Track Link.

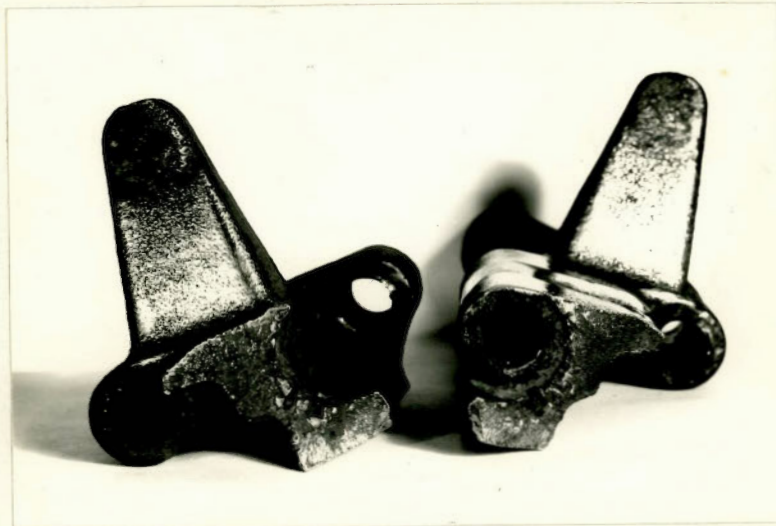
Figure 1.

The failure occurred diagonally at the base of one of the lugs. Figure 1 shows the appearance of the fractured surface. The link was allowed to remain on the track for some time after it was broken, since a good portion of the rough surface has been worn smooth by friction.

APPEARANCE OF FRACTURED CASTING.

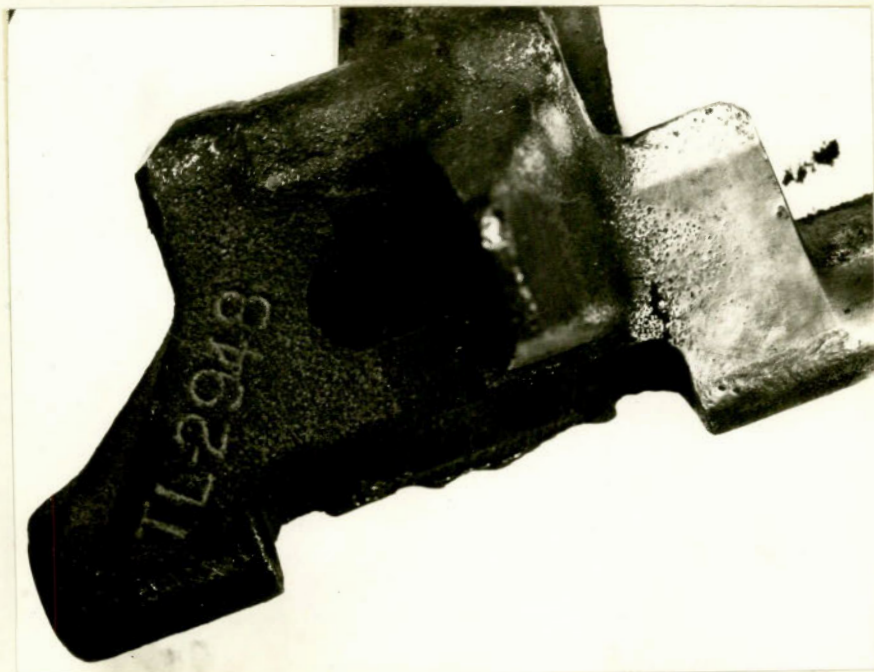
Further visual examination revealed a very slight crack near the opposite lug at a position similar to that where the actual failure occurred. This part of the broken casting was then magnafluxed and the actual length of the crack was revealed, as shown in Figure 2. The relative position of the crack with respect to the lug is shown in Figure 3.

CRACK REVEALED BY MAGNAFLUX.

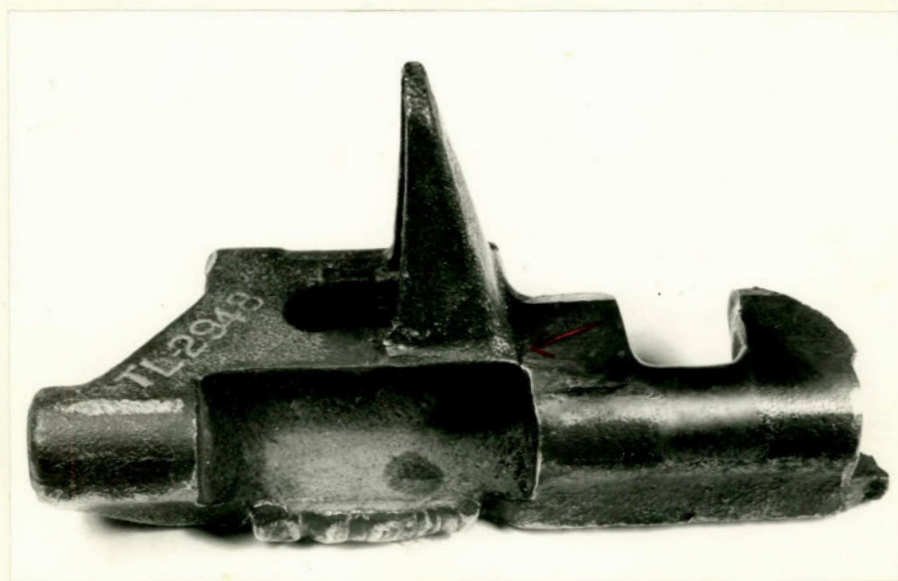
Figure 3.

Relative Position of Crack Shown
in Figure 2.

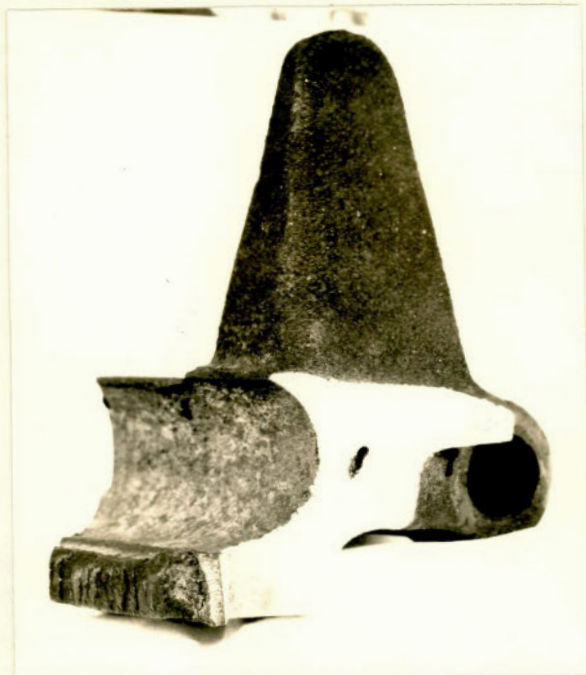
Figure 4.

An X-ray examination was made by Dr. G. C. Laurence of the National Research Council, Ottawa. Two shrinkage cavities were indicated. One of these, at the angular region at the base of the projecting lug, corresponds to the region where the break occurred and is evidently the cause for the appearance of the crack shown in Figure 2. Figure 4 reveals this shrinkage cavity. The other cavity shown by the X-ray is at an identical position on the opposite side of the bearing.

SHRINKAGE CAVITY.

THE FLAWS REVEALED BY THE X-RAY ARE SHRINKAGE CAVITIES. THE CAVITY SHOWN IN FIGURE 4 OCCURS AT A POSITION IN THE CASTING SIMILAR TO THAT WHERE THE FAILURE OCCURRED. Shrinkage cavities are frequently encountered in castings and it is necessary to eliminate them by changing the casting technique, since they obviously reduce the strength of the casting. This can be done by:

- (1) Gating, so as to supply hot liquid metal under pressure to the section while it is solidifying; or
- (2) Using metal chills in the mould, so as to move the shrinkage to a point where Method (1) may be applied more easily.

1. X-rays of the cast links should be taken at certain time intervals, especially at the beginning of

a new contract, to detect any flaws which might give way in use.

2. A proof test should be applied, such as dropping a certain load on an assembly of a number of links and removing those which cannot withstand the load.

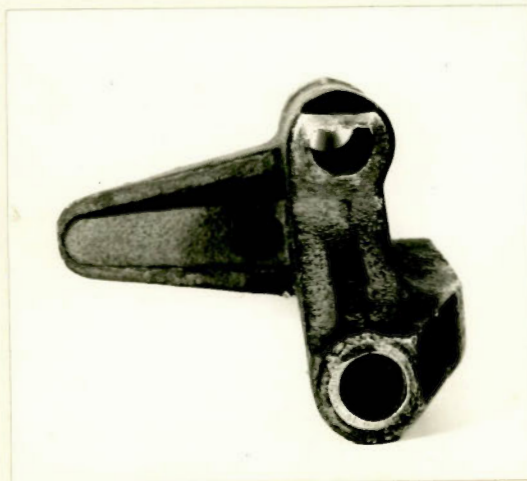
Figure 5.

Figure 5 shows that the result of this test was excellent.

The results of the hammer test would indicate that the steel possesses a fair degree of ductility.

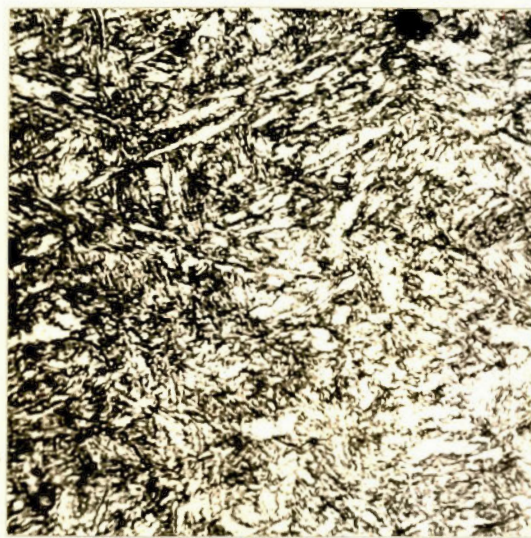
Figure 6.

A specimen was cut from the fractured surface and subjected to microscopic examination. Figure 6, at X1000 magnification, shows a structure characteristic of an alloy steel quenched and tempered to a fairly high hardness.

SURFACE STRUCTURE.

Analysis and microstructure show the metal to be of a satisfactory grade of steel. The hardness obtained (403 Vickers) should give a good wear-resistant material. The photomicrograph, Figure 6, reveals that the casting has been adequately heat-treated.
