ORE DRESSING AND METALLURGICAL LABORATORIES.

Investigation No. 1158.

Examination of Cracked Manganese Steel
Tractor Pad Casting.

CANADA
DEPARTMENT
OF
MINES AND RESOURCES
MINES AND GEOLOGY BRANCH

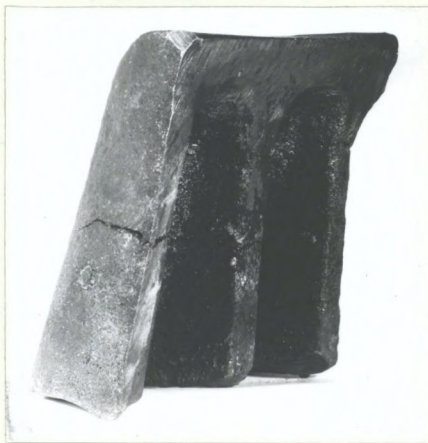
Figure 1.

Figure 1 is a picture of the cracked piece, showing the location of the cracks. Note that these cracks are in the ribs, in the neighbourhood of the heavier mass of metal at the end.

The fact that the metal in the immediate vicinity of the large cracks is much harder and there is evidence of decomposition of the austenite would indicate that the cracks reached their present state during quenching. This assumption would not be valid if this casting had been in service.

The design is one that might be expected to be subject to high casting stresses where these cracks occurred. Since this metal is very brittle in the "as cast" condition, it would tend to be sensitive to stresses caused by this type of design.

CRACKED PIECE,
AS RECEIVED.
(Approximately 1/2 size).

1. The rate of heating in the heat-treatment furnace should be investigated. Too fast heating may be the source of trouble.
2. The design of the casting should be investigated, with a view to the possibility of making metal sections more uniform.
3. The possibility of minimizing casting stresses by means of gating or the use of chills should be investigated.
4. The hot strength of the moulding sand should be determined. If too high, this could cause trouble.
5. The method of quenching (flat or on edge) should be noted. Edgewise quenching, where possible, is recommended.

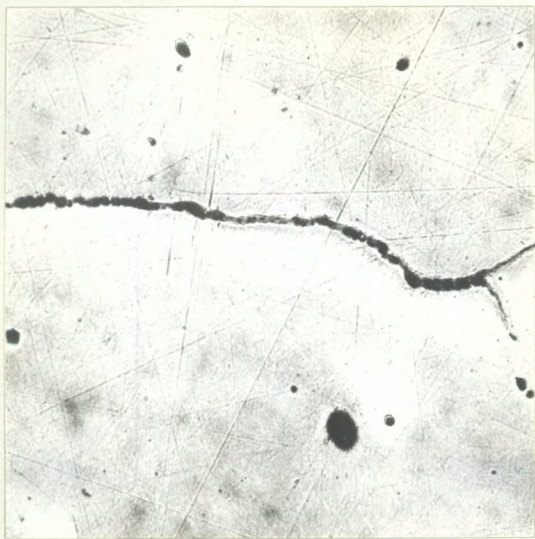
Figure 2 is a photomicrograph at 200 diameters, etched in picral, showing the general structure of the metal and also a small crack occurring on a grain boundary. This particular view is from a location at the base of one of the ribs.

Physical testing indicates that the hardness is correct. This, coupled with microscopic examination, indicates that the quenching temperature and the soaking period are correct. Note the austenitic structure in Figure 2.

The small crack shown in Figure 2 may be an example of how these cracks originate. These small cracks have two possible sources of origin: either in the casting process or in the heating prior to quenching.

If the casting were placed in a hot furnace, or heated very quickly to the quenching temperature, internal stresses would be induced. The metal in the interior would be subjected to tensile stresses. This condition could result in small intergranular cracks such as those shown

in Figure 2.

X200, picral etch.
GENERAL STRUCTURE OF METAL.
(Note small crack on
grain boundary.)

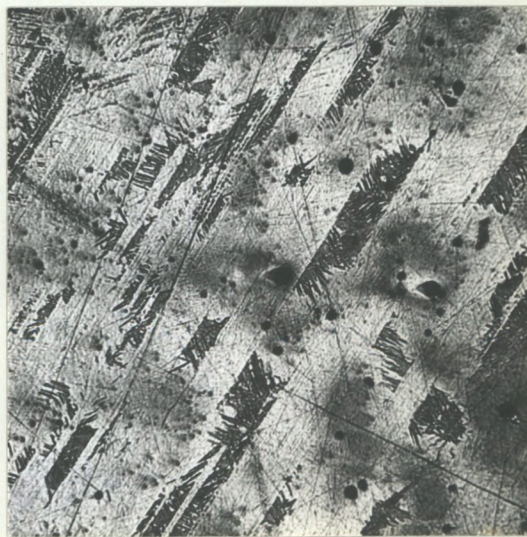
Figure 3.

In the immediate vicinity of the very wide cracks this hardness went up to as high as 397.

Figure 3 is a photomicrograph at 200 diameters, etched in picral, showing the condition of the metal in the vicinity of the very wide cracks. Note that the austenite has started to decompose.

X200, picral etch.
CONDITION OF METAL IN
VICINITY OF WIDE CRACKS.

It is also possible that the method of introduction into the quenching bath may have some bearing on this condition. It is advisable, whenever possible, to quench flat castings edgewise. This will minimize quenching strains.
