February 13th, 1942.

ORE DRESSING AND METALLURGICAL LABORATORIES.

Investigation No. 1164.

Examination of Tracer Body Tubes
(Tracer No. 12).

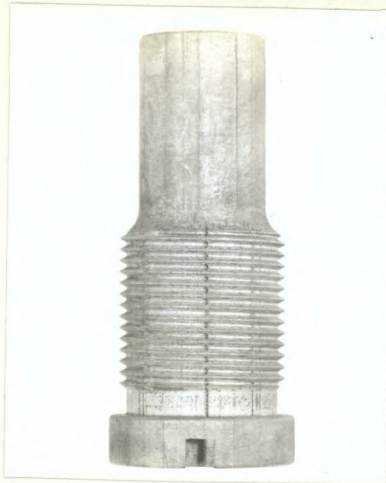
Figure 1.

The parts were carefully examined as received and also subjected to magnaflex inspection. No cracks were detected. However, faint "ghost lines" were seen under the plating.

The parts were next subjected to hot macro-etching in 50 per cent hydrochloric acid. Figure 1 depicts the results. There would appear to be seams or bands of material subject to preferential attack by acid.

Apparently the "ghost lines" that gave rise to the supposition of cracks were caused by some preferential plating action due to the banded microstructure of the metal. This banded structure would also be the cause of the appearance after macro-etching.

Hot etched in 50% HCl.
(Natural size).

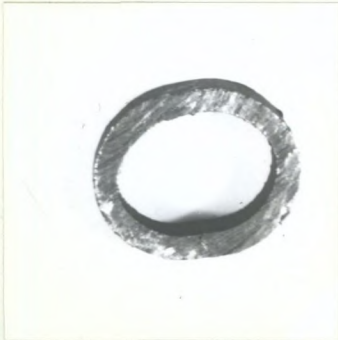
Figure 2.

Two rings were cut from the small end of one of the tubes, below the internal threads. One of these rings was normalized at 1650° F. for 20 minutes. Both were squeezed in a vise until cracks appeared. The results are shown in Figures 2 and 3.

The benefits of this normalizing treatment are quite evident in Figures 2 and 3. Figures 4 and 5 show how the structure is improved. There does not appear to be any undue segregation of the sulphides.

RESULTS OF SQUEEZE TEST,
BEFORE NORMALIZING.
(Natural size).

If the service requirements of these parts are even moderately severe, performance could be improved by normalizing at 1650° F. for 20 minutes.

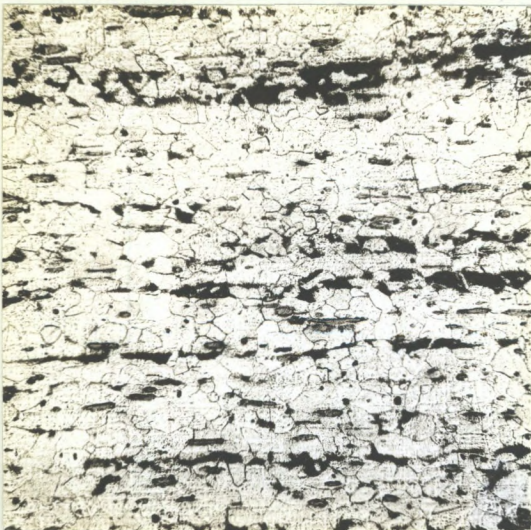
Figure 4.

Figure 4 shows the characteristic structure existing in the material in the condition submitted for examination. Note that it is composed of wide bands of ferrite containing numerous sulphide inclusions and much narrower bands of the normal ferrite-pearlite structure.

X100, picral etch.
MICROSTRUCTURE AS RECEIVED.

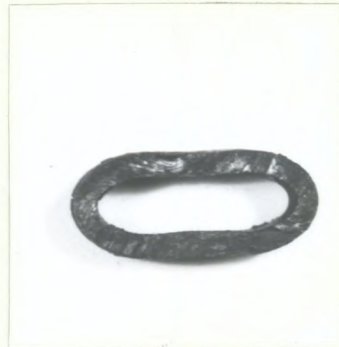
Figure 3.

RESULTS OF SQUEEZE TEST,
AFTER NORMALIZING AT 1650° F.
(Natural size).

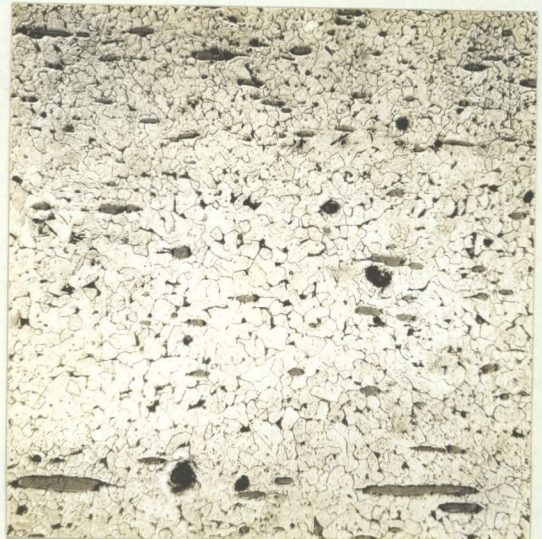
Figure 5.

Figure 5 shows that the normalizing treatment has broken up the banded structure.

X100, picral etch.
MICROSTRUCTURE AFTER NORMALIZING.
