March 4th, 1942.

ORE DRESSING AND METALLURGICAL LABORATORIES.

Investigation No. 1171.

Examination of a Cracked Spigot on the Barrel
of a 3-Inch Trench Mortar.

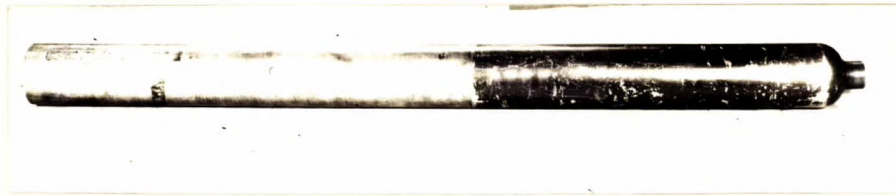
Figure 1.

Figure 1 shows the barrel submitted for examination. Figure 2 is a "close-up" of the cracked end, showing the nature and position of the crack.

3-in. Trench Mortar Barrel, 1/10 size.

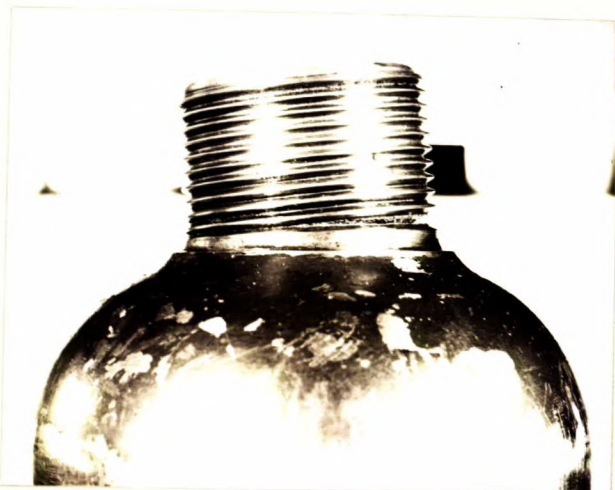
Figure 2.

On February 21st, 1942, a 3-in. trench mortar barrel was received from Mr. H. H. Scotland, of The Inspection Board of the United Kingdom and Canada, 58 Lyon Street, Ottawa. The spigot (see Figure 2) was cracked at the base of the threads.

Photograph showing crack in spigot. Natural size.

2. Care should be taken that the base of the thread be not absolutely sharp. It should have a slight radius. This point is fully as important as is proper design, since sharp angles or notches can cause a concentration of stresses that may cause an otherwise properly designed section to fail.

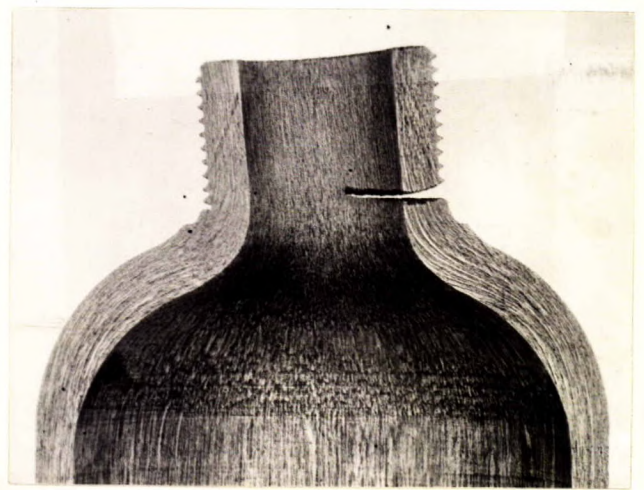
The spigot end was cut off and slit. One half was etched in 38 per cent HCl, 12 per cent H₂SO₄ for 2 hours, to develop the forging pattern. This is shown in Figure 3.

The macro etching indicates good forging practice. This is also confirmed by both the microscopic examination and the physical tests.

Macro etch of forged end, showing lines of flow. Natural size.

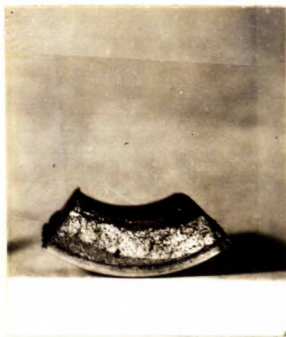
Figure 4.

Figure 4 shows a portion of the fractured surface. It would seem that this crack was developing for some time.

The crack is the type of failure one would expect from impact, occurring as it does at the root of a thread. It would appear from Figure 4 that the crack developed over a period of time, probably indicating fatigue impact failure. The staining on the cracked surface might be due to some other cause, however.

Photograph of surface of fracture.

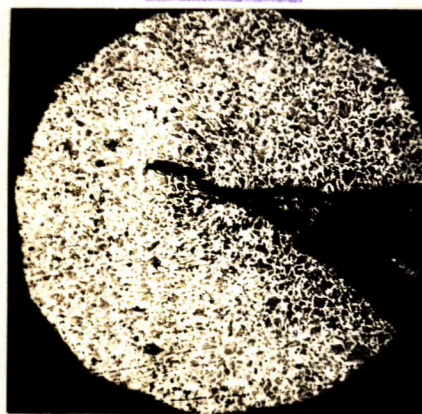
Figure 5.

Figure 5 is a macrophotograph, taken at 40 diameters, showing a crack developing at the base of a thread. This is taken on the side of the spigot opposite to where the actual failure occurred.

It is evident, from Figure 5, that cracks have commenced to develop all around the circumference of the spigot, since this area is opposite the visible failure. This condition could be caused by tensile impact stresses which could originate in the firing of the gun.

Microphotograph showing crack starting at base of thread. X40, picral etch.

1. The intensity of stresses generated in the spigot metal by firing should be determined. If these stresses approach the minimum specified yield strength they are too high and the barrel should be redesigned.

3. Should the concentration of stresses be too high and redesigning not practical, a stronger material would be indicated.

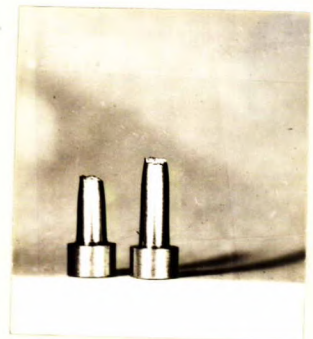
The physical properties of the metal in the forged section of the barrel were determined by means of the tensometer. Tensile test bars were obtained from the shoulder of the forged end. One of these broken bars

is shown in Figure 6. In Table II the values obtained are compared with the specifications:

Photograph of tensile tests used. Natural size.

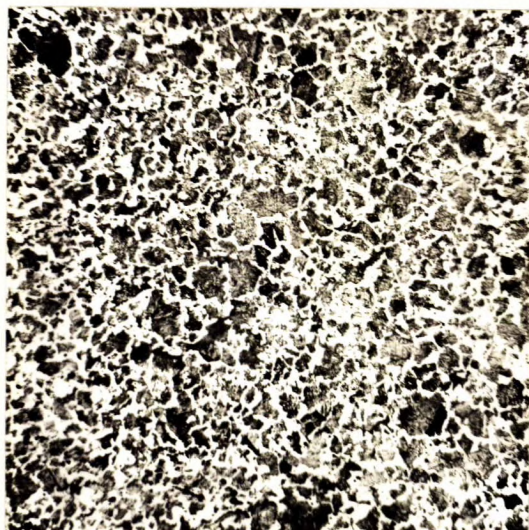
Figure 7.

Specimens for microscopic examination were obtained from both the forged and the untreated portions of the barrel. Figure 7 is a photomicrograph of the forged metal at 100 diameters, picral etch, and Figure 8 is one of the untreated metal at 100 diameters, picral etch. Note the similarity of structure.

X100, Picral etch.
MICROSTRUCTURE OF FORGED
METAL.

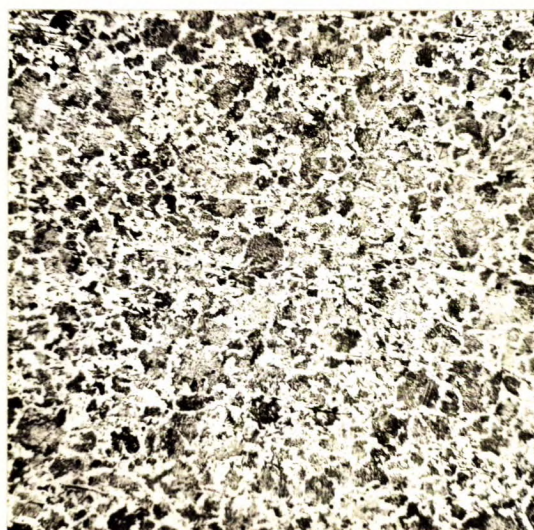
Figure 8.

X100, Picral etch.
MICROSTRUCTURE OF
UNFORGERD METAL.
