R E P O R T
of the
ORE DRESSING AND METALLURGICAL LABORATORIES.

Investigation No. 1180.

Examination of Springs,
Part No. 5277Q5.

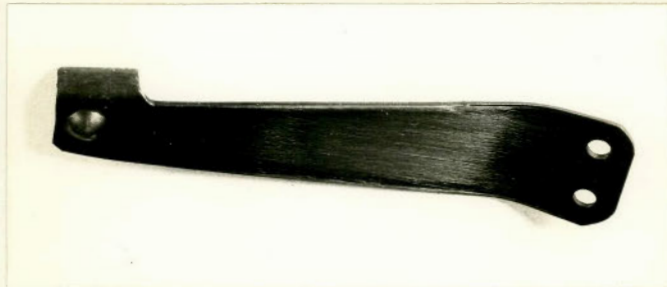
Figure 1.

in their present condition, were soft and therefore unserviceable. He requested that we determine whether the chemical analysis or the heat treatment was at fault.

PHOTOGRAPH OF SPRING, PART NO. 5277Q5.
(Natural size).

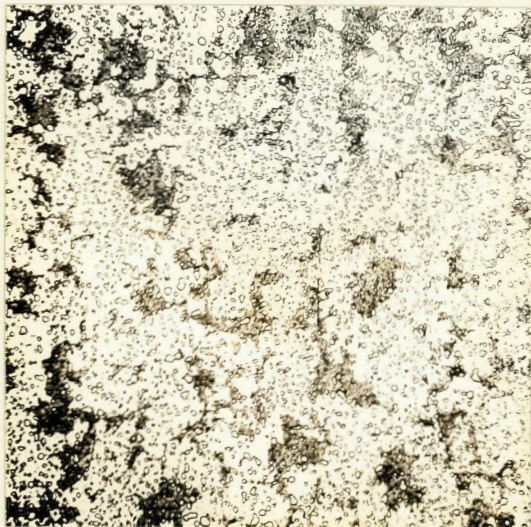
Figure 2.

Figure 2, which was taken from the soft end, would indicate that the steel was probably in the spheroidized condition for fabrication.

The presence of a little sorbite in the soft end (Figure 2) indicates that the steel in this end probably was heated to a temperature just over the AC_1 temperature. As we progress towards the hard end (Figures 3 and 4) the increasing amount of sorbite present indicates that the temperature of the steel is gradually approaching the AC_3 temperature and Figure 5 could be interpreted as meaning

X500, picral etch.
PHOTOMICROGRAPH OF SOFT END.

Proper precautions should be taken that these springs be uniformly heated to the proper quenching temperature (860°C.). This heating should be done under such conditions that the danger of decarburization is minimized.

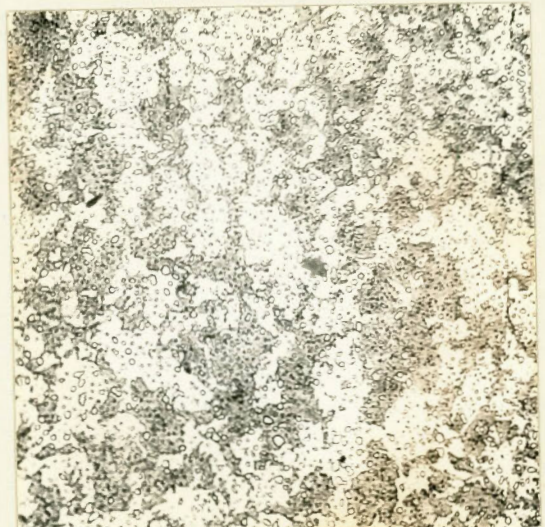
Figure 3.

X500, picral etch.
PHOTOMICROGRAPH OF INTERMEDIATE ZONE.

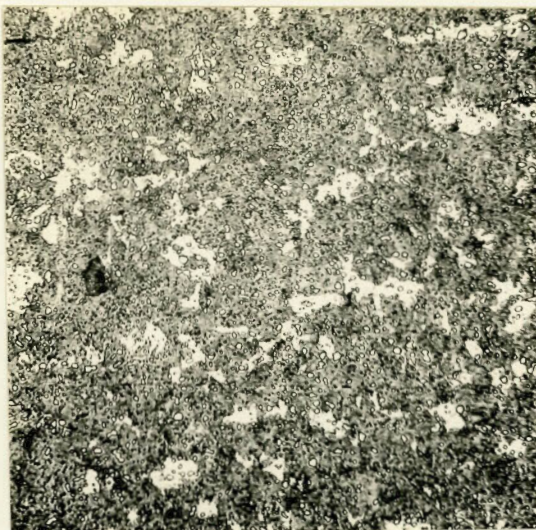
Figure 4.

X500, picral etch.
PHOTOMICROGRAPH OF
INTERMEDIATE ZONE.

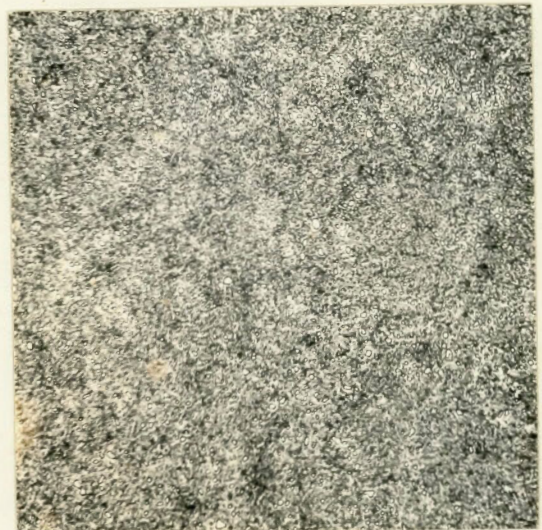
Figure 5.

An examination of Figure 5 reveals that, while the metal in this area is entirely sorbitic, there still remain some undissolved spheroidized carbides. This could mean that the steel in this area was not held at the quenching temperature for a long enough period of time to dissolve all the carbides.

that the temperature of the steel in the hard end had exceeded the AC_3 temperature slightly.

X500, picral etch.
PHOTOMICROGRAPH OF HARD END.
