R E P O R T
of the
ORE DRESSING AND METALLURGICAL LABORATORIES.

Investigation No. 1184.

Examination of Welding Failure on a
Cessna Aircraft Control Elevator Walking Beam.

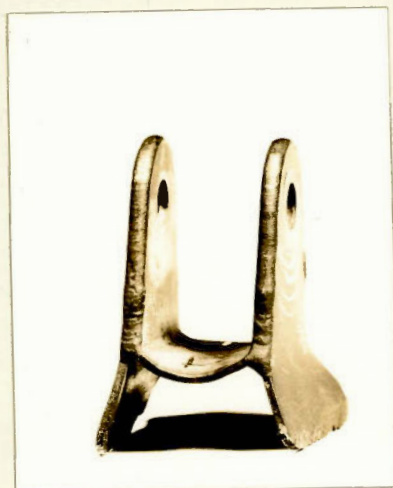
This part is shown in Figure 1.

Two small portions were cut out of the broken edge of the loose clip and mounted in bakelite for hardness tests and microscopic examination.

An average hardness value of 259 Vickers was obtained, using a 5-kilogram load. There were no distinct hard or soft areas.

The hardness of the metal adjacent to the weld in the loose clip is normal for X4130 steel. It would, therefore, not be reasonable to expect that failure had occurred because of a brittle hard weld.

2. Microscopic examination of the area where failure occurred in the loose clip reveals evidence of dirty welding.

3. Microscopic examination of the area where failure occurred in the loose clip shows that failure took place between the weld metal and the clip.

4. There is no evidence that failure occurred because of hard brittle weld metal.

Broken Clip (natural size) tagged as follows:

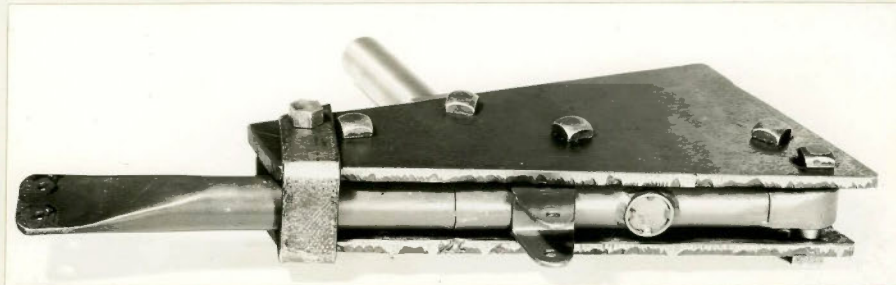
A special jig was constructed to hold the beam for testing. This is shown in Figure 3. For the actual test the lower half of the beam was not used but was replaced by a solid steel rod which was driven up into the upper part of the beam. Additional clamps were put on

about $\frac{1}{8}$ inch on either side of the clip. The load was applied through a 7/36-inch diameter drill steel pin inserted through the holes in the clip. At a load of 6,822 pounds this pin sheared off, without damaging the weld.

The sample of welding done on the complete control elevator walking beam is good. It forms one of the strongest parts of the assembly.

1. The weld joining the clip to the control elevator walking beam in the complete assembly tested is satisfactory.

Jig for holding walking beam for testing.
($\frac{1}{2}$ actual size)

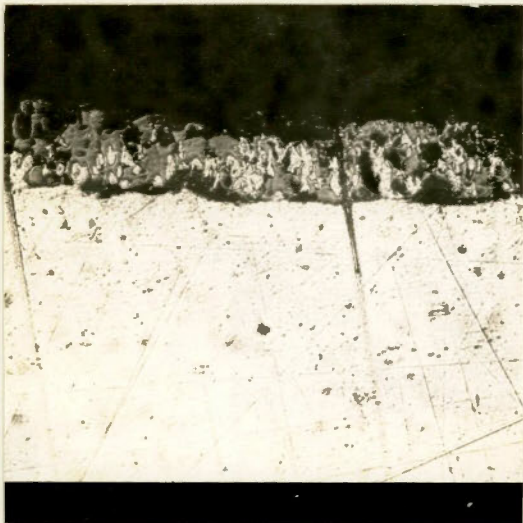
Figure 4 is a photomicrograph taken at 200 diameters magnification showing a fragment of slag, containing some weld metal, clinging to the face where failure occurred on the loose clip. Figure 5 is the same area, at 200 diameters, etched in picric acid. Figure 6 is again this area, at a magnification of 1,000 diameters.

Microscopic examination gives a clue as to why failure may have taken place and at what point in the weld this failure occurred. Evidence of dirty welding is clearly visible in the slag inclusion in Figure 4. Figure 5 shows that the face to which this slag is attached is the surface of the X4130 steel clip where it comes in contact with the weld metal. Failure, then, took place at the clip-weld interface. Note the characteristic martensitic structure present in the surface metal of the clip.

Photomicrograph X200,
as polished, showing
fragment of slag on
metal-weld interface.

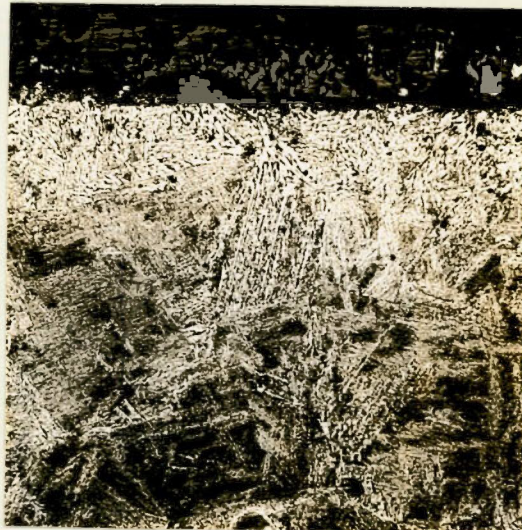
Figure 5.

Photomicrograph, X200.
Same as Figure 4
picral etch.

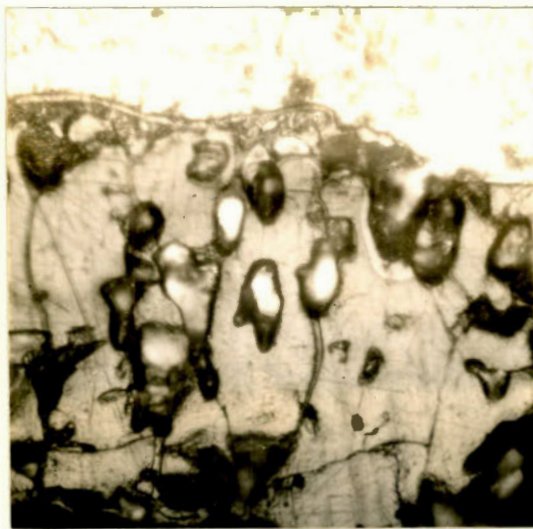
Figure 6.

Photomicrograph, X1000,
of slag found on metal-
weld interface.
