March 19th, 1942.

ORE DRESSING AND METALLURGICAL LABORATORIES.

Investigation No. 1185.

Examination of Boeing Aircraft  
Casting 28-L-054.

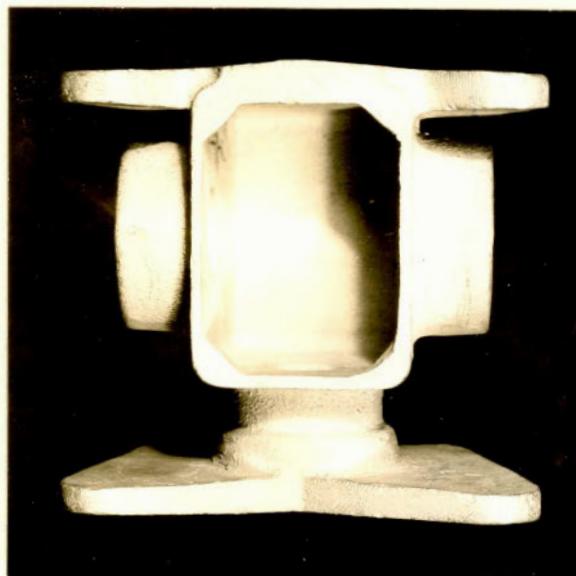
Figure 1.

The letter stated that the castings had been made about a year ago by the Robert Mitchell Company and that on being examined prior to installation cracks have been observed in the thin section. Due to aging the physical properties may

have changed, which may have released the shrinkage stresses, hence the cracks. The thin-walled section, in contrast to the thick adjacent section, contributes substantially to the fault and is an obvious defective design.

Casting as received.

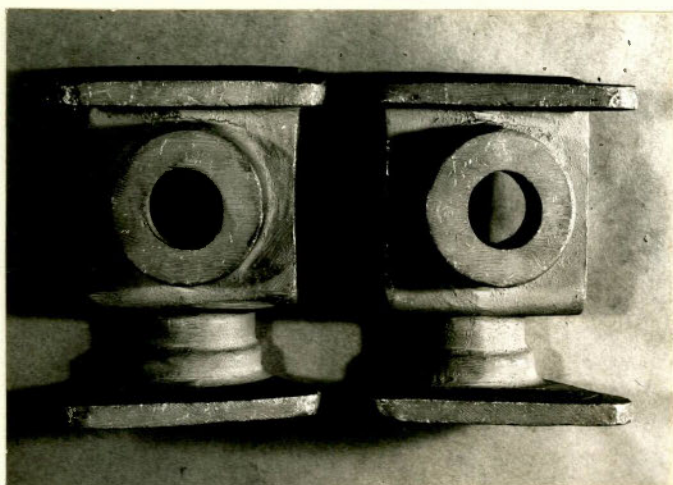
Figure 2.

Cracks on the outside surfaces.  
(Approx. 1/3 size).

As mentioned in the accompanying letter, the casting has a very poor design. The considerable contrast in the thickness of adjacent sections should always be avoided if at all possible, more especially in castings intended for heat treatment.

2. The cracks in the casting were due primarily to faulty design, which caused internal shrinkage stresses in the casting by unequal cooling rates, aggravated by additional stresses from the heat treatment. The cracking during the storage period can be attributed to the progress of the aging.

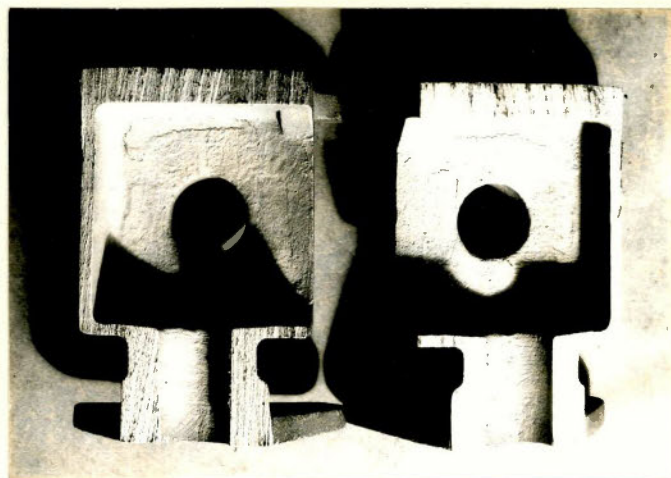
Figure 3.

Cracks on the inside surfaces.  
(Approx. 1/3 size).

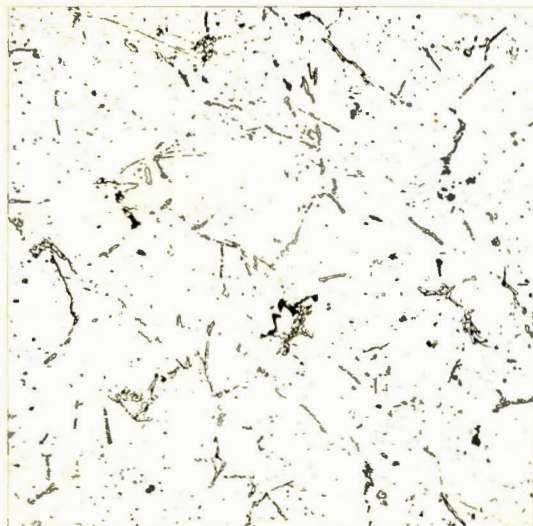
Figure 4.

Figures 4 and 5 show the average microstructure of the casting, normal for this type of aluminium alloy. There is a relative high amount of undissolved  $\text{CuAl}_2$  constituent.
