ORE DRESSING AND METALLURGICAL LABORATORIES.

Investigation No. 1190.

Examination of Defective Steel
in 3.7 Anti-Aircraft Gun.

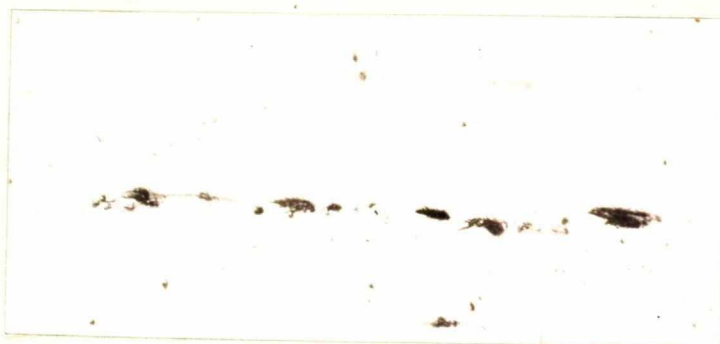
Figure 1.

Unetched surface, X200, showing seam of slag inclusions.

The above photomicrograph (Figure 1) illustrates very clearly that seams of slag are present in the metal.

Fissures present in the steel coincide with seams of slag.

Ingot condition prior to rolling should have been more carefully controlled.
