March 27th, 1942.

ORE DRESSING AND METALLURGICAL LABORATORIES.

Investigation No. 1191.

Examination of a Steel Bar which
Failed by Fatigue.

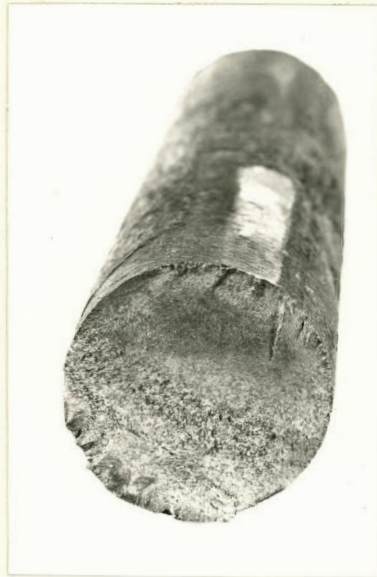
Figure 1.

The outside diameter was 1-3/8" and there was some rust and scale on the outer surface. The fracture shown in Figure 1 is a typical fatigue fracture.

This investigation has shown that this steel failed by corrosion fatigue.

FATIGUE FRACTURE
(Approximately to size).

(1) Machining the bars to obtain a smooth surface, or

(2) By shot blasting,

Whether or not a smooth surface is obtained on the bars they should be given a protective coating.

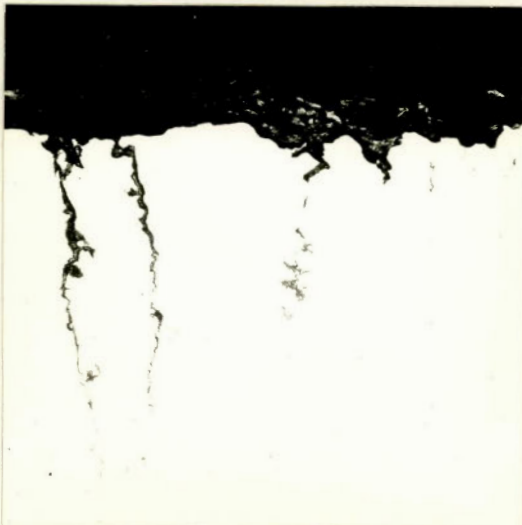
Figure 2.

A cross-section of the steel through the fracture was given a metallographic polish and examined under the microscope. Figure 2 is a photomicrograph at X100 magnification of the unetched material and shows corrosion fatigue cracks radiating from the outer surface towards the centre of the bar.

The presence of an oxide scale on the bar does not offer any protection from corrosion as the oxide is porous. When further oxidation takes place, minute pits and grooves are formed which act as "stress raisers". Under these conditions the fatigue strength of the steel is lowered as much as 12 per cent. However, it has been shown that if the bar is subjected to corrosion and repeated stresses simultaneously the fatigue limit is reduced as much as 65 per cent. Failures of this nature are known as "corrosion fatigue" failures. Figure 2 shows the progress of one of these corrosion fatigue cracks which accelerated the failure of this bar.

X100, unetched.
CORROSION FATIGUE CRACK.

1. Metal Coating; zinc or cadmium plate; zinc hot dip galvanizing.
2. Chemical Coatings; parkerizing.
3. Metal Spray Coatings; zinc or aluminium.
4. Grease on all coatings or on unprotected metal.

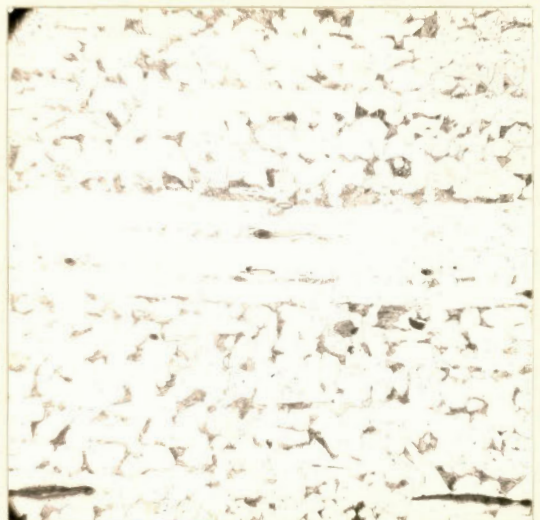
Figure 3.

Figure 3 shows the structure of the steel (at X100 magnification) after an etch in a solution of 2 per cent nitric acid in alcohol. The light areas within the grains are ferrite and the dark etching material is pearlite (the iron-iron carbide constituent). There are also some manganese sulphide inclusions present.

The material was a low-carbon steel with a fairly high inclusion content. The Brinell hardness of the steel, 107, indicates that its endurance limit is approximately 25,000 p.s.i. The observed inclusion content in Figure 3 would lower this value somewhat.

X100, etched in 2
per cent nital.
GRAIN STRUCTURE OF STEEL.

It may be possible to increase the present service life of this apparatus by the use of a better quality steel, such as plain carbon or medium alloy steel.
